Closure Report
Black River State 004H (08.16.2023)
Incident #: NAPP2324233216
Eddy County, New Mexico
Unit M Sec 05 T24S R27E
32.2409°, -104.2199°

Crude Oil Release
Point of Release: Flare fire
Release Date: 08.16.2023
Volume Released: 0.0732 Barrels of Crude Oil
Volume Recovered: 0 Barrels of Crude Oil

Re: Closure Report
Black River State 004H (08.16.2023)
Concho Operating, LLC
Site Location: Unit M, S05, T24S, R27E
(Lat 32.2409°, Long -104.2199°)
Eddy County, New Mexico

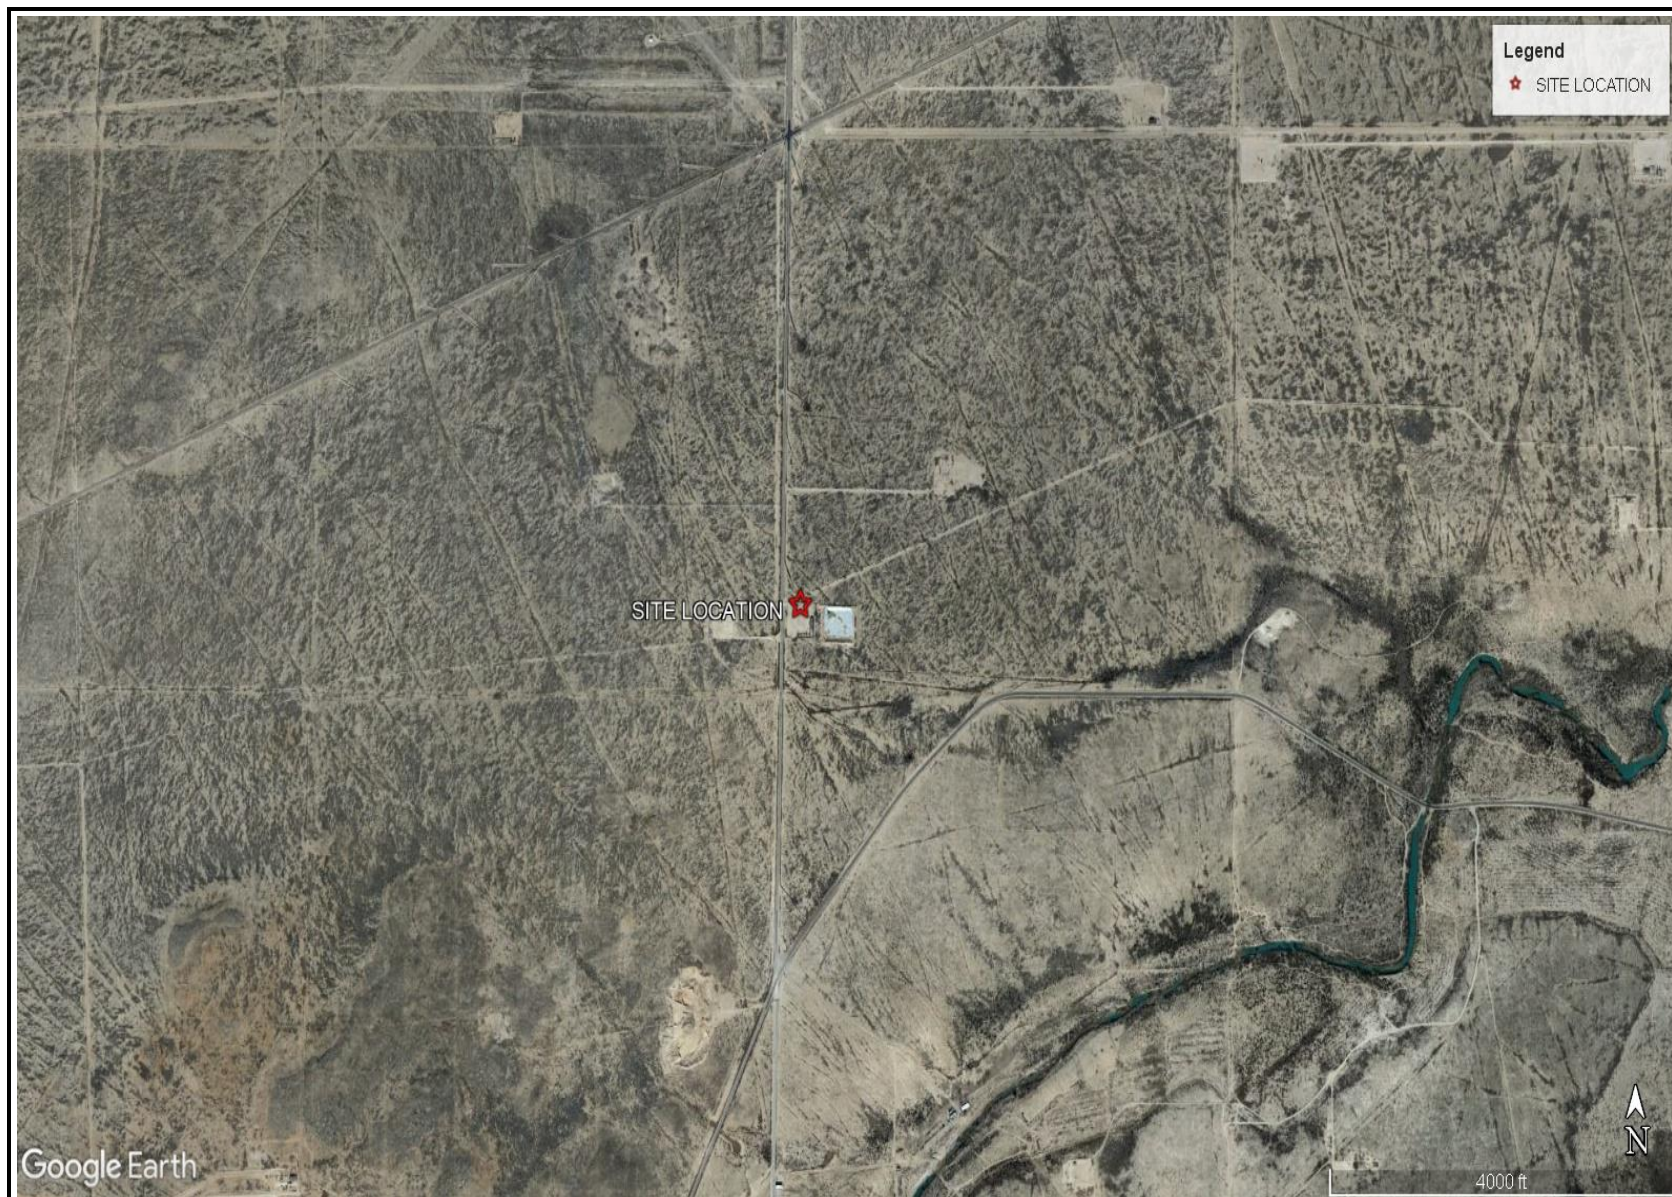
FIGURE 1

OVERVIEW MAP
COG OPERATING, LLC
BLACK RIVER STATE 004H (08.16.2023)
EDDY COUNTY, NEW MEXICO
32.2409°, -104.2199°

On behalf of Concho Operating, LLC (COG), Carmona Resources, LLC has prepared this letter to document site assessment activities at the Black River State 004H. The site is located at 32.2409°, -104.2199° within Unit M, S05, T24S, R27E, in Eddy County, New Mexico (Figures 1 and 2).

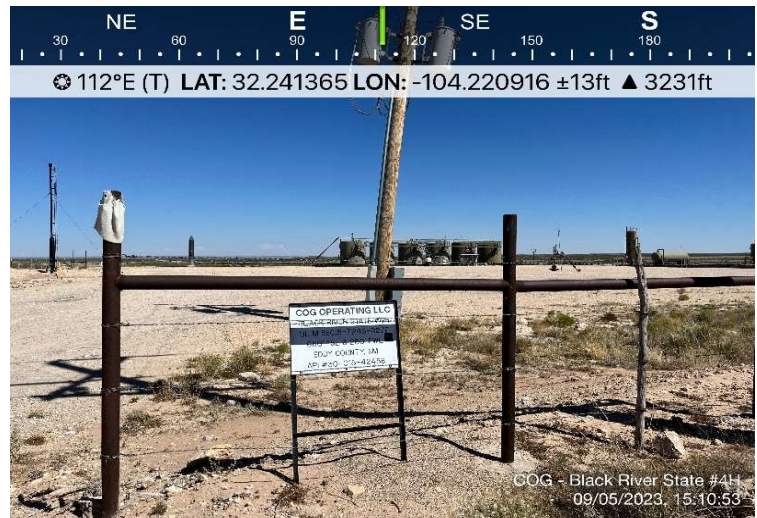
**Photograph No. 2****Facility:** Black River State 004H
(08.16.2023)**County:** Eddy County, New Mexico**Description:**
View Southeast, area of S-1.

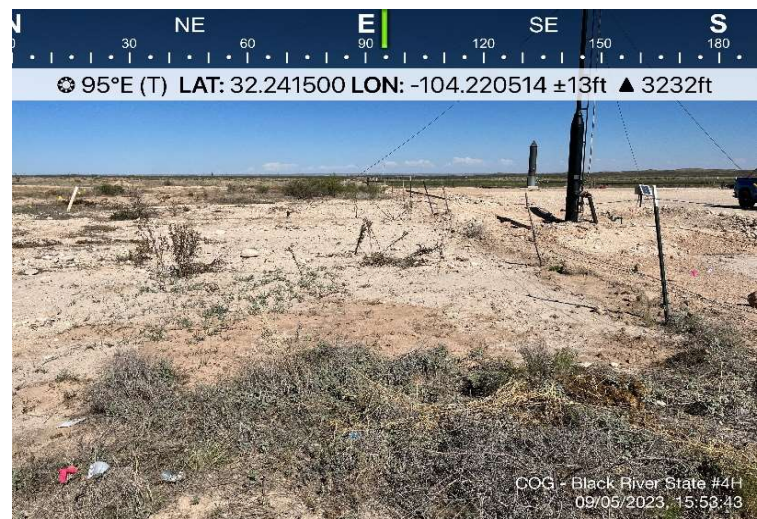
**Photograph No. 3****Facility:** Black River State 004H
(08.16.2023)**County:** Eddy County, New Mexico**Description:**
View East, area of S-1 and S-2.

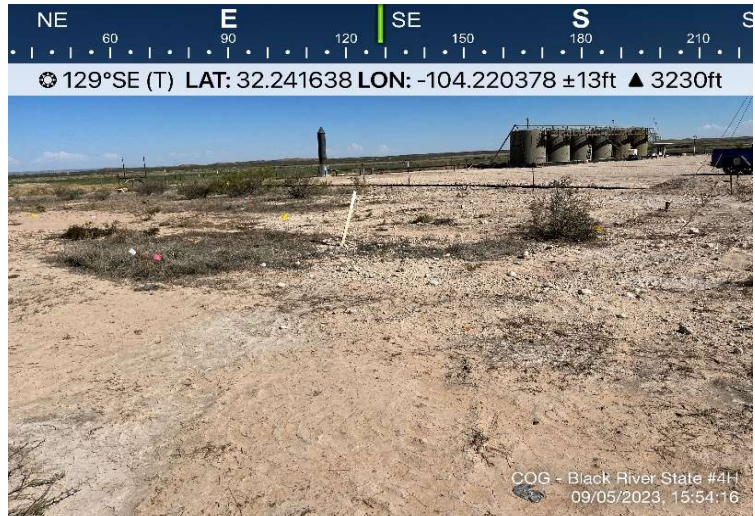
Description:
View Southeast, area of S-2.

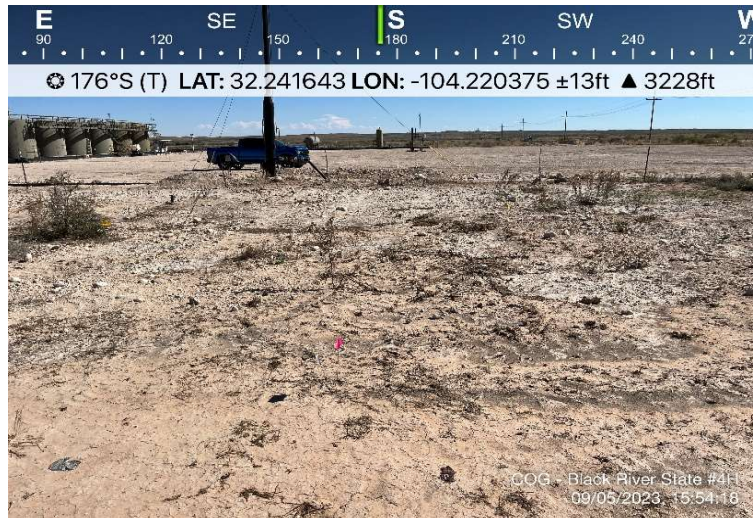
Description:
View South, area of S-3.

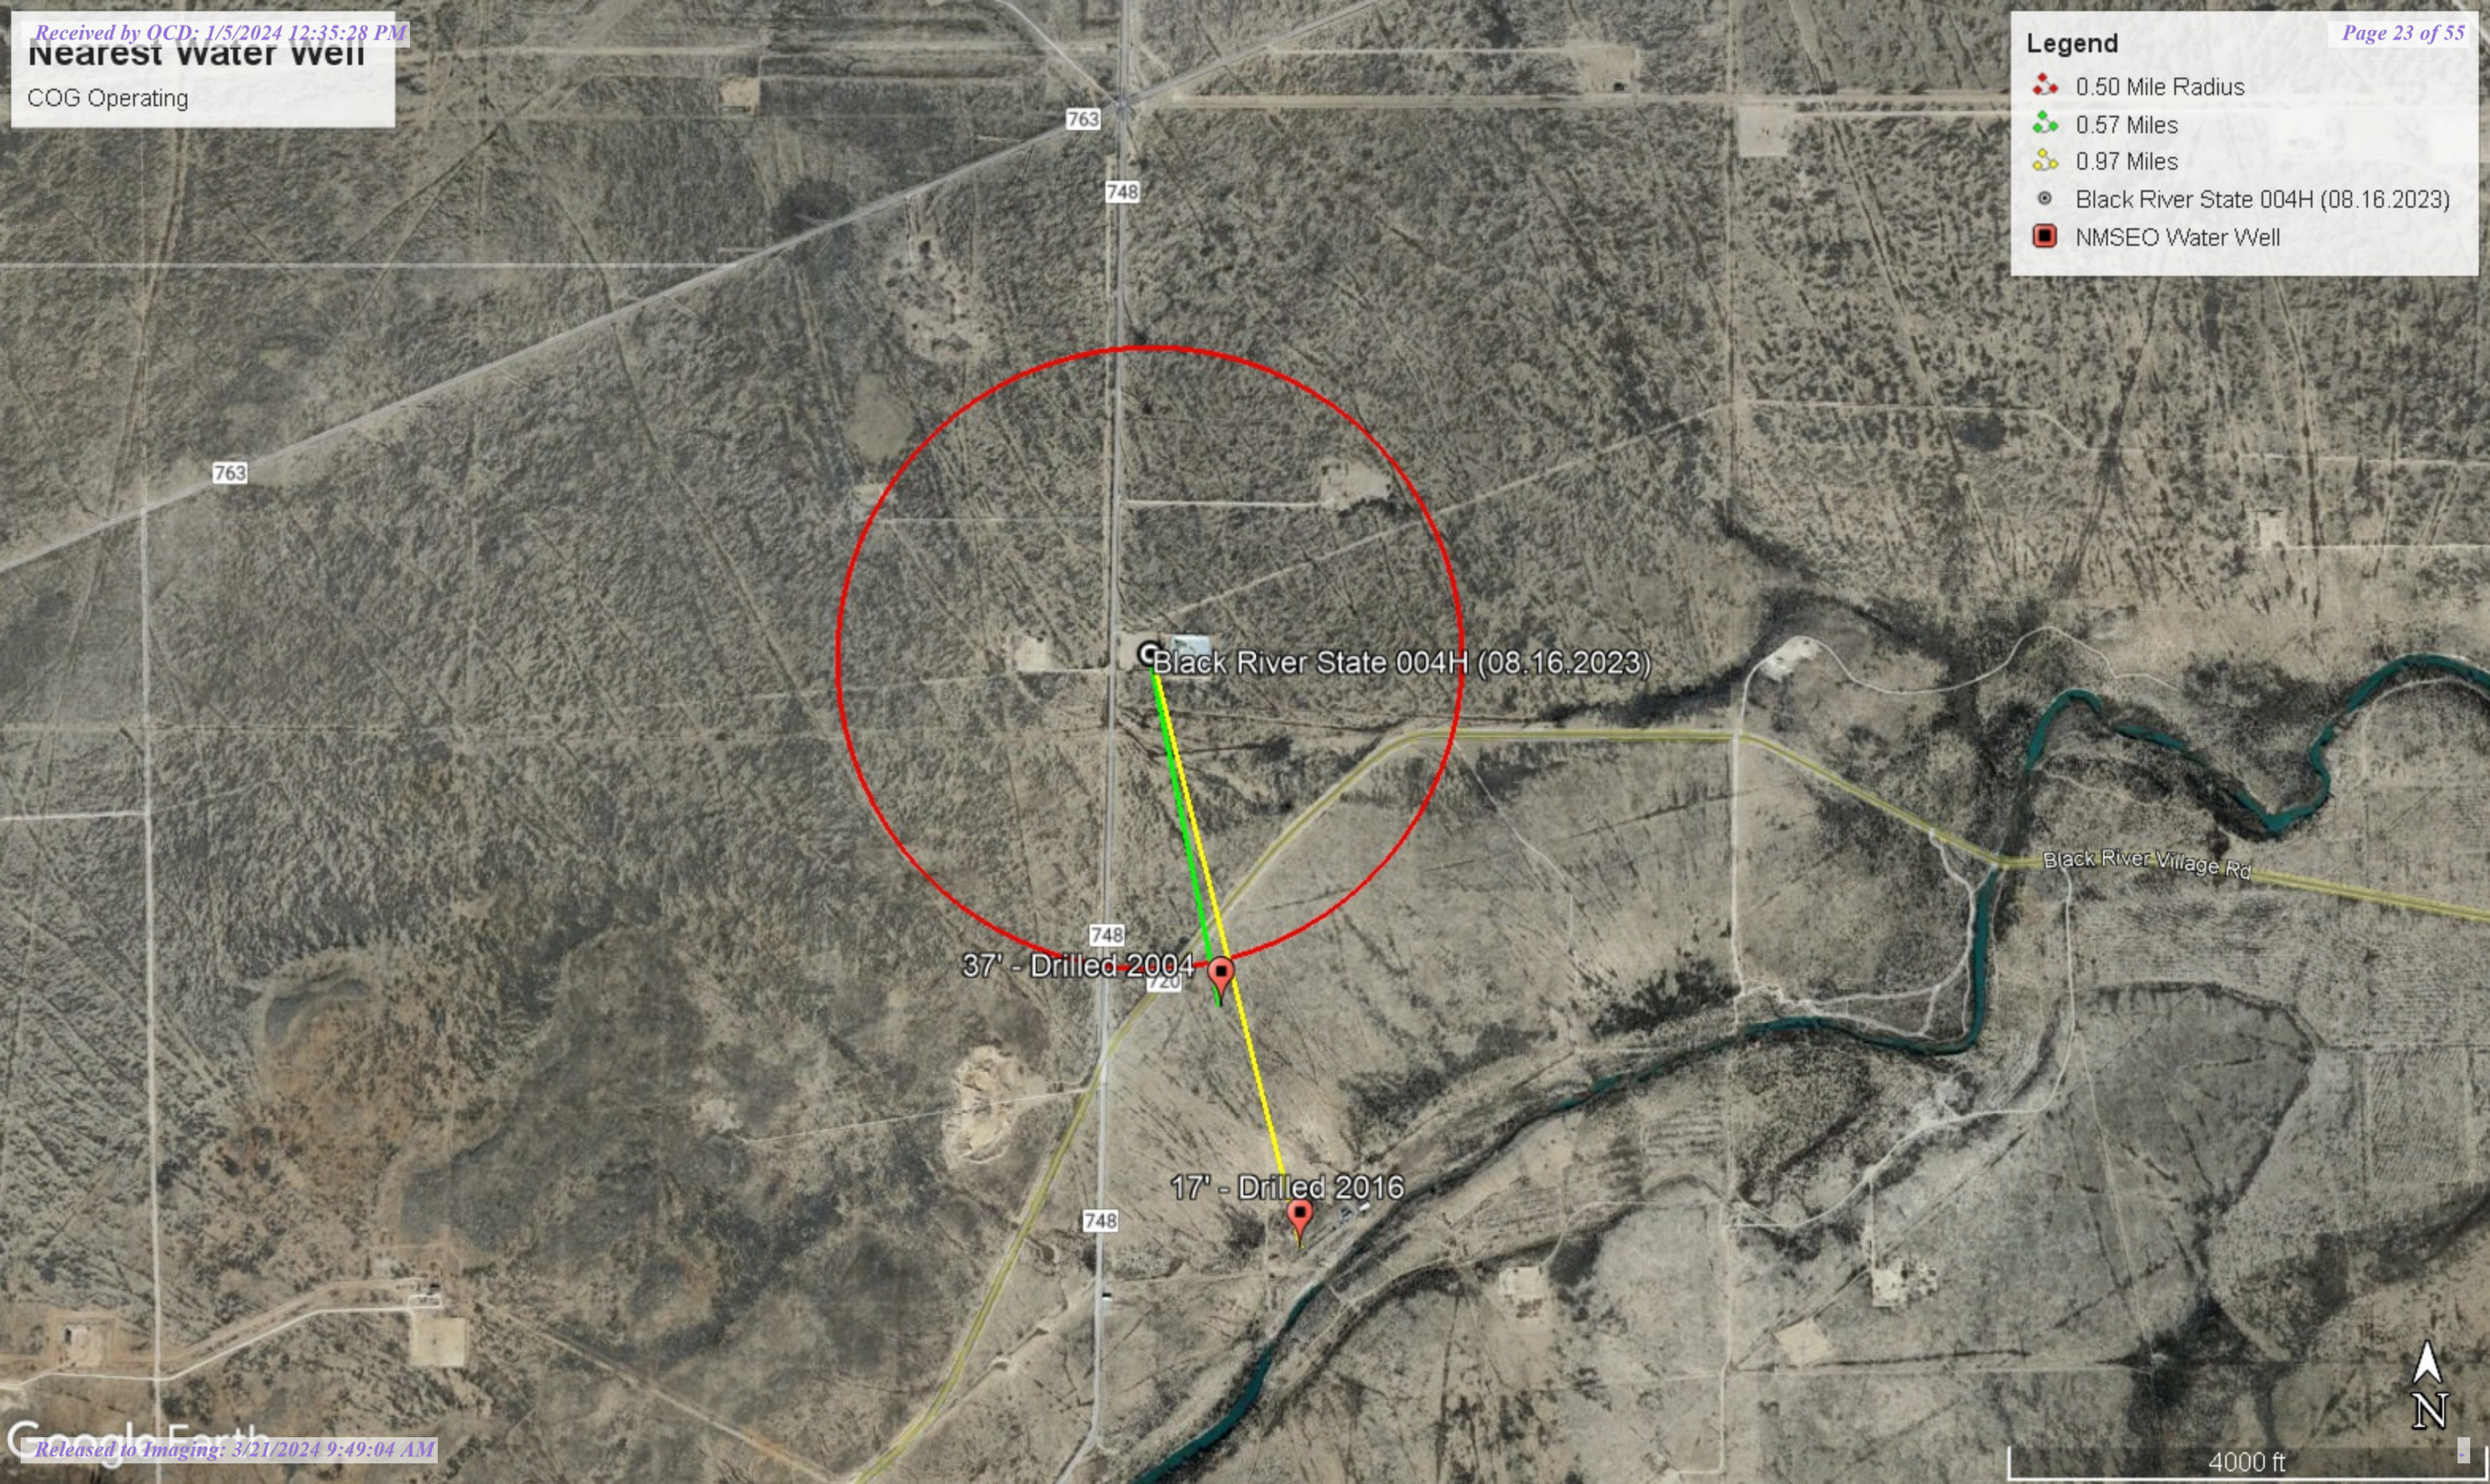
Nearest water well

The site is located within a high karst area. Based on a review of the New Mexico Office of State Engineers and USGS databases, no known water sources are within a 0.50-mile radius of the location. The nearest identified well is approximately 0.57 miles southeast of the site in S08, T24S, and R27E and was drilled in 2004. The well has a reported depth to groundwater of 37 feet below the ground surface (ft bgs). A copy of the associated Summary Report is attached in Appendix D.

- 0.50 Mile Radius
- 0.57 Miles
- 0.97 Miles
- Black River State 004H (08.16.2023)
- NMSEO Water Well
