**RE: Liner Inspection and Closure Report**  
**Bradley 8 Fee 2H Battery**  
**API No. 30-015-39811**  
**GPS: Latitude 32.66842 Longitude -104.40683**  
**UL- N, Section 8, Township 19S, Range 26E**  
**NMOCD Reference No. NAPP2328944050**

**Bradley 8 Fee 2H**

**Liner Inspection**

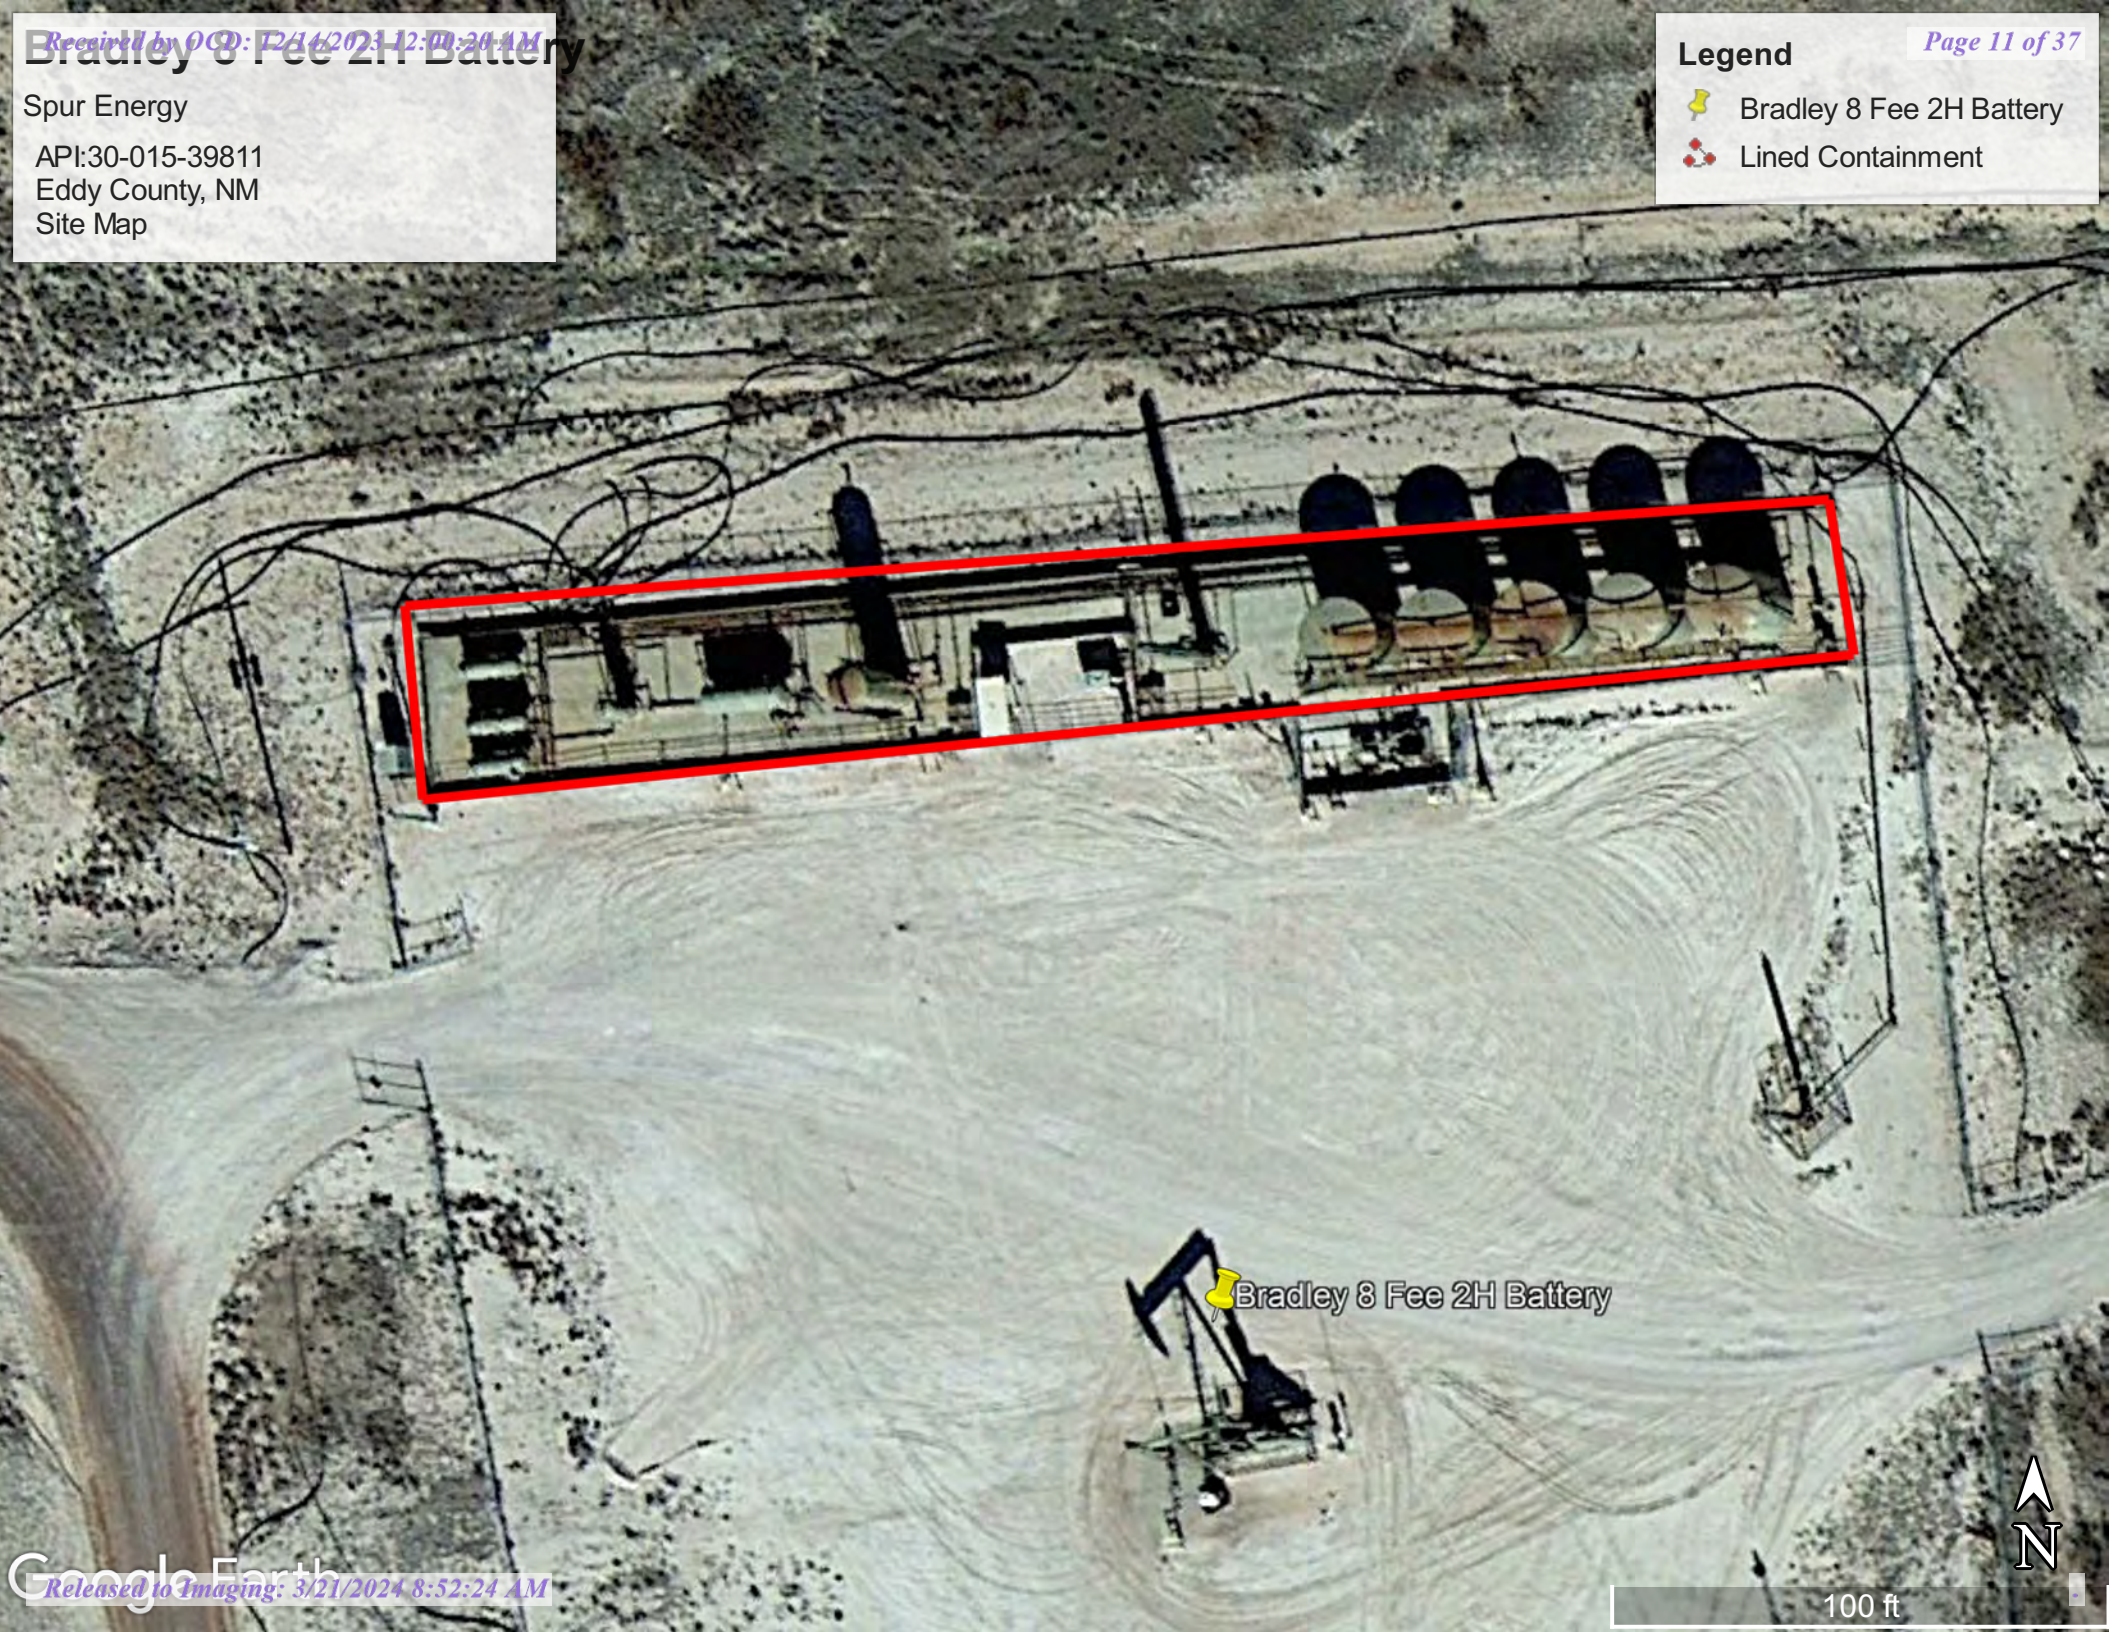
Spur Energy  
API:30-015-39811  
Eddy County, NM  
Site Map

Lined Containment

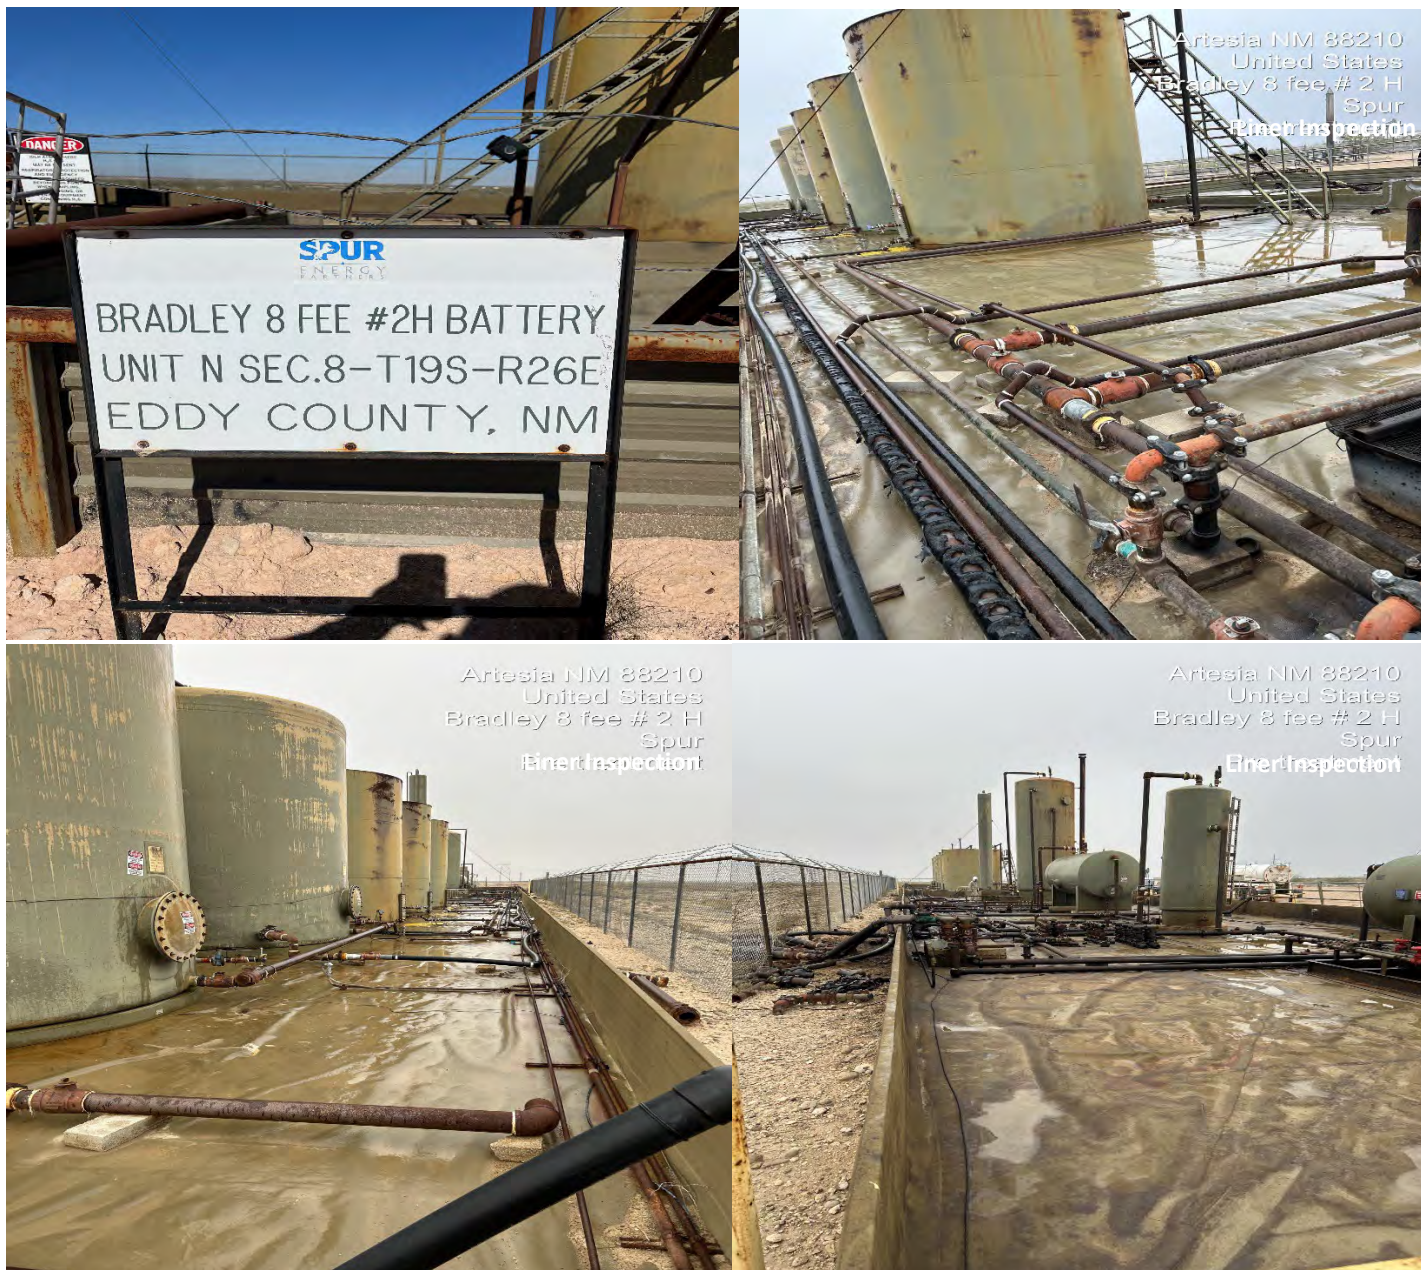
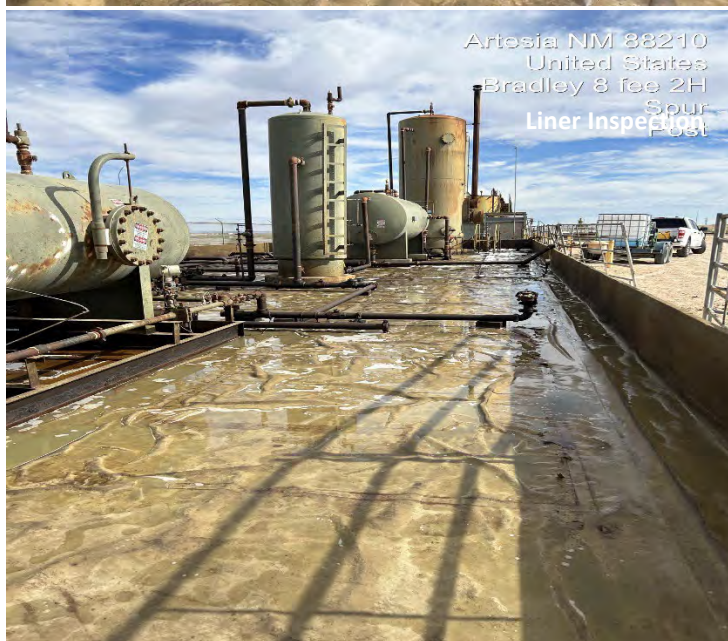
On November 17, 2023, after sending the 48-hour notification via email, Pima Environmental conducted a liner inspection at this location. We concluded that this liner and containment maintained its integrity and was able to retain the fluids. The liner inspection form and photographic documentation can be found in Appendix C.

| Visualization | Yes | No | Comments |
|---|---|---|---|
| Does the liner have integrity to contain a leak? | X | | |

| Summarize any additional remediation activities not included by answers (above) | LINER POWER WASHED AND INSPECTED, FOUND TO BE INTACT AND WORKING PROPERLY |
