Re: Site Summary Report and Closure Request

Kutz J Federal #1E
San Juan County, New Mexico
Hilcorp Energy Company
NMOCD Incident No: napp2330627962

Ensolum, LLC (Ensolum), on behalf of Hilcorp Energy Company (Hilcorp), presents this *Site Summary Report and Closure Request* associated with a produced water release at the Kutz J Federal #1E natural gas production well (Site, Figure 1). The Site is located on surface managed by the Bureau of Land Management (BLM) in Unit J, Section 1, Township 27 North, Range 10 West, San Juan County, New Mexico.

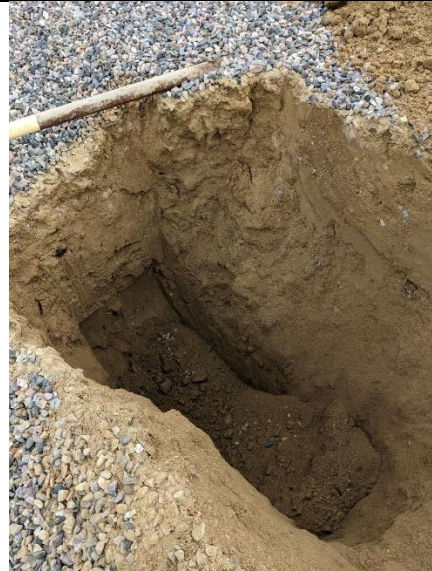
Photograph 3: 12/13/2023

View of completed pothole PH01, located directly adjacent to the site below grade tank and source of the release.
