Remediation Summary and Closure Request

Grand Banks Energy Co.

ARU #4

NMOCD Incident # nAPP2329041834

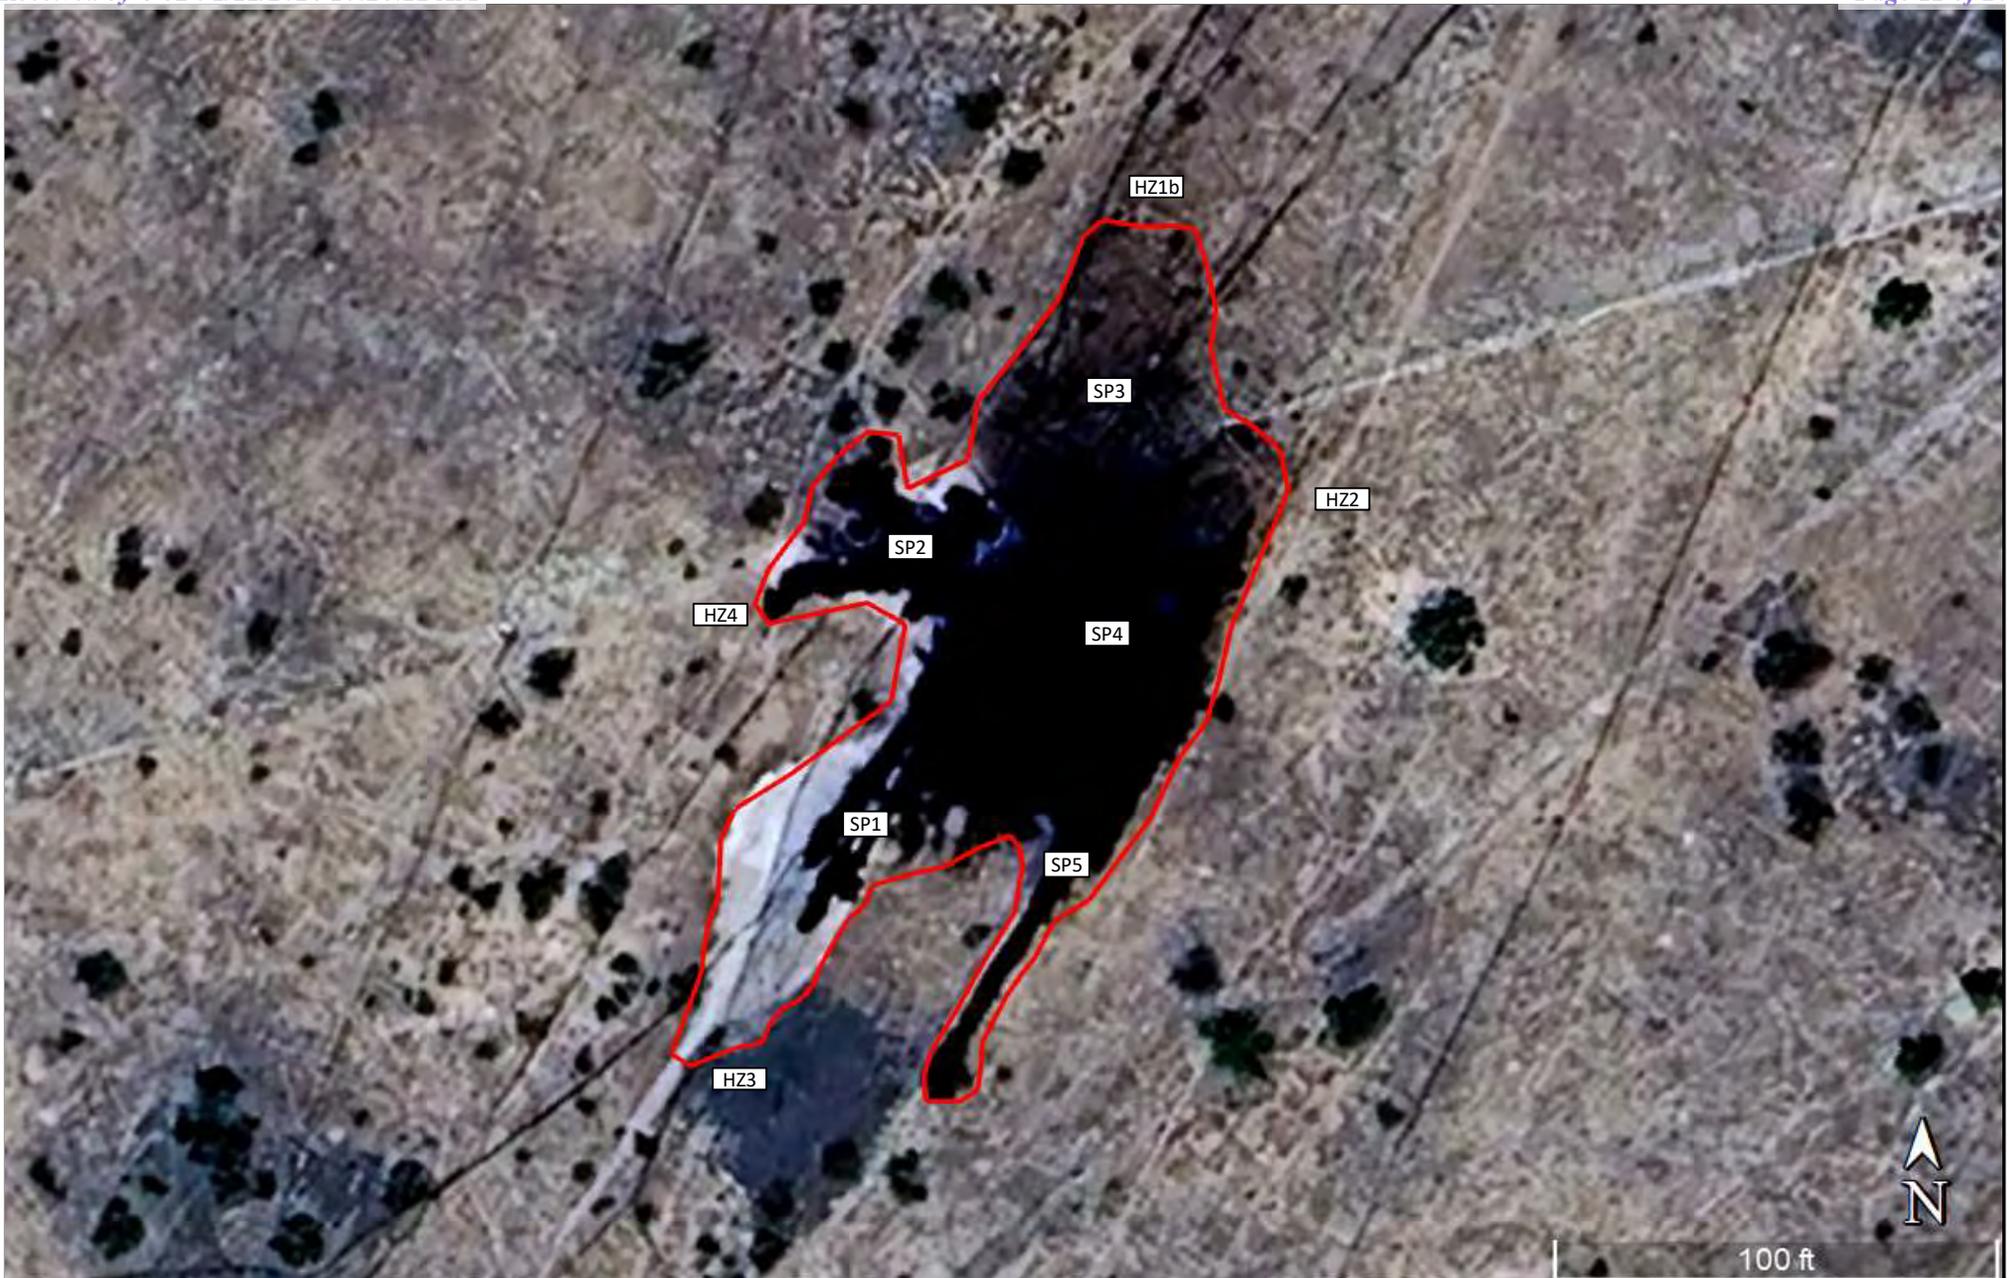
Figure 4

Based on field observations and field test data noted above and provided in Attachment V, eighteen representative soil samples, two from each sample location, were selected for laboratory analysis. Delineation soil samples SP1 through SP5, HZ1 through HZ4, were submitted to the laboratory for analysis of BTEX, TPH, and chloride. Laboratory analytical results indicated contaminant concentrations were below the NMOCD Closure Criteria in each of the submitted samples, with the exception of SP1, SP2, SP3, SP5, each at Surface, and HZ1 at Surface and one-foot bgs, which exhibited TPH and/or chloride concentrations in excess of the NMOCD Closure Criteria.

Delineation Sample Map
 Grand Banks Energy Co
 ARU #4
 GPS: 32.940186, -103.736002
 Lea County

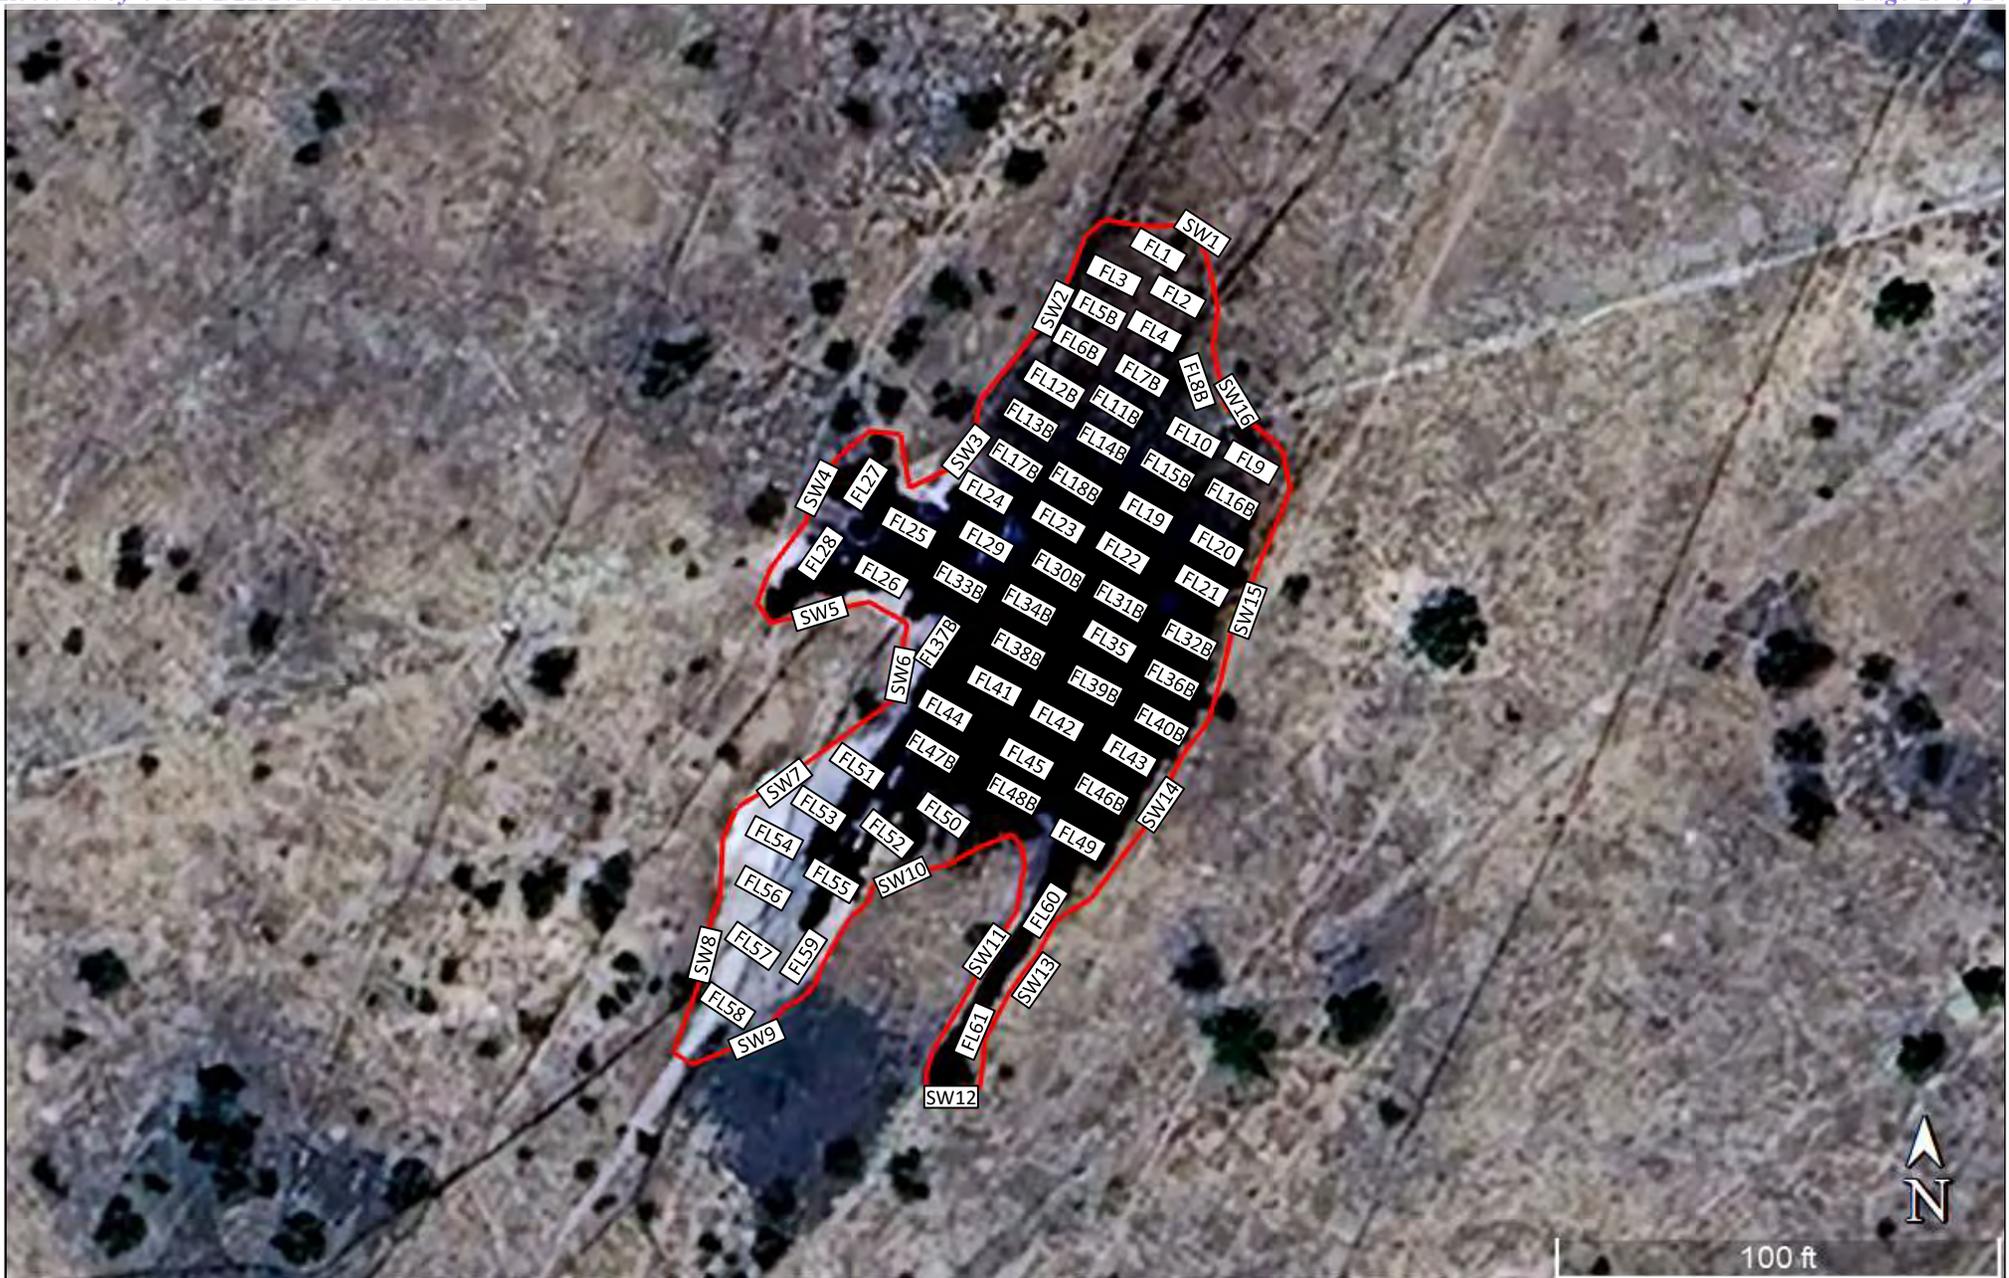
Figure 5
 Excavation Sample Map
 Grand Banks Energy Co
 ARU #4
 GPS: 32.940186, -103.736002
 Lea County

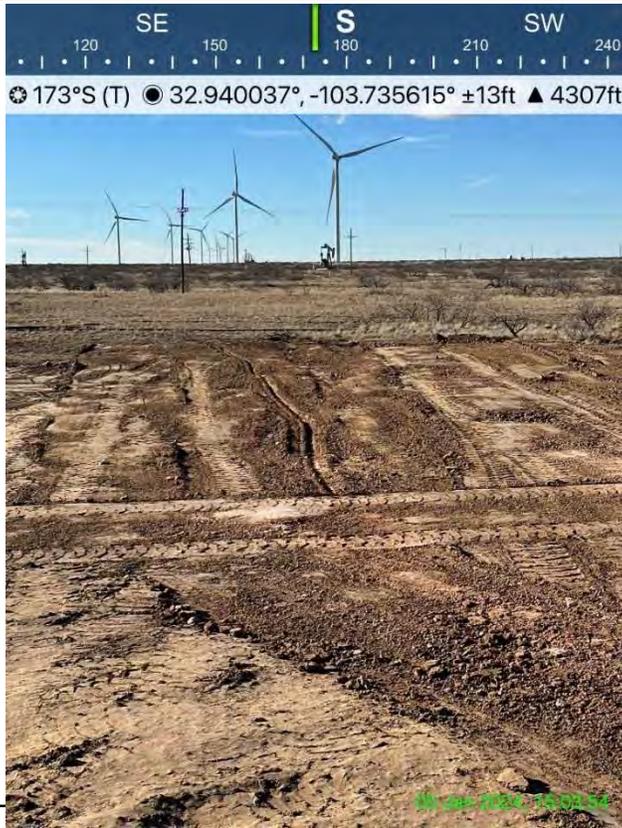
Photo: 11 **Description:** Backfilled

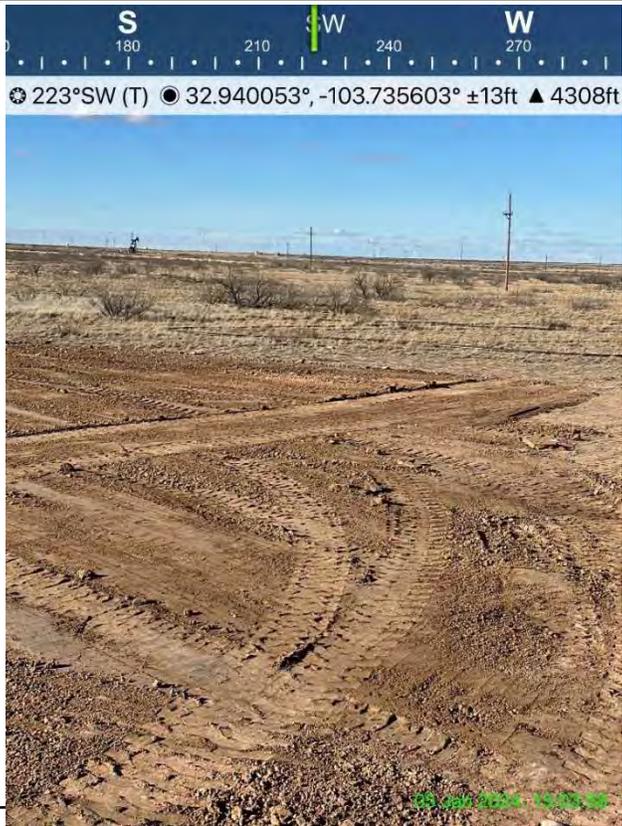
Photo: 12 **Description:** Backfilled
