Closure Report
New Mexico DD State Com #004 (02.05.2016)
Incident ID: NAB1604026777
Eddy County, New Mexico
Unit J Sec 32 T24S R26E
32.1710014°, -104.3118362°

Point of Release:
Dump Valve malfunctioned on a 3-phase separator.
Release Date: 02.05.2016
Volume Released: 150 Barrels of Produced Water
Volume Recovered: 140 Barrels of Produced Water

Re: Closure Report
New Mexico DD State Com #004 (02.05.2016)
Incident ID: NAB1604026777
Cimarex Energy Co. of Colorado
Site Location: Unit J, S32, T24S, R26E
(Lat 32.1710014°, Long -104.3118362°)
Eddy County, New Mexico

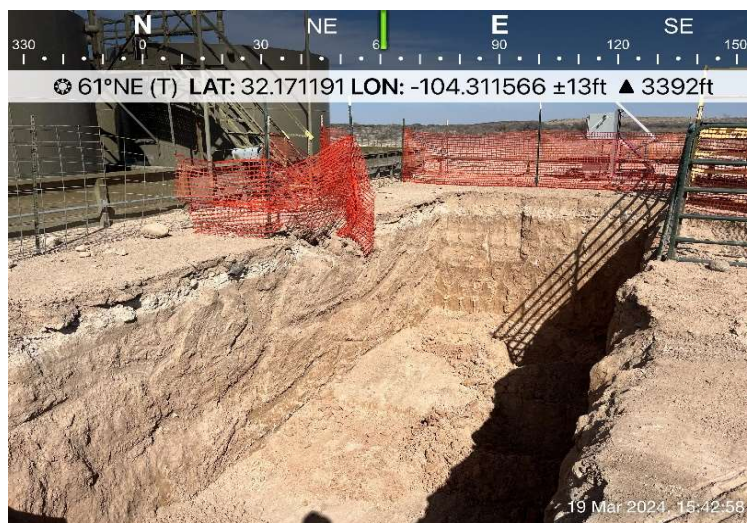
View Northeast, area of CS-1 & CS-2.

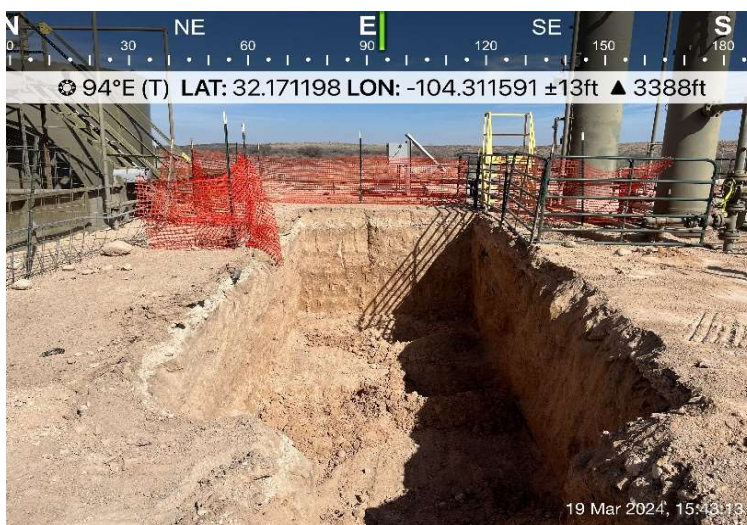
Photograph No. 2

View East, area of CS-1 & CS-2.

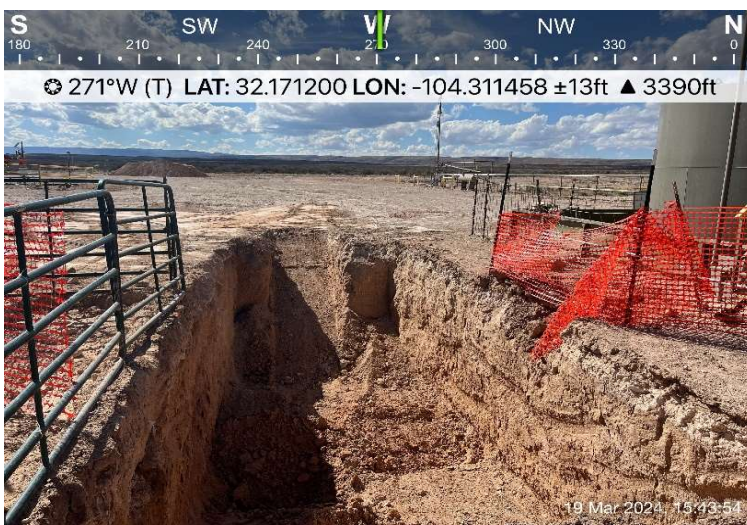
Photograph No. 3

View West, area of CS-1 & CS-2.

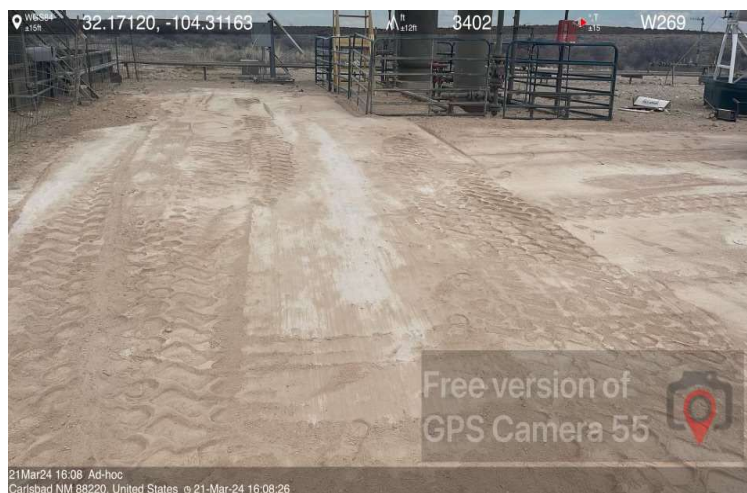
View East, backfilled area.

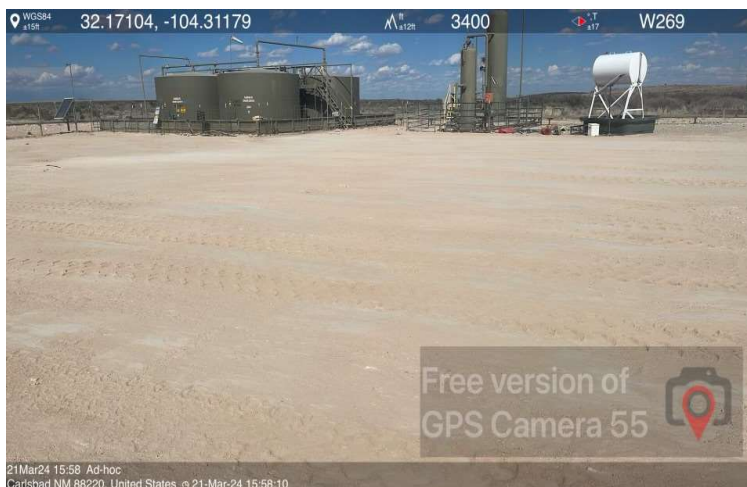
Photograph No. 5

View Northeast, backfilled area.
