Site Assessment and Closure Report

Federal 13 Com #002 Incident# nJMW1224849818 Eddy County, New Mexico

Cimarex Energy Co. of Colorado 6001 Deauville Blvd. Suite 300N Midland, TX 79706

March 20, 2024

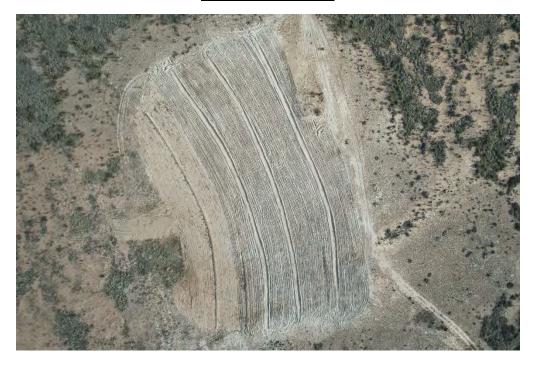
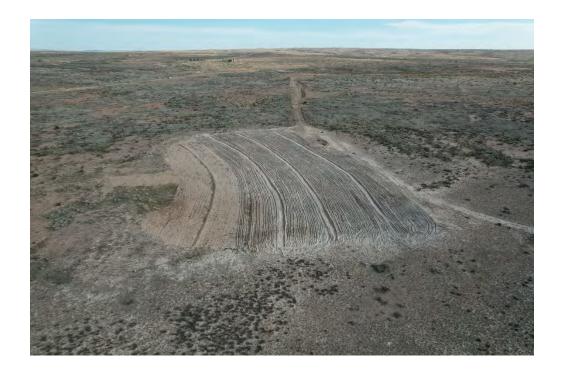
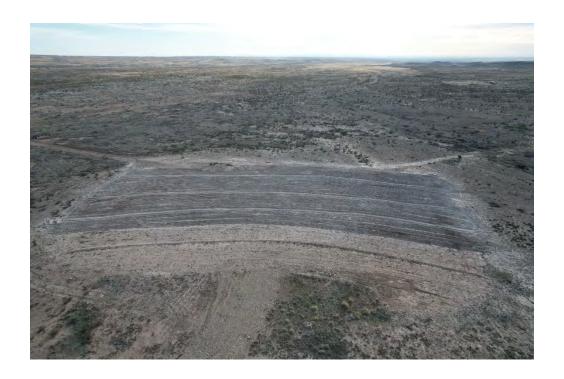
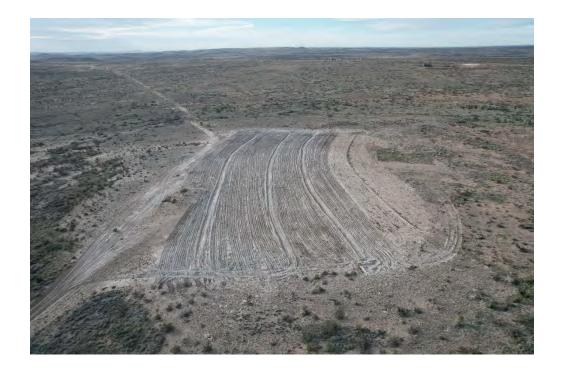
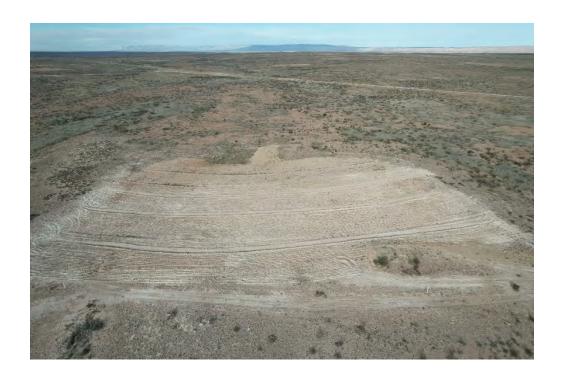
FINAL PHOTOGRAPHS

- This site was re-ripped and contoured to match the surrounding area due to a previous historical release being remediated.
- This site was re-ripped and contoured to match the surrounding area due to a previous historical release being remediated.
- This site will be inspected bi-annually for proper vegetation growth and any noxious/invasive plant growth. Reseeding will take place as necessary as well as any noxious/invasive plant growth removed, and proper steps taken to prevent any future growth.
