Re: Site Summary Report and Closure Request

L C Kelly 17
San Juan County, New Mexico
Hilcorp Energy Company
NMOCD Incident No: nAPP2331720576

Site Summary Report and Closure Request
L C Kelly 17
Hilcorp Energy Company

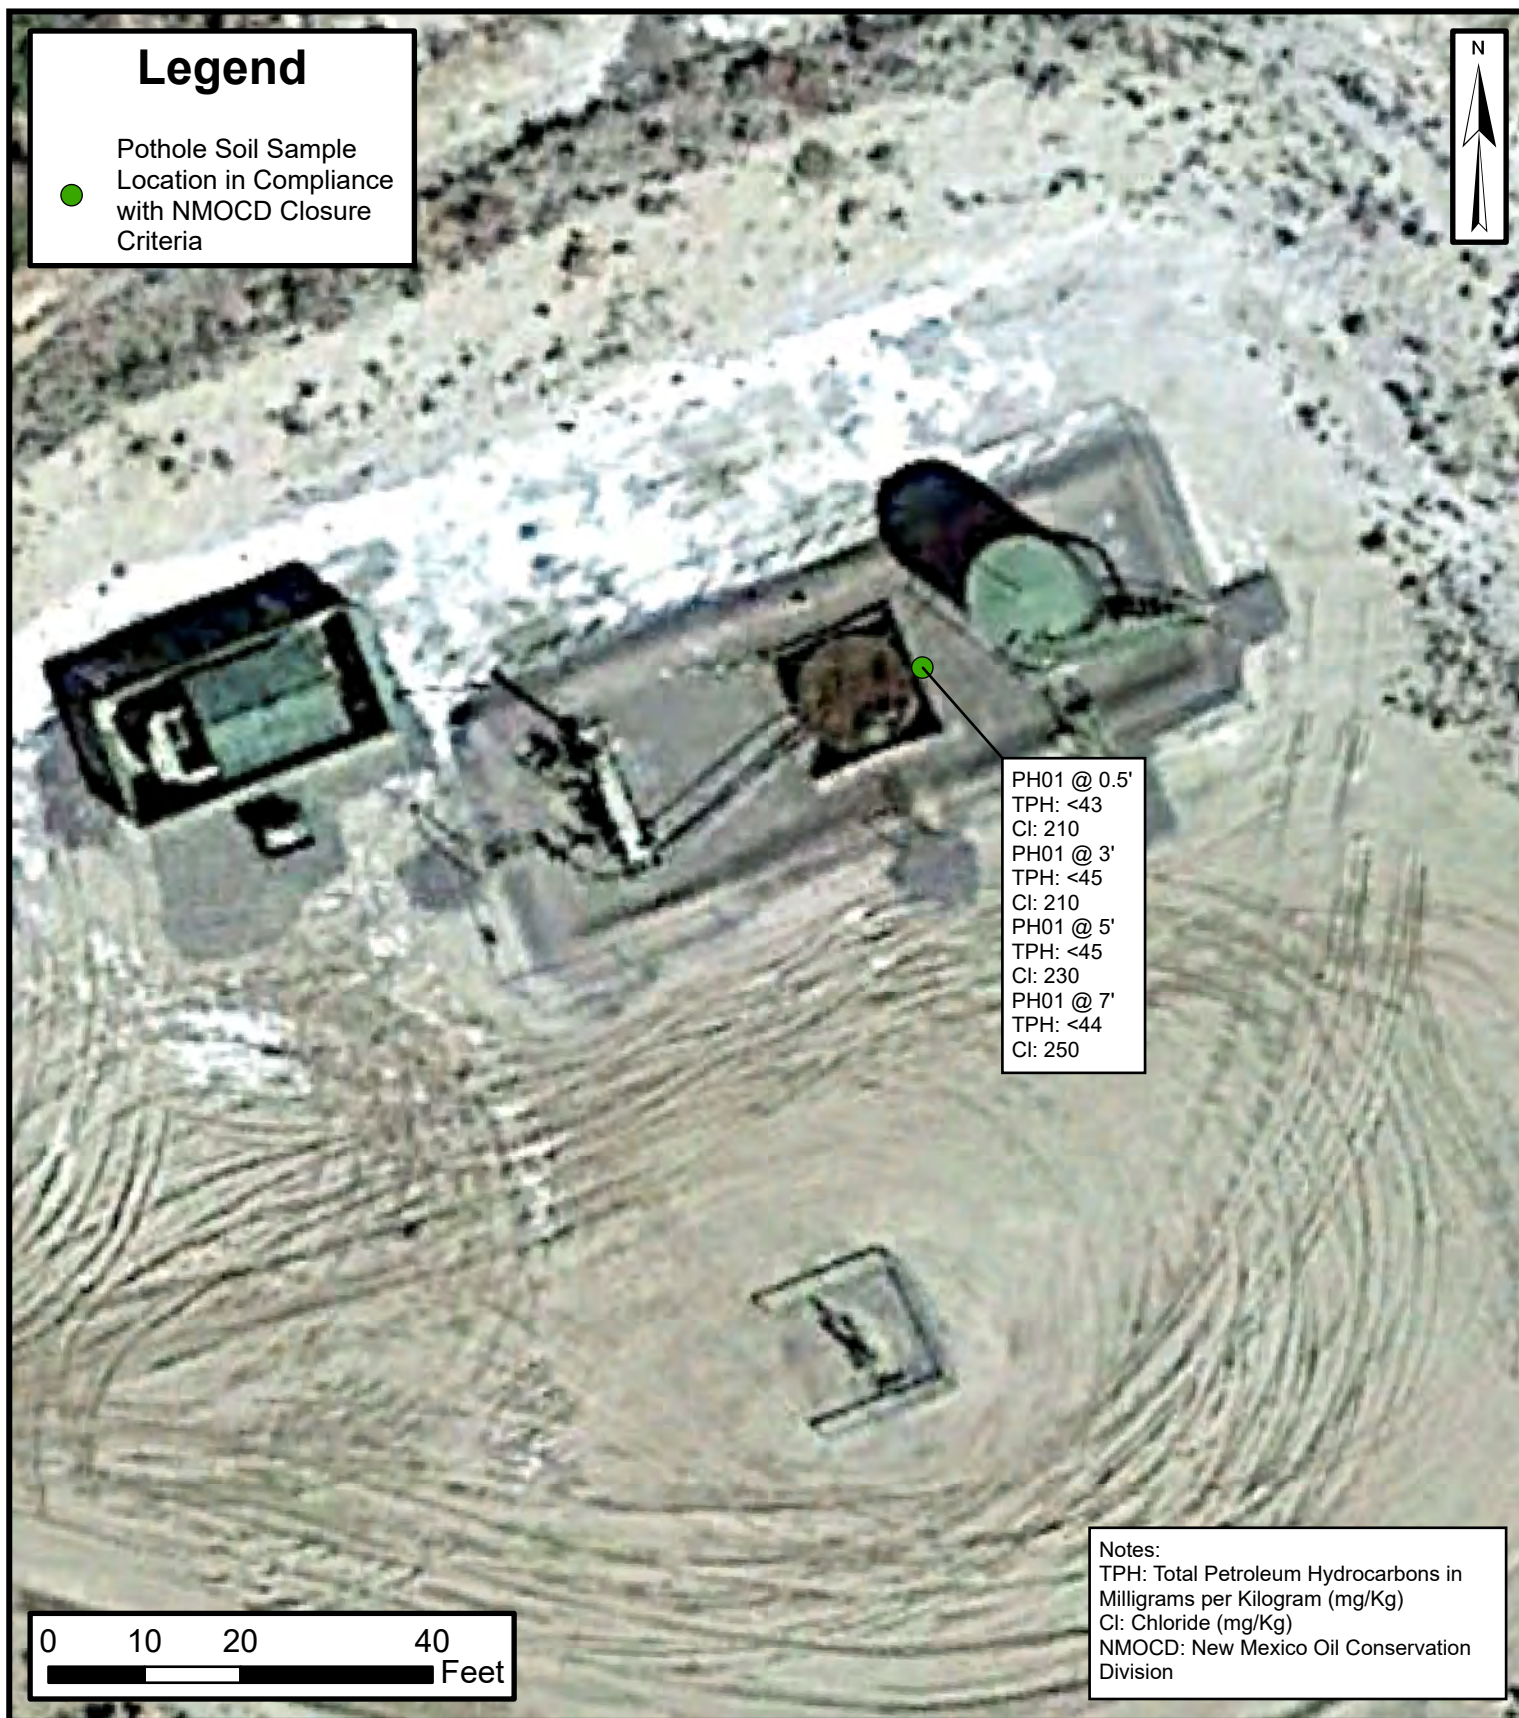
FIGURE
2

BTEX, TPH, and chloride were not detected above the NMOCD Table I Closure Criteria or reclamation requirement in any of the soil samples collected during the January 2024 assessment. Soil sample analytical results are summarized in Table 1 and Figure 2, with complete laboratory analytical reports attached as Appendix E.

Soil Sample Analytical Results

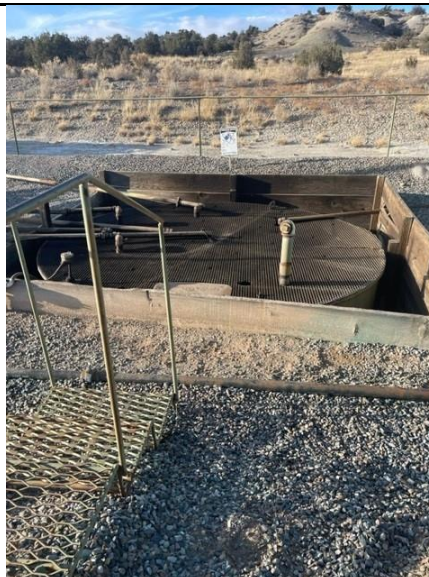
Photograph 1: 11/10/2023

On November 8, 2023, a Hilcorp operator discovered produced water fluid standing within the wood cribbing surrounding the Site below grade tank (BGT). Upon discovery, the well was shut-in pending repairs. Based on the tank production data, the release of produced water was determined to be 19.5 barrels (bbls), of which, 19 bbls were recovered from within the cribbing by a vacuum truck. After further inspection, a hole was discovered at the bottom of the BGT, likely due to corrosion. Hilcorp notified the New Mexico Oil Conservation Division (NMOCD) within 24 hours of discovery and submitted an initial *Form C-141 Release Notification* on November 21, 2023. NMOCD assigned the release incident number nAPP2331720576.

View of the below grade tank and source after discovery of the release, looking north.

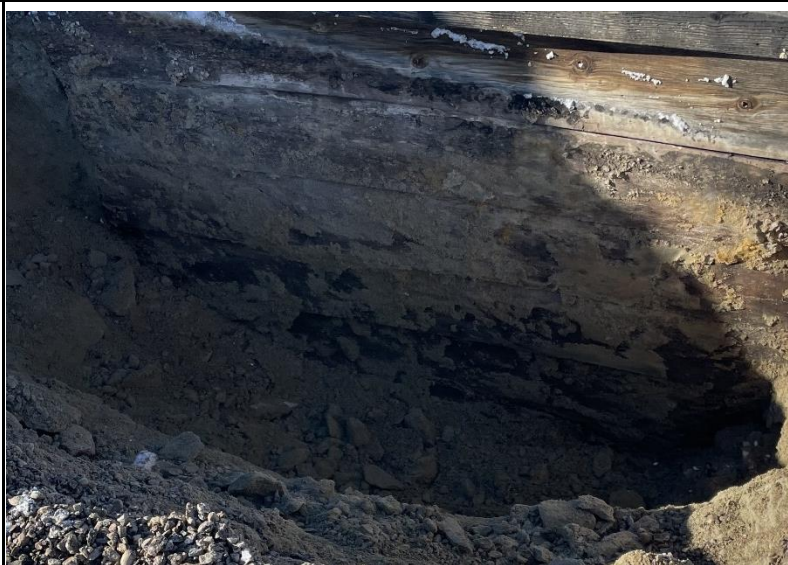
Photograph 2: 1/9/2024

To assess potential soil impacts from the release, Hilcorp and Ensolum advanced one pothole, PH01, on January 9, 2024, directly adjacent to the source of the release using a backhoe. The NMOCD was notified at least two business days prior to commencing on-Site activities (Appendix B). Pothole PH01 was advanced to a depth of 7 feet bgs, with soil field screened for petroleum hydrocarbon staining, odors, and chloride crusting during advancement. Soil samples were field screened for the presence of organic vapors using a calibrated photoionization detector (PID) and chloride using Hach® QuanTab® test strips, with results noted on the field notes (attached as Appendix C).

Dark red brown coarse sand
trace silt to 4.8'

4.8'- 7' gray blue coarse
Sandstone well cemented

View looking into pothole PH01.
