Closure Report
Daisy State 24 CTB (11.11.2023)
Incident #: NAPP2333835289
Eddy County, New Mexico
Unit B Sec 23 T25S R37E
32.1207°, -104.1585°

Crude Oil & Produced Water Release
Point of Release: Failed Check Valve
Release Date: 11.11.2023
Volume Released: 4 Barrels of Crude Oil
Volume Released: 3.8 Barrels of Produced Water
Volume Recovered: 2 Barrels of Crude Oil
Volume Recovered: 1 Barrel of Produced Water

**Re: Closure Report
Daisy State 24 CTB (11.11.2023)
Concho Operating, LLC
Site Location: Unit B, S23, T25S, R37E
(Lat 32.1207°, Long -104.1585°)
Eddy County, New Mexico**

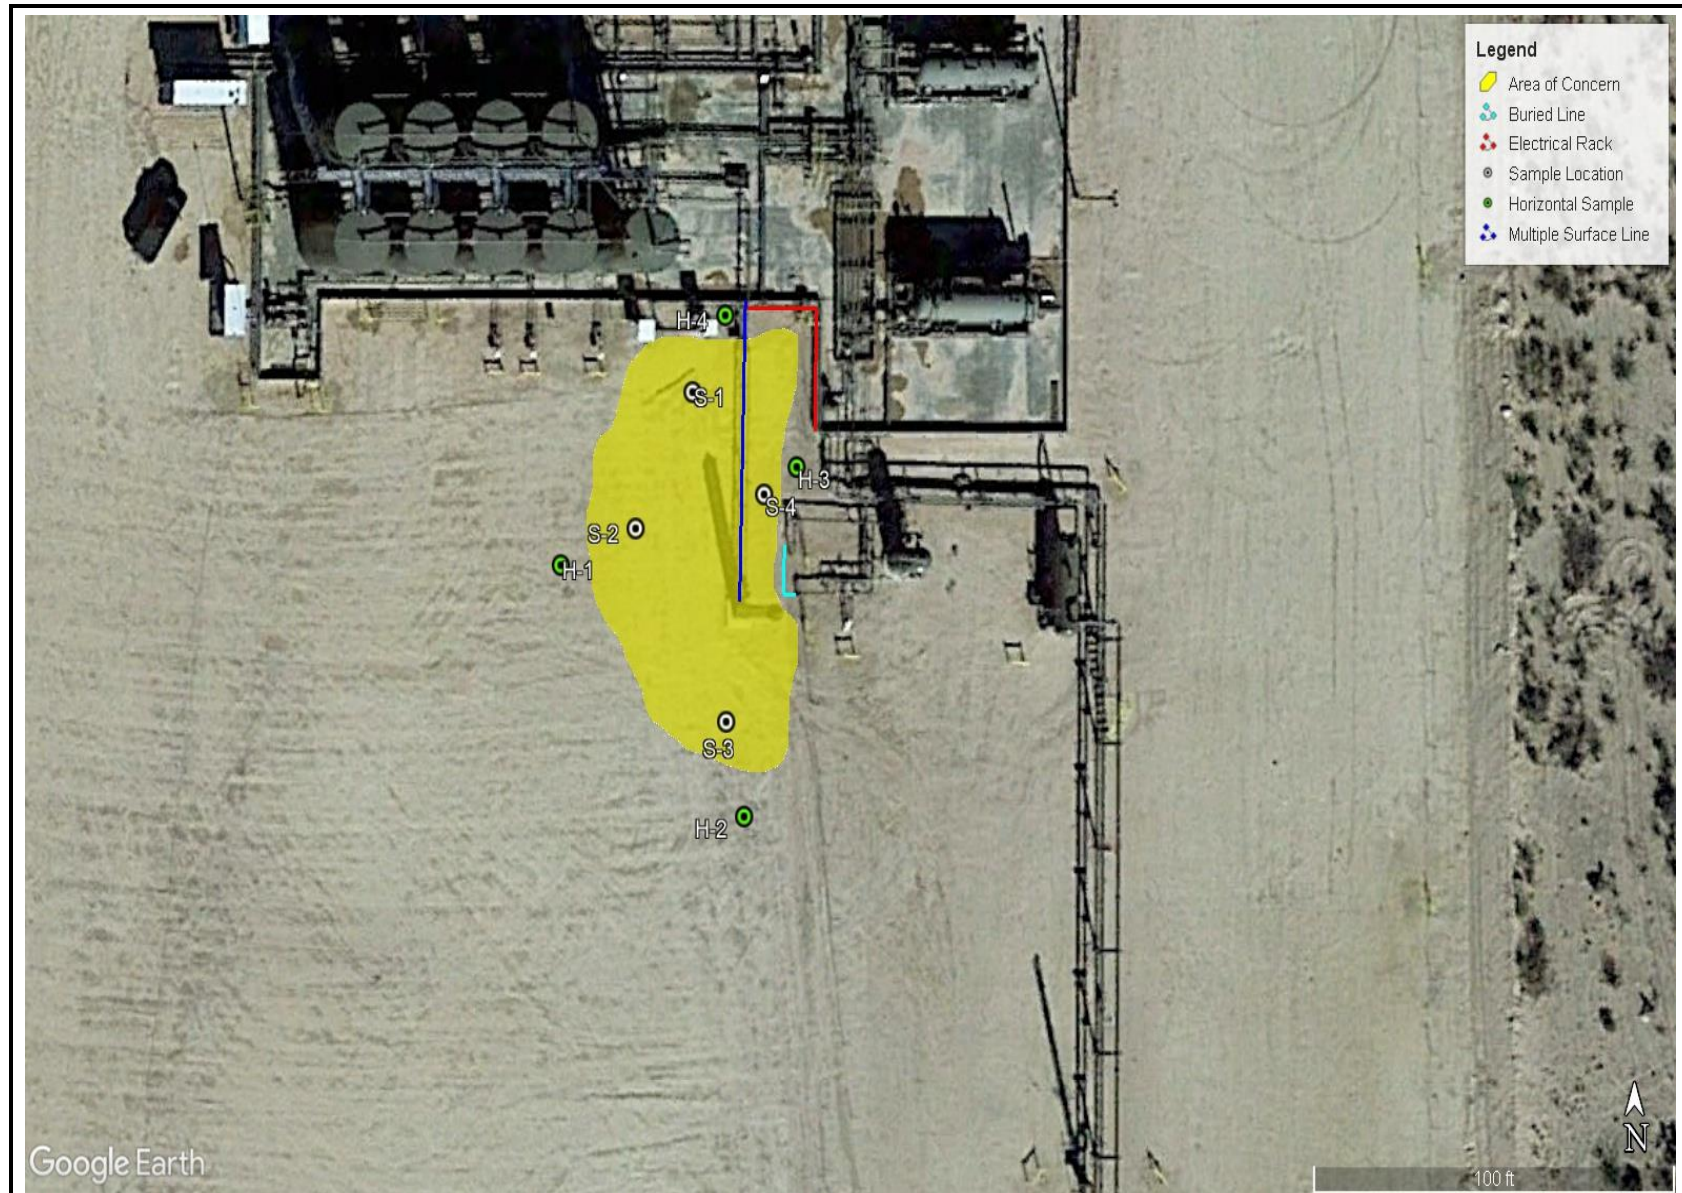
FIGURE 3

SAMPLE LOCATION MAP
COG OPERATING, LLC
DAISY STATE 24 CTB (11.11.2023)
EDDY COUNTY, NEW MEXICO
32.1207°, -104.1585°

Based on the initial C-141 obtained from the New Mexico Oil Conservation Division (NMOCD), the release was discovered on November 11, 2023, caused by a failed check valve, resulting in the release of crude oil and produced water. It resulted in approximately four (4) barrels of crude oil, three-point eight (3.8) barrels of produced water, and two (2) barrels of crude oil, one (1) barrel of produced water recovered. The impacted area occurred on the pad, shown in Figure 3. The initial C-141 form is attached in Appendix C.

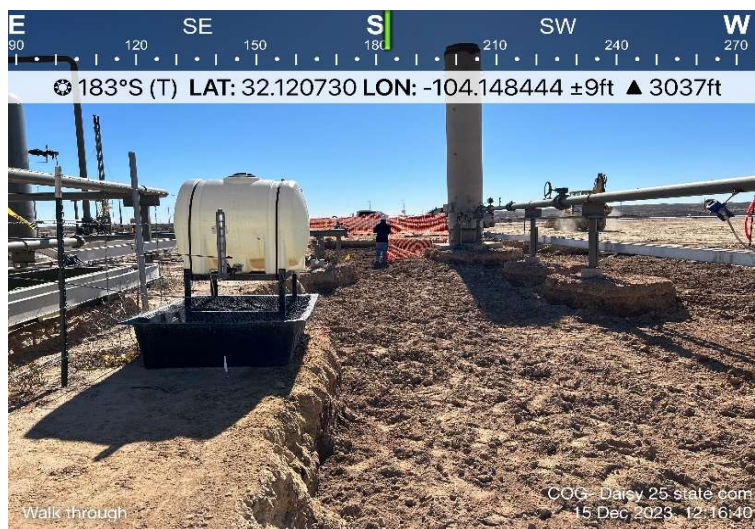
PHOTOGRAPHIC LOG**Concho Operating, LLC****Photograph No. 1****Facility:** Daisy State 24 CTB (11.11.2023)**County:** Eddy County, New Mexico**Description:**

View South of CS-1 through CS-10.

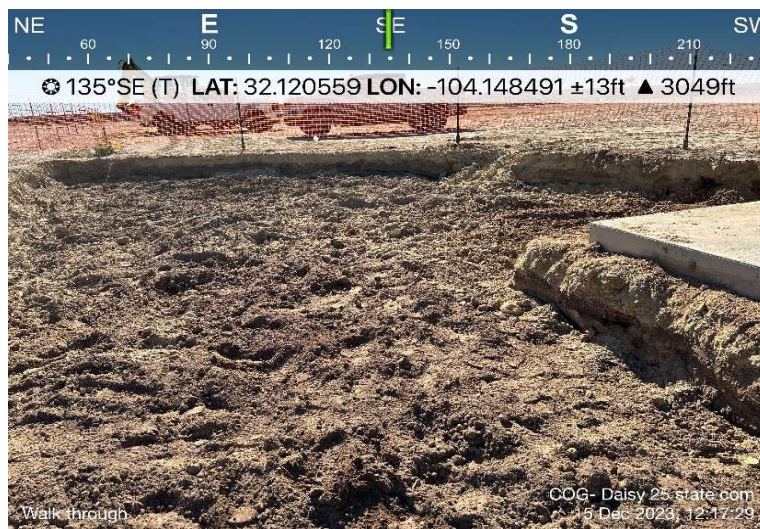
**Photograph No. 2****Facility:** Daisy State 24 CTB (11.11.2023)**County:** Eddy County, New Mexico**Description:**

View Southeast of CS-7 through CS-13

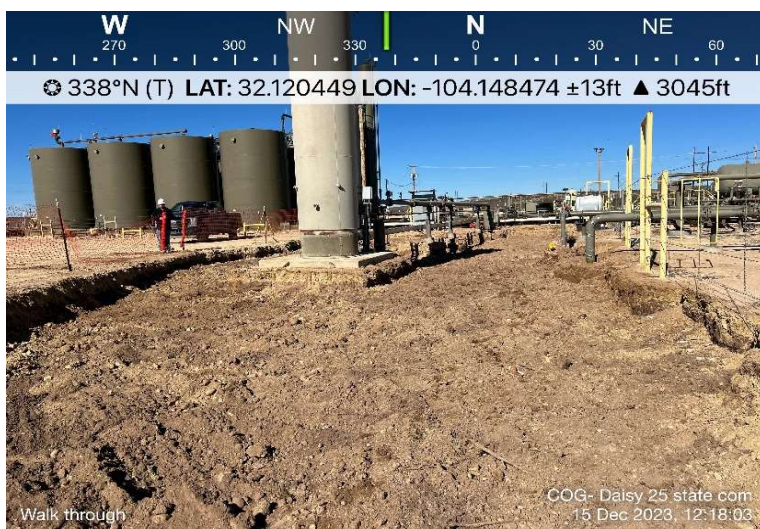
**Photograph No. 3****Facility:** Daisy State 24 CTB (11.11.2023)**County:** Eddy County, New Mexico**Description:**

View North of CS-1 through CS-14.

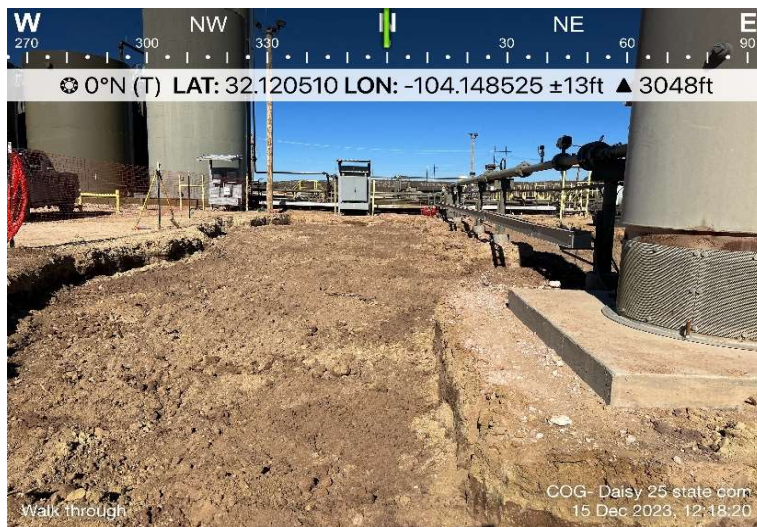
PHOTOGRAPHIC LOG**Concho Operating, LLC****Photograph No. 4****Facility:** Daisy State 24 CTB (11.11.2023)**County:** Eddy County, New Mexico**Description:**

View North of CS-14 through CS-17.

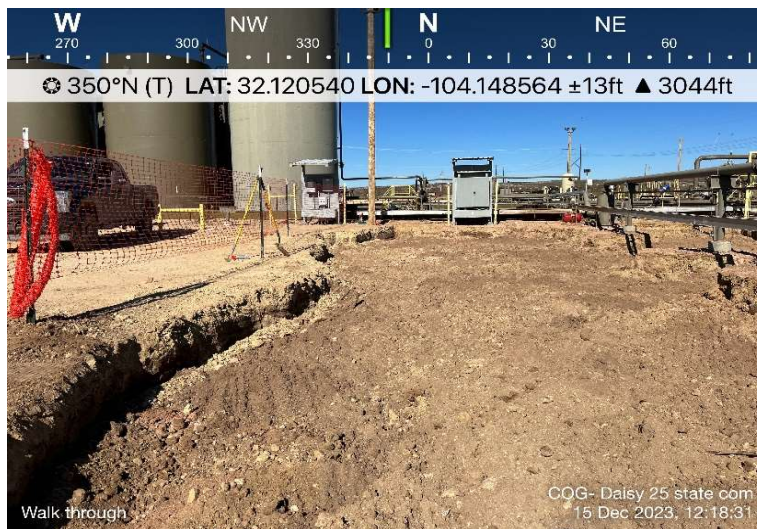
**Photograph No. 5****Facility:** Daisy State 24 CTB (11.11.2023)**County:** Eddy County, New Mexico**Description:**

View North of CS-15 through CS-17.
