**Re: Closure Request
EVGSAU 2437-001
Incident Numbers NAPP2303273838 and NAPP2334650001
Lea County, New Mexico**

Maverick Permian, LLC
Closure Request
EVGSAU 2437-001

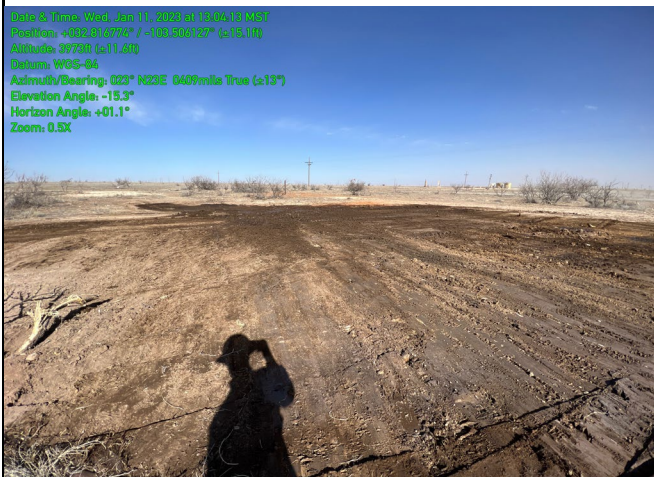
Photograph 1

Description: Soil staining in release footprint

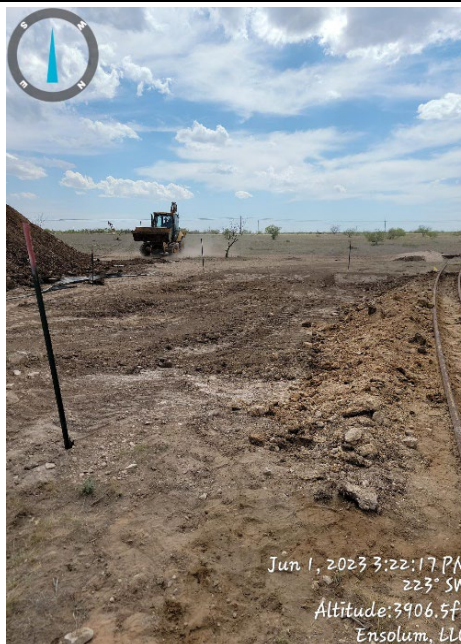
Photograph 2

Description: Excavation activities

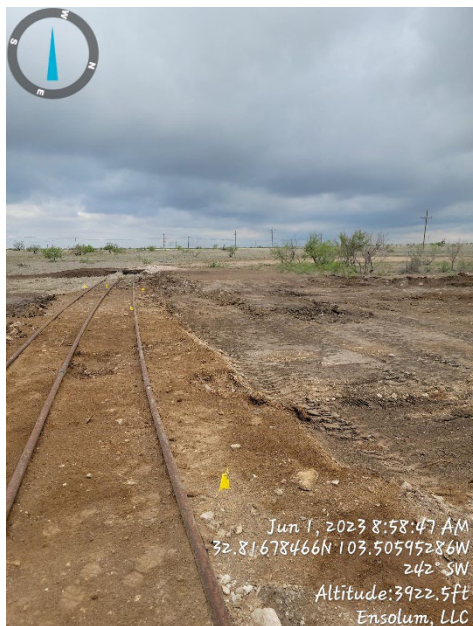
Photograph 5

Description: Excavation activities

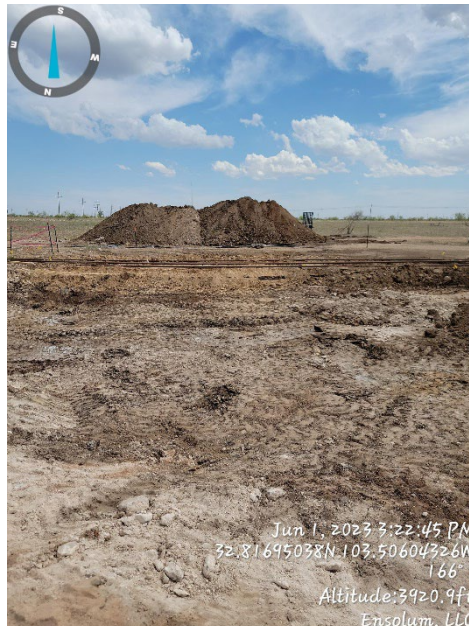
Photograph 6

Description: Excavation activities

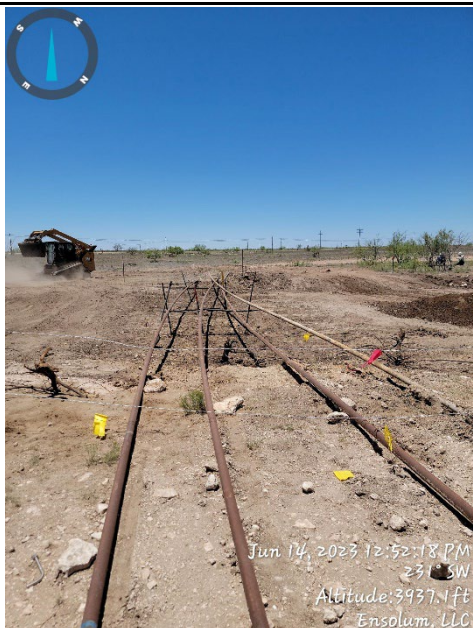
Photograph 7

Description: Excavation activities

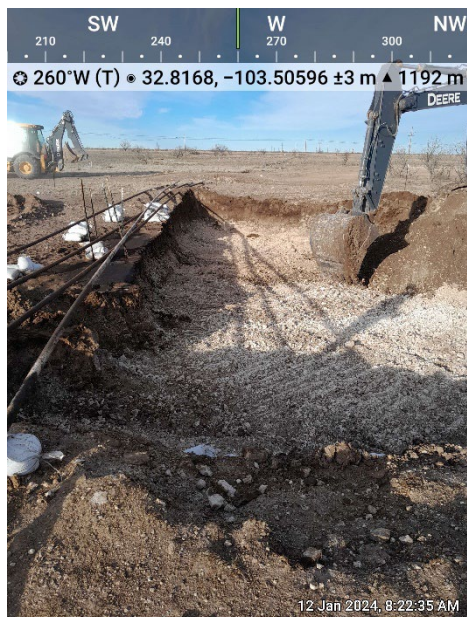
Photograph 9

Description: Excavation activities

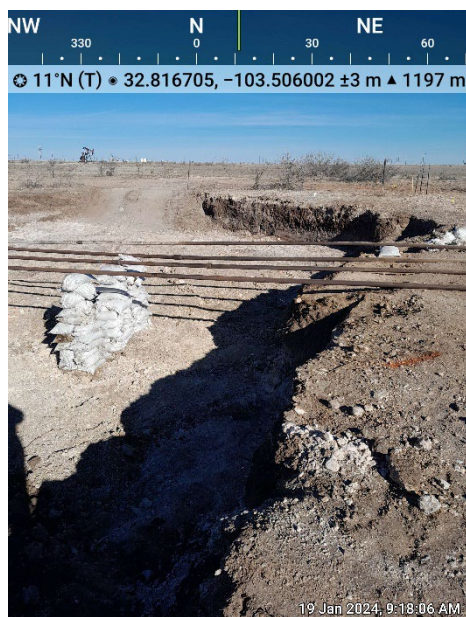
Photograph 10

Description: Excavation activities

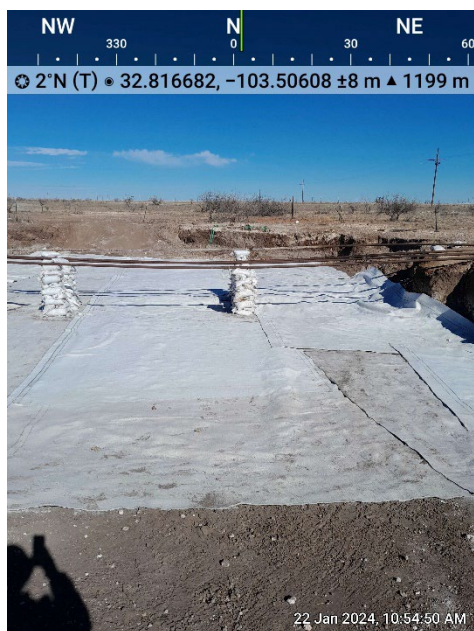
Photograph 11

Description: Liner Installation
