**RE: Spur Energy Partners, LLC  
Conoco 8 St 4 Tank Battery  
NMOCD Reference No. nAPP2104859748  
UL/ O Sec. 8, T17S, R29E  
API No. 30-015-39882  
GPS: 32.8452, -104.0935**

Etech Environmental & Safety Solutions (Etech), on behalf of Spur Energy Partners, LLC, has prepared this *Amended Remediation and Liner Inspection Summary* for the release at the Conoco 8 St 4 Tank Battery location. The site is located approximately 17 miles east of Artesia, NM, in Unit Letter O, Section 8, Township 17 South, Range 29 East. The GPS coordinates of the site are: 32.8452, -104.0935. A "Site Location Map" is provided as Attachment #1.

# **Liner Integrity Inspection Report**

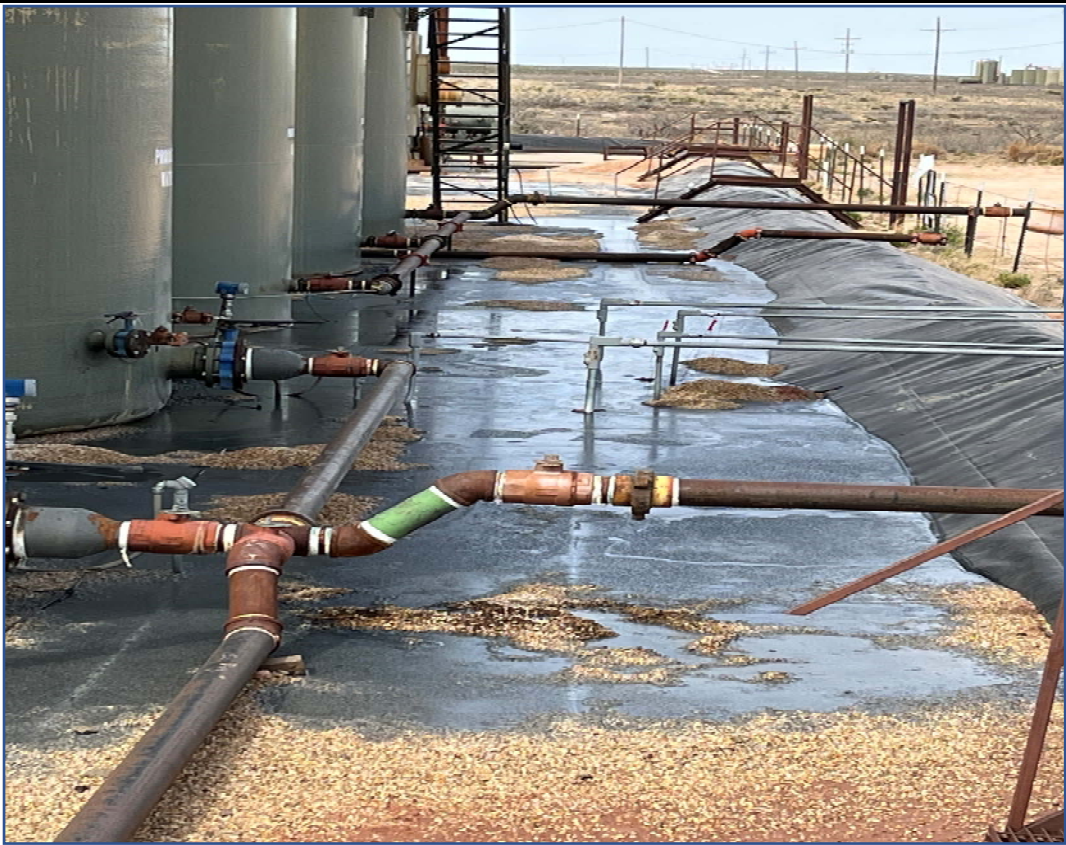
| <b>Photo Number:</b><br>#1 | |

| <b>Photo Direction:</b><br>West | |
| <b>Photo Description:</b><br><br>Spill Area | |

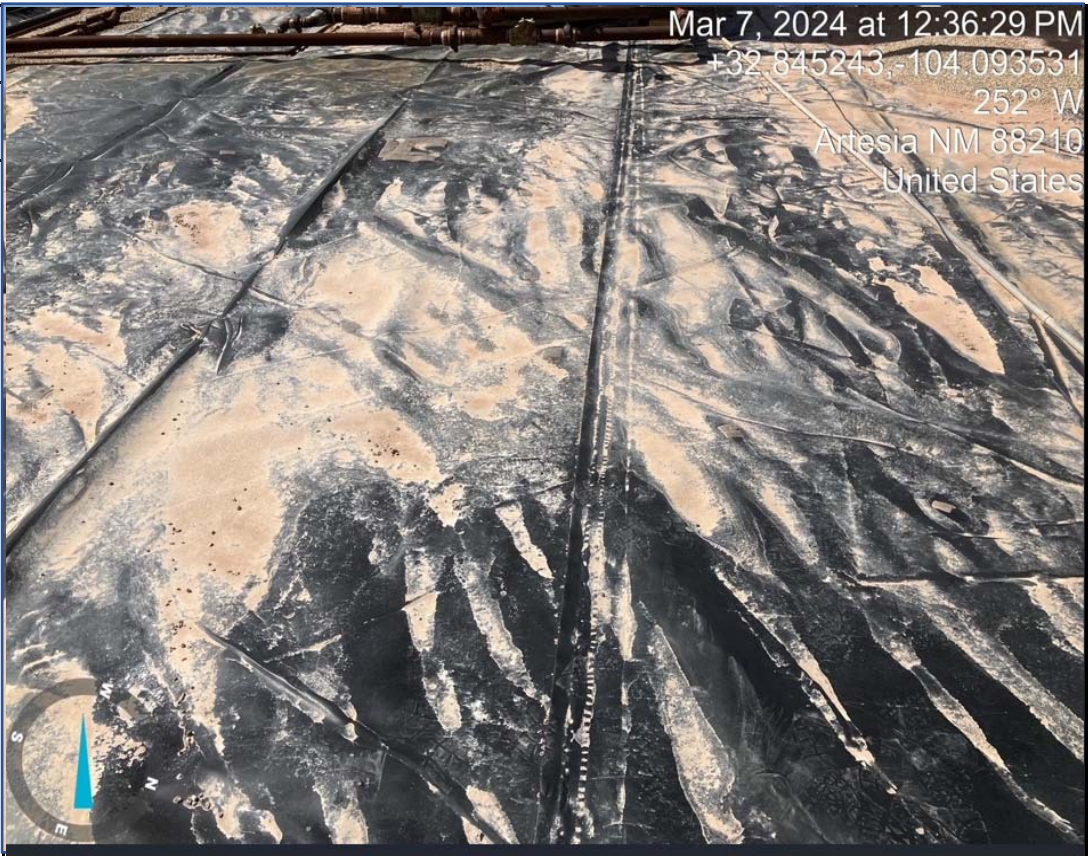
| <b>Photo Number:</b><br>#5 | |

| <b>Photo Direction:</b><br>West | |
| <b>Photo Description:</b><br><br>Exposed Liner | |

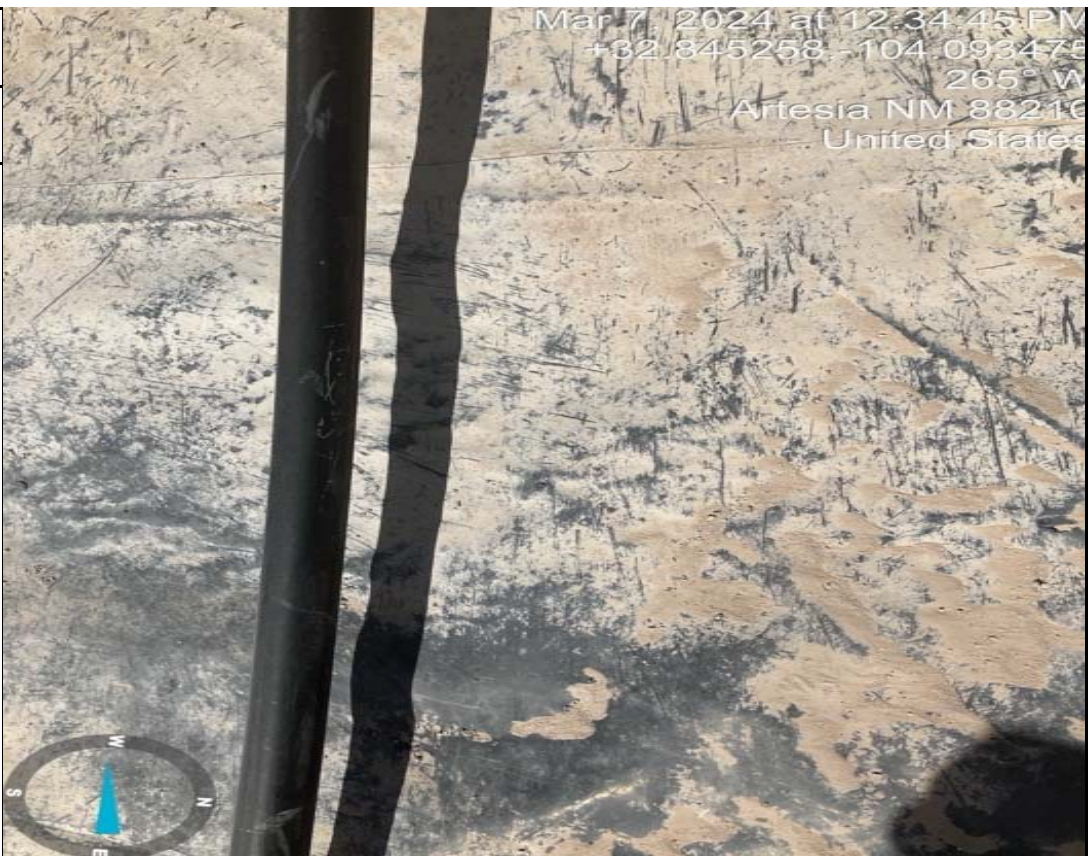
| <b>Photo Number:</b><br>#6 | |

| <b>Photo Direction:</b><br>West | |
| <b>Photo Description:</b><br><br>Exposed Liner | |

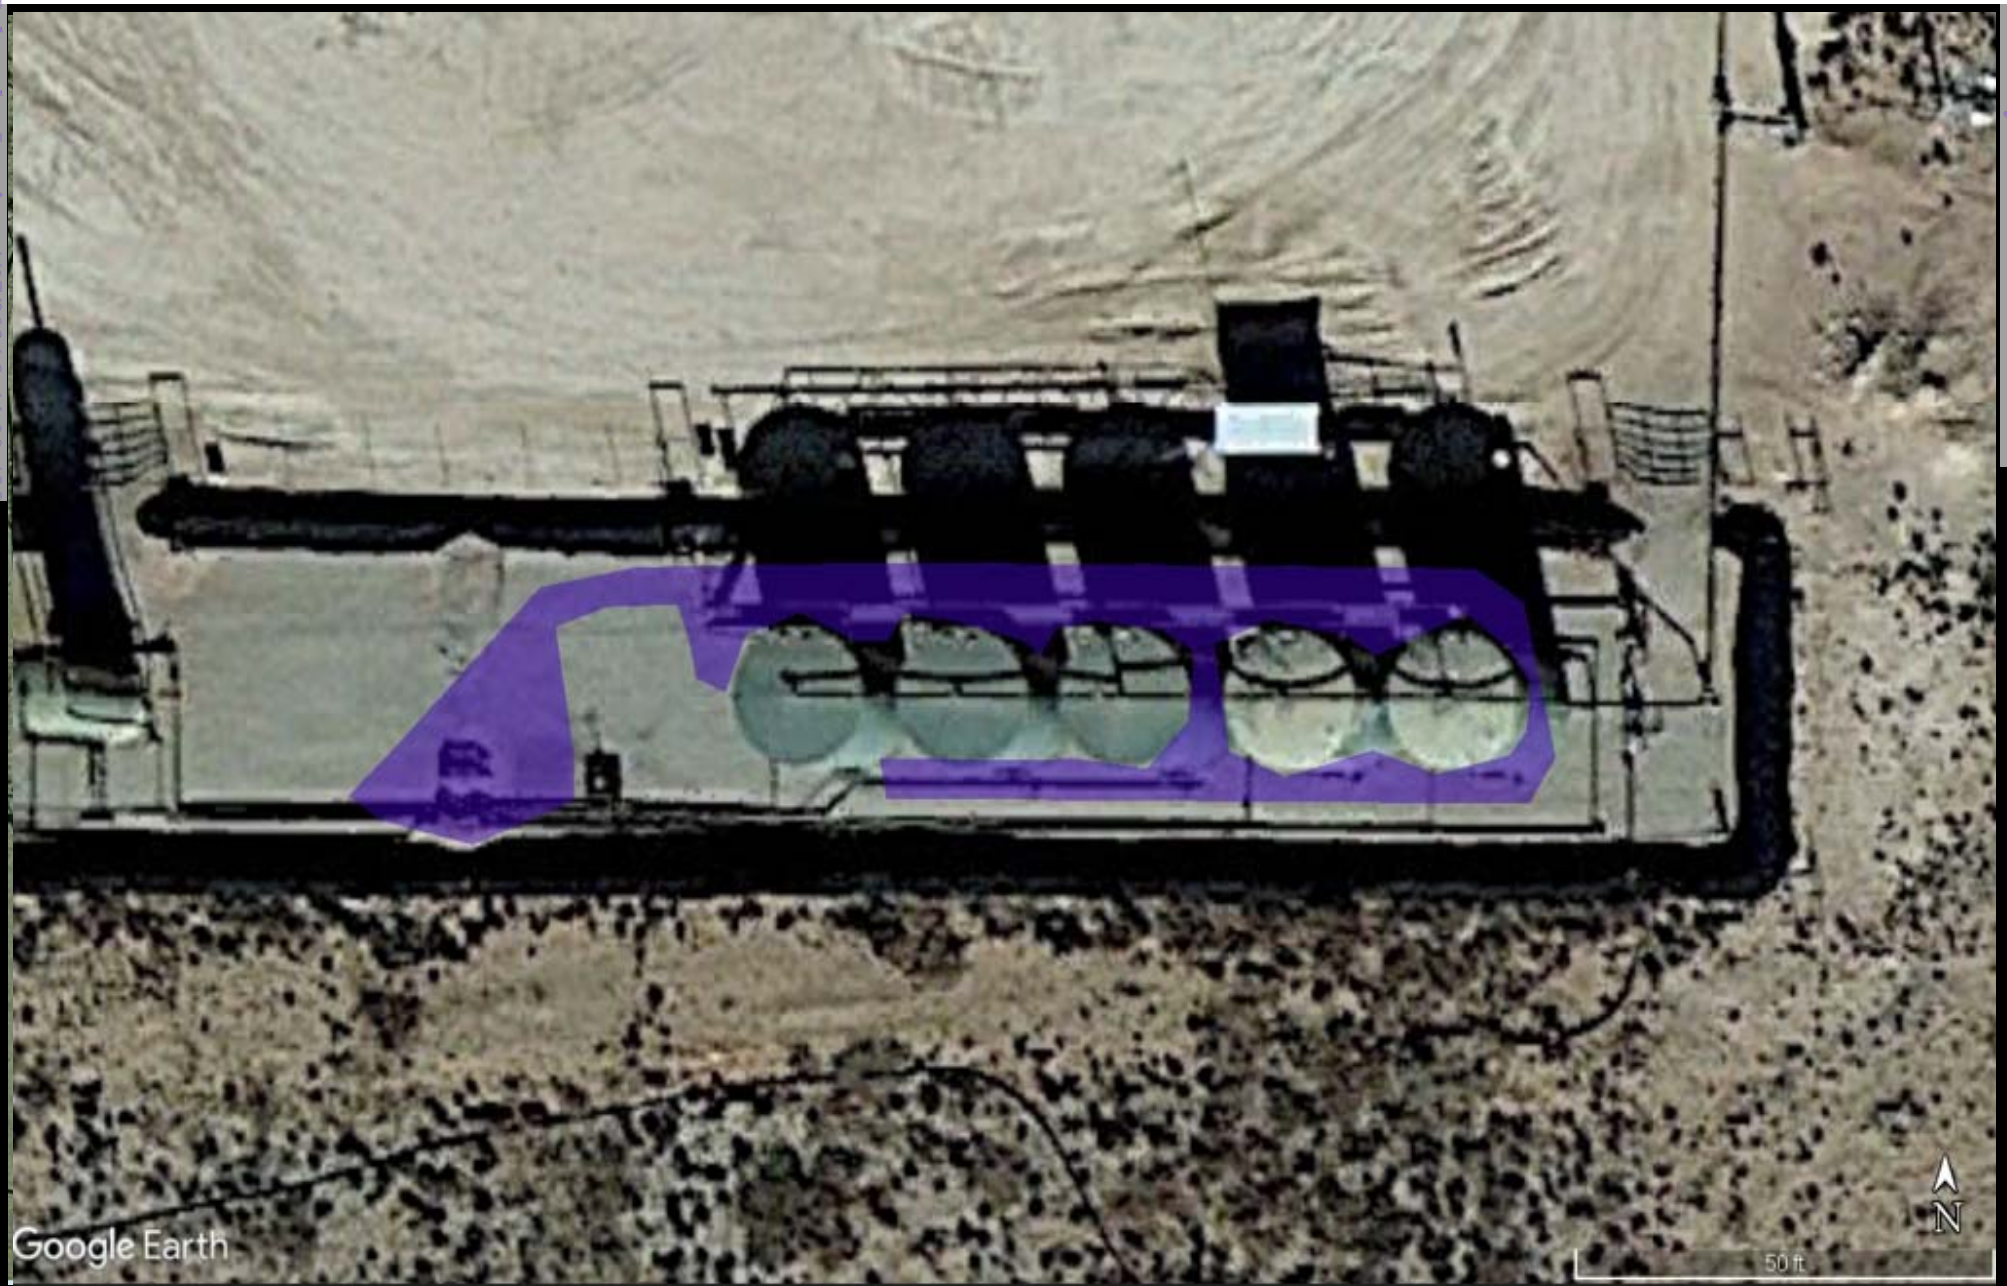
**Attachment 4**  
 Scaled Site Map  
 Spur Energy Partners, LLC  
 Conoco 8 St 4 Tank Battery  
 GPS: 32.8452, -104.0935  
 Eddy County

Impacted Area

A closure request was previously submitted to the NMOCD and subsequently rejected for the following reasons: affected material was not removed before inspection, and a scaled diagram showing exactly what area was impacted by the release was not included. However, all impacted material was removed before inspection to clearly verify liner integrity. Each portion of the liner was free of material before being inspected. The photographs are indicative of post liner inspection where clean material had begun to be installed. A "Scaled Site Map" is included as Attachment 4.
