**Closure Report**  
**Cottonmouth 23 Federal Com 001H (12.24.23)**  
**Eddy County, New Mexico**  
**Incident ID: NAPP2336063904**  
**Unit C Sec 23 T26S R28E**  
**32.0348°, -104.0594°**

**Crude Oil and Produced Water Release**  
**Point of Release: Equipment Failure Due to Corrosion**  
**Release Date: 12.24.2023**  
**Volume Released: 25 barrels of Crude Oil and 45 barrels of Produced Water**  
**Volume Recovered: 25 barrels of Crude Oil and 45 barrels of Produced Water**

**Re: Closure Report  
Cottonmouth 23 Federal Com 001H (12.24.23)  
Concho Operating, LLC  
Incident # NAPP2336063904  
Site Location: Unit C, S23, T26S, R28E  
(Lat 32.0348°, Long -104.0594°)  
Eddy County, New Mexico**

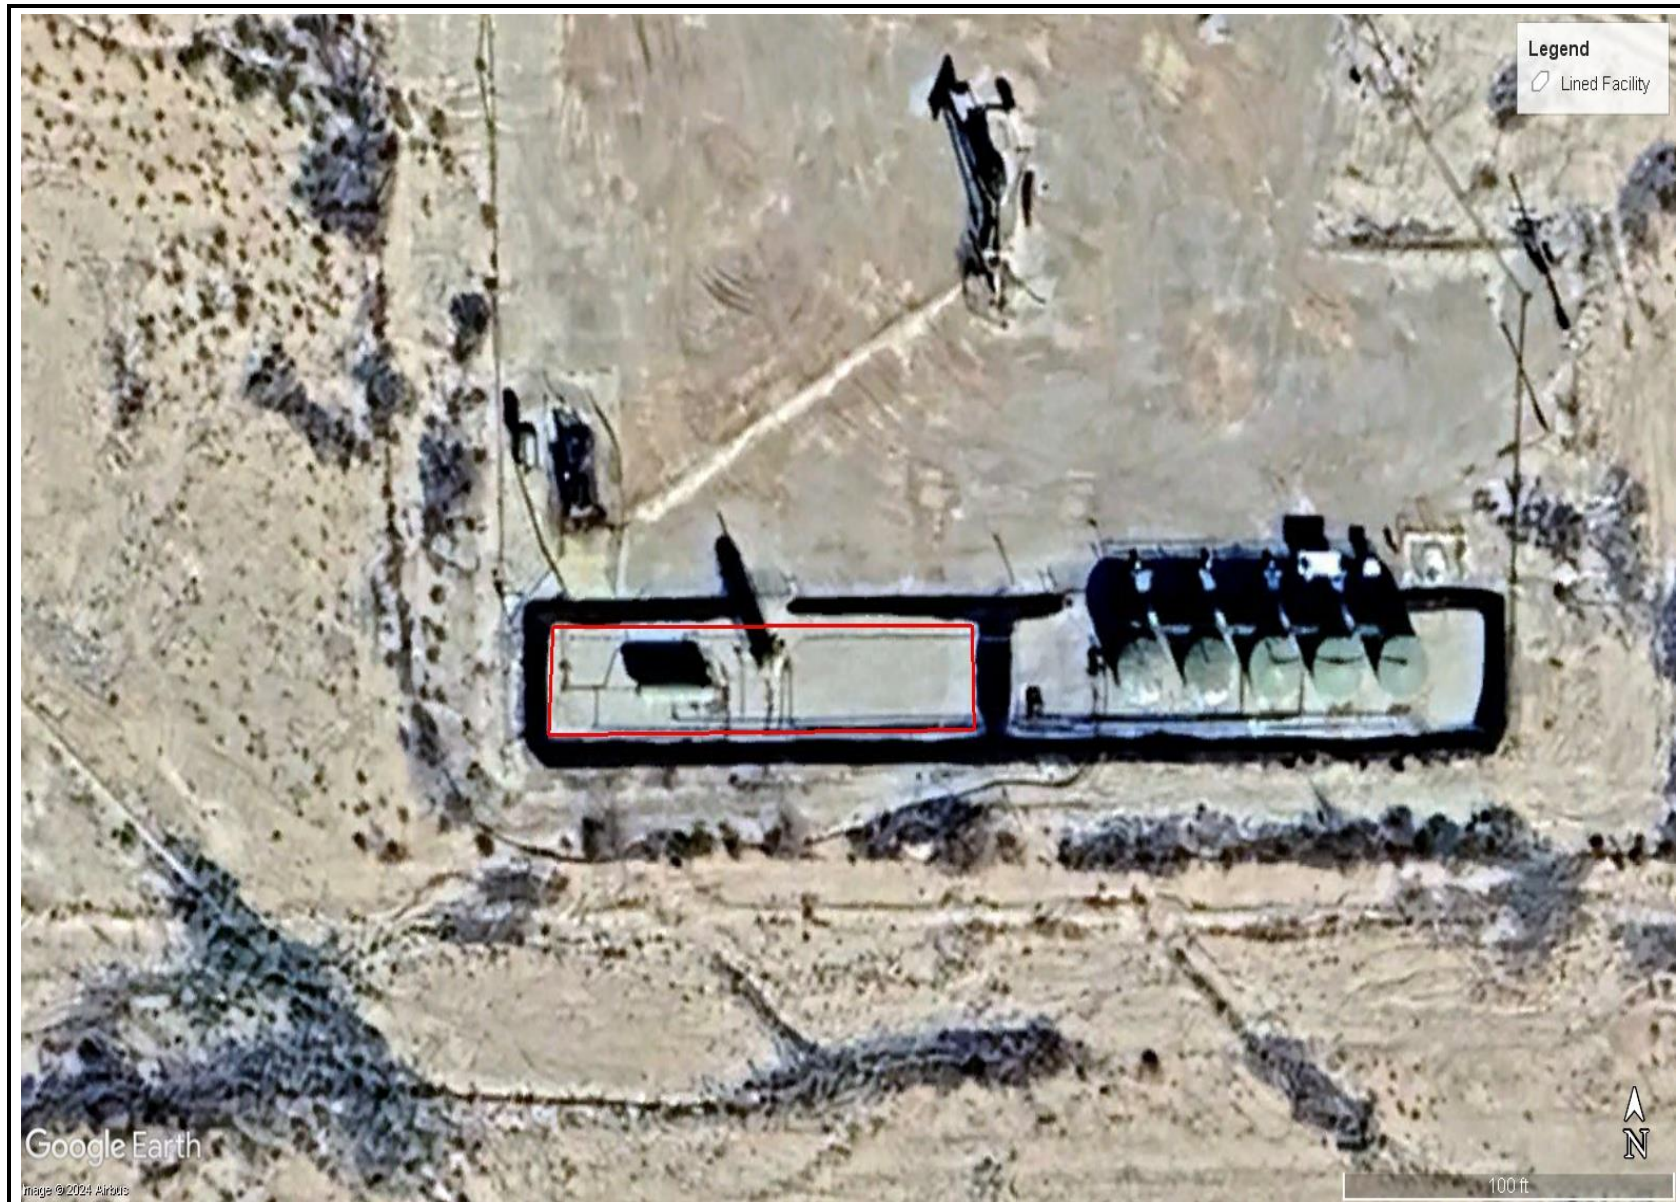
FIGURE 3

Based on the initial C-141 obtained from the New Mexico Oil Conservation Division (NMOCD), the release was discovered on December 24, 2023, due to the corrosion of the tank valve threading which created a hole. This resulted in the release of twenty-five (25) barrels of crude oil and forty-five (45) barrels of produced water. Approximately twenty-five (25) barrels of crude oil and forty-five (45) barrels of produced water were recovered within the lined facility. Refer to Figure 3. The initial C-141 form is attached in Appendix B.

SECONDARY CONTAINMENT MAP  
COG OPERATING, LLC  
COTTONMOUTH 23 FEDERAL COM 1H (12.24.23)  
EDDY COUNTY, NEW MEXICO  
32.0348°, -104.0594°

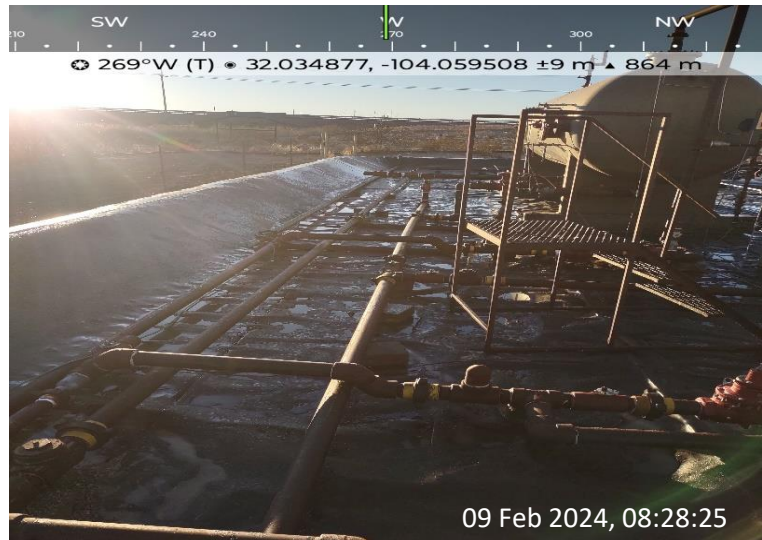
## Photograph No. 1

On February 9, 2024, Carmona Resources, LLC conducted liner inspection activities to assess the liner's integrity within the facility. Before performing the liner inspection, the NMOCD division office was notified via the NMOCD web portal on February 7, 2024, per Subsection D of 19.15.29.12 NMAC. See Appendix B. Before Carmona Resources conducted the liner inspection, all pea gravel was removed from the facility. Carmona Resources, LLC personnel inspected the liner visually and determined it to be intact with no integrity issues. Refer to the Photolog in Appendix A.

**Description:**  
View West, of liner.

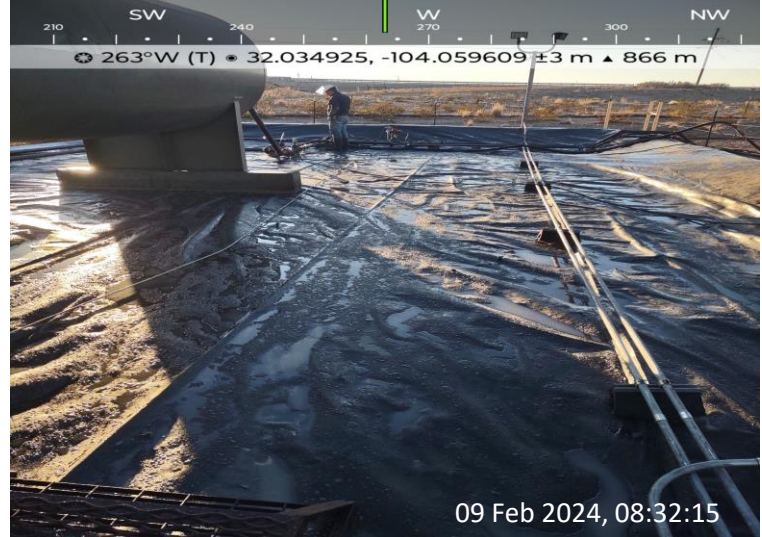
## Photograph No. 2

**Description:**  
View West, of liner.

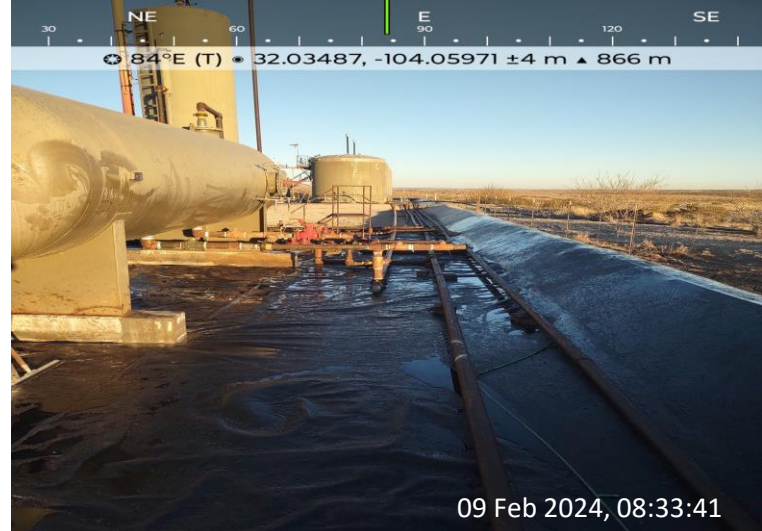
## Photograph No. 3

**Description:**  
View East, of liner.
