April 17, 2024

**Re: Closure Report
ConocoPhillips Company (Heritage COG Operating, LLC)
King Tut Federal #001H Flowline Release
Unit Letter D, Section 30, Township 24 South, Range 32 East
Lea County, New Mexico
Incident ID# nKL1630650239**

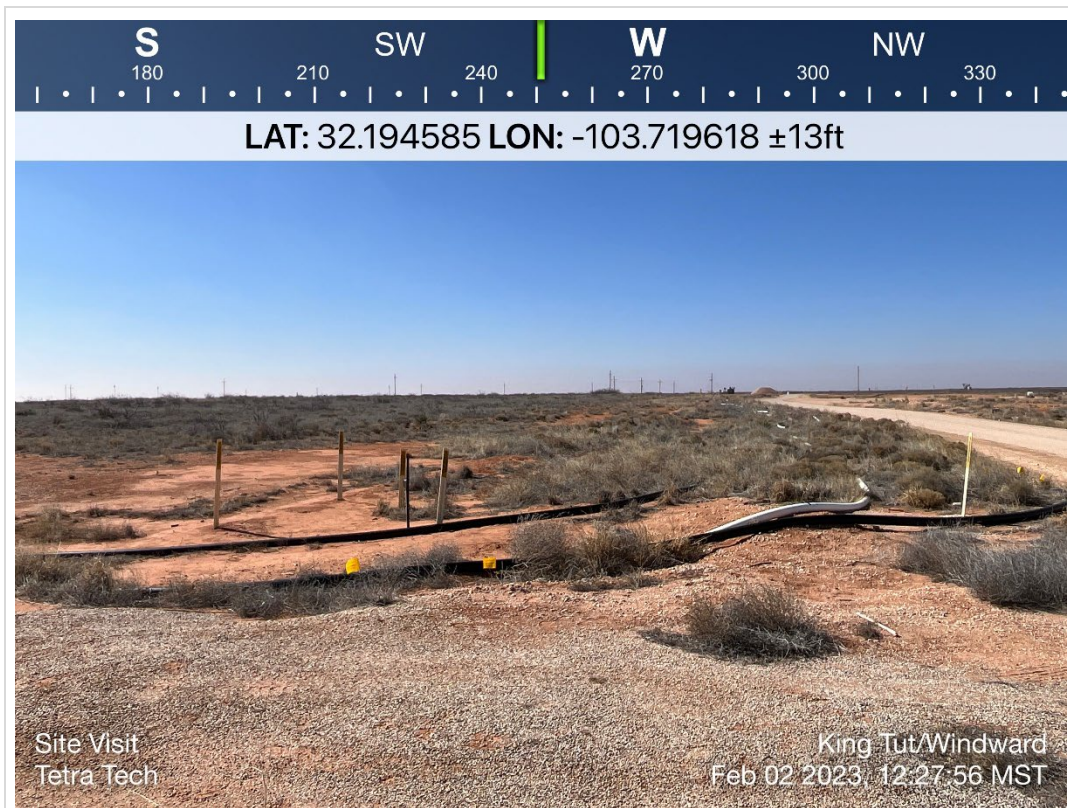
TETRA TECH, INC. PROJECT NO. 212C-MD-02999	DESCRIPTION	View SW-W of release extent at the NW corner of pad. Vegetated towards lease road Surface poly-lines present.	1
	SITE NAME	KING TUT FEDERAL #001H, KING TUT FEDERAL #003H, & WINDWARD FEDERAL #001H Releases	2/2/2023

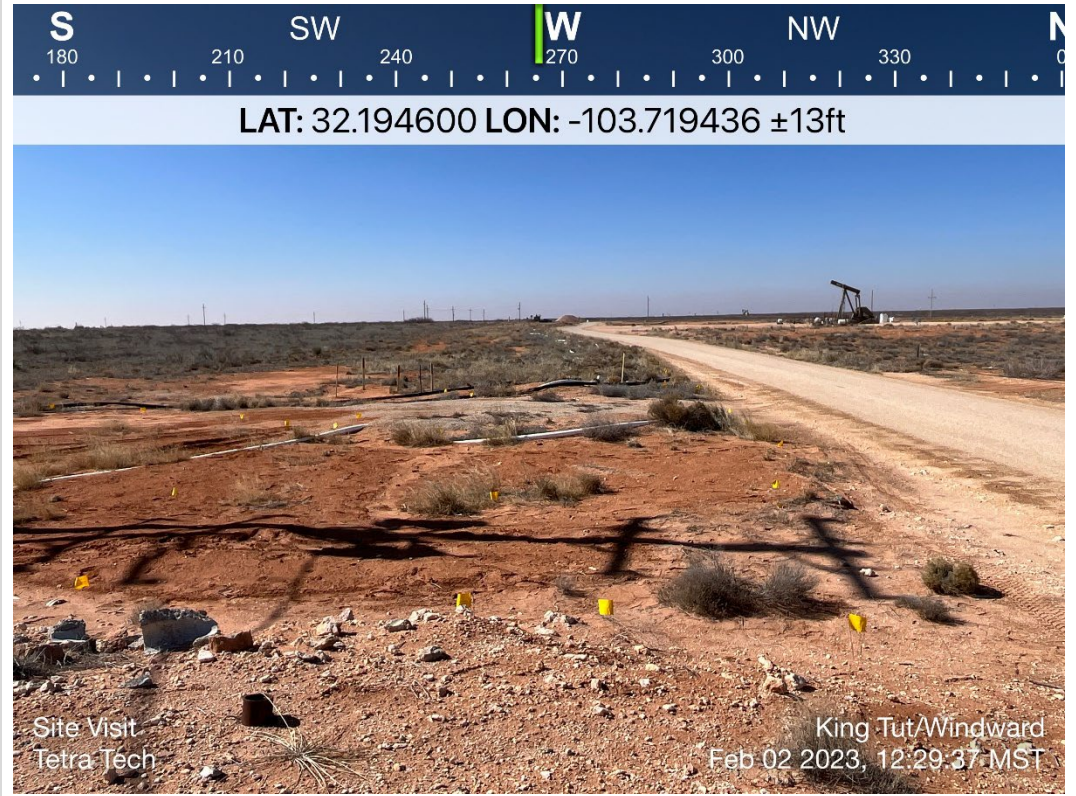
TETRA TECH, INC. PROJECT NO. 212C-MD-02999	DESCRIPTION	View W towards lease road.	4
	SITE NAME	KING TUT FEDERAL #001H, KING TUT FEDERAL #003H, & WINDWARD FEDERAL #001H Releases	2/2/2023

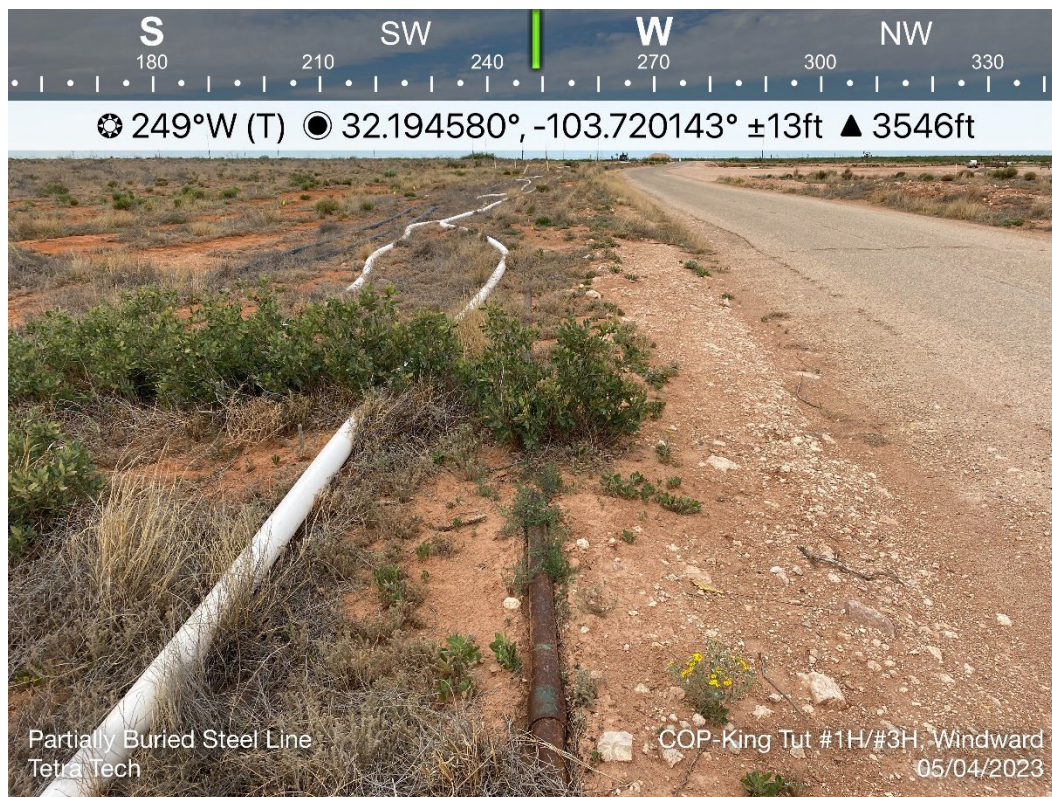
TETRA TECH, INC. PROJECT NO. 212C-MD-02999	DESCRIPTION	View southwest west. View surface poly lines and buried steel line.	10
	SITE NAME	KING TUT FEDERAL #001H, KING TUT FEDERAL #003H, & WINDWARD FEDERAL #001H Releases	5/4/2023

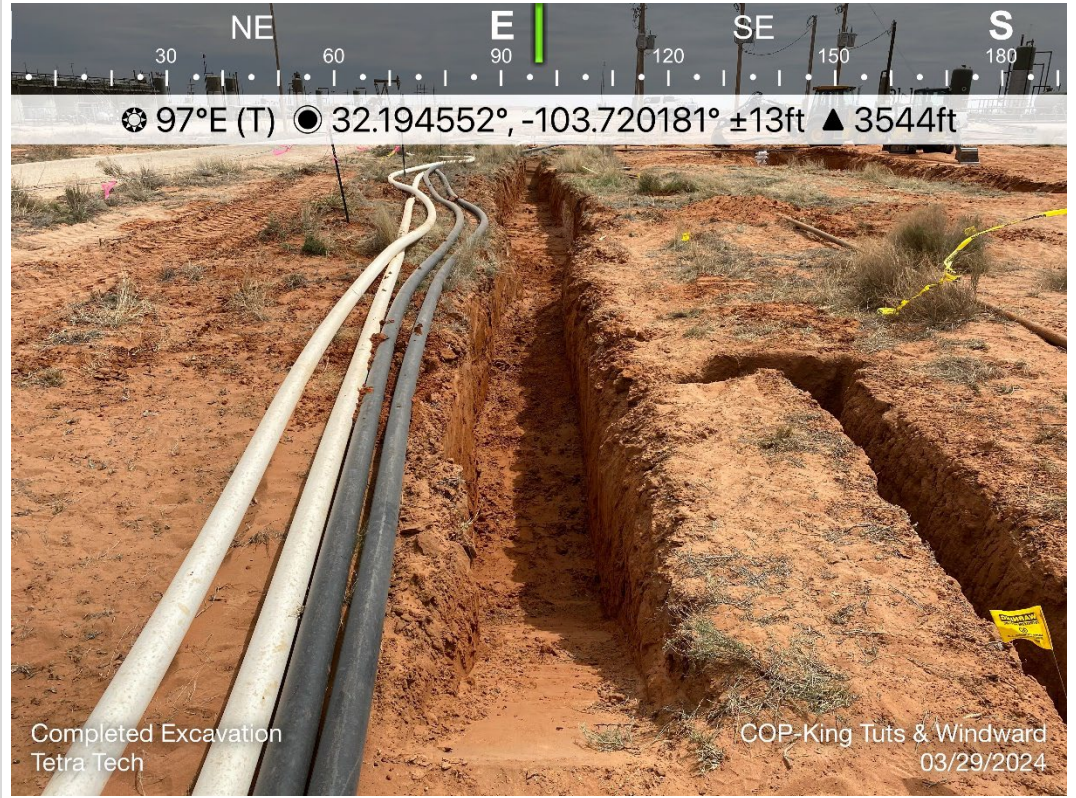
TETRA TECH, INC. PROJECT NO. 212C-MD-02999	DESCRIPTION	View east. View of excavation activities.	14
	SITE NAME	KING TUT FEDERAL #001H, KING TUT FEDERAL #003H, & WINDWARD FEDERAL #001H Releases	3/29/2024

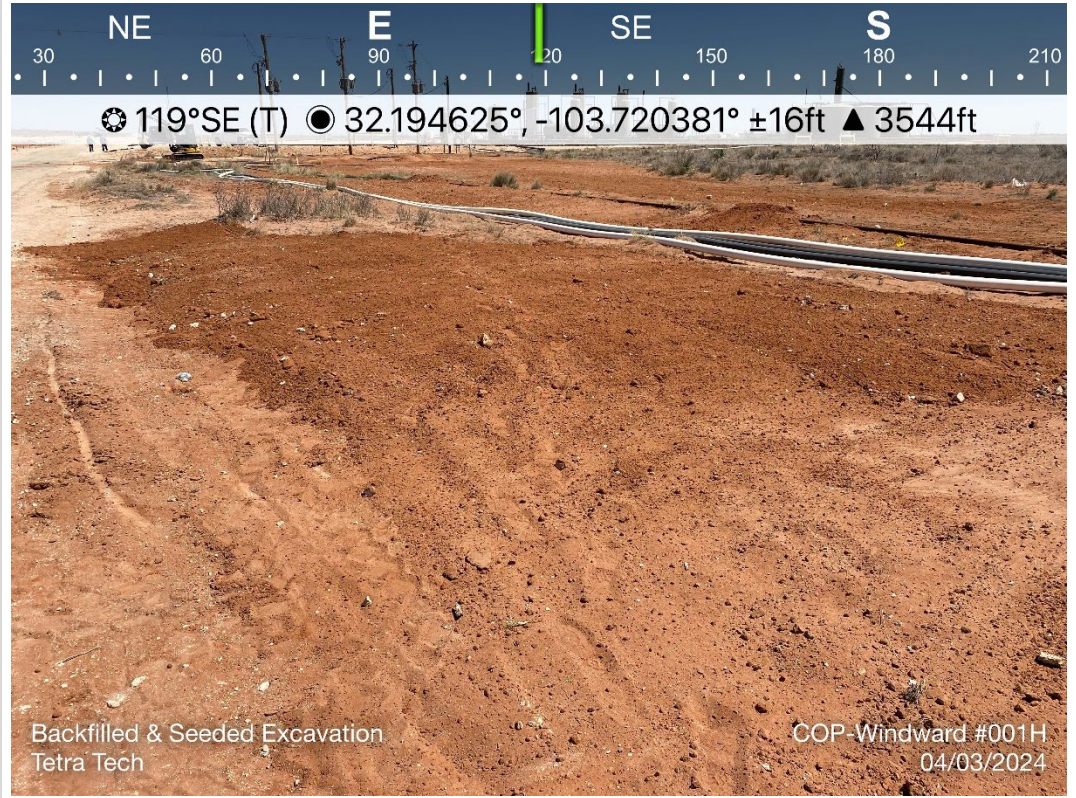
TETRA TECH, INC. PROJECT NO. 212C-MD-02999	DESCRIPTION	View east. View of backfilled and seeded excavated areas.	16
	SITE NAME	KING TUT FEDERAL #001H, KING TUT FEDERAL #003H, & WINDWARD FEDERAL #001H Releases	4/3/2024
