**RE: Liner Inspection and Closure Report**  
**Aid State 14 #001 Battery**  
**API No. 30-015-29569**  
**GPS: Latitude 32.83002 Longitude -104.14270**  
**UL- O, Section 14, Township 17S, Range 28E**  
**NMOCD Reference No. NAPP2235636397**

# Aid State 14 #1 Battery

**Liner Inspection Form**

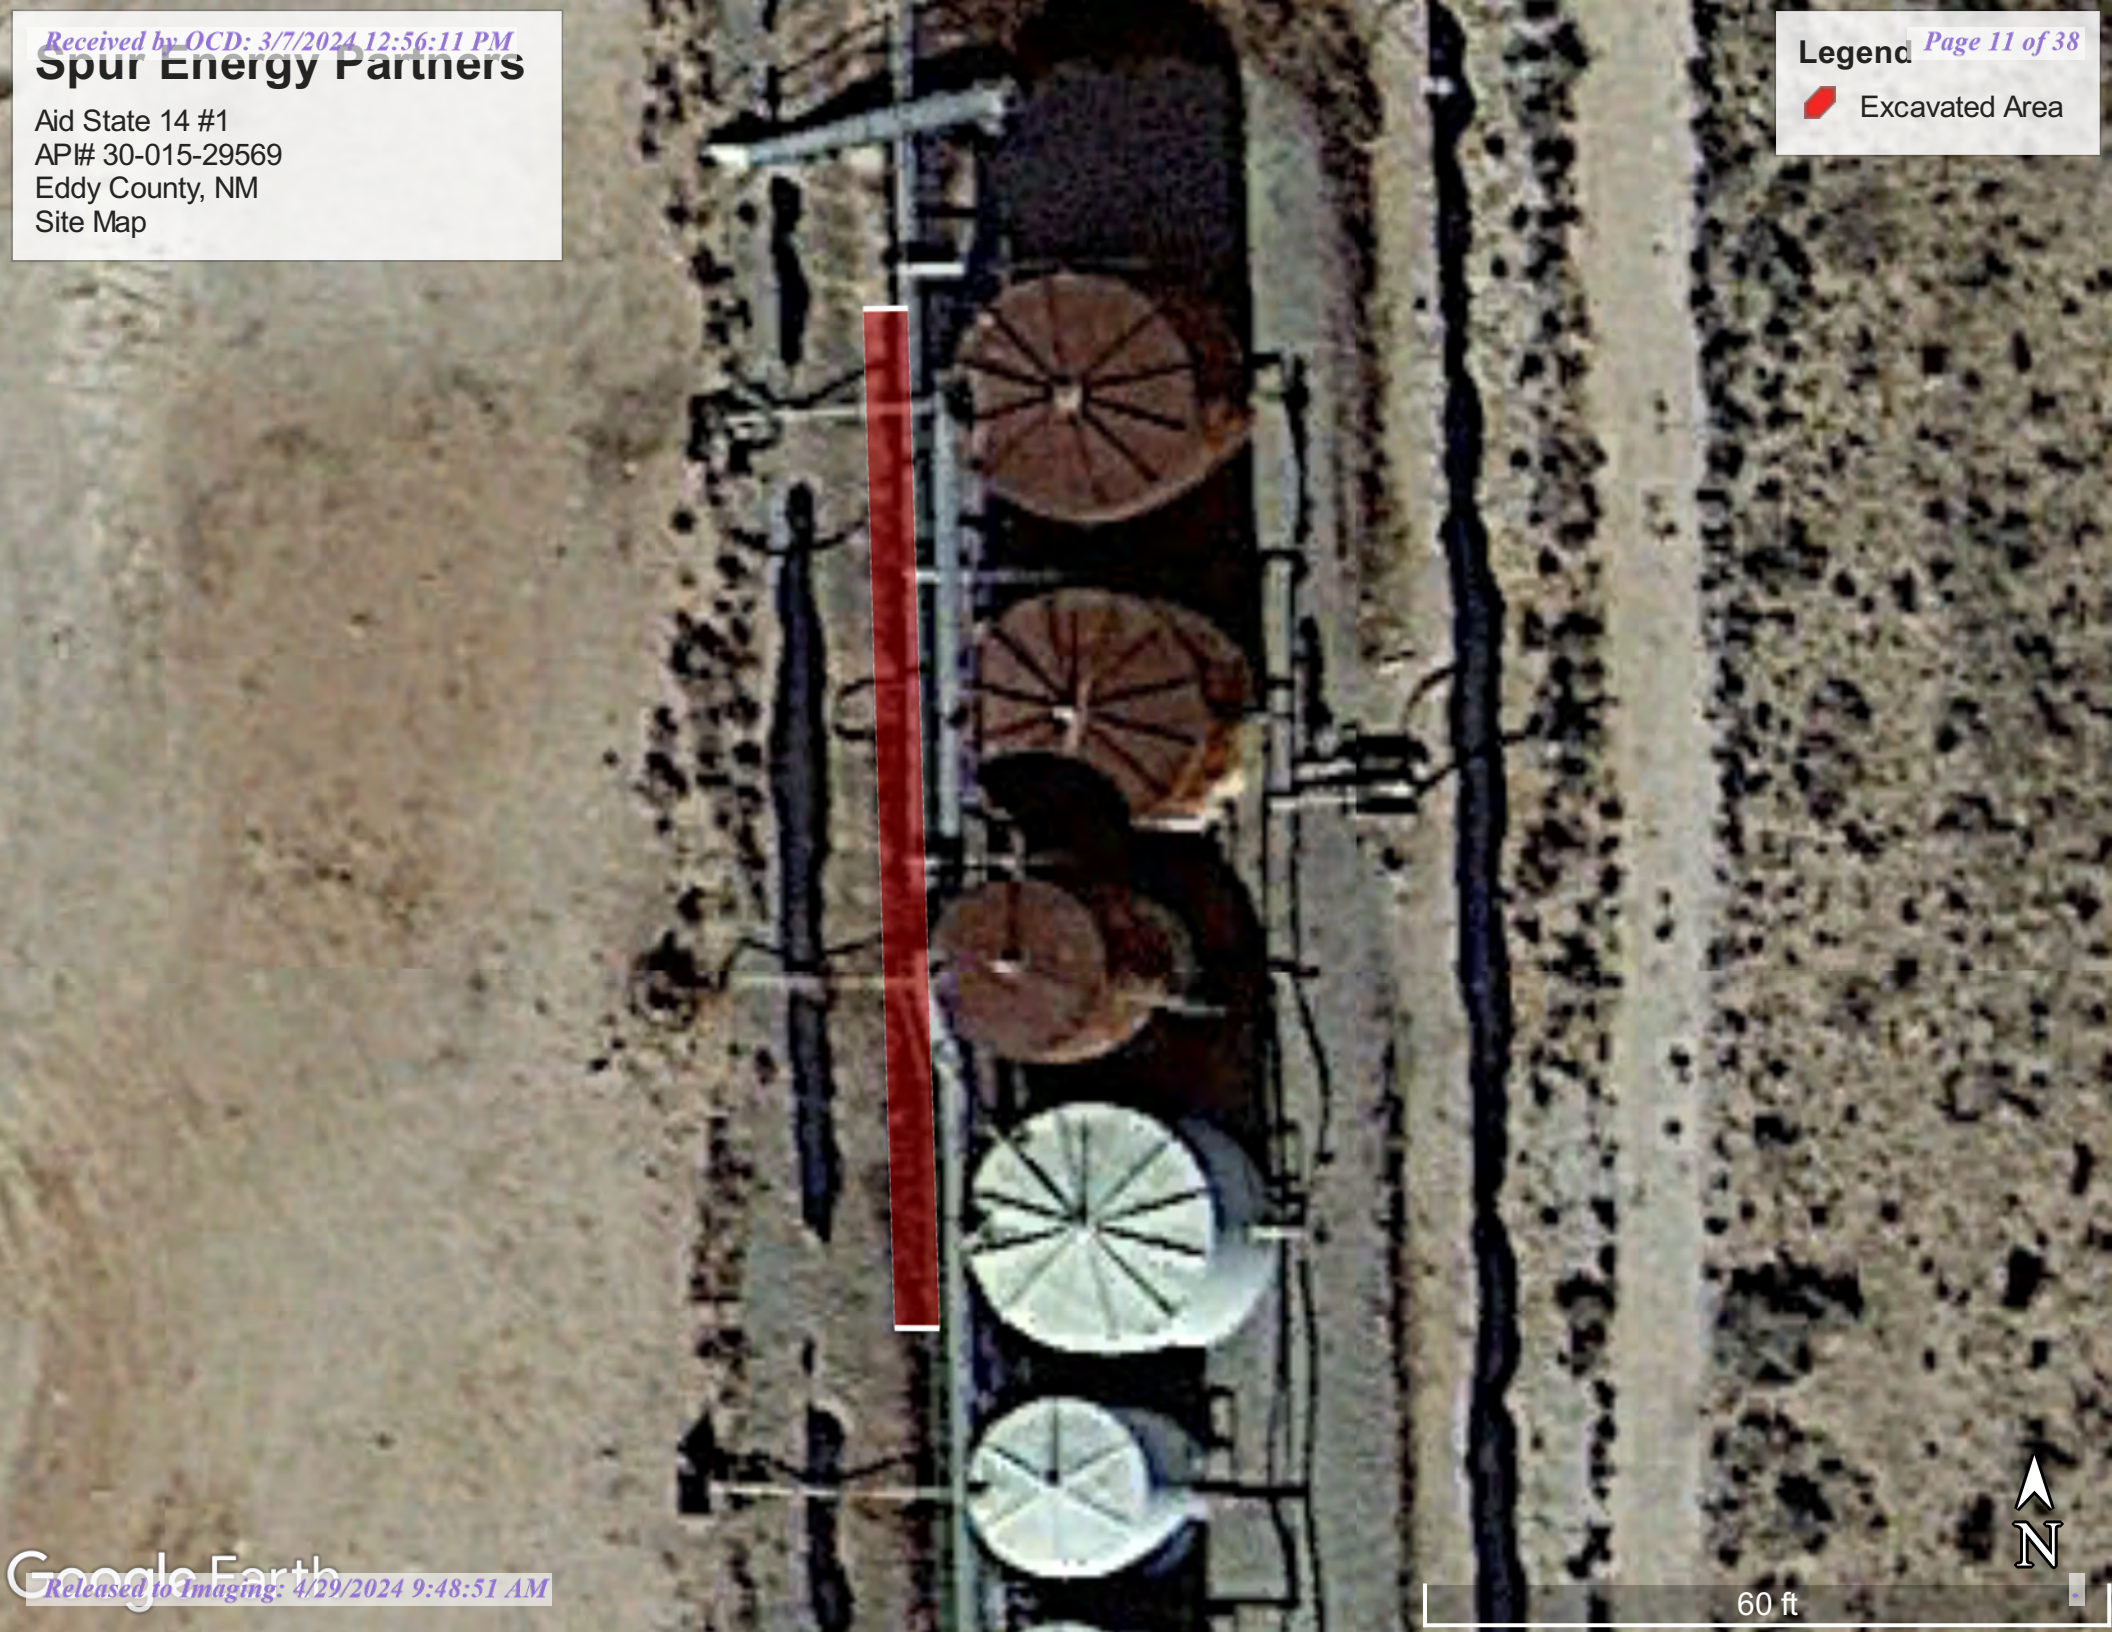
Aid State 14 #1  
API# 30-015-29569  
Eddy County, NM  
Site Map

A Site Map can be found in Figure 4.

Excavated Area

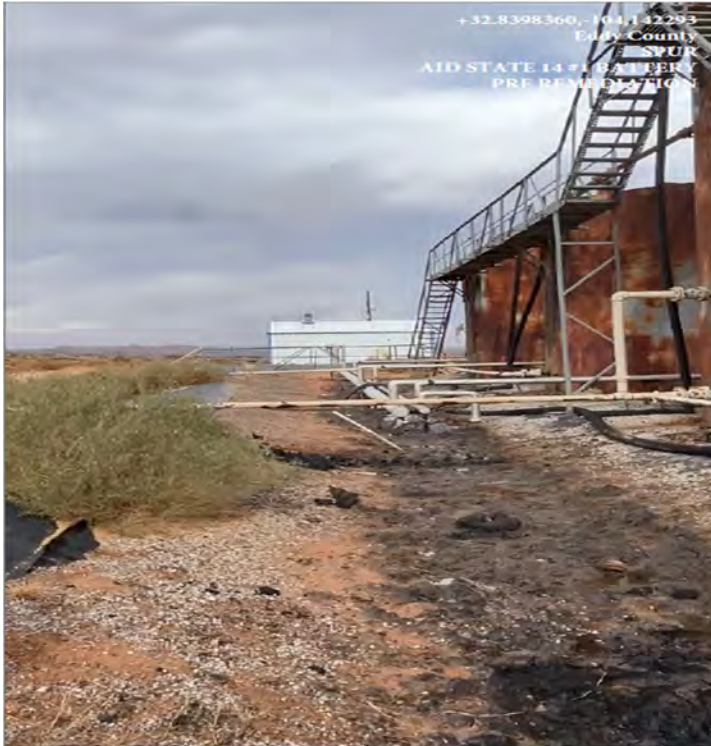
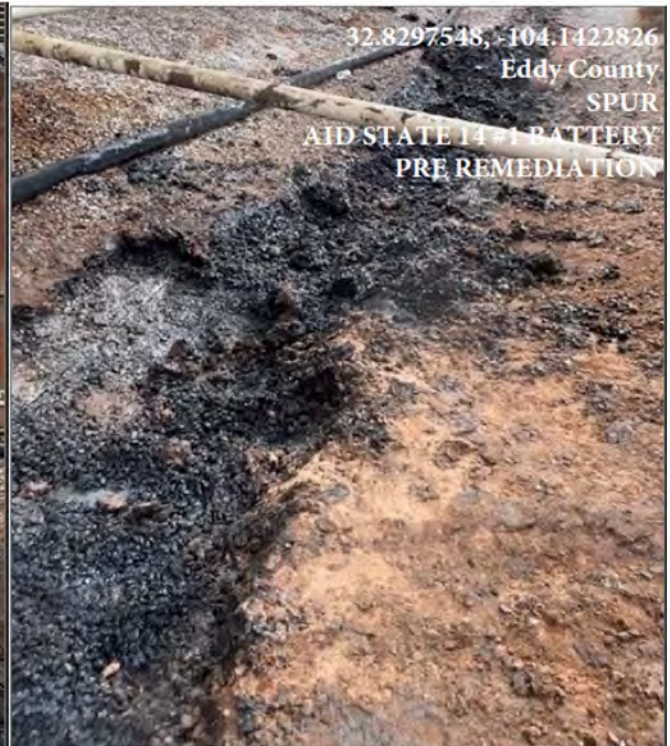
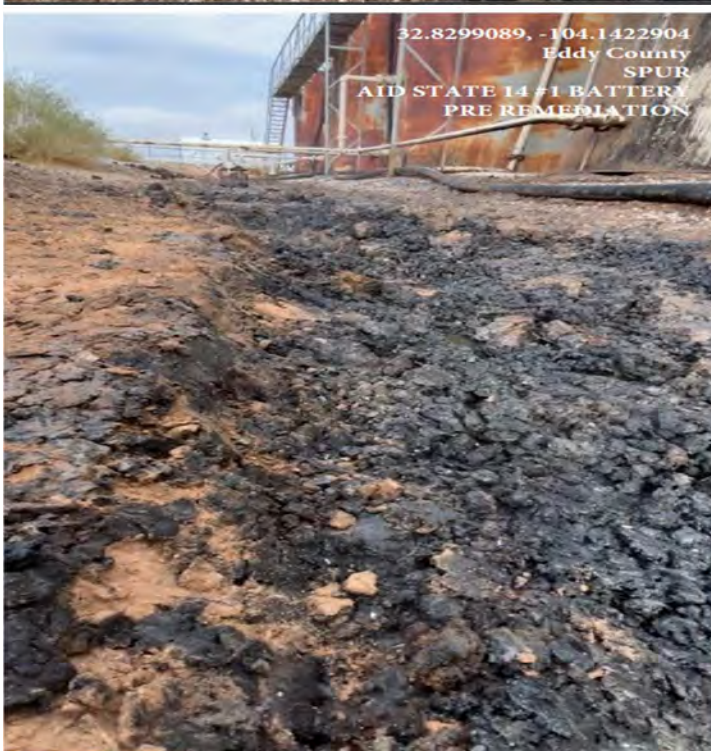
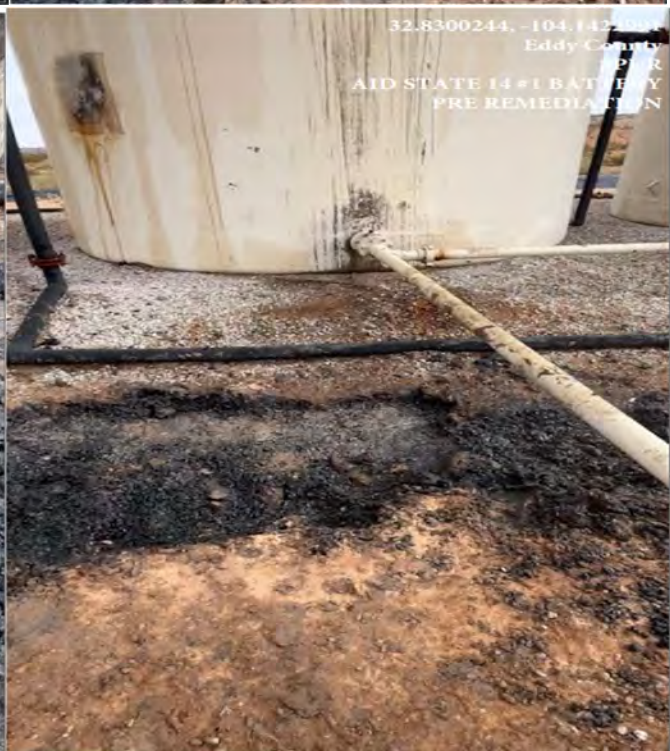
#### PRE REMEDIATION-

**NAPP2235636397:** On December 21, 2022, a breach occurred in the oil tank as a result of internal corrosion, leading to the release of both crude oil and produced water within the lined containment. Approximately 72 barrels of crude oil and 71 barrels of produced water were discharged, but prompt measures resulted in the successful recovery of 71 barrels of each. The final barrel of crude oil is slated for recovery during subsequent remediation activities.

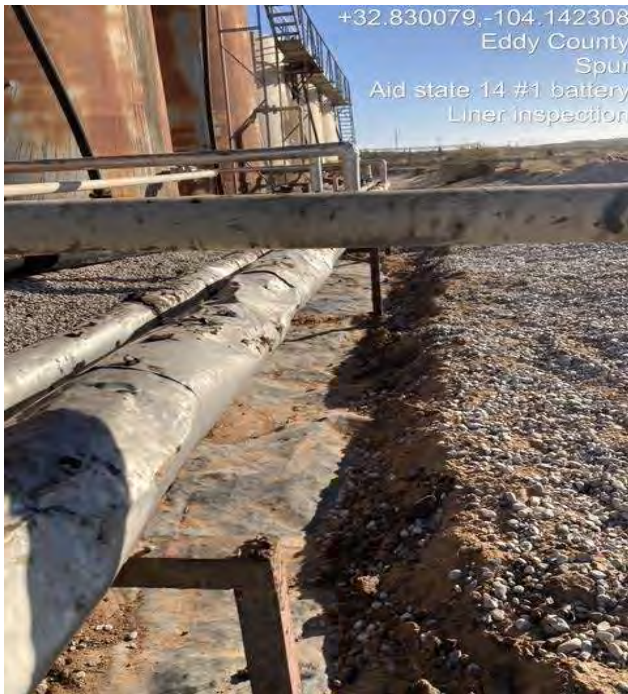
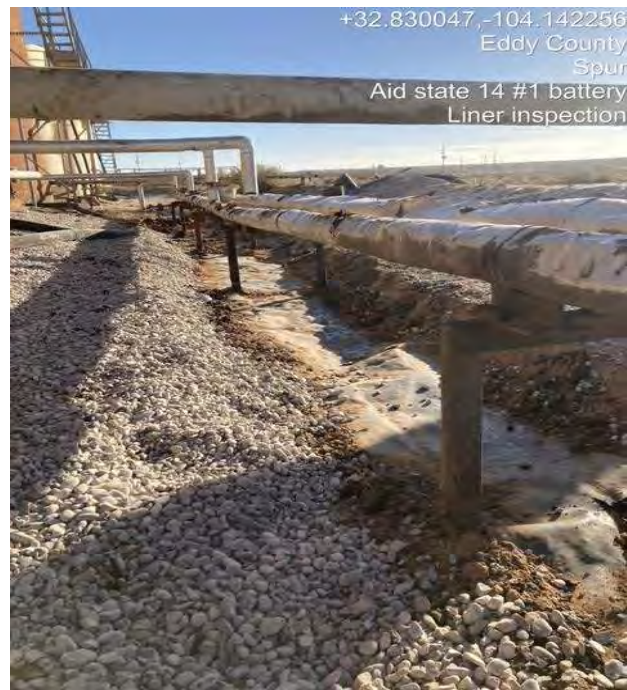
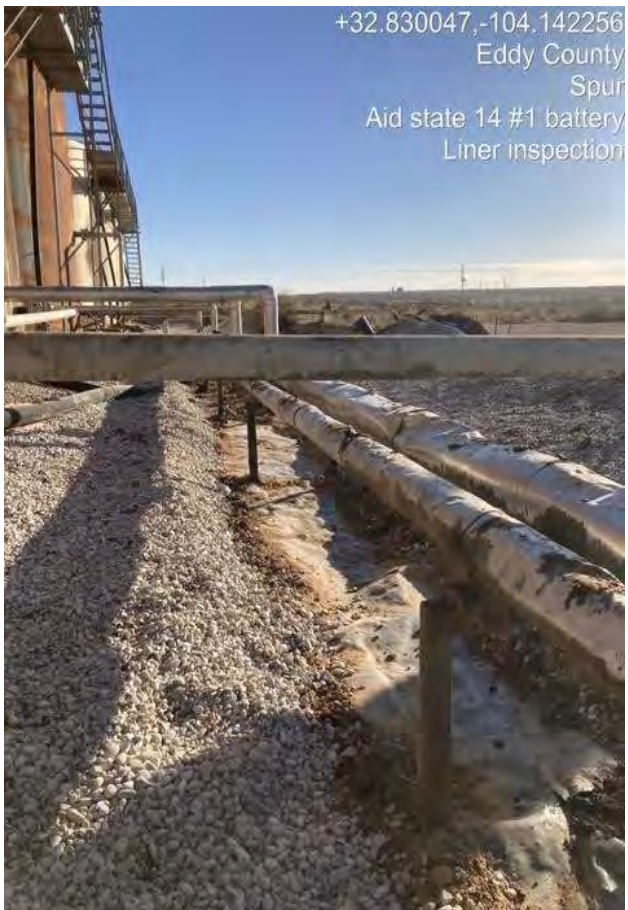
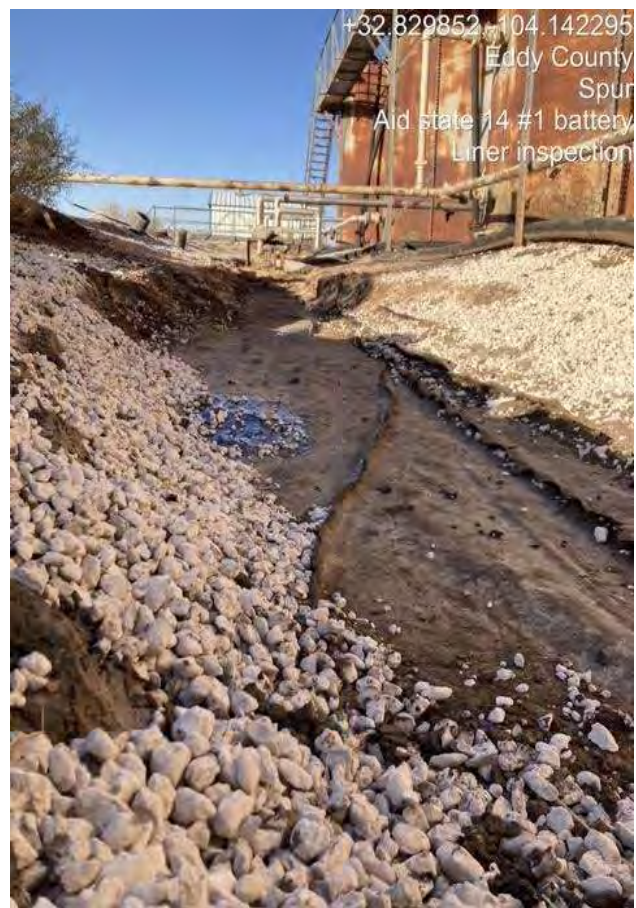
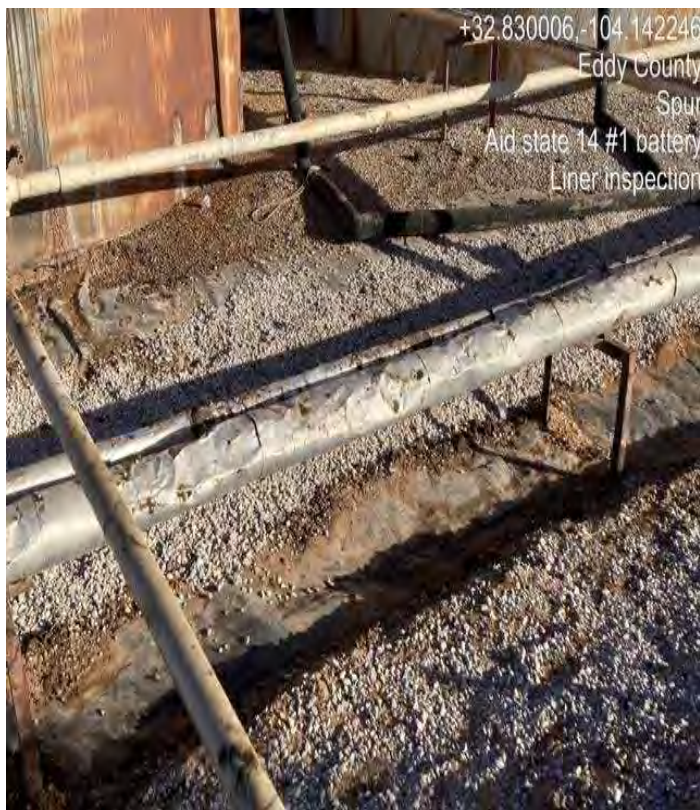
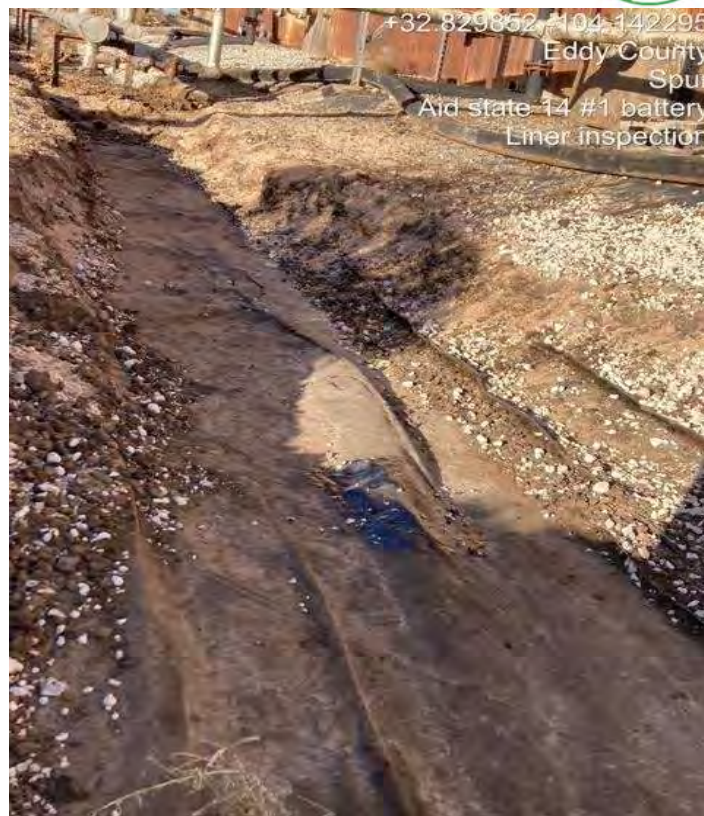
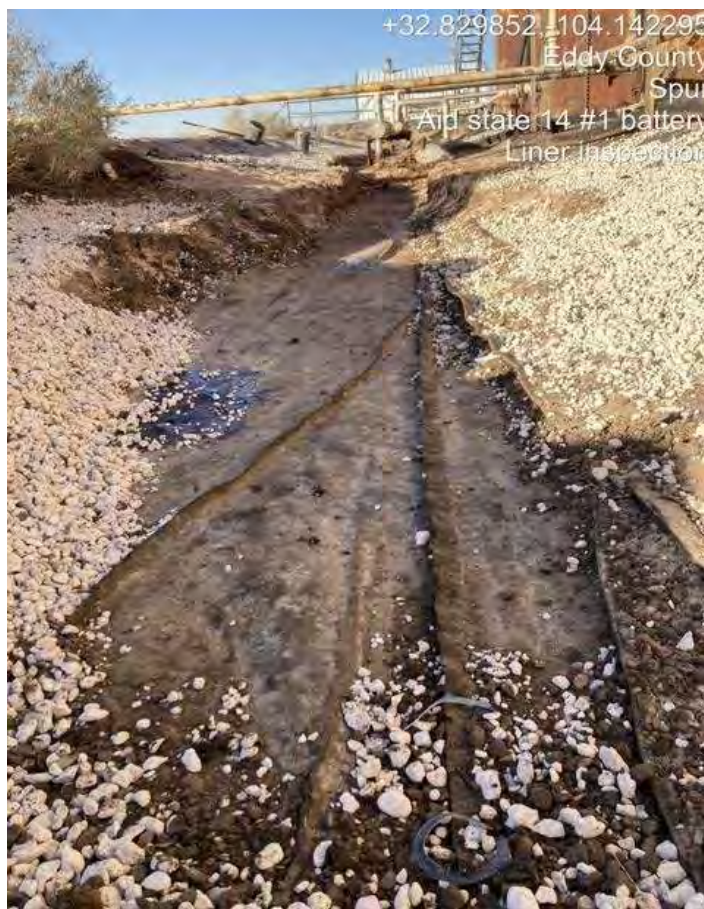
### AID STATE 14 # 1 BATTERY/ LINER INSPECTION

On January 12<sup>th</sup>, 2024, after sending the 48-hour notification via email, Pima Environmental conducted a liner inspection at this location. Pima conducted an inspection of the area directly impacted by the release of crude oil and produced water. We concluded that this liner and containment maintained its integrity and was able to retain the fluids. The liner inspection form and photographic documentation can be found in Appendix C.

| Visualization | Yes | No | Comments |
|---|---|---|---|
| Is the liner retaining any fluids? | | X | The inspection images of the liner reveal residual fluid resulting from the remediation event involving power washing. |
| Does the liner have integrity to contain a leak? | X | | |

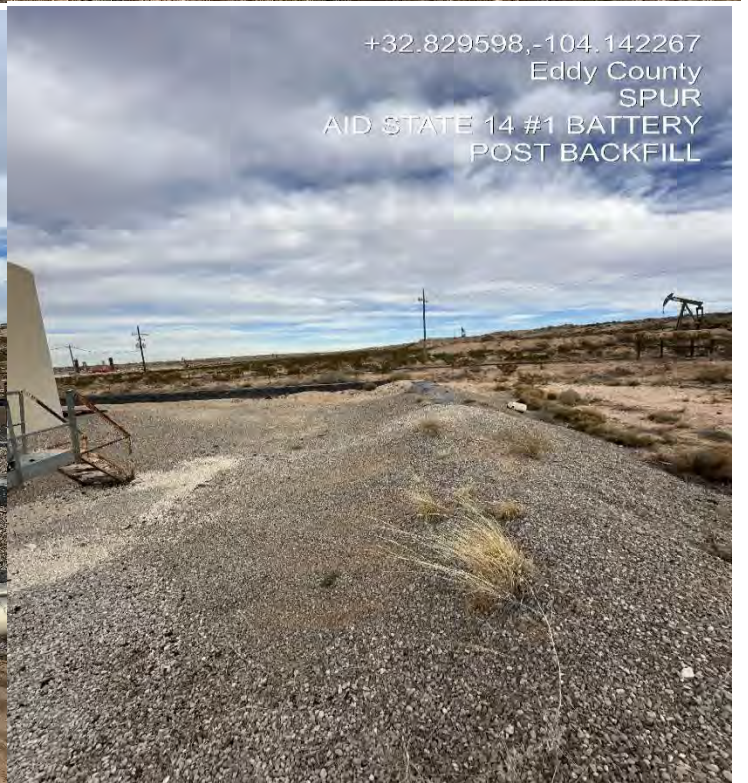
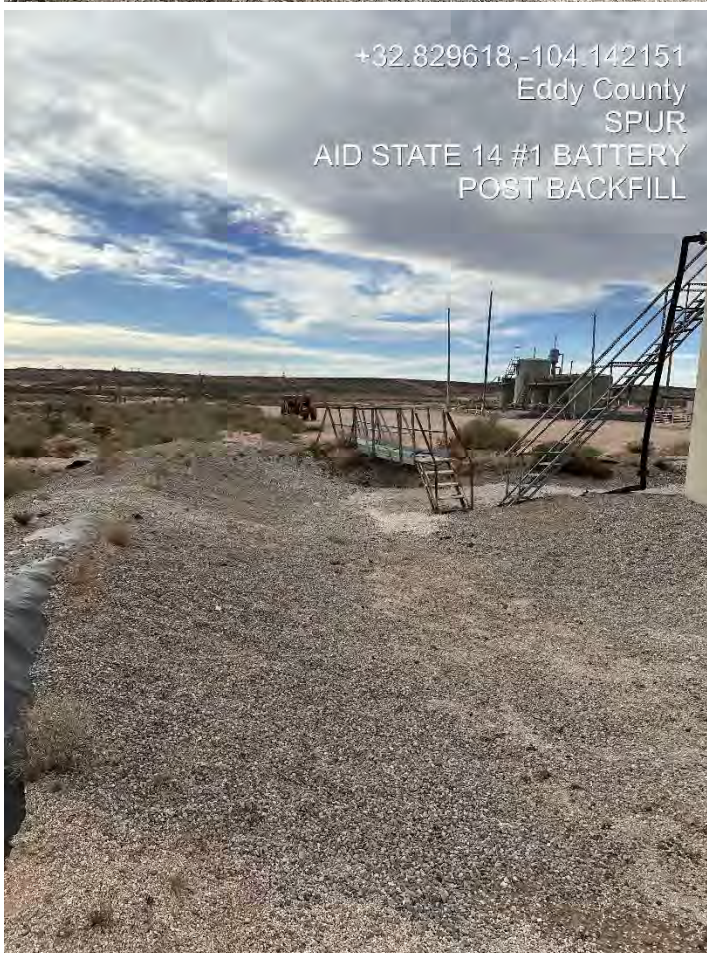
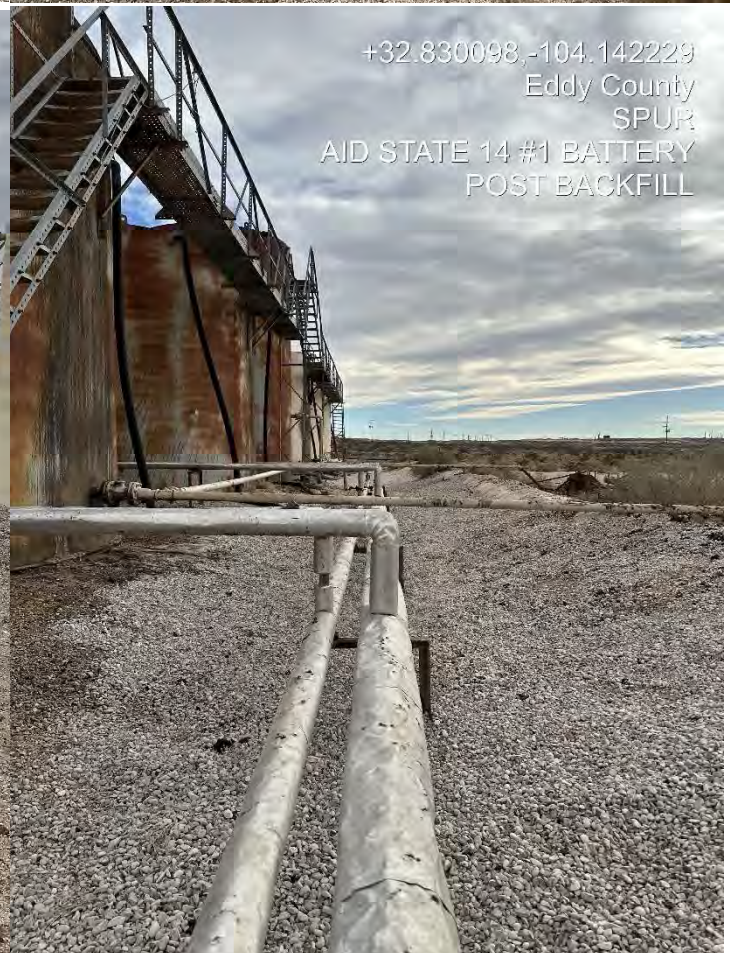
**POST REMEDIATION-**

On January 3<sup>rd</sup>- January 10<sup>th</sup>, 2024, the Pima team carried out a comprehensive cleaning of spill area in the lined containment, employing a hand shoveling crew to meticulously remove all contaminated gravel. Pima Environmental has effectively completed the recovery of all remaining contamination from within the release area of the lined containment. Upon the completion of gravel removal, Pima personnel proceeded to pressure wash the exposed lining, ensuring thorough cleaning and restoration.
