**Re: Site Assessment, Remediation, and Closure Report**  
**Goodman 22 Battery**  
**API No. N/A**  
**GPS: Latitude 32.64524 Longitude -104.47353**  
**UL "K", Sec. 22, T19S, R25E**  
**Eddy County, NM**  
**NMOCD Ref. No. NAPP2331037699**

Pima Environmental Services, LLC (Pima) has been contracted by Spur Energy Partners, LLC. (Spur) to perform a spill assessment, remediation, and submit this closure report for a crude oil release that occurred at the Goodman 22 Battery (Goodman). The initial C-141 was submitted on November 6, 2023, (Appendix C). This incident was assigned Incident ID NAPP2331037699, by the New Mexico Oil Conservation Division (NMOCD).

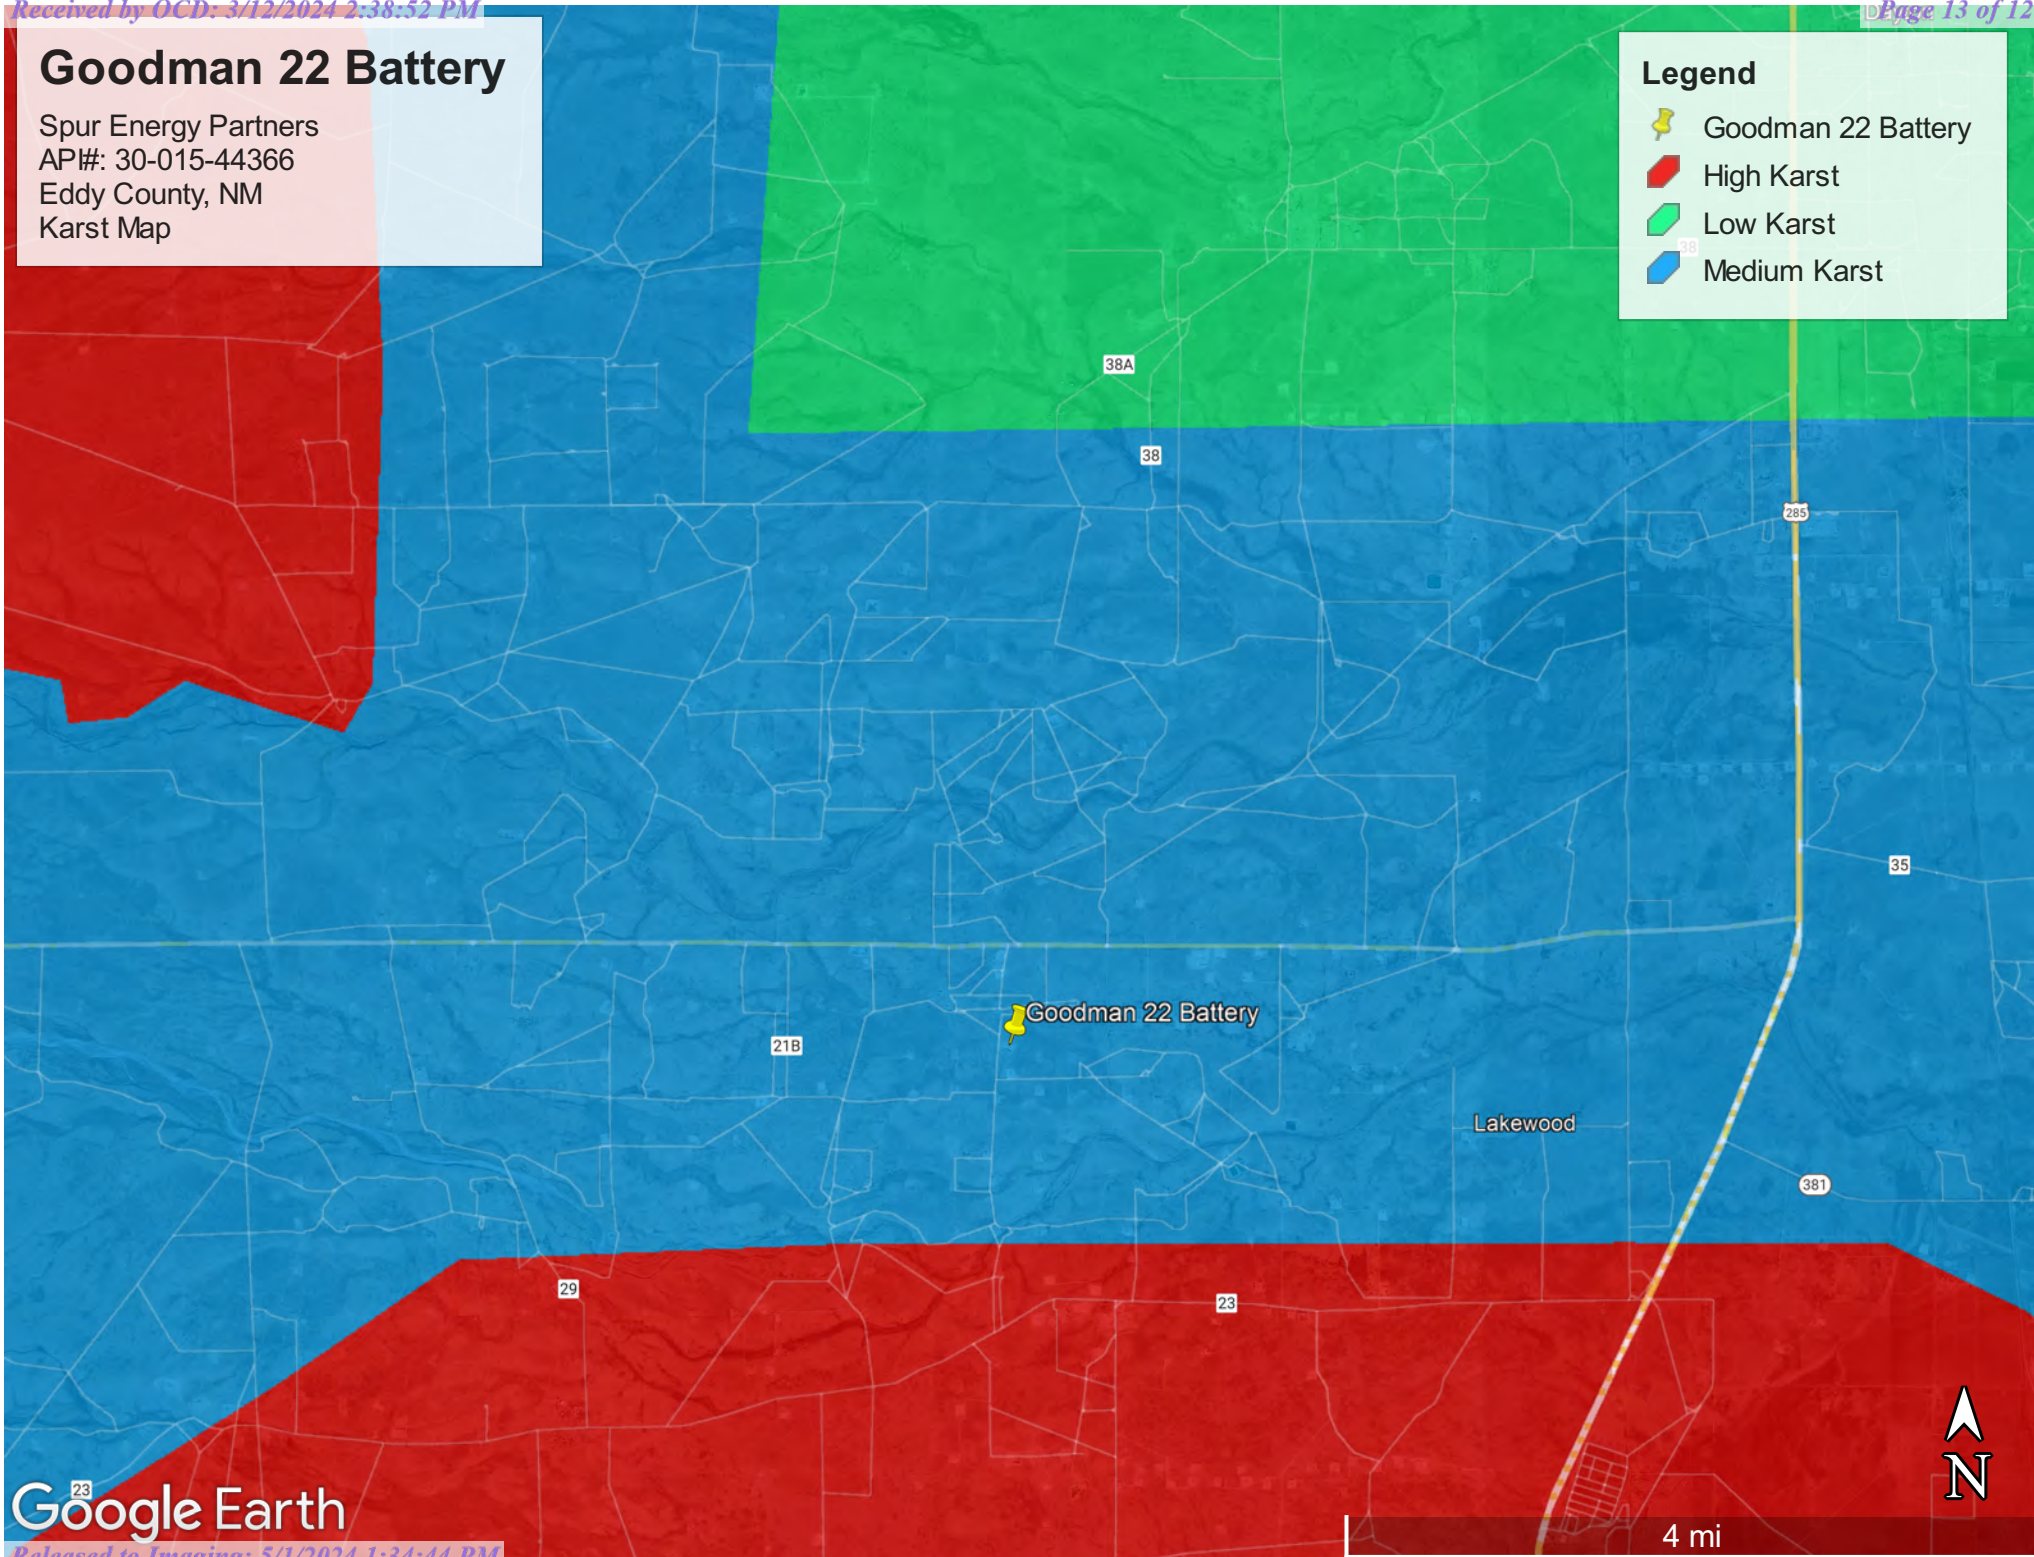
Spur Energy Partners  
API#: 30-015-44366  
Eddy County, NM  
Karst Map

Per the New Mexico Bureau of Geology and Mineral Resources, the geology is made up of Piedmont alluvial deposits. Includes deposits of higher gradient tributaries bordering major stream valleys, alluvial veneers of the piedmont slope, and alluvial fans. May locally include uppermost Pliocene deposits. The soil in this area is made up of Reagan loam, 0 to 3 percent slopes according to the United States Department of Agriculture Natural Resources Conservation Service soil survey (Appendix B). The drainage courses in this area are well-drained. There is a medium potential for karst geology around the Goodman (Figure 3).

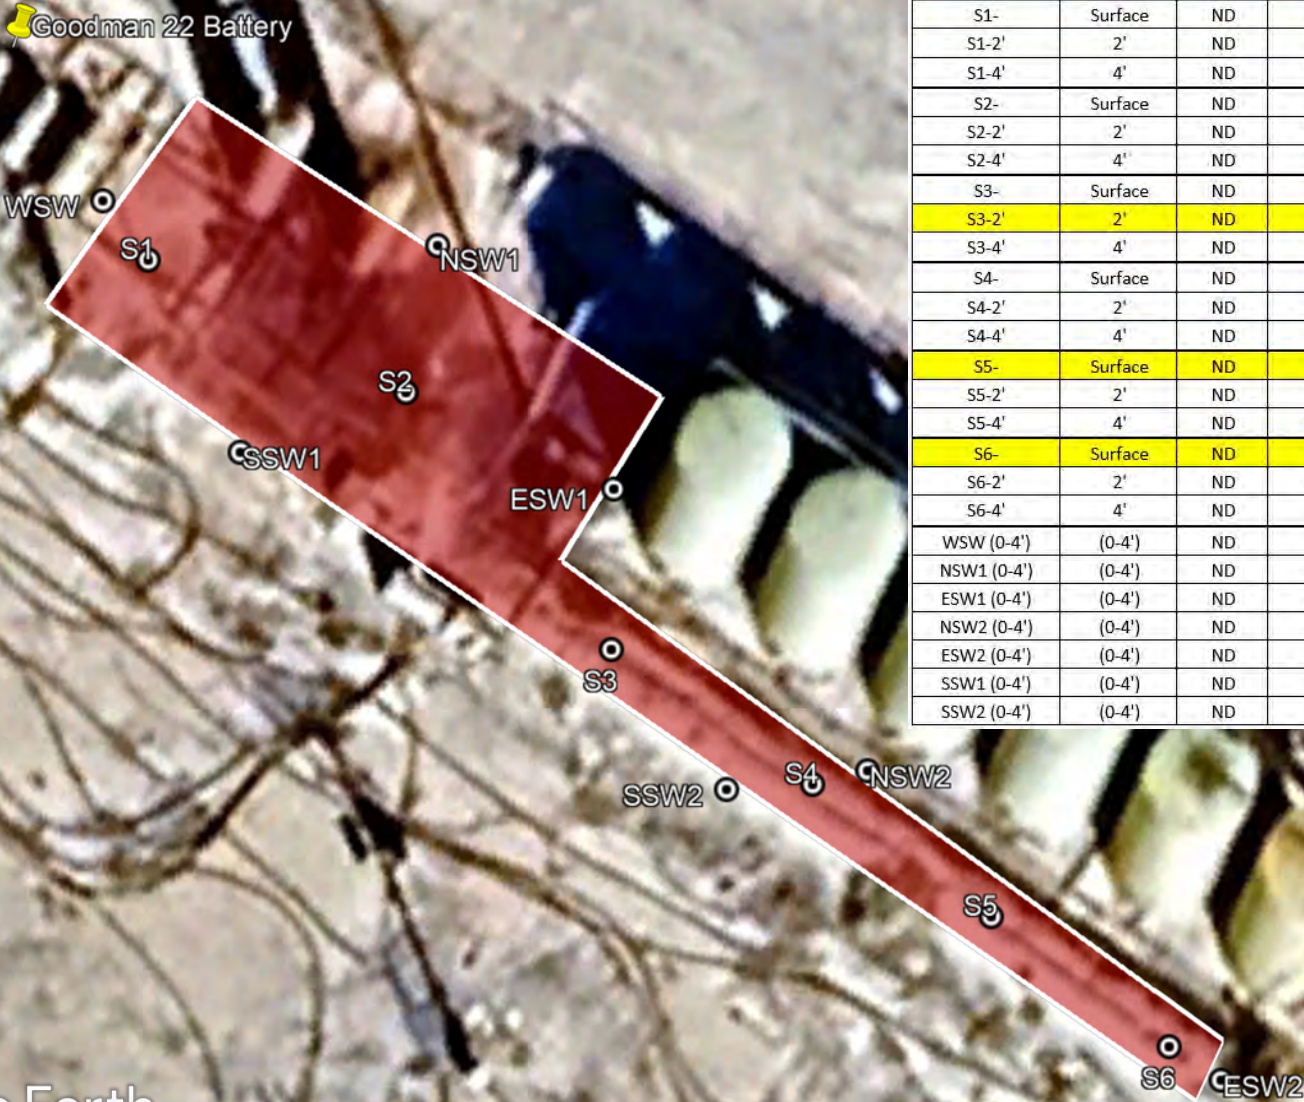
Spur Energy Partners  
AP#:30-015-44366  
Eddy County, NM  
Initial Site Map

NMOCD Table 1 Closure Criteria 19.15.29 NMAC - Depth to Groundwater is >100'								
SPUR ENERGY - Goodman 22 Battery								
Date: 11-10-2023		NM Approved Laboratory Results						
Sample ID	Depth (BGS)	BTEX mg/kg	Benzene mg/kg	GRO mg/kg	DRO mg/kg	MRO mg/kg	Total TPH mg/kg	Cl mg/kg
S1-	Surface	ND	ND	ND	184	147	331	983
S1-2'	2'	ND	ND	ND	837	ND	837	466
S1-4'	4'	ND	ND	ND	347	220	567	375
S2-	Surface	ND	ND	ND	1830	ND	1830	1270
S2-2'	2'	ND	ND	ND	1230	605	1835	475
S2-4'	4'	ND	ND	ND	473	345	818	385
S3-	Surface	ND	ND	ND	569	306	875	904
S3-2'	2'	ND	ND	ND	2920	1280	4200	543
S3-4'	4'	ND	ND	ND	348	228	576	376
S4-	Surface	ND	ND	ND	576	378	954	1110
S4-2'	2'	ND	ND	ND	923	ND	923	600
S4-4'	4'	ND	ND	ND	135	97.8	232.8	332
S5-	Surface	ND	ND	ND	3950	2830	6780	1490
S5-2'	2'	ND	ND	ND	1620	697	2317	346
S5-4'	4'	ND	ND	ND	631	374	1005	414
S6-	Surface	ND	ND	ND	3050	2680	5730	1230
S6-2'	2'	ND	ND	ND	1320	707	2027	462
S6-4'	4'	ND	ND	ND	751	495	1246	408

WSW (0-4')	(0-4')	ND	ND	ND	ND	ND	0	33.2
NSW1 (0-4')	(0-4')	ND	ND	ND	ND	ND	0	42.4
ESW1 (0-4')	(0-4')	ND	ND	ND	ND	ND	0	33
NSW2 (0-4')	(0-4')	ND	ND	ND	ND	ND	0	47.3
ESW2 (0-4')	(0-4')	ND	ND	ND	ND	ND	0	44.4
SSW1 (0-4')	(0-4')	ND	ND	ND	ND	ND	0	38.9
SSW2 (0-4')	(0-4')	ND	ND	ND	ND	ND	0	47.9

On November 10, 2023, Pima Environmental Services initiated the mobilization of personnel to the site for delineation activities. Our team conducted sampling procedures covering the area spanning from the point of release to the easternmost limit of the unlined containment. For vertical delineation, a total of six bottom samples (S1-S6) were collected, while seven side wall samples (WSW, NSW1, ESW1, NSW2, ESW2, SSW1, SSW2) were acquired for horizontal delineation. Bottom samples (S1-S6) were gathered at depths ranging from surface levels down to four feet below ground surface (bgs), and side wall samples (SW1-SW4) were collected at surface down to 4' bgs. The detailed laboratory results from this sampling event are presented in the accompanying data table. For further reference, a comprehensive laboratory report can be located in Appendix E.

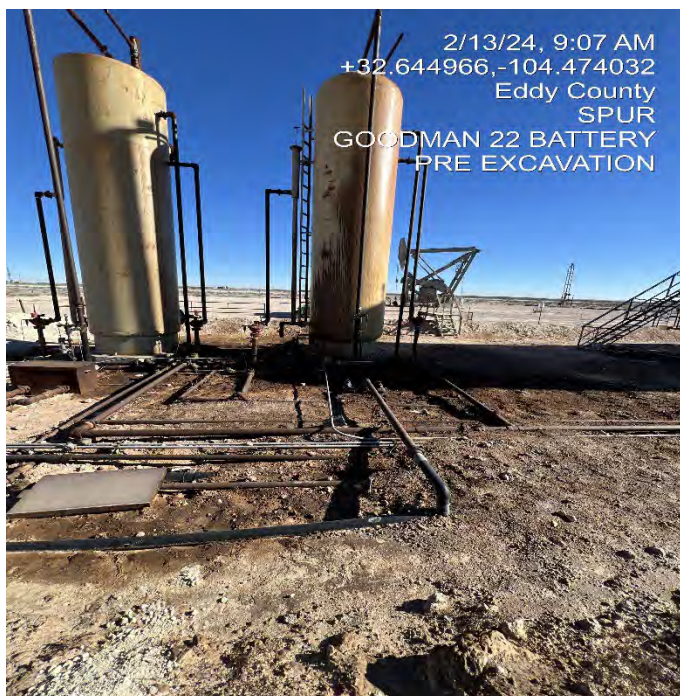
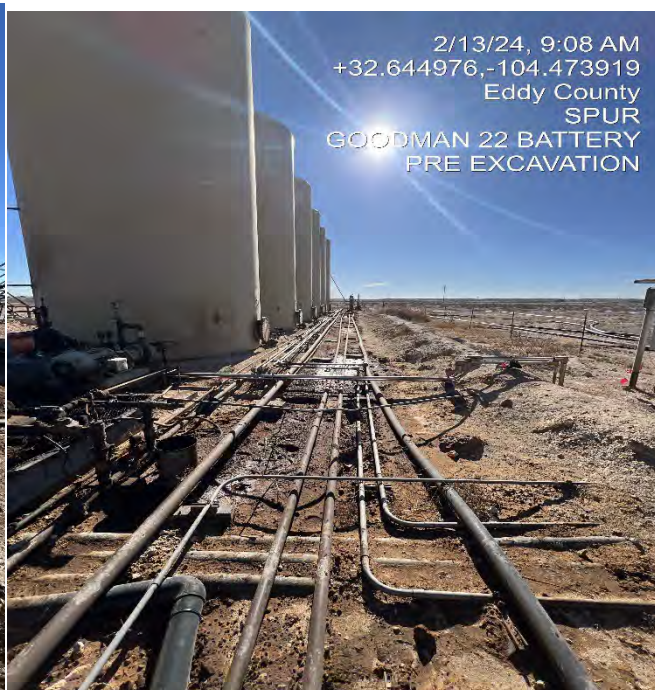
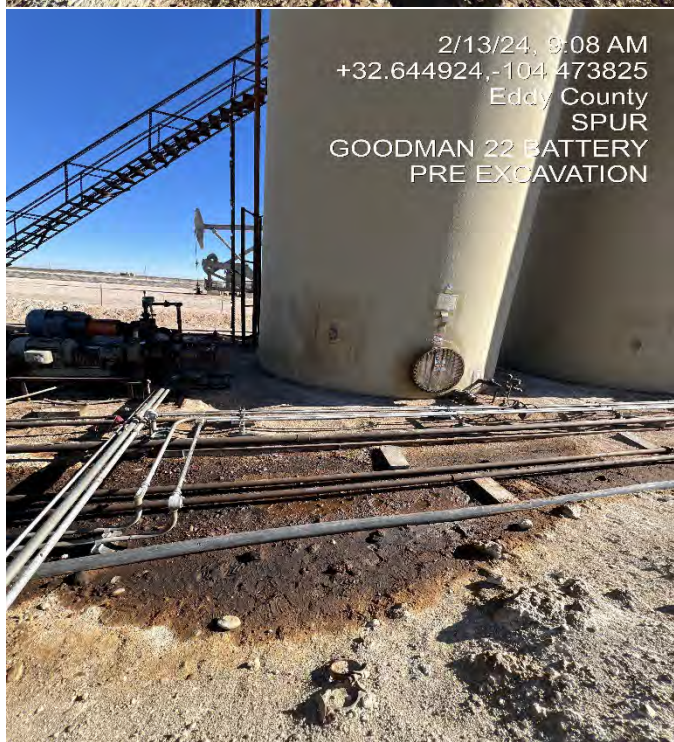
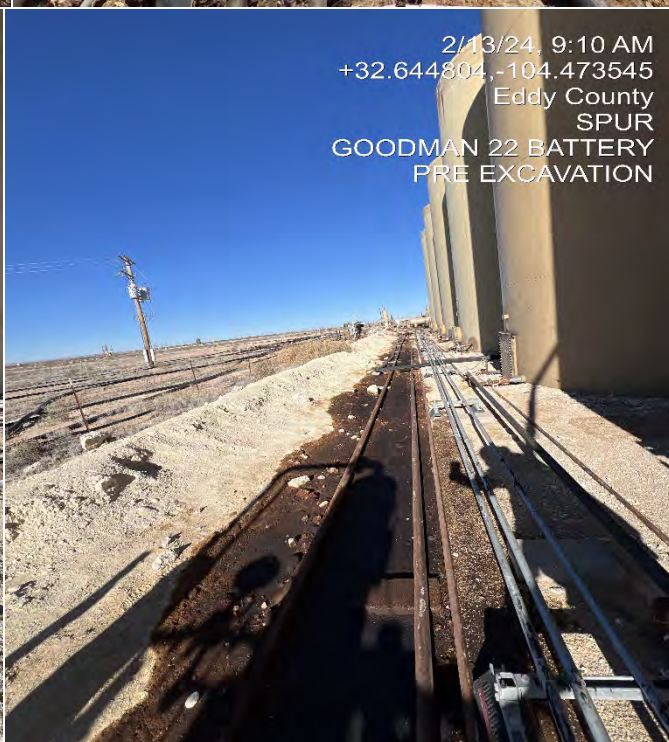
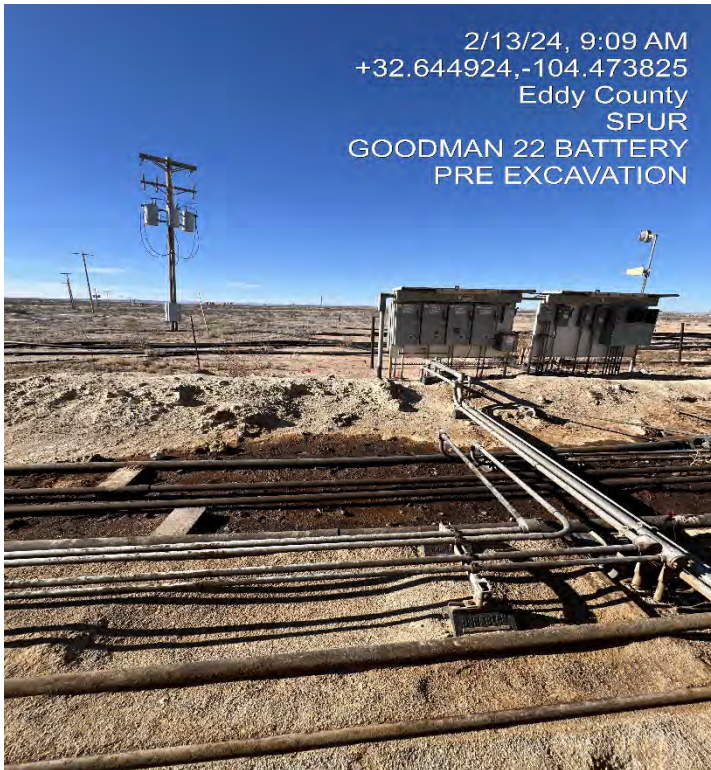
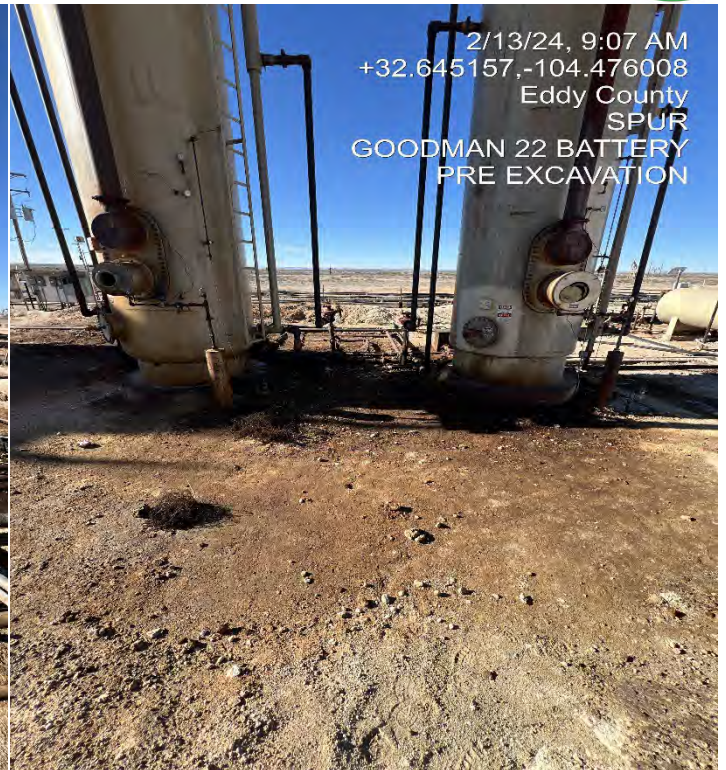
**PRE-**

On November 4, 2023, an incident occurred where the seal on the access cover of the heater treater malfunctioned, resulting in the discharge of crude oil onto the unlined containment area. Approximately 12 barrels of crude oil were released, with recovery efforts successfully retrieving 11 barrels. The final barrel was effectively recovered during subsequent remediation activities. It is noteworthy that all fluids were confined on-site within the unlined containment system. The total affected area of the release encompassed approximately 3,800 square feet.
