Re: Site Assessment and Closure Report

Sea Snake 35 State #001H API No. 30-025-41625

NMOCD Ref. No. NAPP2101437181

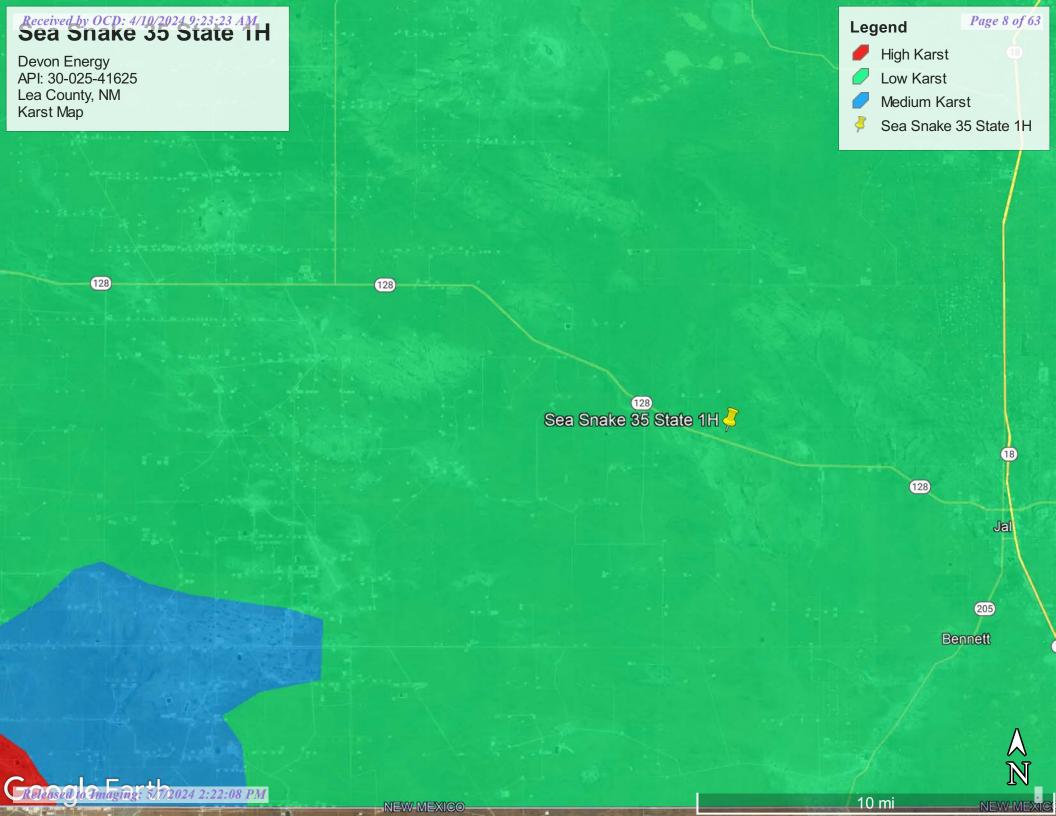
Per the New Mexico Bureau of Geology and Mineral Resources, the geology is in Interlayered eolian sands and piedmont-slope deposits along the eastern flank of the Pecos River valley, primarily between Roswell and Carlsbad. Typically capped by thin eolian deposits. The soil in this area is made up of Pyote loamy fine sand according to the United States Department of Agriculture Natural Resources Conservation Service soil survey (Appendix B). The drainage courses in this area are well-drained. There is a low potential for karst geology to be present around the Sea Snake (Figure 3).

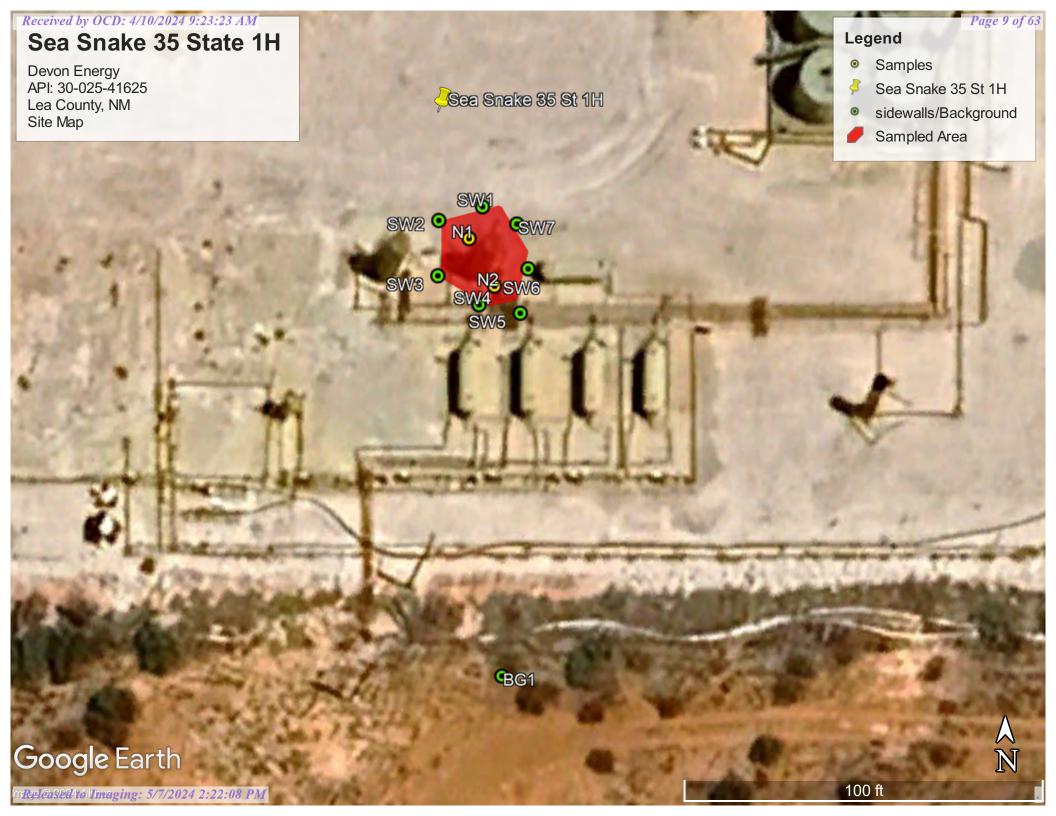
On March 22, 2024, Pima Environmental conducted a site assessment and obtained soil samples. The laboratory results of this sampling event can be found in the following data table. Photographic documentation can be found in Appendix D.

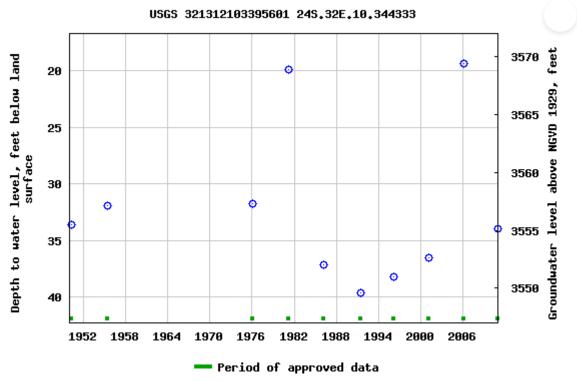
Breaks in the plot represent a gap of at least one year between field measurements. <u>Download a presentation-quality graph</u>

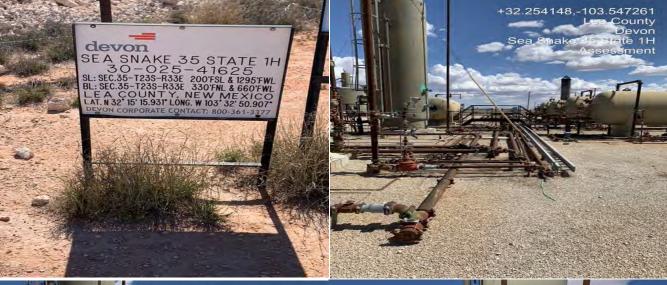
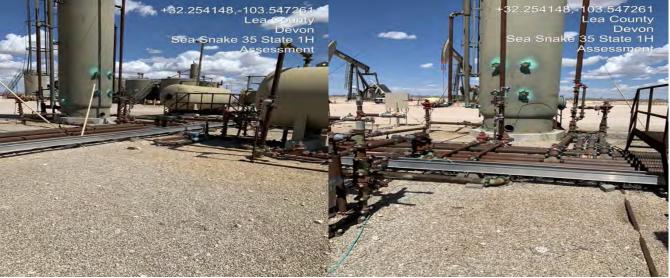
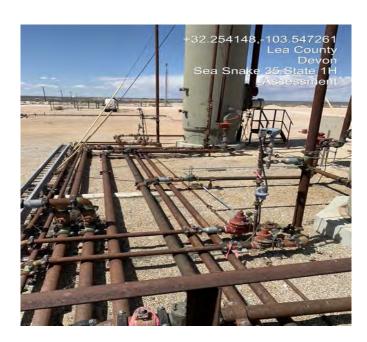
Assessment

NAPP2101437181: On January 5, 2021, a fire resulted due to a leak in the fire tube on heater treater. The fire extinguished itself and heater treater was isolated, drained, and depressurized. Minimal fluid was released on a small area of the pad and was cleaned. The released fluids were calculated to be approximately 0.14 barrels (bbls) of crude oil. A vacuum truck was able to recover 0.14 bbls of standing fluid.

The sample results were below NMOCD Closure Criteria 19.15.29 NMAC. Based on these findings, no remediation activities were needed at this location.
