Closure Report
Rustler Bluff 25 Central Tank Battery (12.26.2023)
Incident #: nAPP2336146606
Eddy County, New Mexico
Unit M Sec 25 T26S R28E
32.007336°, -104.047266°

Crude Oil and Produced Water Release
Point of Release: Equipment Failure, Separator
Release Date: 12.26.2023
Volume Released: 8 Barrels of Crude Oil & 31 Barrels of Produced Water
Volume Recovered: 4 Barrel of Crude Oil & 3 Barrels of Produced Water

**Re: Closure Report
Rustler Bluff 25 Central Tank Battery (12.26.2023)
Chevron U.S.A., Inc.
Site Location: Unit M, S25, T26S, R28E
(Lat 32.007336°, Long -104.047266°)
Eddy County, New Mexico**

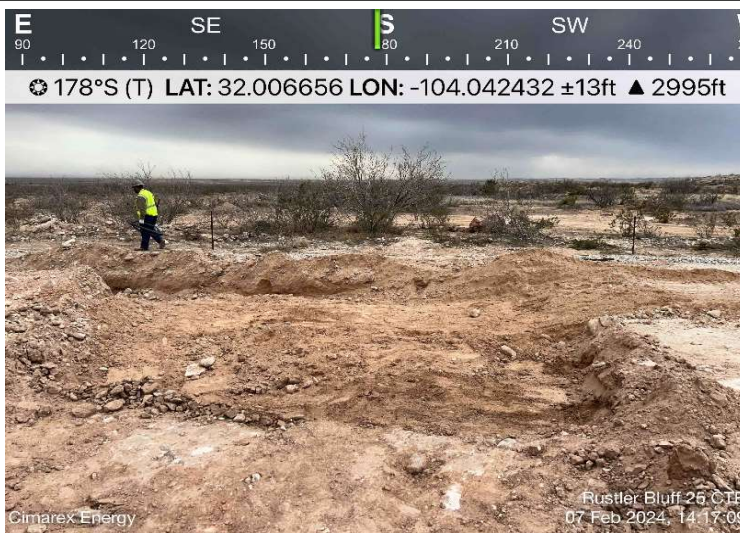
Photograph No. 4**Facility:** Rustler Bluff 25 CTB (12.26.2023)**County:** Eddy County, New Mexico**Description:**

View South, Area of Confirmation Sample (CS-14 and CS-16).

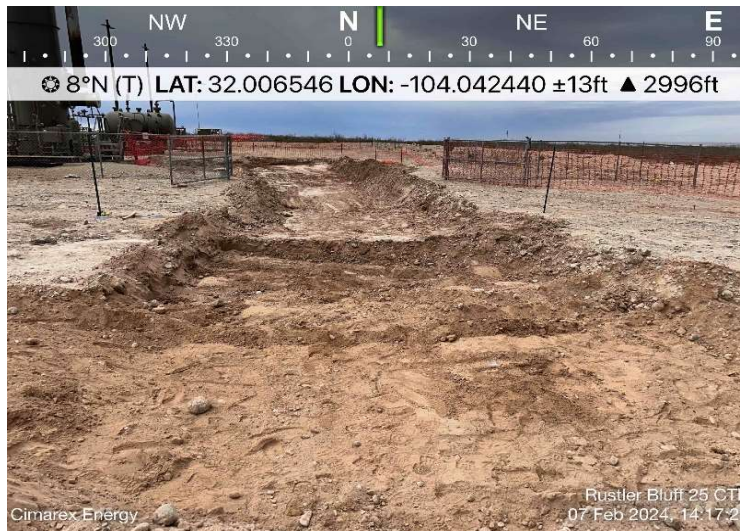
**Photograph No. 5****Facility:** Rustler Bluff 25 CTB (12.26.2023)**County:** Eddy County, New Mexico**Description:**

View North, Area of Confirmation Sample (CS-14 and CS-16).
