Closure Report

Bill Alexander Tank Battery
Lea County, New Mexico
Incident # nAB1907829070

March 5, 2024

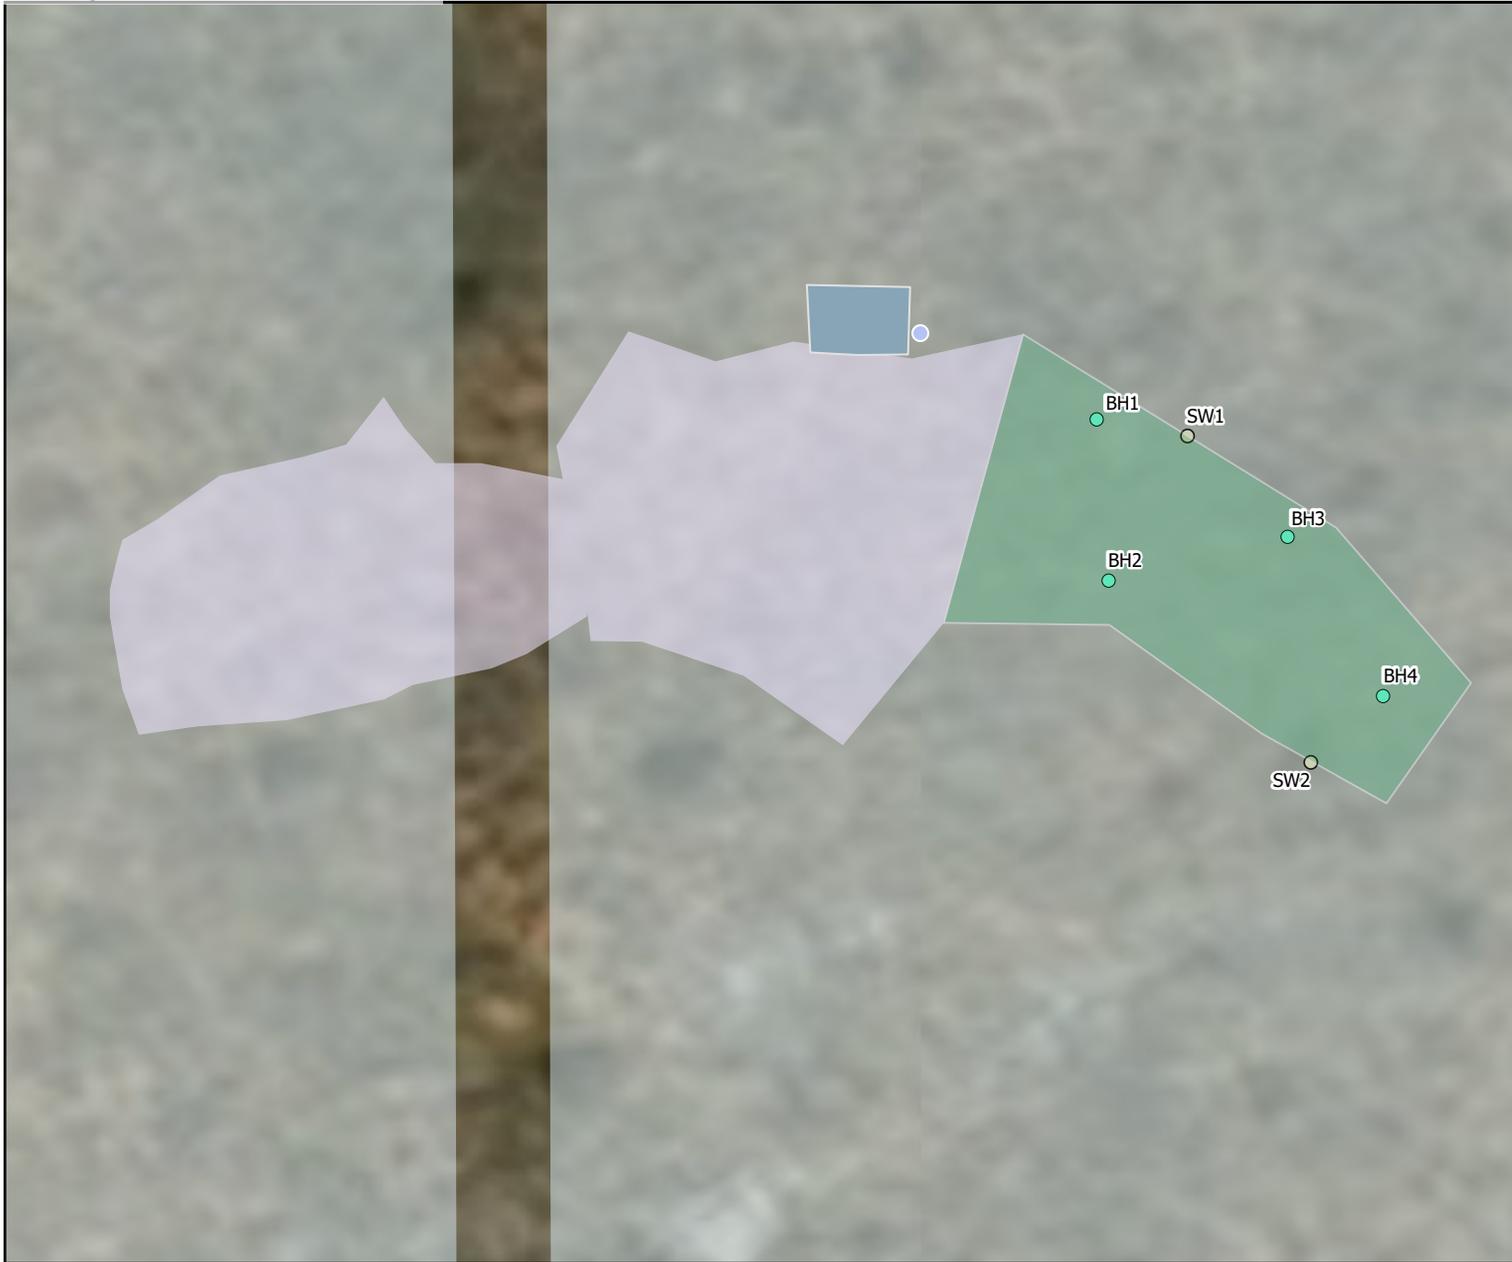
Figure 3b

- SW Sample Locations
- BH Sample Locations
- Point of Release
- Release Area
- 2' Excavation
- Equipment

Site & Closure Sample Map
 Bill Alexander: Matador Resources

Final confirmation samples were collected on January 25, 2024 to confirm that NMOCD closure criteria had been met from previous remediation activities, the results of which can be found Table 2 in [Appendix II](#). Confirmation sample locations and excavation dimensions can be found on the confirmation sample map in [Appendix I](#).

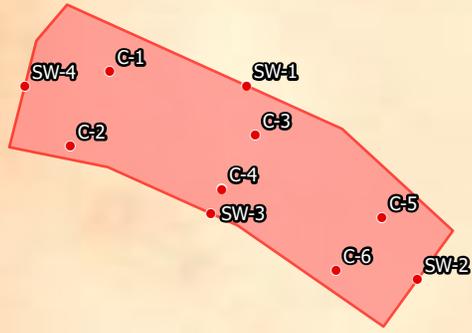
- Soil Sample
- Historical Excavation Area

Bill Alexander Tank Battery
 Matador Resources Company
 Lea County, NM
 Confirmation Sample Map

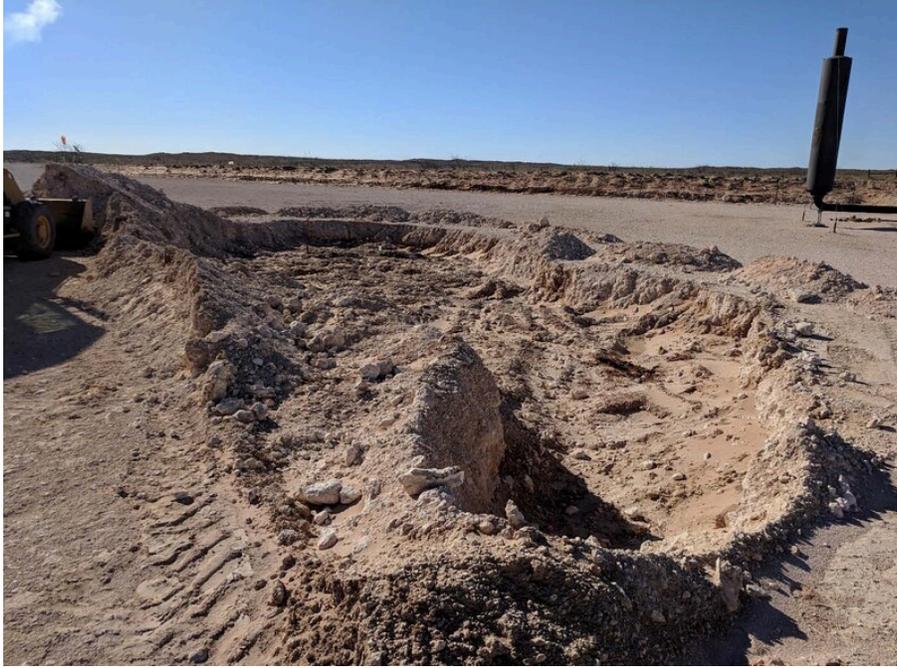
Photograph No. 1
Description:

2' excavation.

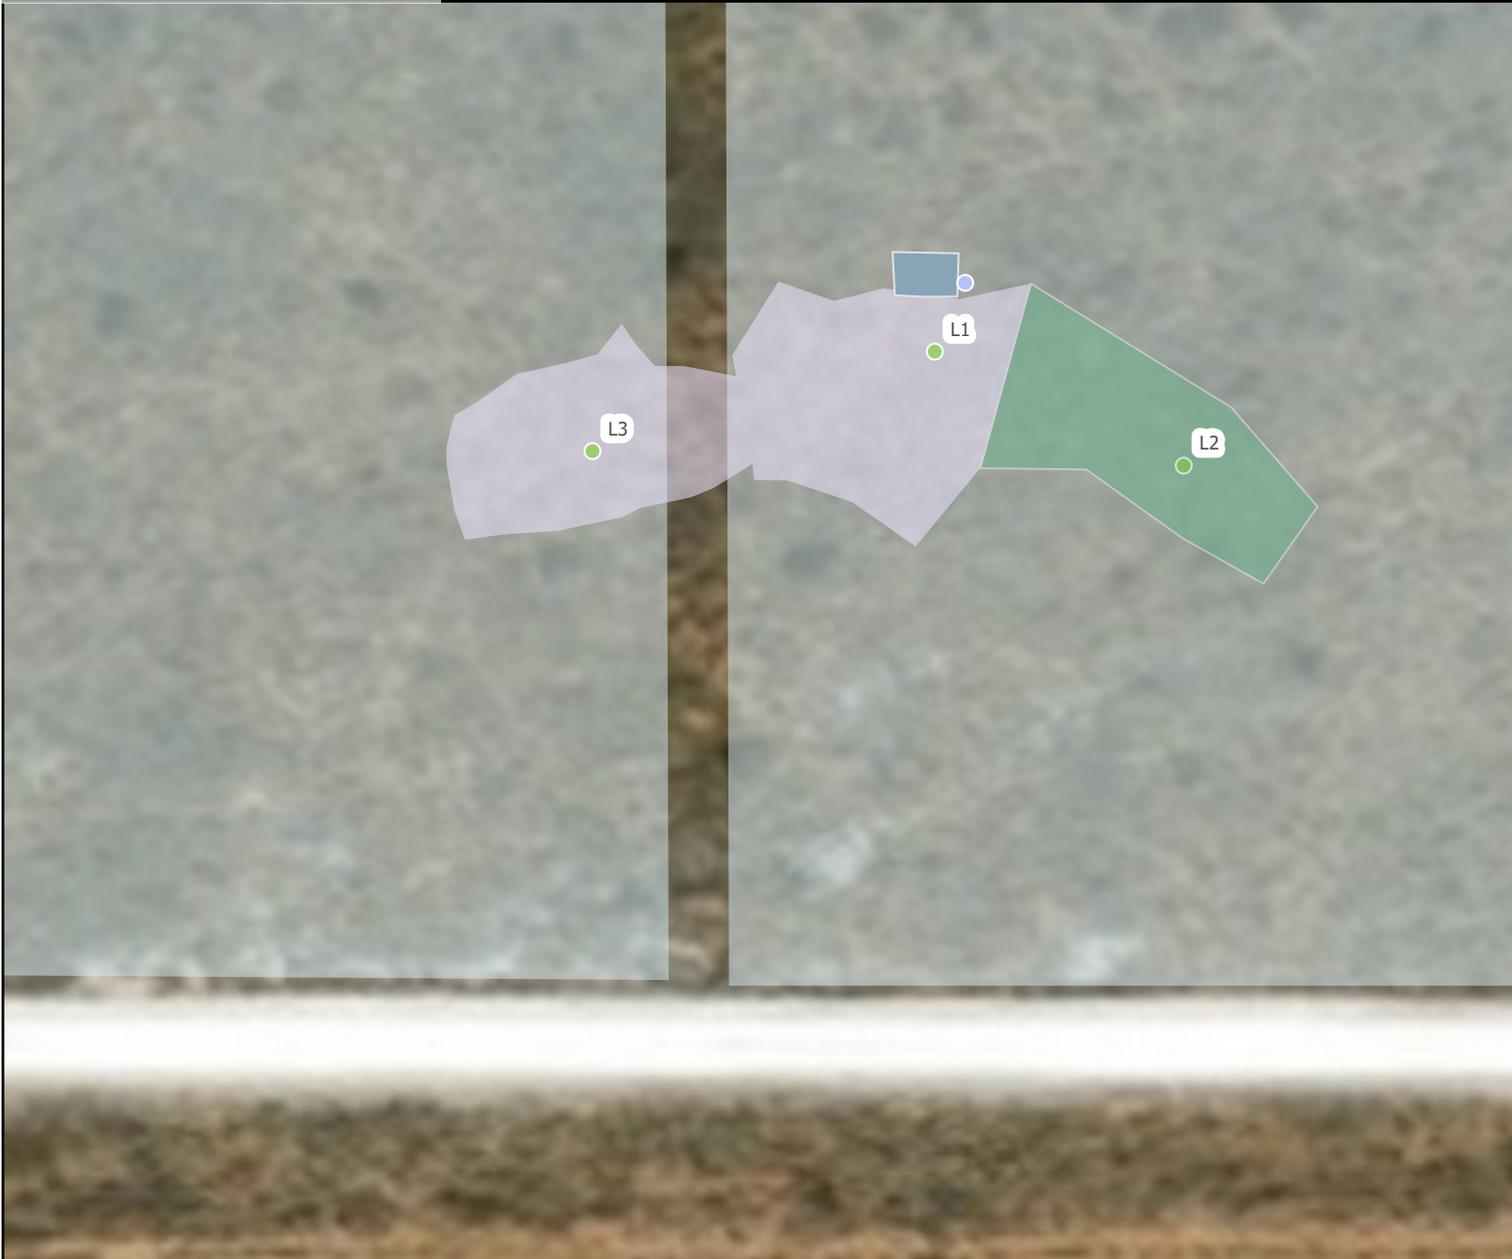
Figure 3a

- Sample Locations
- Point of Release
- Release Area
- 2' Excavation
- Equipment

Site & Initial Sample Map
Bill Alexander: Matador Resources

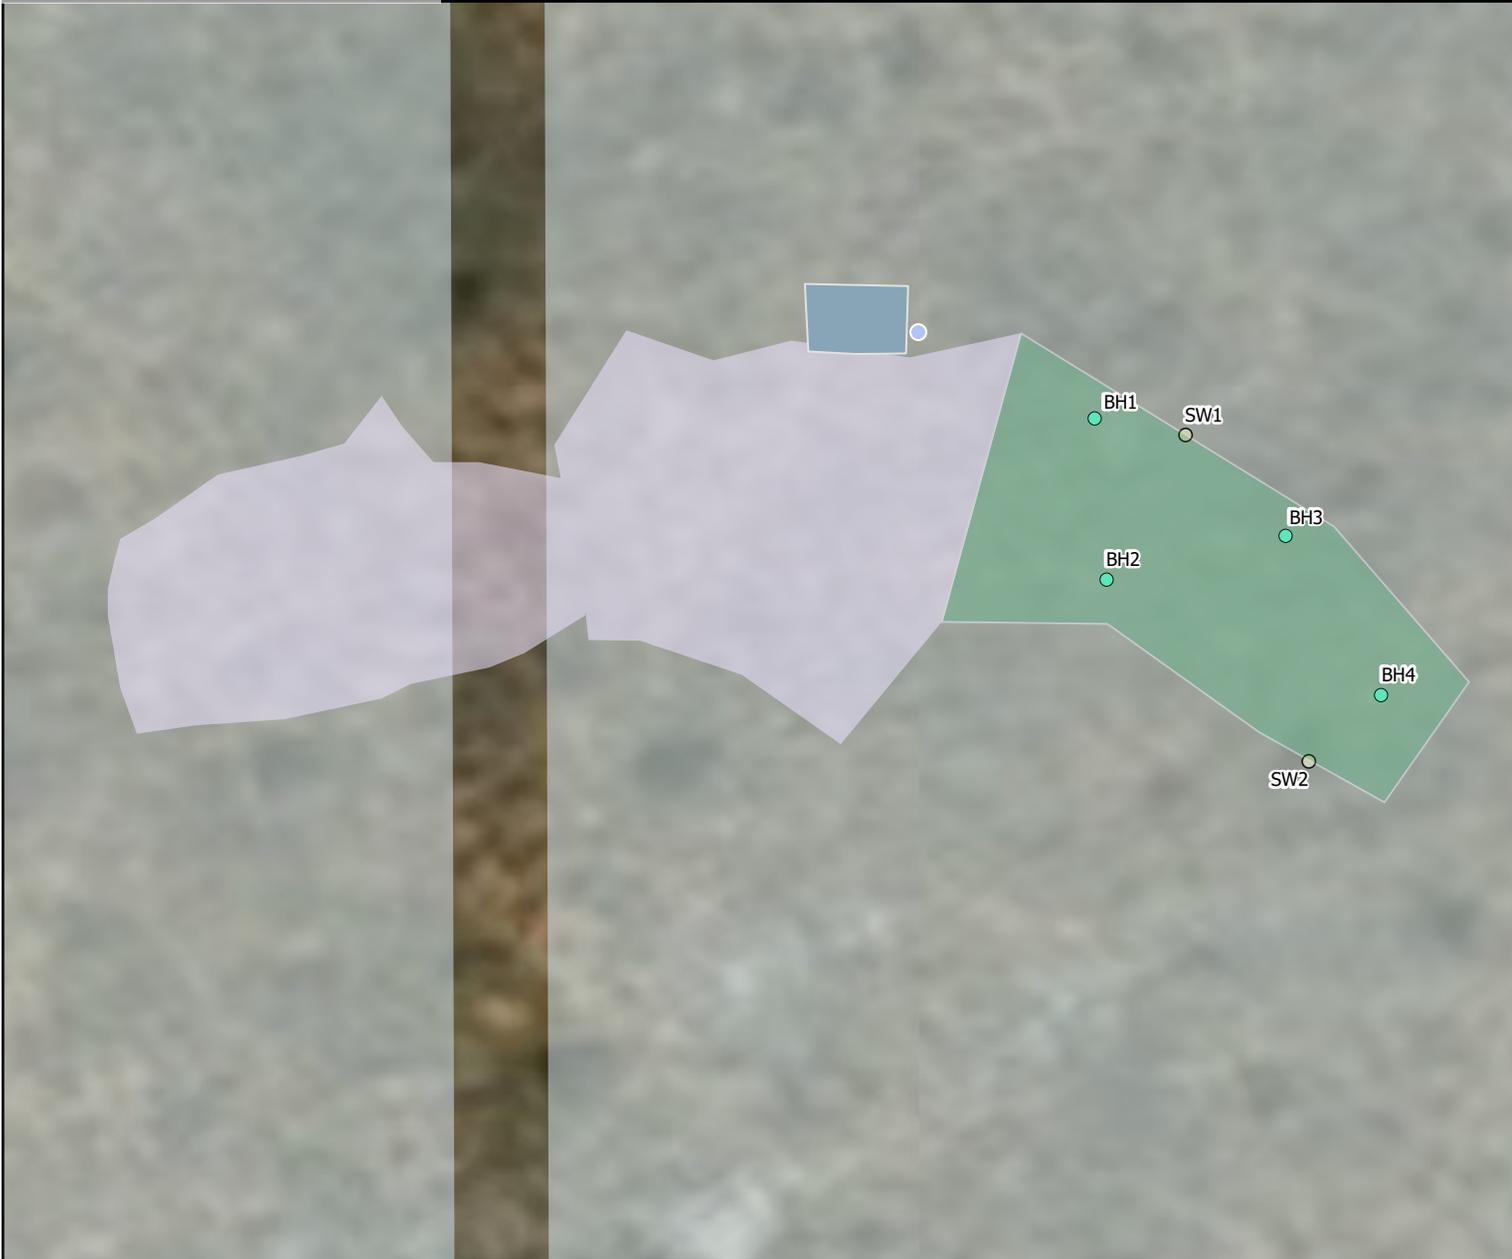
Figure 3b

- SW Sample Locations
- BH Sample Locations
- Point of Release
- Release Area
- 2' Excavation
- Equipment

Site & Closure Sample Map
 Bill Alexander: Matador Resources
