## Remediation Summary & Soil Closure Request

**Spur Energy Partners, LLC**

**Blalock 32 State Com Tank Battery**

**NMOCD Reference No. nAPP2310834343**

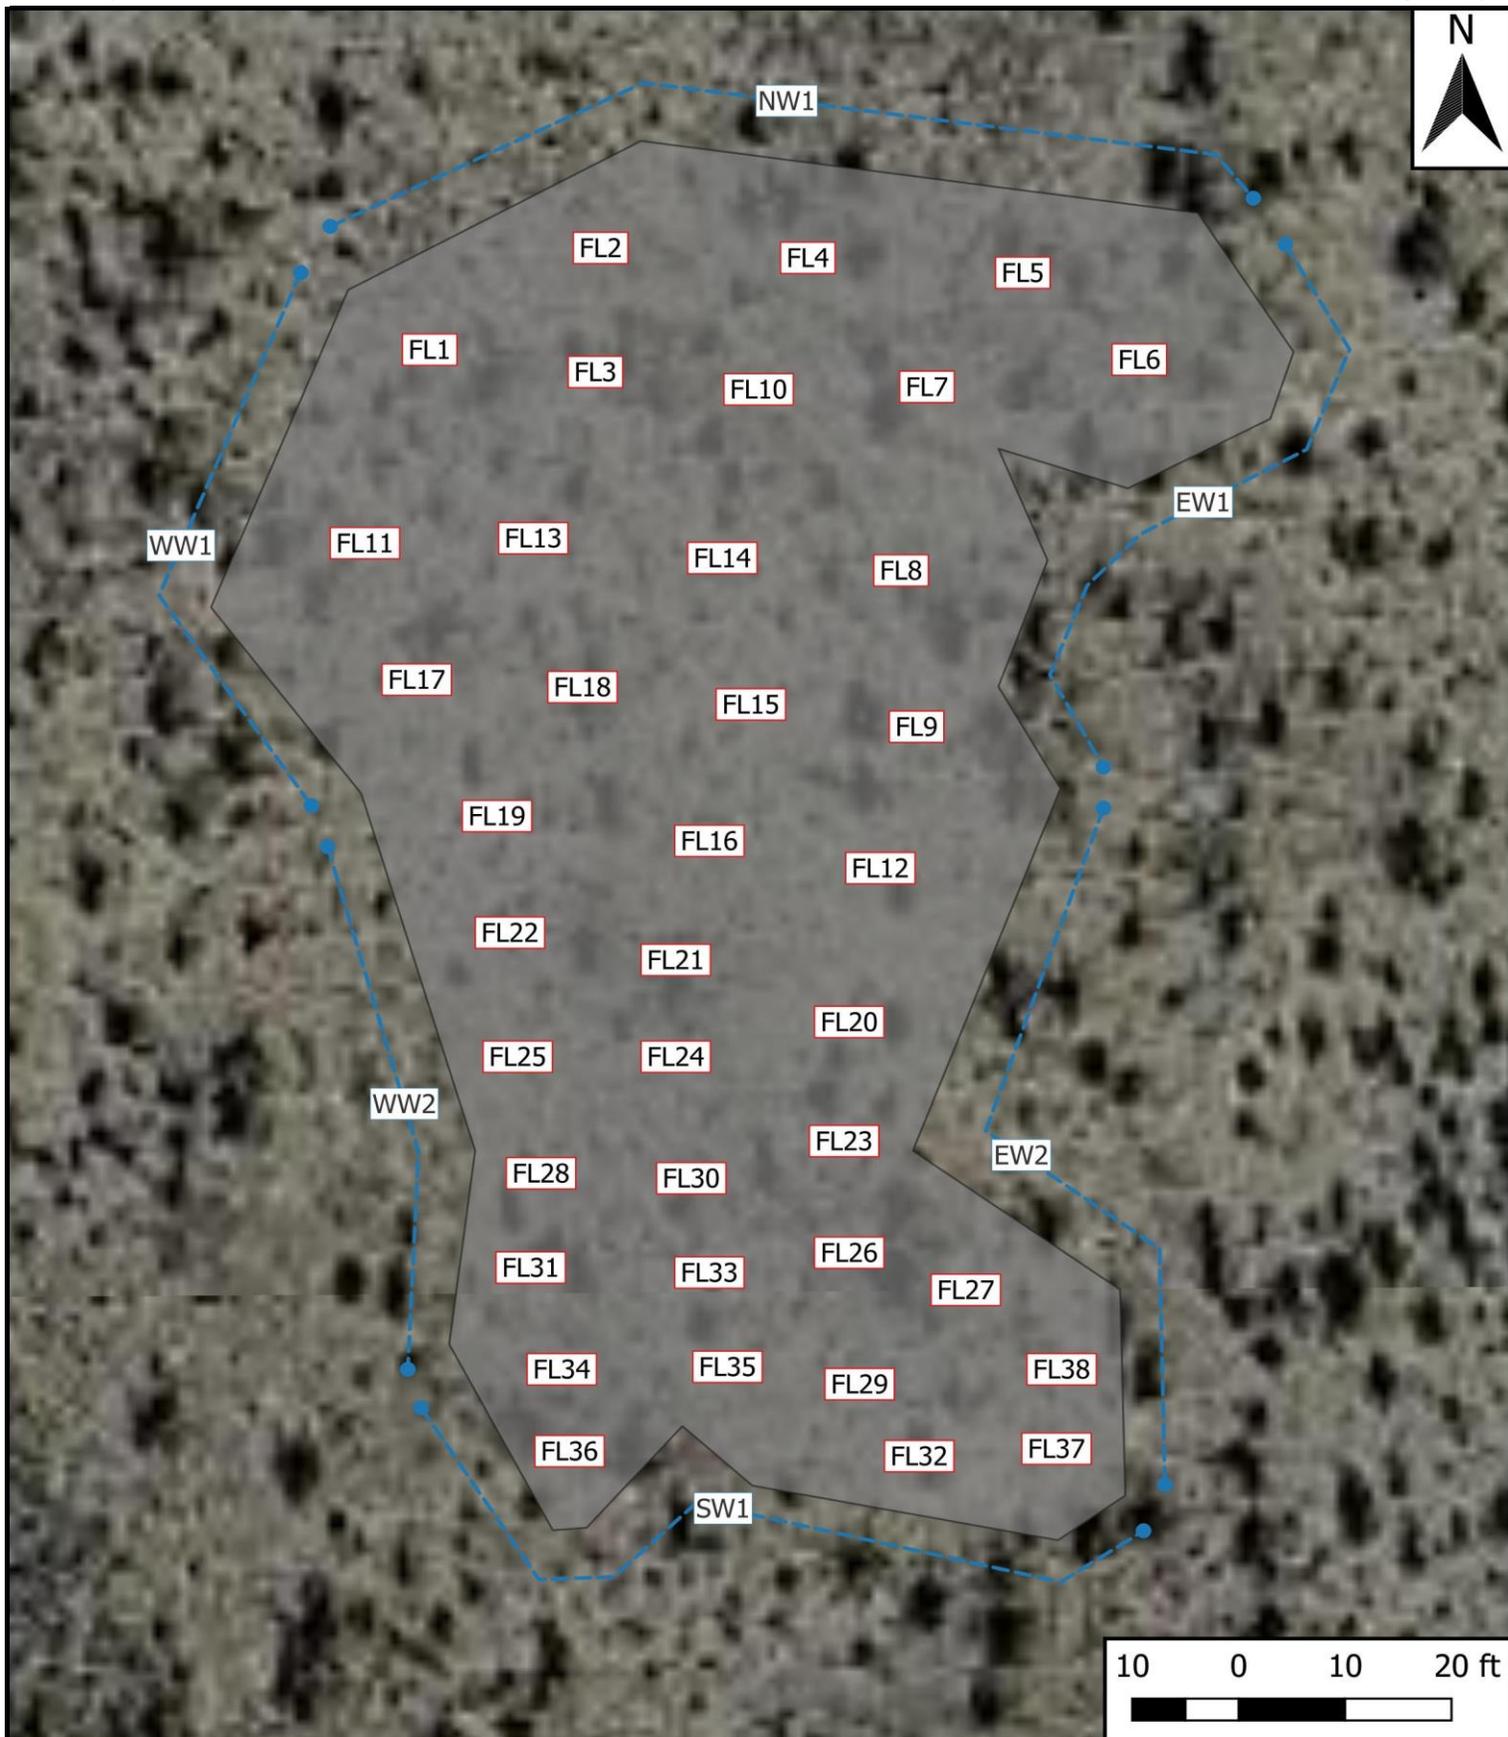
## **Figure 3**

### **Site and Sample Location Map**

- Floor Sample
- Wall Sample
- Excavation

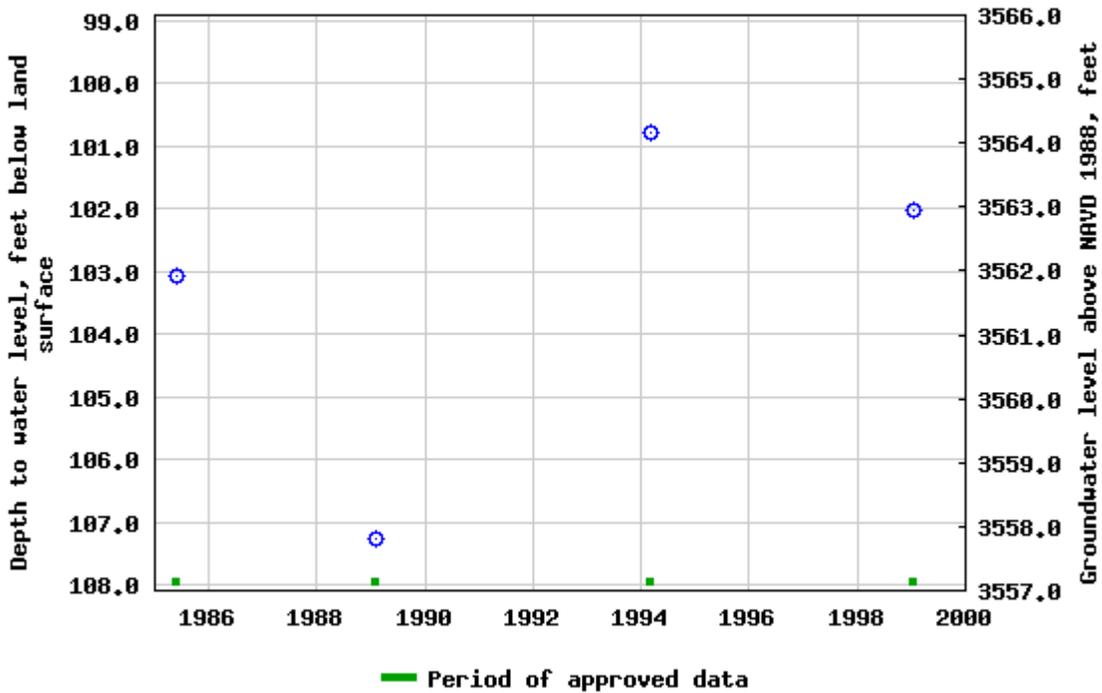
USGS 324633104105401 18S.28E.04.32412

Breaks in the plot represent a gap of at least one year between field measurements. [Download a presentation-quality graph](#)

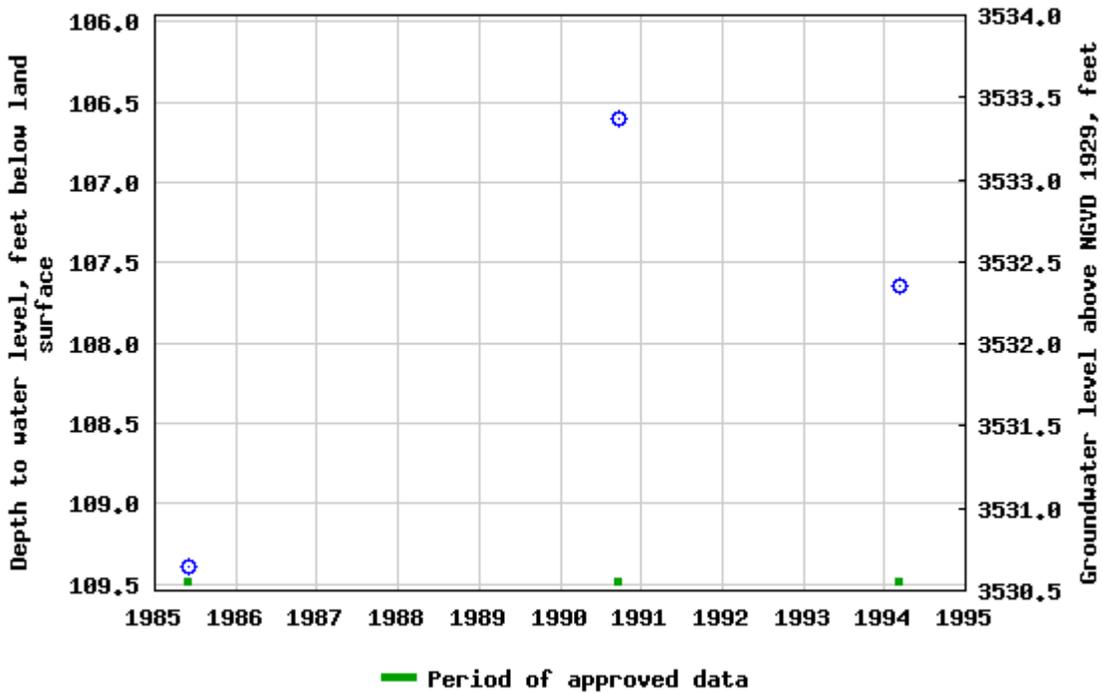
USGS 324642104111001 18S.28E.04.131444

This well is completed in the Rustler Formation (312RSLR) local aquifer.

Breaks in the plot represent a gap of at least one year between field measurements. [Download a presentation-quality graph](#)

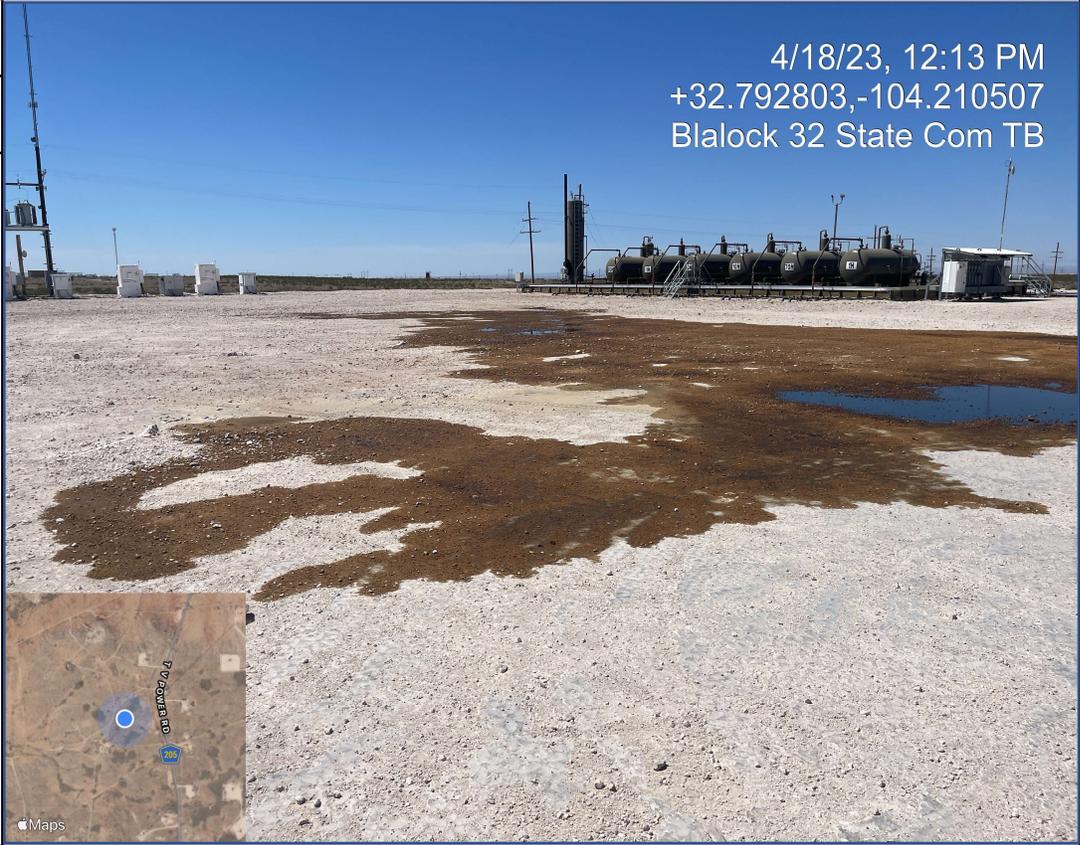
<b>Photo Number:</b> #1

<p>4/18/23, 12:13 PM +32.792803,-104.210507 Blalock 32 State Com TB</p>
<b>Photo Direction:</b> Southwest	
<b>Photo Description:</b> Initial release area.

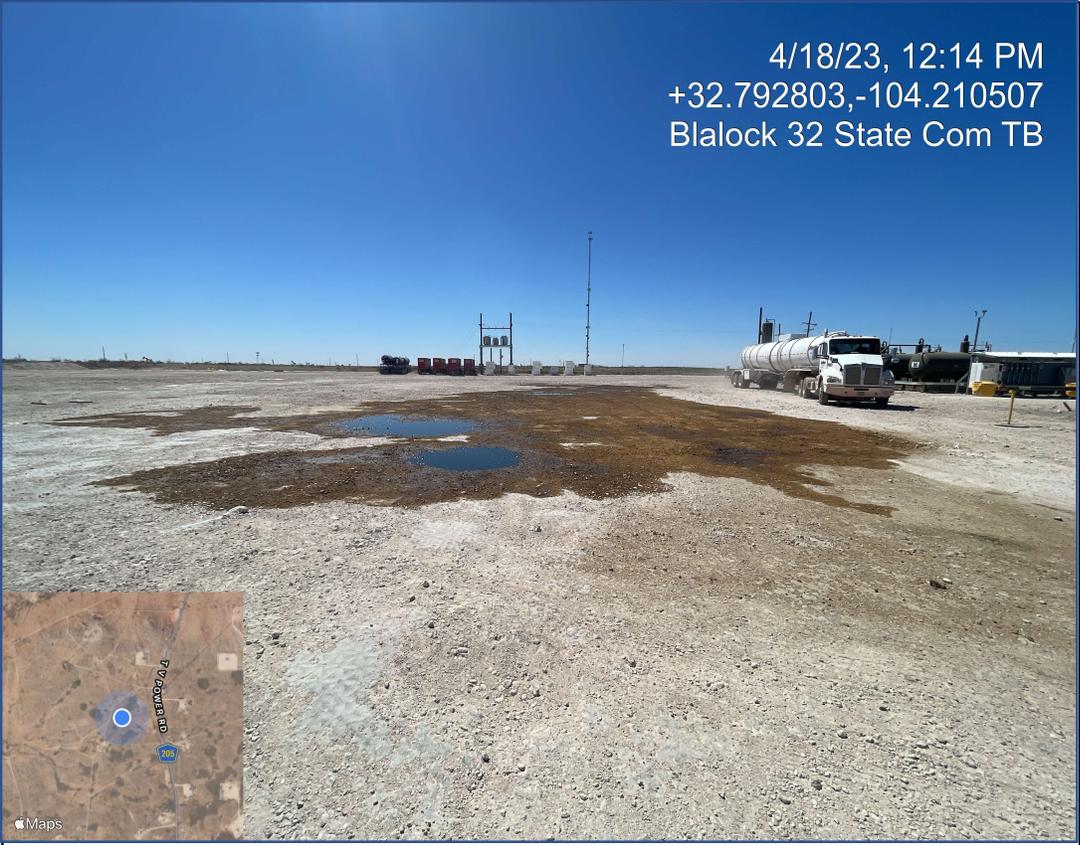
<b>Photo Number:</b> #2

<p>4/18/23, 12:14 PM +32.792803,-104.210507 Blalock 32 State Com TB</p>
<b>Photo Direction:</b> South	
<b>Photo Description:</b> Initial release area.

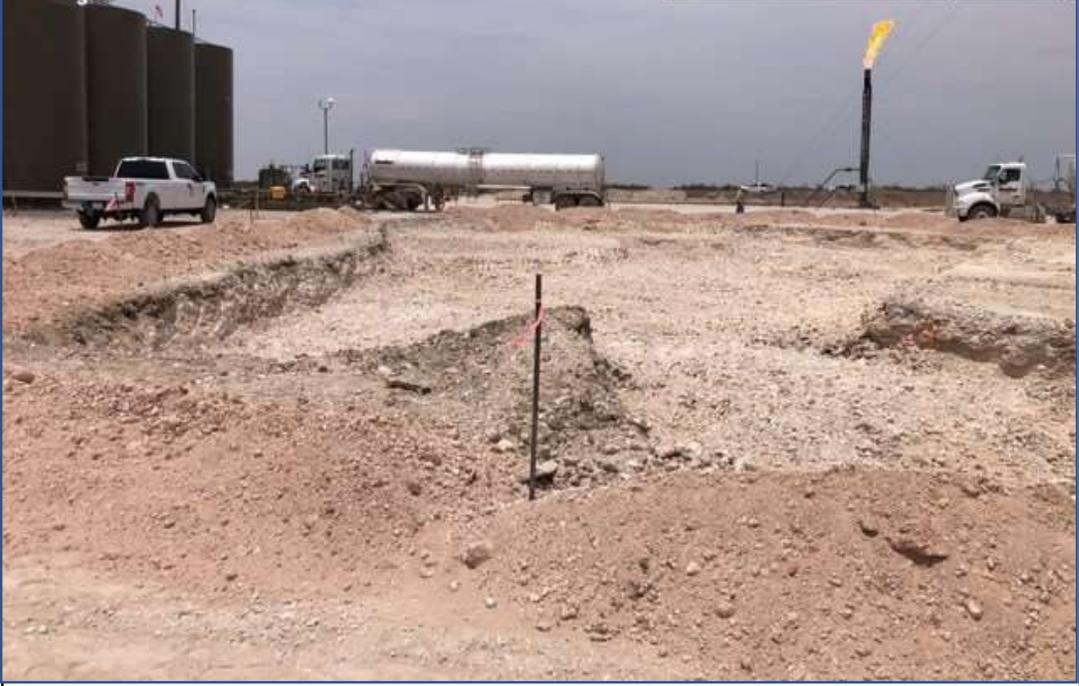
<b>Photo Number:</b> #3

<b>Jun 20, 2023 at 1:04:18 PM</b> <b>+32.792442,-104.210511</b> <b>308° NW</b> <b>Eddy County</b>
<b>Photo Direction:</b> Northwest		
<b>Photo Description:</b> Open excavation.

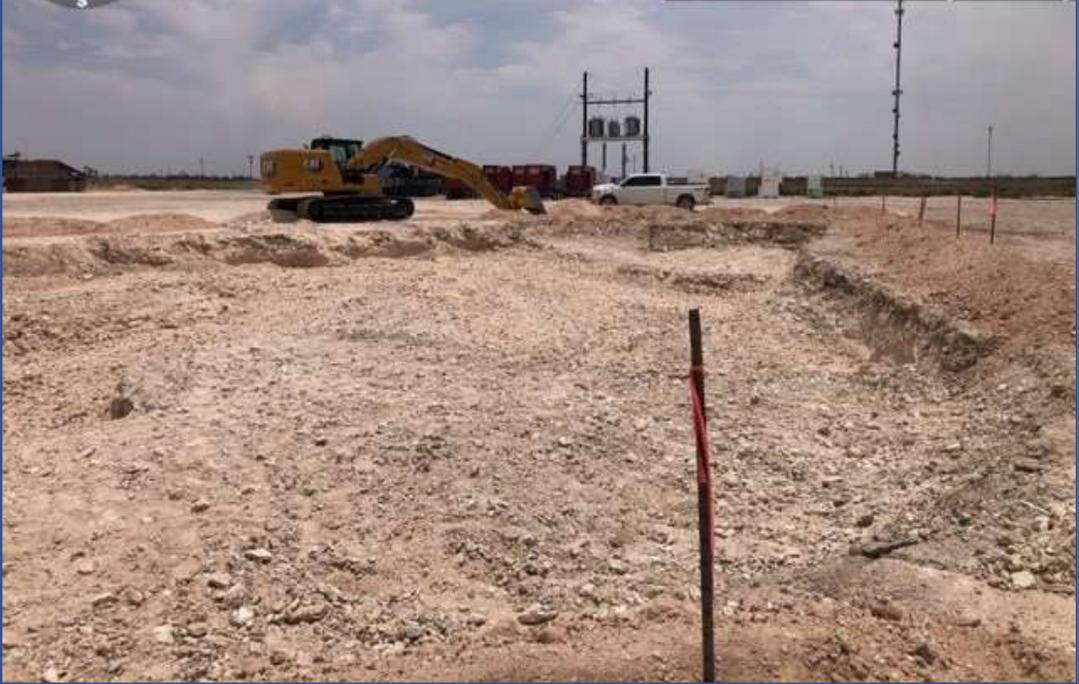
<b>Photo Number:</b> #4

<b>Jun 20, 2023 at 1:05:14 PM</b> <b>+32.792741,-104.210651</b> <b>146° SE</b> <b>Eddy County</b>
<b>Photo Direction:</b> Southeast		
<b>Photo Description:</b> Open excavation.

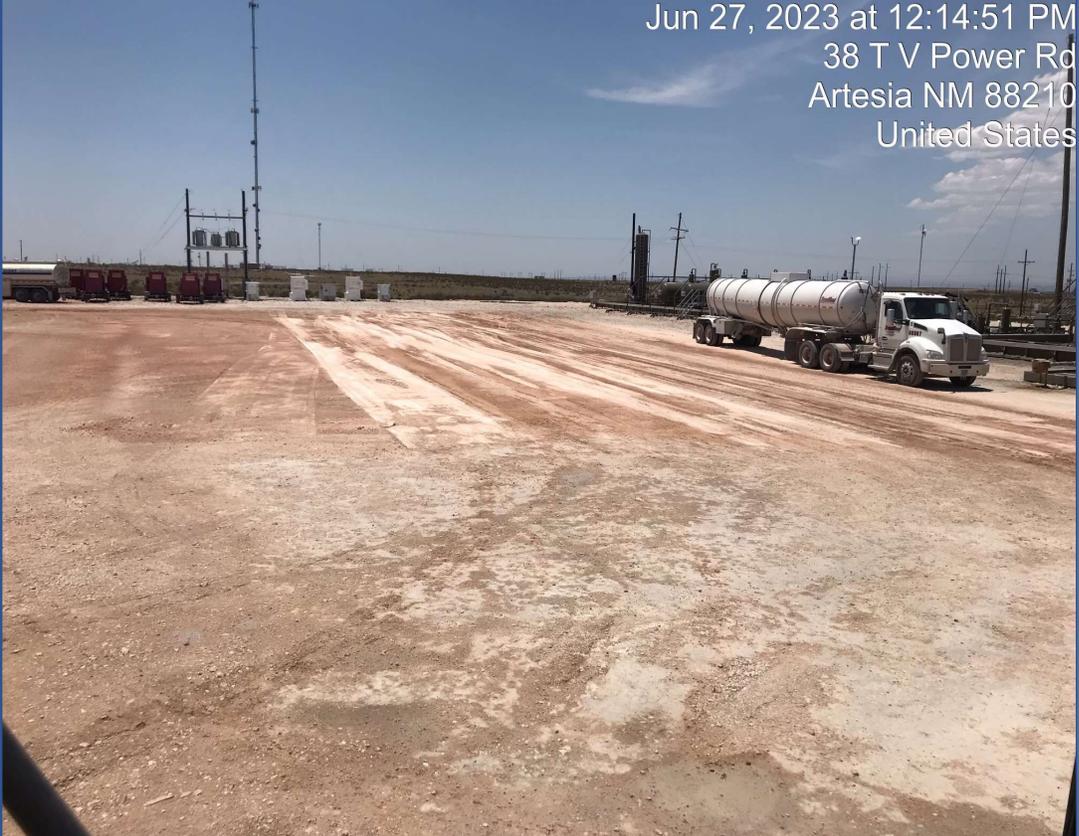
<b>Photo Number:</b> #5

<p>Jun 27, 2023 at 12:14:51 PM 38 T V Power Rd Artesia NM 88210 United States</p>
<b>Photo Direction:</b> Southwest	
<b>Photo Description:</b> After completed remediation.

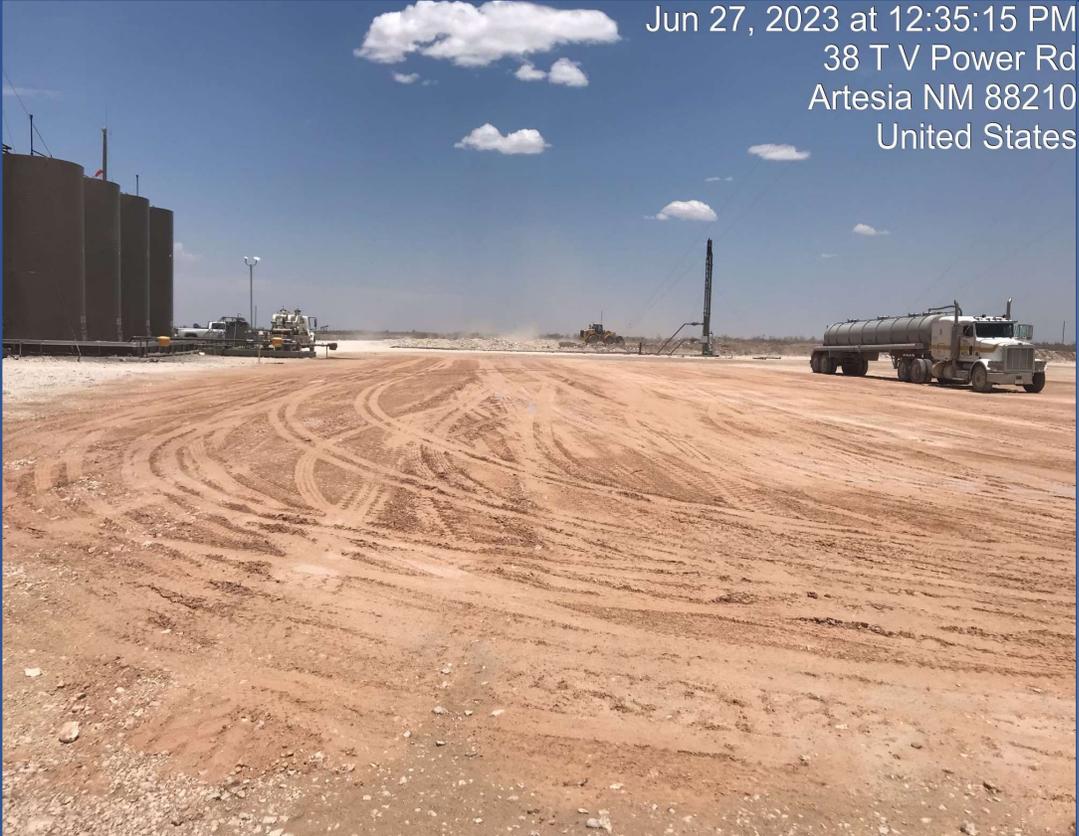
<b>Photo Number:</b> #6

<p>Jun 27, 2023 at 12:35:15 PM 38 T V Power Rd Artesia NM 88210 United States</p>
<b>Photo Direction:</b> North	
<b>Photo Description:</b> After completed remediation.
