Remediation Summary & Soil Closure Request

Mewbourne Oil Company
Lindale 24/25 W1AH Fed Com #1H Battery
Eddy County, New Mexico
Unit Letter "A", Section 24, Township 26 South, Range 30 East
Latitude 32.033988 North, Longitude 103.827985 West
NMOCD Reference No. nAPP2406731234

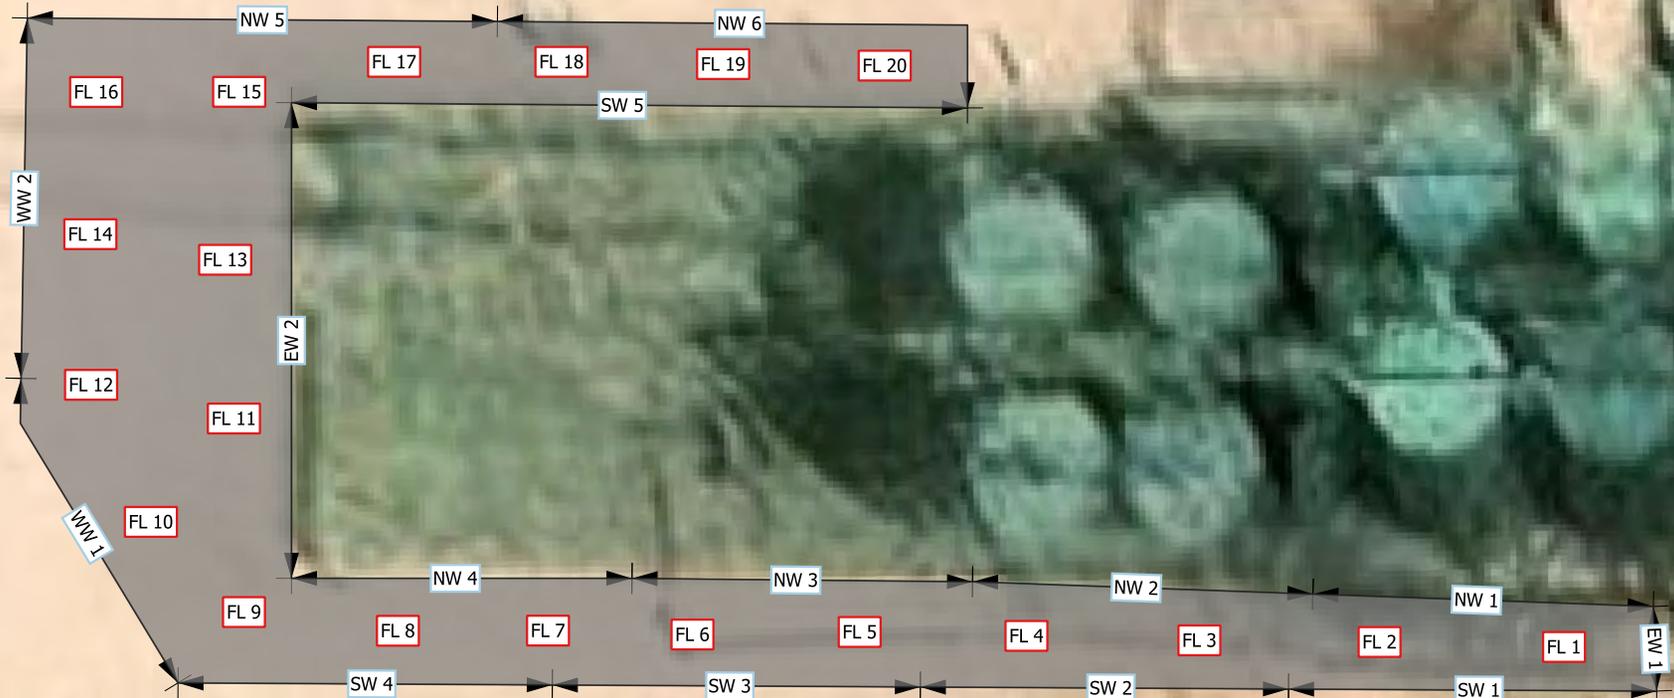
Figure 3
 Sample Location Map
 Mewbourne Oil Company
 Lindale 24/25 W1AH Fed Com #1H Battery
 GPS: 32.033988, -103.827985
 Eddy County, New Mexico

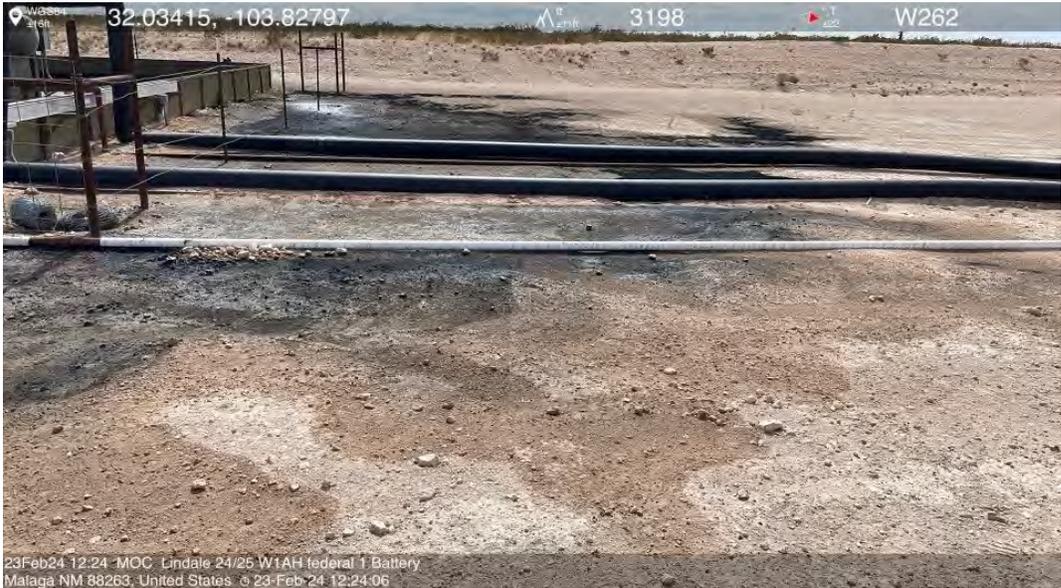
Photo Number: 1

Photo Direction: West	
Photo Description: View of the affected area.

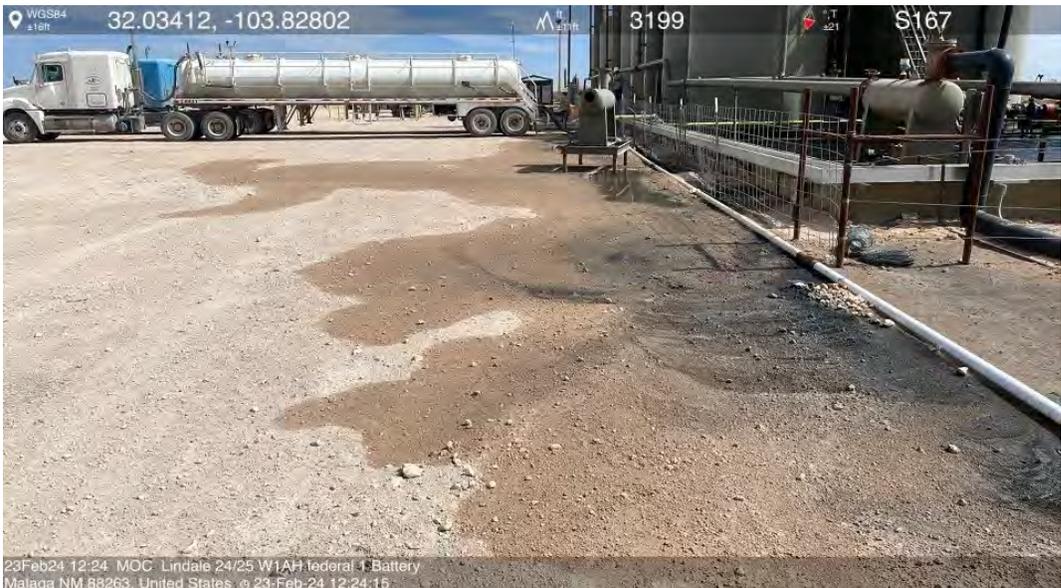
Photo Number: 2

Photo Direction: South-Southeast	
Photo Description: View of the affected area.

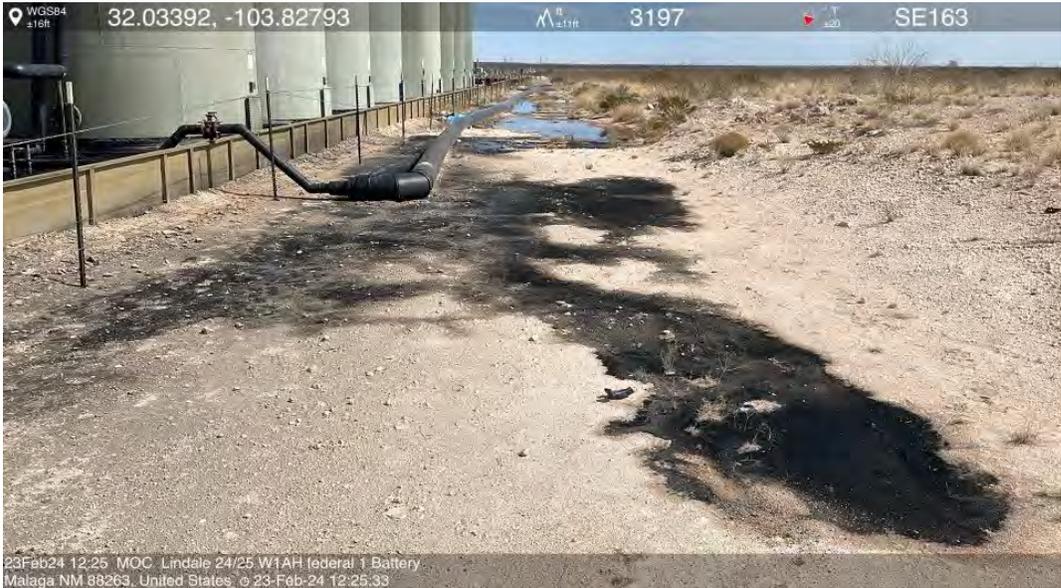
Photo Number: 3

<p>WGS84 32.03392, -103.82793 3197 SE163</p> <p>23Feb24 12:25 MOC Lindale 24/25 W1AH federal 1 Battery Malaga NM 88263, United States © 23-Feb-24 12:25:33</p>
Photo Direction: South-Southeast	
Photo Description: View of the affected area.

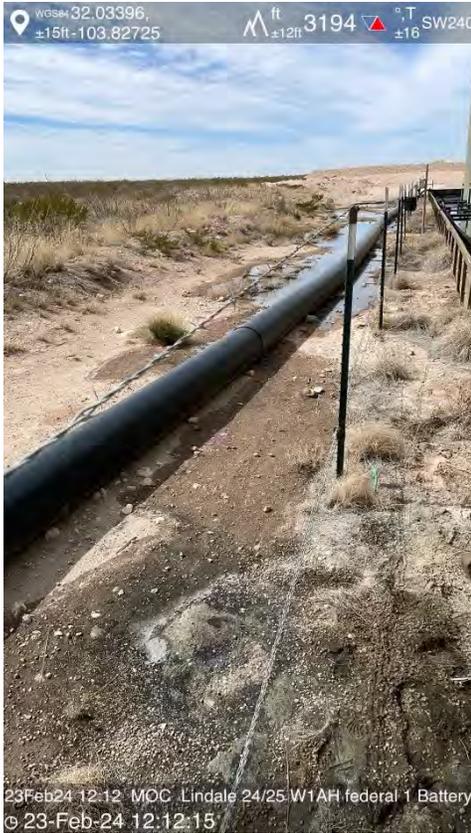
Photo Number: 4

<p>WGS84 32.03396, ±15ft -103.82725 3194 SW240</p> <p>23Feb24 12:12 MOC Lindale 24/25 W1AH federal 1 Battery © 23-Feb-24 12:12:15</p>
Photo Direction: West-Southwest	
Photo Description: View of the affected area.

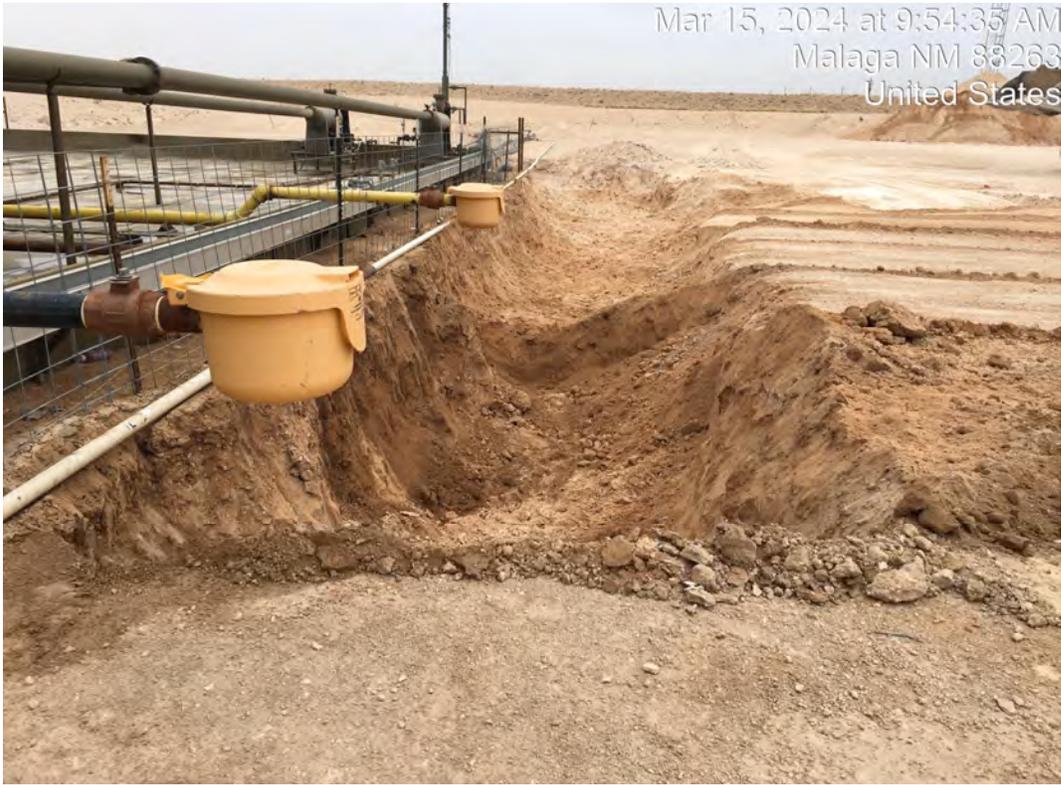
Photo Number: 5

<p>Mar 15, 2024 at 9:54:35 AM Malaga NM 88263 United States</p>
Photo Direction: East	
Coordinates: 32.034082,-103.827710	
Photo Description: View of the excavated area.

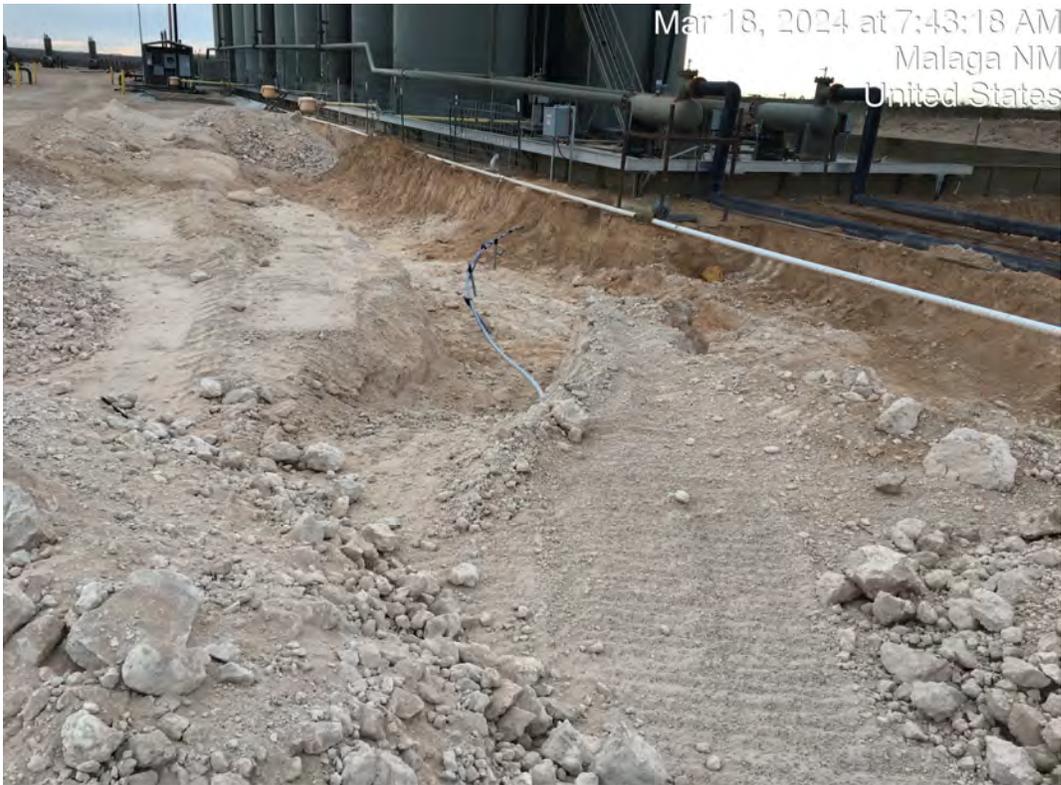
Photo Number: 6

<p>Mar 18, 2024 at 7:43:18 AM Malaga NM United States</p>
Photo Direction: South-Southeast	
Coordinates: 32.034114,-103.828064	
Photo Description: View of the excavated area.

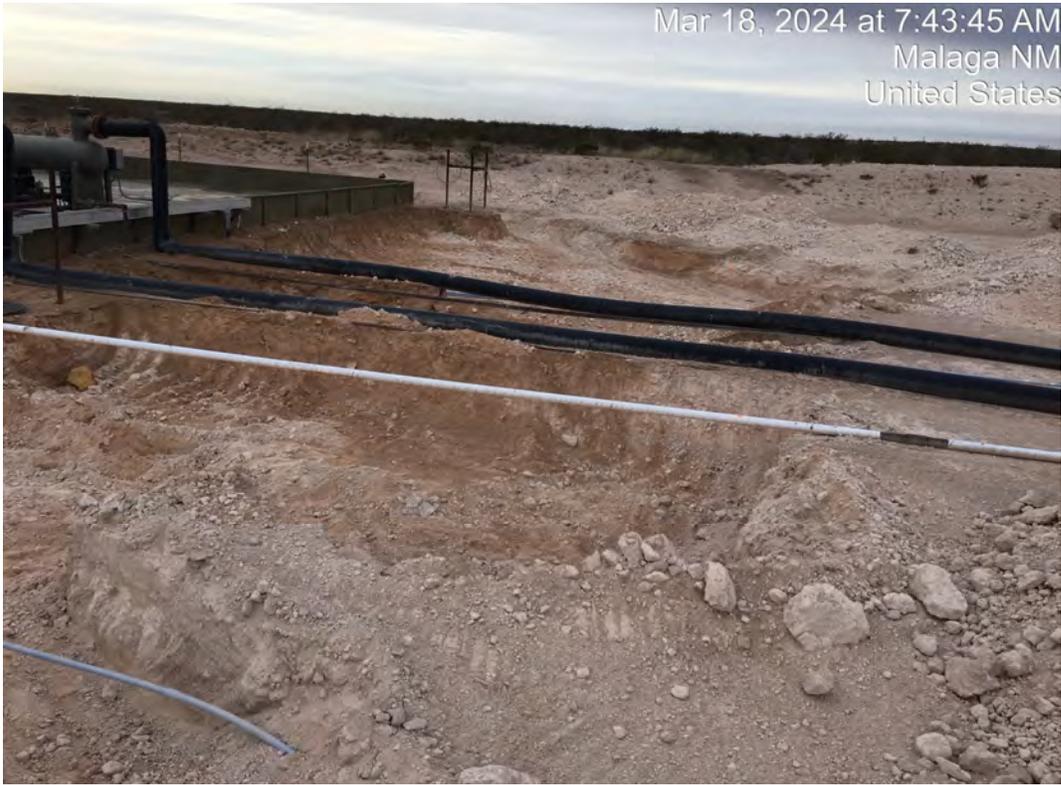
Photo Number: 7

<p>Mar 18, 2024 at 7:43:45 AM Malaga NM United States</p>
Photo Direction: South-Southeast	
Coordinates: 32.034113,-103.828040	
Photo Description: View of the excavated area.

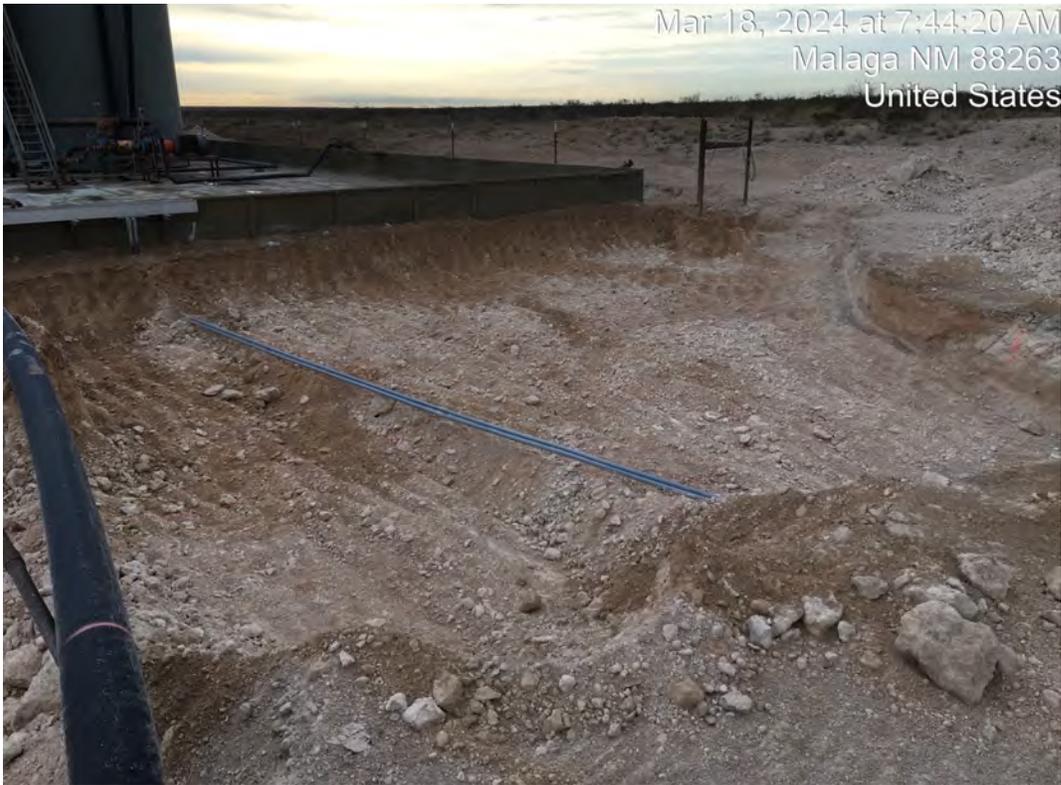
Photo Number: 8

<p>Mar 18, 2024 at 7:44:20 AM Malaga NM 88263 United States</p>
Photo Direction: Southeast	
Coordinates: 32.034099,-103.828063	
Photo Description: View of the excavated area.

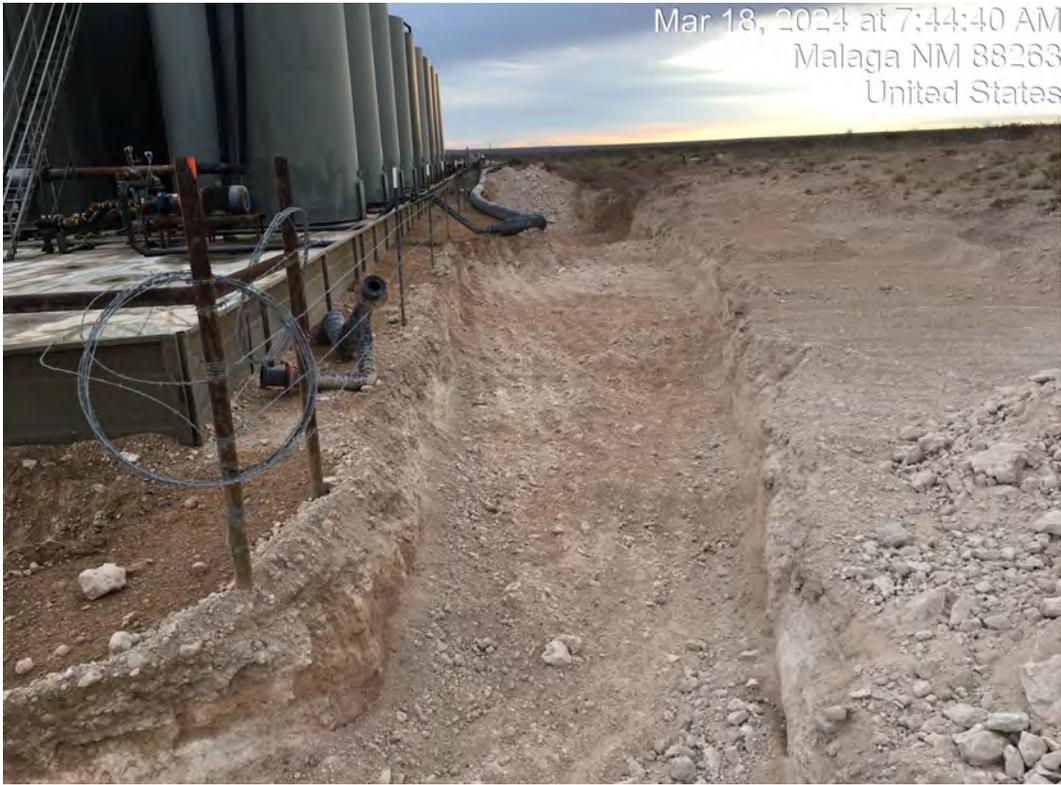
Photo Number: 9

Photo Direction: East	
Coordinates: 32.033917,-103.828001	
Photo Description: View of the excavated area.

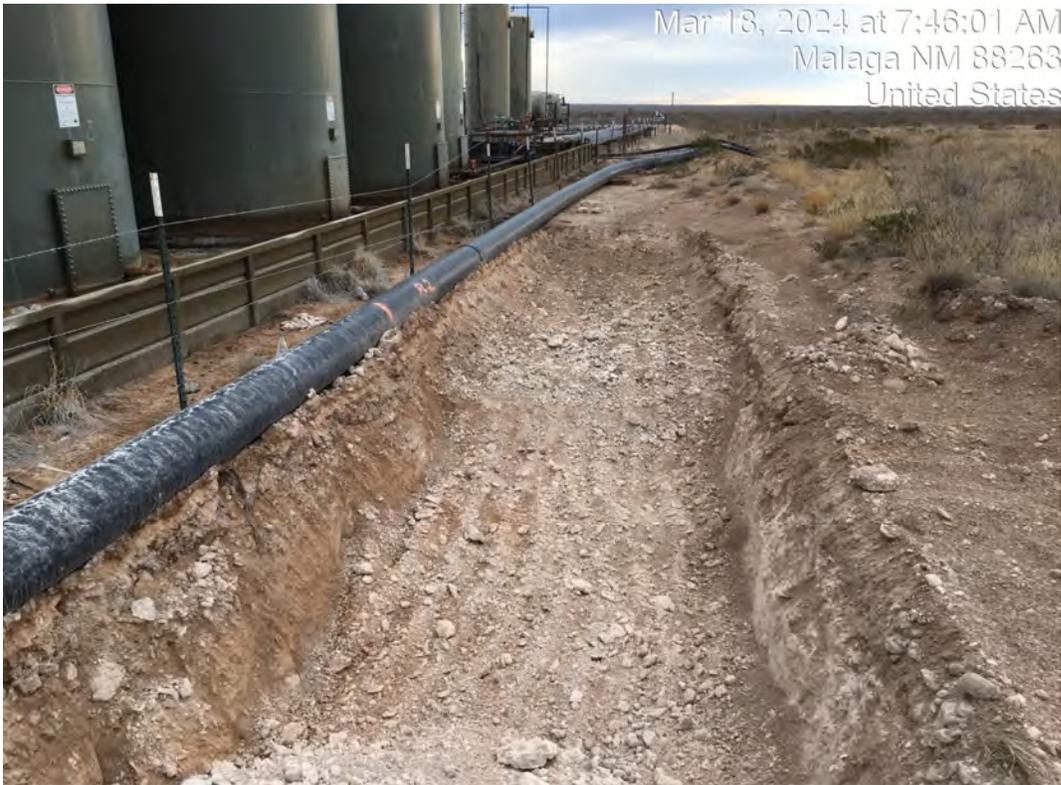
Photo Number: 10

Photo Direction: East	
Coordinates: 32.033909,-103.827579	
Photo Description: View of the excavated area.

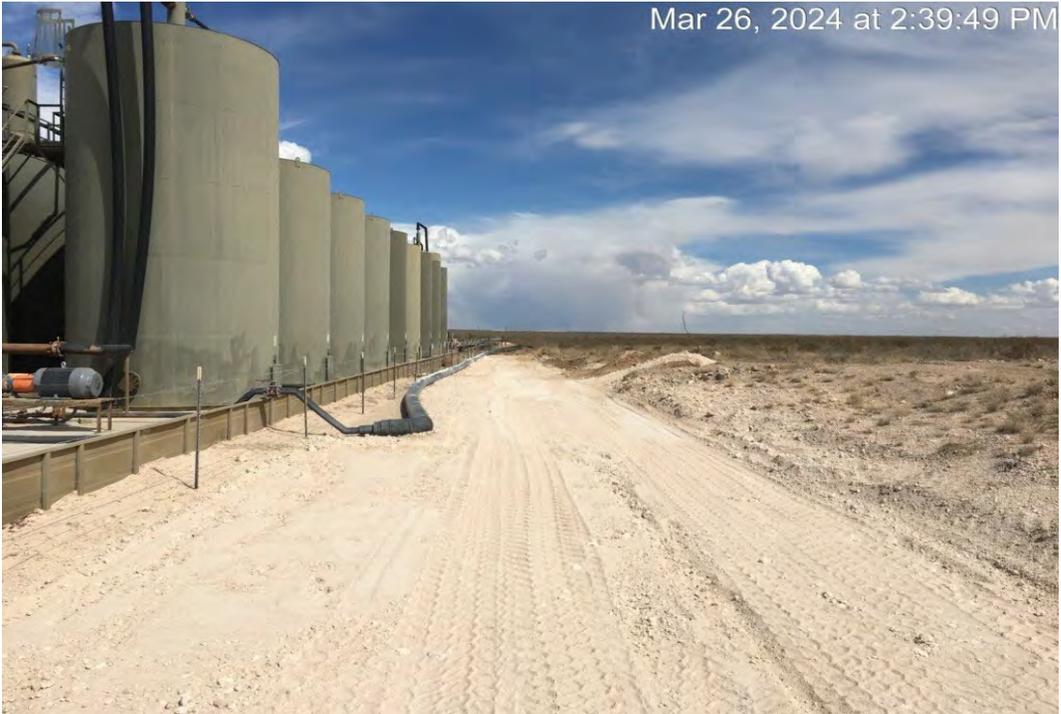
Photo Number: 11

<p>Mar 26, 2024 at 2:39:49 PM</p>
Photo Direction: East	
Coordinates: 32.033912,-103.827789	
Photo Description: View of the remediated area after backfill and regrading.

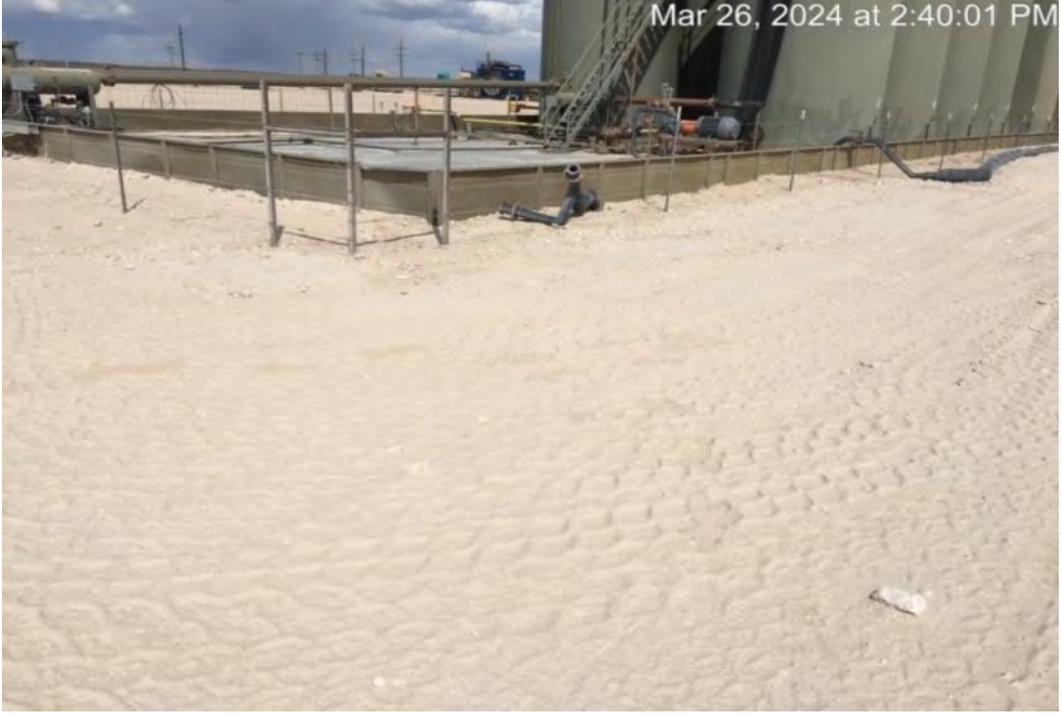
Photo Number: 12

<p>Mar 26, 2024 at 2:40:01 PM</p>
Photo Direction: Northeast	
Coordinates: 32.033869,-103.828035	
Photo Description: View of the remediated area after backfill and regrading.

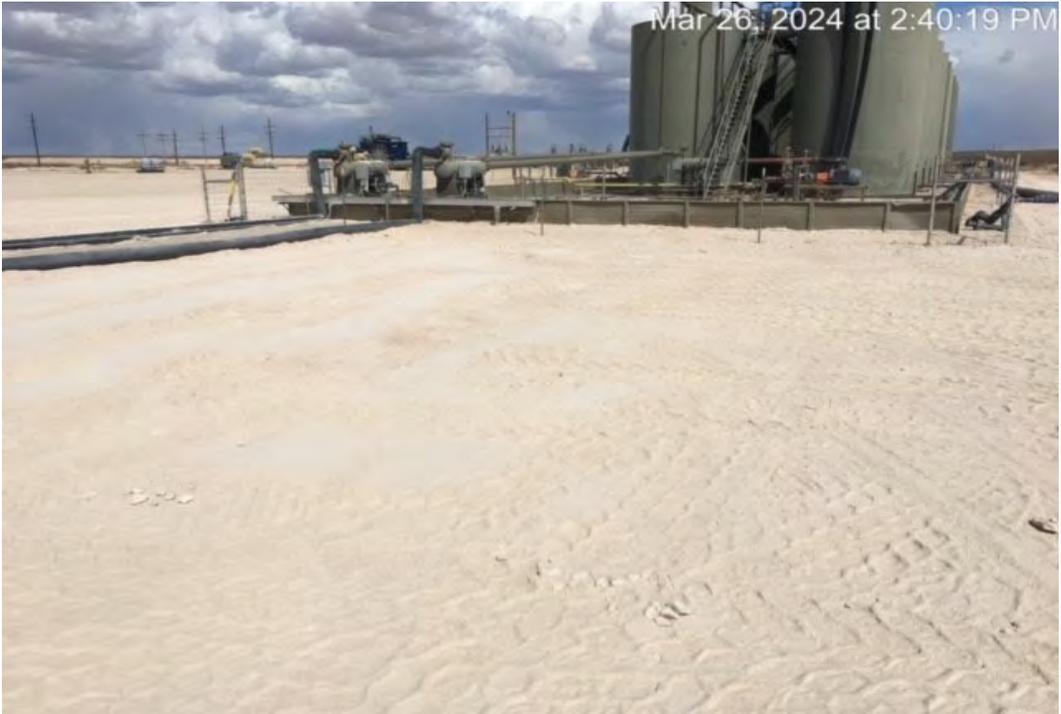
Photo Number: 13

<p>Mar 26, 2024 at 2:40:19 PM</p>
Photo Direction: East-Northeast	
Coordinates: 32.033895,-103.828125	
Photo Description: View of the remediated area after backfill and regrading.

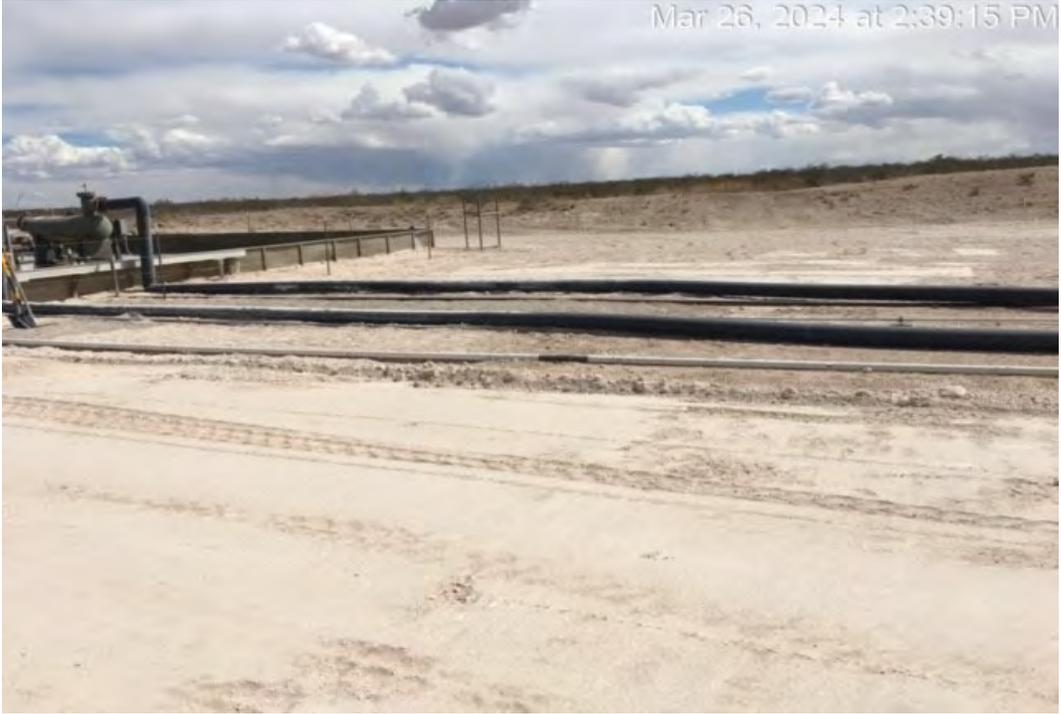
Photo Number: 14

<p>Mar 26, 2024 at 2:39:15 PM</p>
Photo Direction: South-Southwest	
Coordinates: 32.034113,-103.828040	
Photo Description: View of the remediated area after backfill and regrading.
