Closure Report
Bultaco State 002H
Incident ID: NAPP2406735085
Unit O Sec 36 T22S R31E
Eddy County, New Mexico
32.3412°, -103.7300°

Produced Water Release
Point of Release: Equipment Failure
Release Date: 2.19.2024
Volume Released: 12 Barrels of Produced Water
Volume Recovered: 10 Barrels of Produced Water

Re: Closure Report
Bultaco State 002H
Concho Operating, LLC
Incident ID: NAPP2406735085
Site Location: Unit O, S36, T22S, R31E
(Lat 32.3412°, Long -103.7300°)
Eddy County, New Mexico

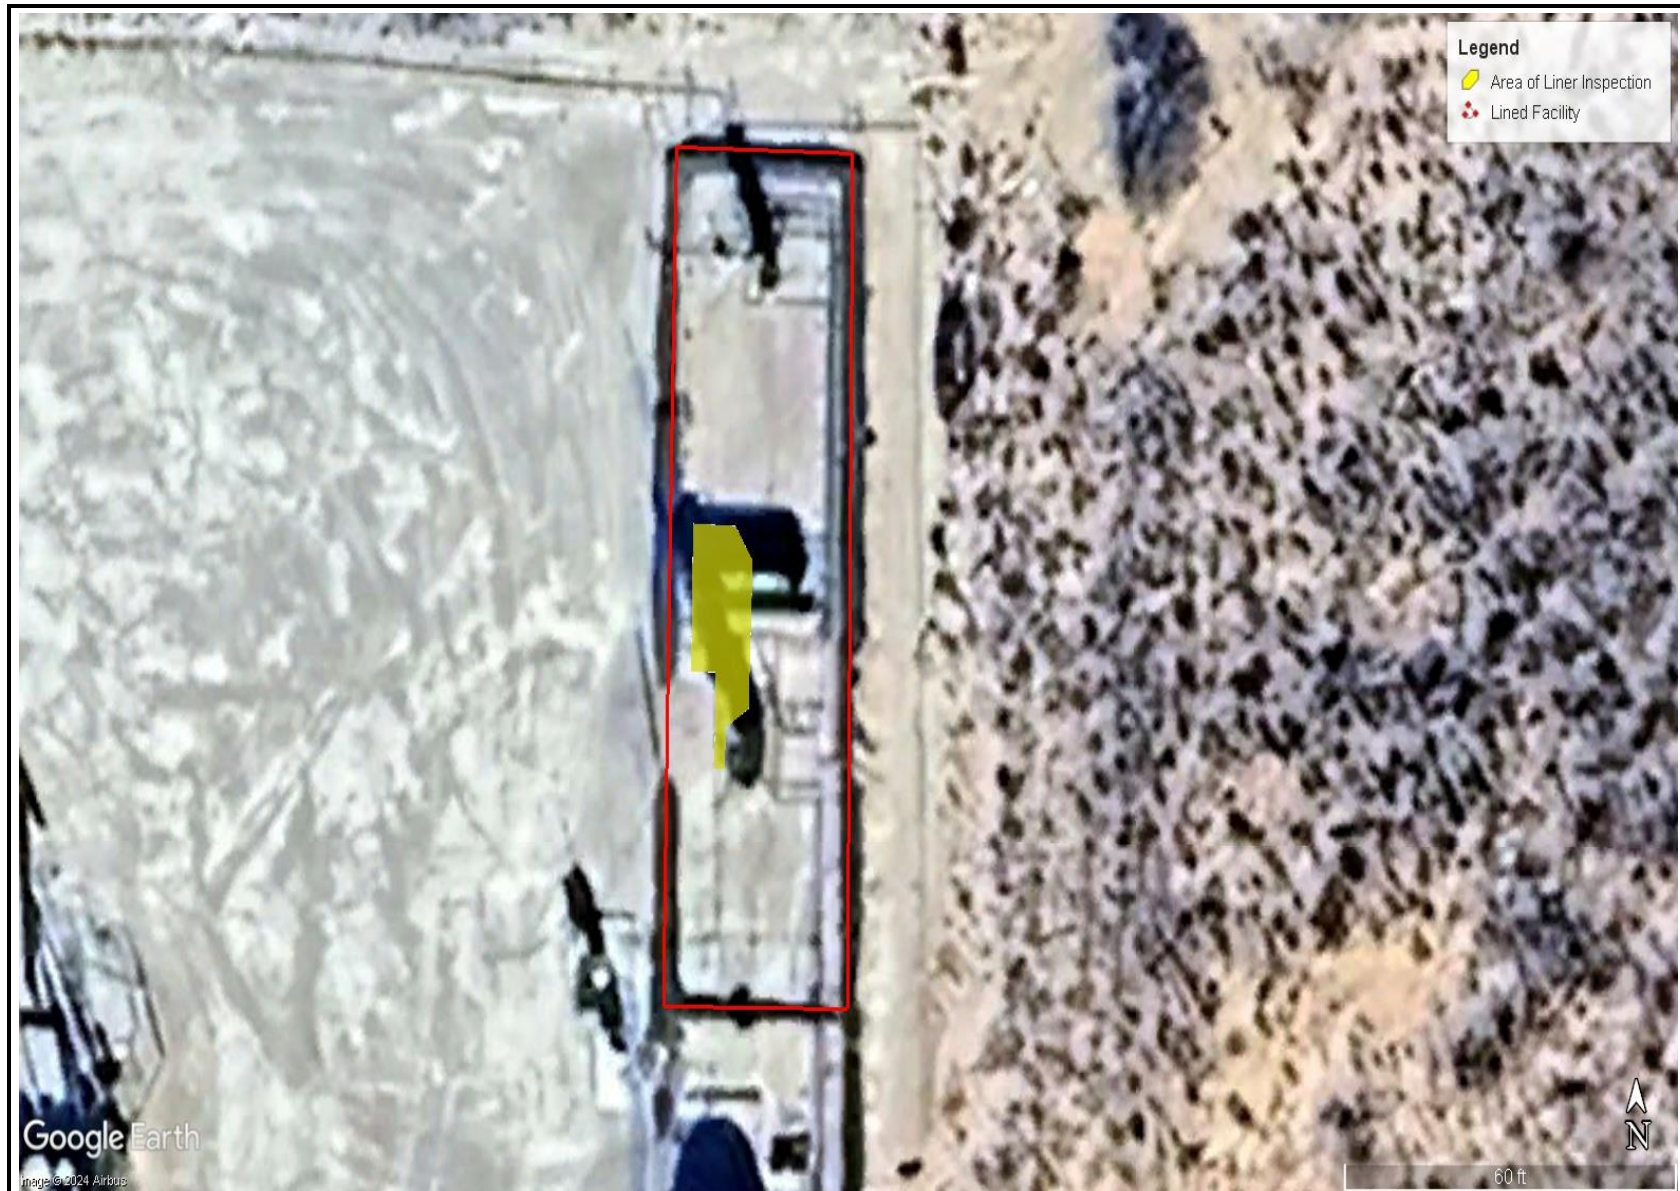
FIGURE 3

Based on the initial C-141 obtained from the New Mexico Oil Conservation Division (NMOCD), the release was discovered on February 19, 2024, caused by a leak on the ball valve due to a pin hole. It resulted in the release of approximately one or two (12) barrels of produced water, and one zero (10 barrels of produced water was recovered inside the lined facility. See Figure 3. The initial C-141 form is attached in Appendix B.

SECONDARY CONTAINMENT MAP
COG OPERATING, LLC
BULTACO STATE 002H
EDDY COUNTY, NEW MEXICO
32.3412°, 103.7300°

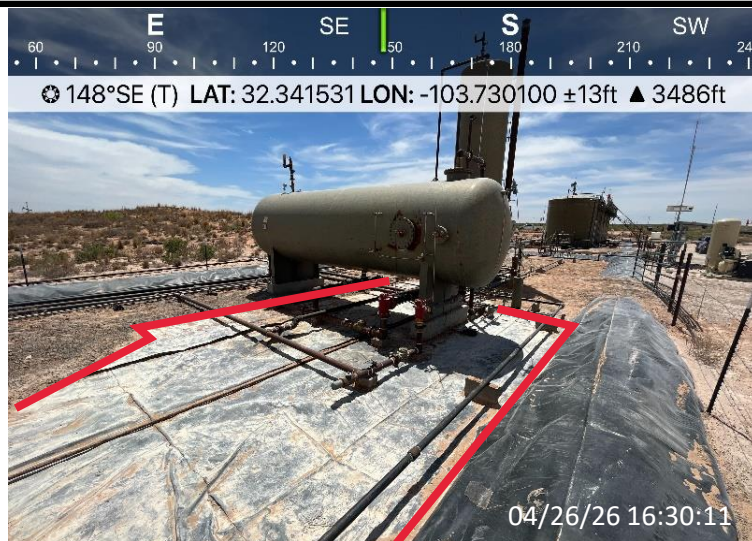
Photograph No. 4

View Southeast of the intact liner after the pea gravel has been removed. Red outline is the area of the liner inspection.

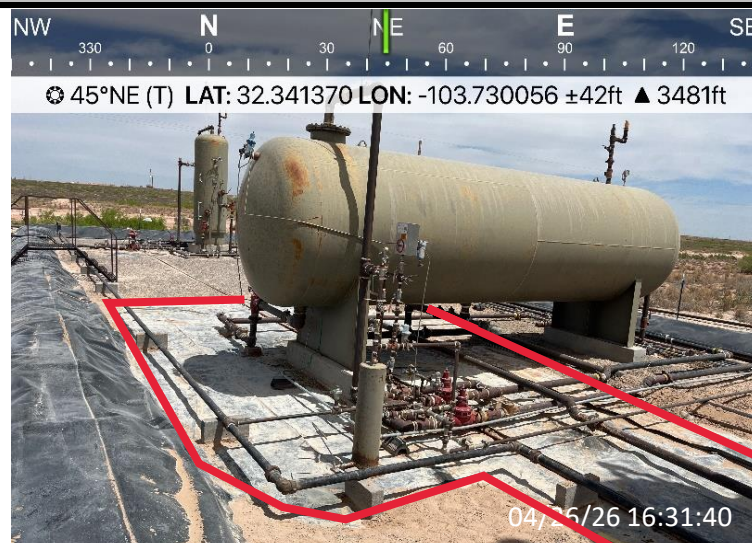
Photograph No. 5

View Northeast of the intact liner after the pea gravel has been removed. Red outline is the area of the liner inspection.

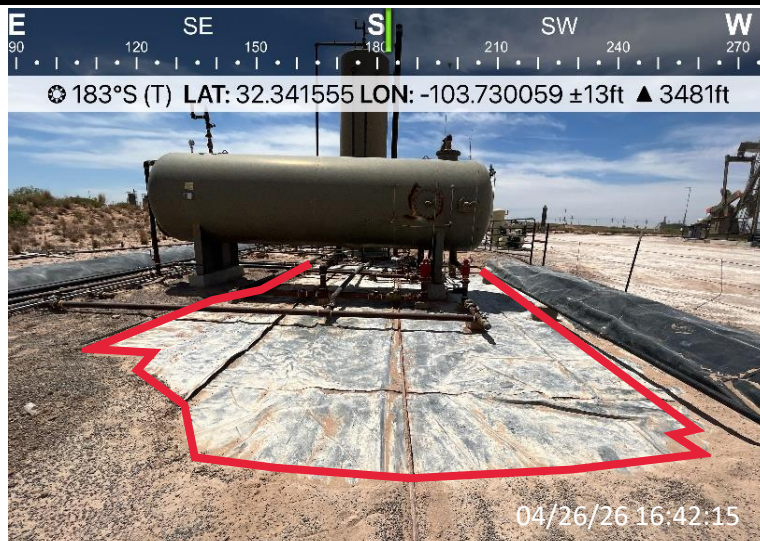
Photograph No. 6

View South of the intact liner after the pea gravel has been removed. Red outline is the area of the liner inspection.
