RE: Liner Inspection and Closure Report
Tex Mack 11 Federal #3 Battery
API No. 30-015-36835
GPS: Latitude 32.85518 Longitude -103.84818
UL- D, Section 11, Township 17S, Range 31E
NMOCD Reference No. nAPP2333127555 and nAPP2301130080

Spur Energy Partners (Spur) has contracted Edge Safety (Edge) to perform a liner inspection and prepare this closure report for the release of oil and produced water that happened at the Tex Mack 11 Federal #3 Battery (Tex Mack). On January 9, 2023 and November 25, 2023, the initial C-141s were formally submitted. The corresponding releases received the designation Incident IDs nAPP2333127555 and nAPP2301130080 from the New Mexico Oil Conservation Division (NMOCD).

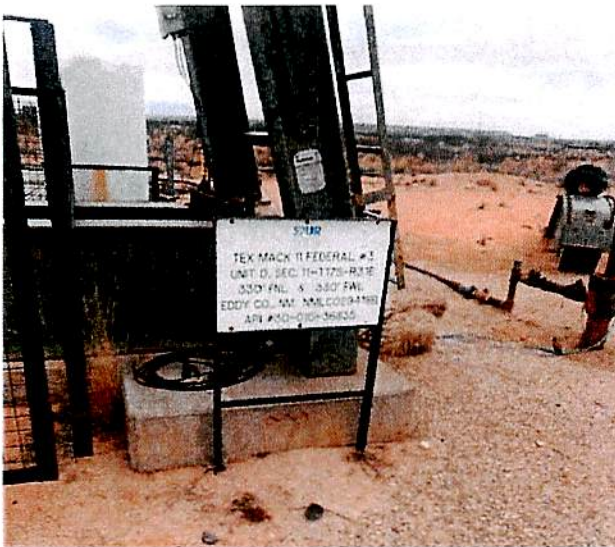
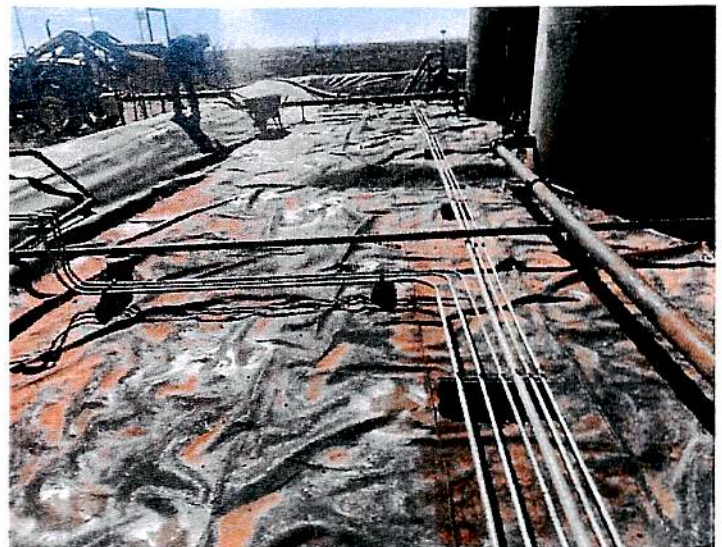
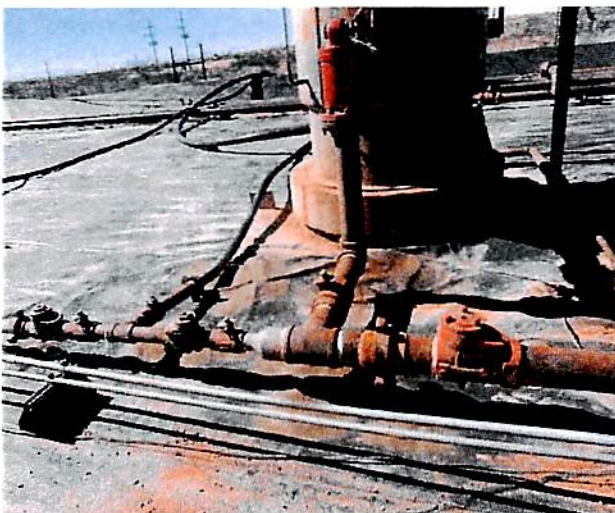
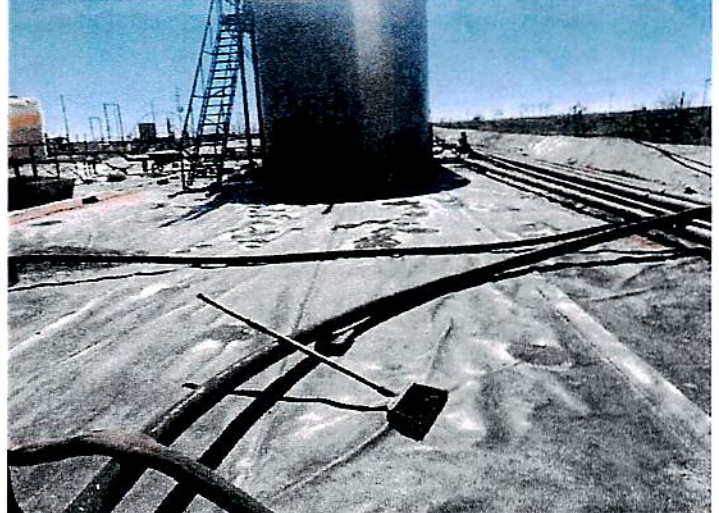
Liner Inspection:

On January 19, 2024, Edge Safety conducted a liner inspection at this location. We concluded that this liner and containment maintained its integrity and was able to retain the fluids. The liner inspection form and photographic documentation can be found in Appendix C.

Visualization	Yes	No	Comments
Is there a tear in the liner?		x	
Are there Holes in the liner?		x	
Is the liner retaining any fluids?		x	
Does the liner have integrity to contain a leak?	x

After removing all contaminated gravel from the affected area, a power washing unit was used to clean any remaining oil or residue from the exposed plastic liner. A vacuum truck was deployed to extract standing fluid, and this process was repeated until all oil and produced water residue was thoroughly eliminated. Following this, a detailed inspection for tears and rips was conducted. Upon confirming the absence of any tears or rips, an inspection was conducted to validate the integrity of the liner.
