Remediation Summary & Soil Closure Request

Permian Resources

Black River 3 Fed #1

Eddy County, New Mexico

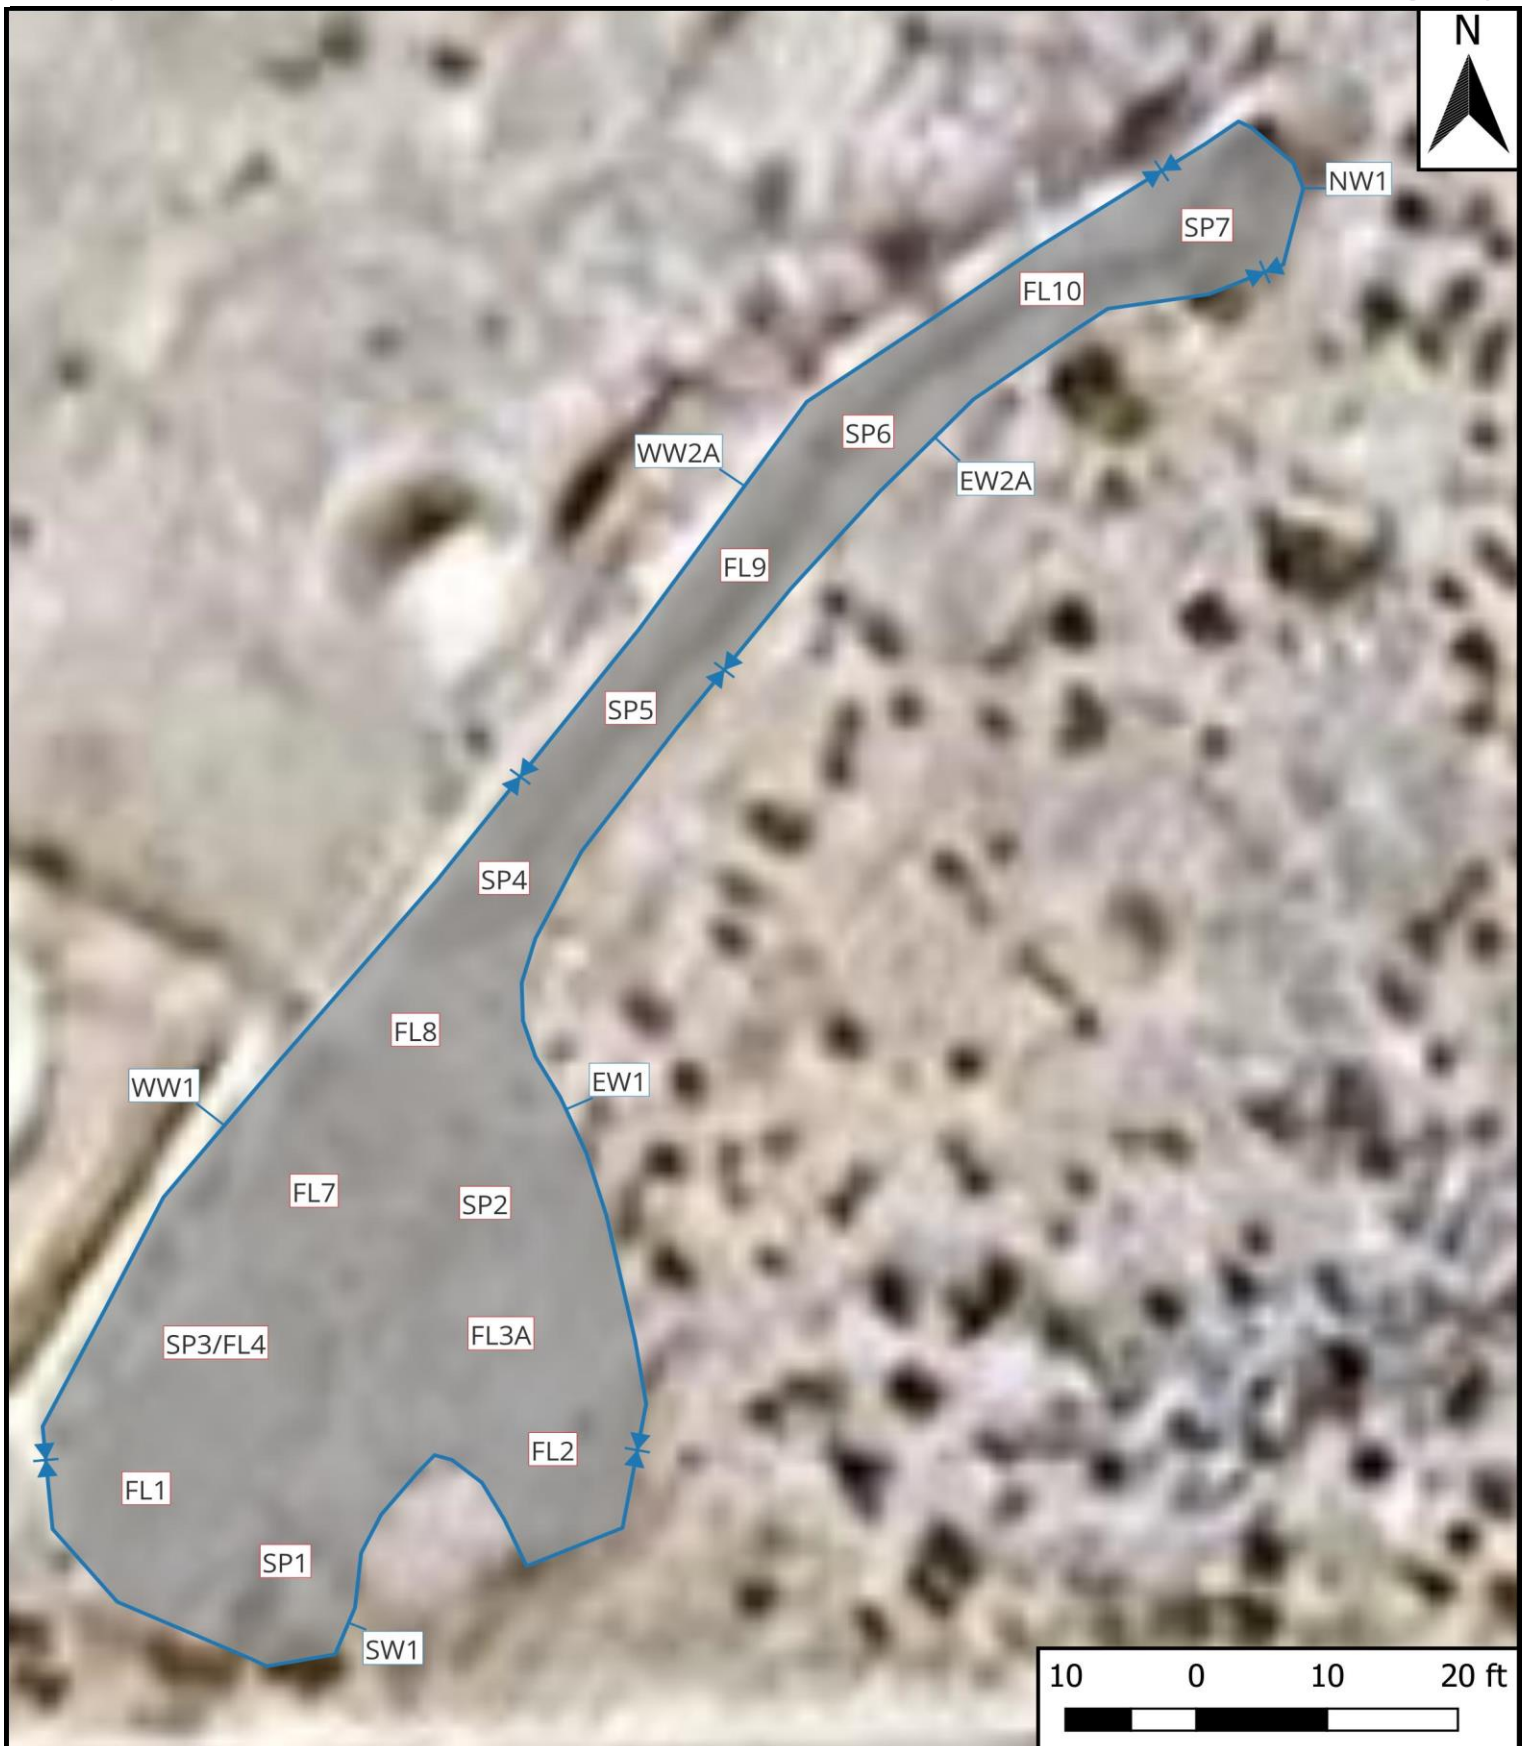
Figure 3

Site and Sample Location Map

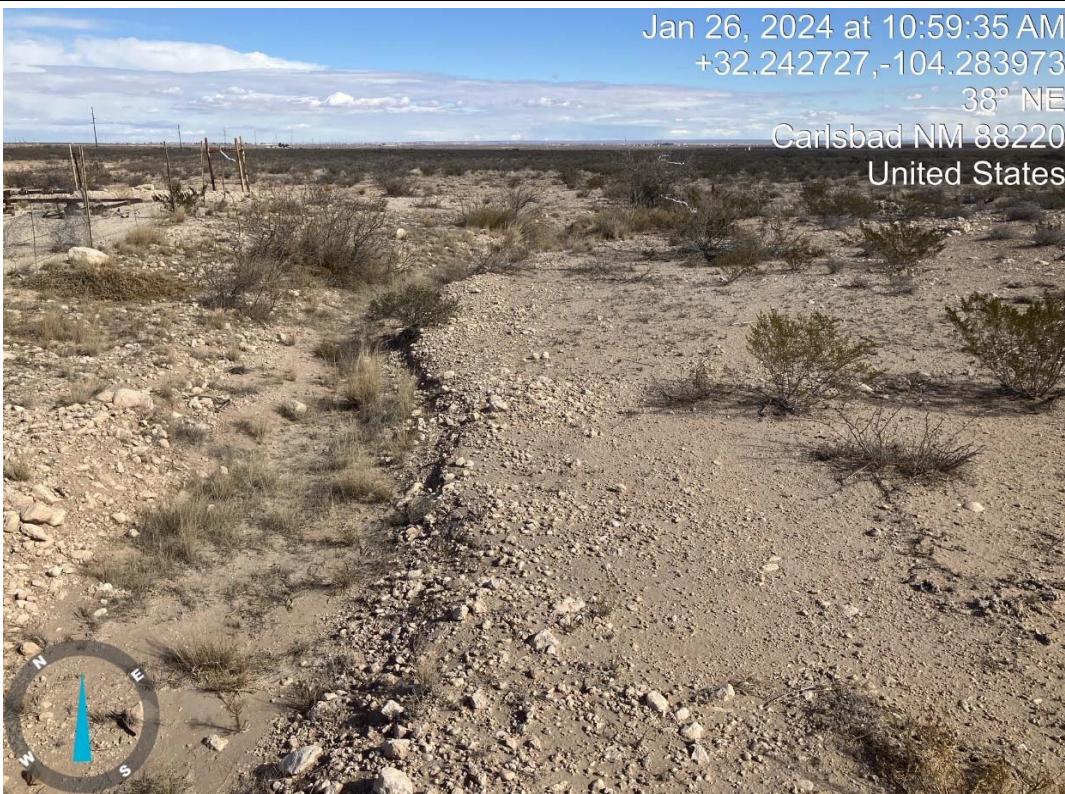
Photo Number: 3	<div>Jan 26, 2024 at 10:59:35 AM +32.242727,-104.283973 38° NE Carlsbad NM 88220 United States</div>

Photo Direction: Northeast	
Photo Description: View of original excavation.

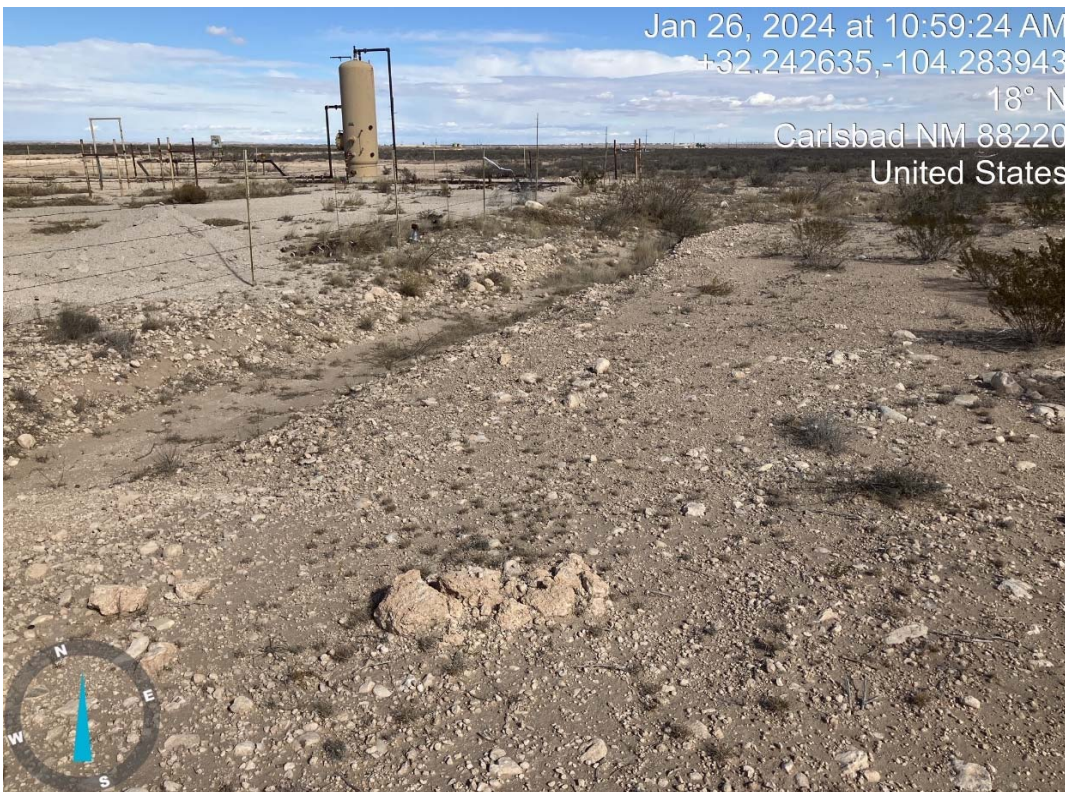
Photo Number: 4	<div>Jan 26, 2024 at 10:59:24 AM +32.242635,-104.283943 18° N Carlsbad NM 88220 United States</div>

Photo Direction: North	
Photo Description: View of original excavation.

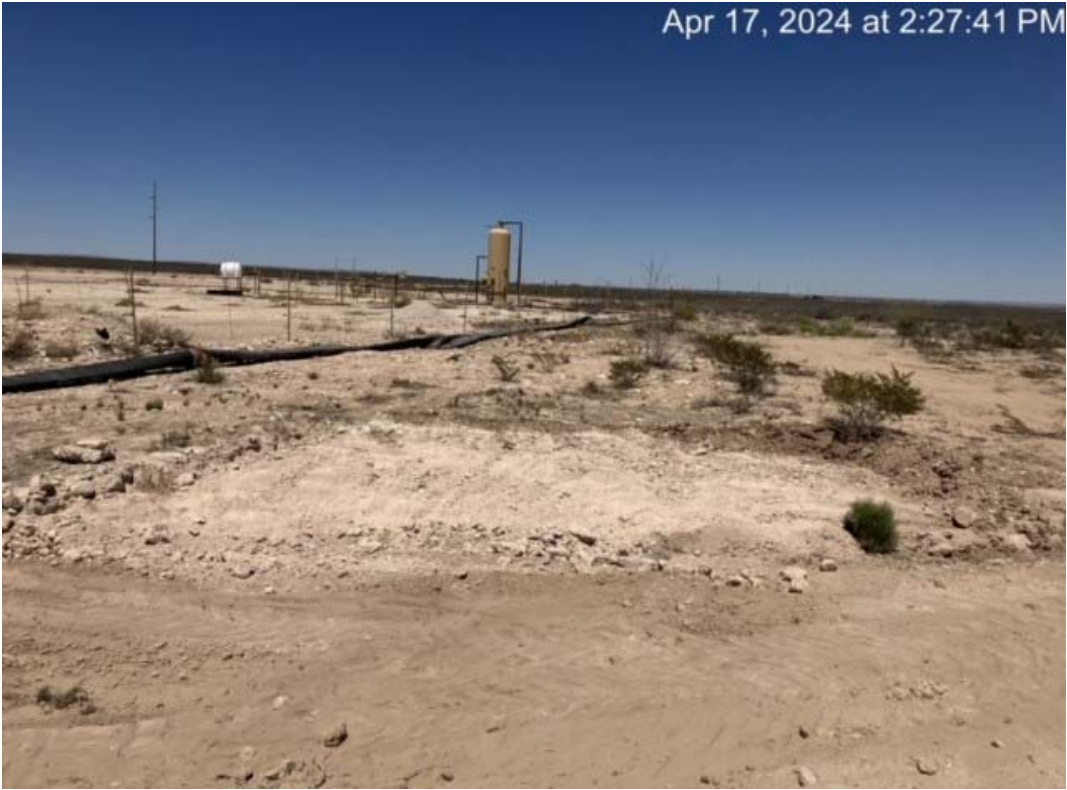
Photo Number: 5

<p>Apr 17, 2024 at 2:27:41 PM</p>
Photo Direction: Northeast	
GPS: 32.24255, -104.28408	
Photo Description: View of portion of open excavation.

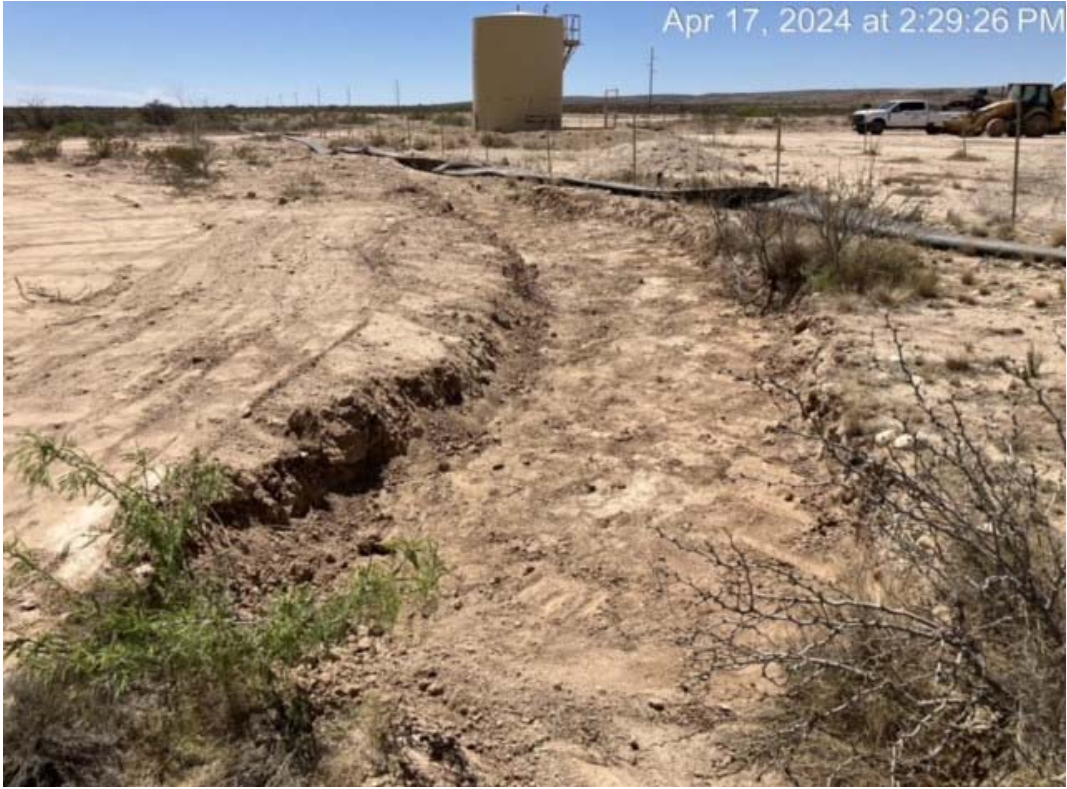
Photo Number: 6

<p>Apr 17, 2024 at 2:29:26 PM</p>
Photo Direction: Southwest	
GPS: 32.24288, -104.28379	
Photo Description: View of portion of open excavation.

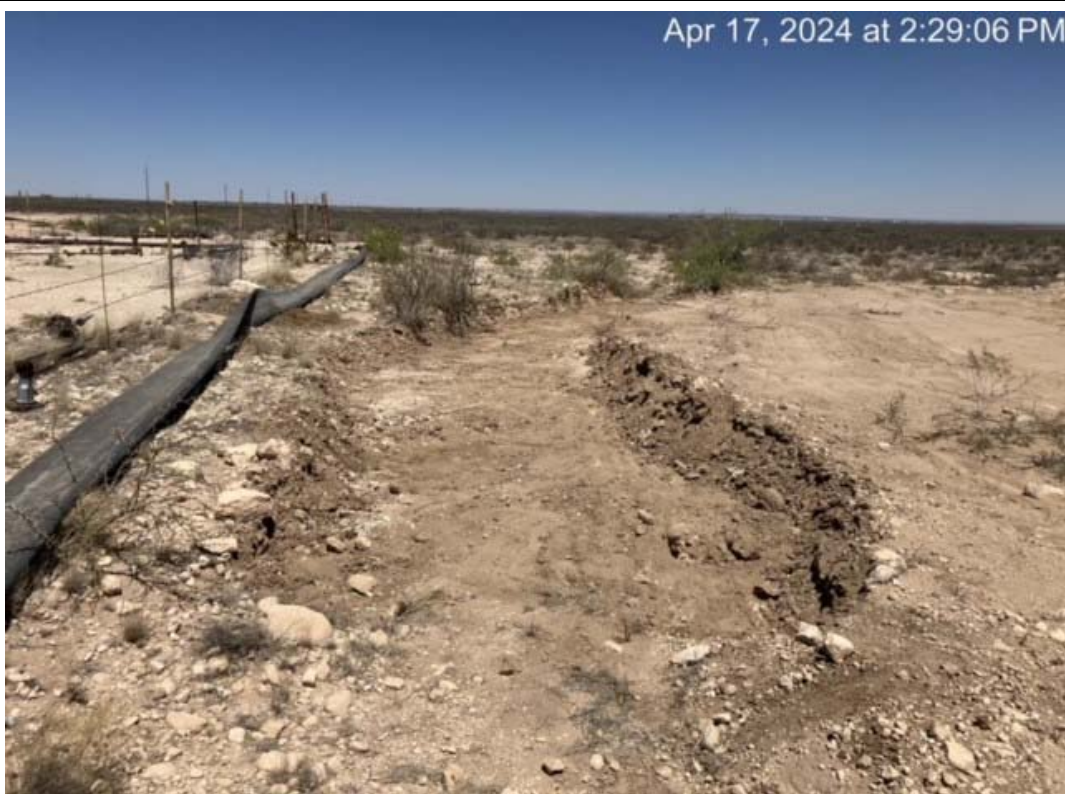
Photo Number: 7

Photo Direction: Northeast	
GPS: 32.24266, -104.28403	
Photo Description: View of portion of open excavation.

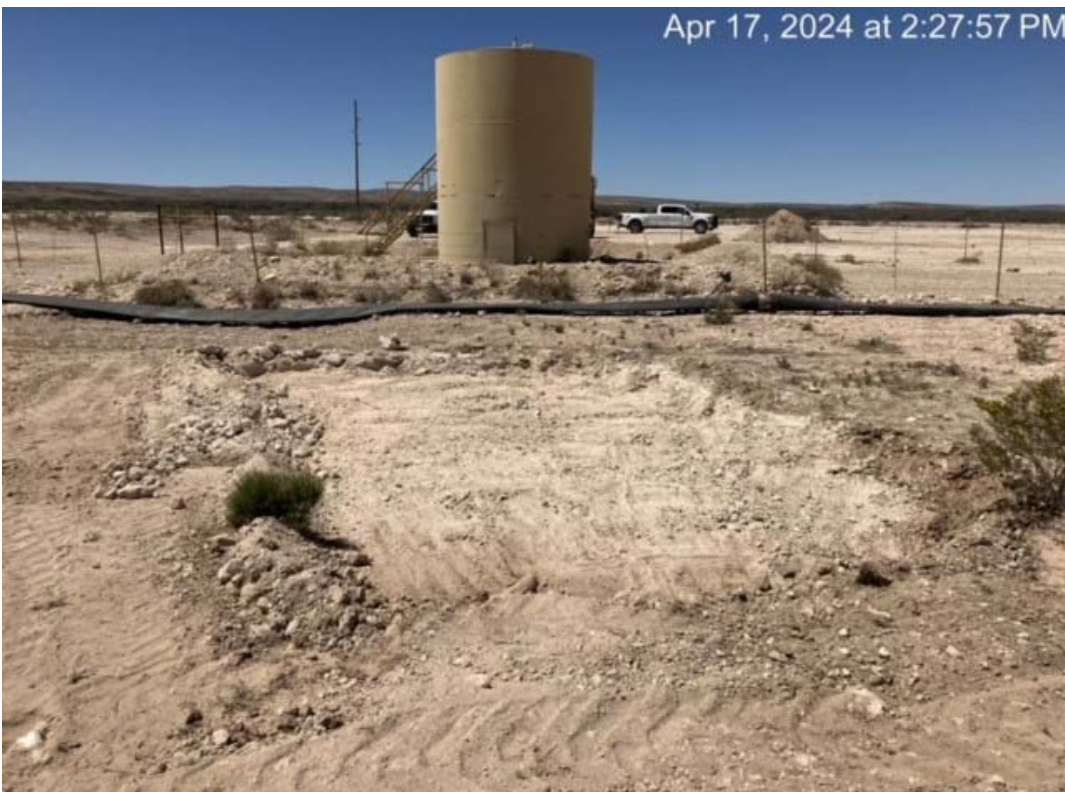
Photo Number: 8

Photo Direction: Northwest	
GPS: 32.24258, -104.28394	
Photo Description: View of portion of open excavation.

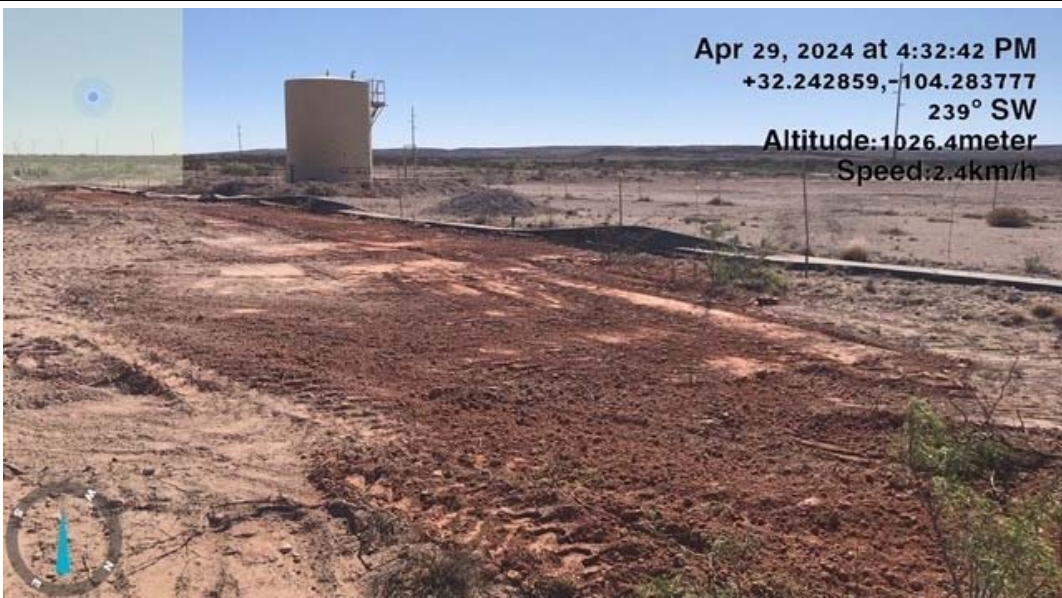
Photo Number: 9

<p>Apr 29, 2024 at 4:32:42 PM +32.242859,-104.283777 239° SW Altitude:1026.4meter Speed:2.4km/h</p>
Photo Direction West	
Photo Description: View of remediated area after backfill and grading.
