Closure Report
Arrowhead Compressor Station (06.05.2023)
Incident ID: nAPP2315837844
Eddy County, New Mexico
Unit N Sec 10 T18S R29E
32.756368°, -104.06458°

Condensate Release
Point of Release: Line deterioration caused weak spot in pipeline
Release Date: 06.05.2023
Volume Released: 10.7 Barrels of Condensate
Volume Recovered: 0 Barrels of Condensate

Re: Closure Report
Arrowhead Compressor Station (06.05.2023)
Incident ID: nAPP2315837844
Durango Midstream
Site Location: Unit N, S10 T18S, R29E
(Lat 32.756368°, Long -104.06458°)
Eddy County, New Mexico

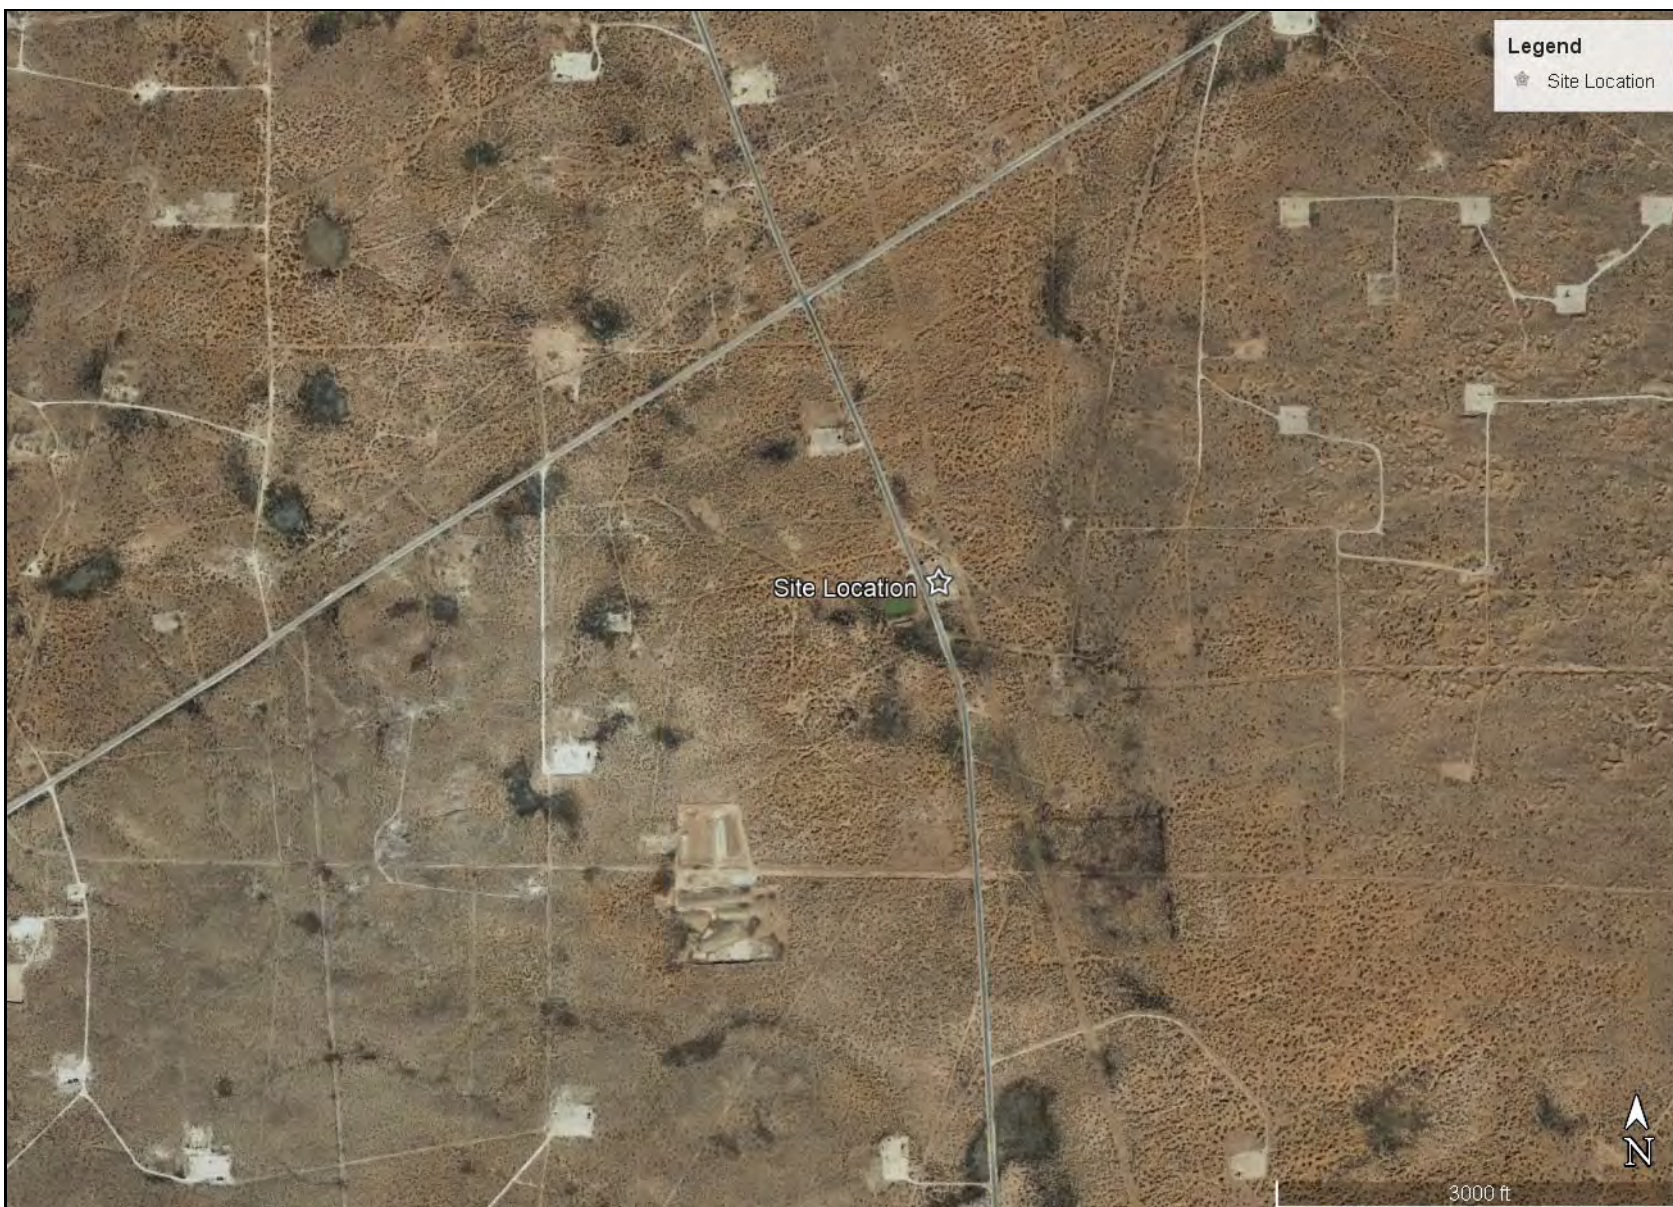
OVERVIEW MAP
DURANGO MIDSTREAM
ARROWHEAD COMPRESSOR STATION (06.05.2023)
EDDY COUNTY, NEW MEXICO
32.756368°, -104.06458°

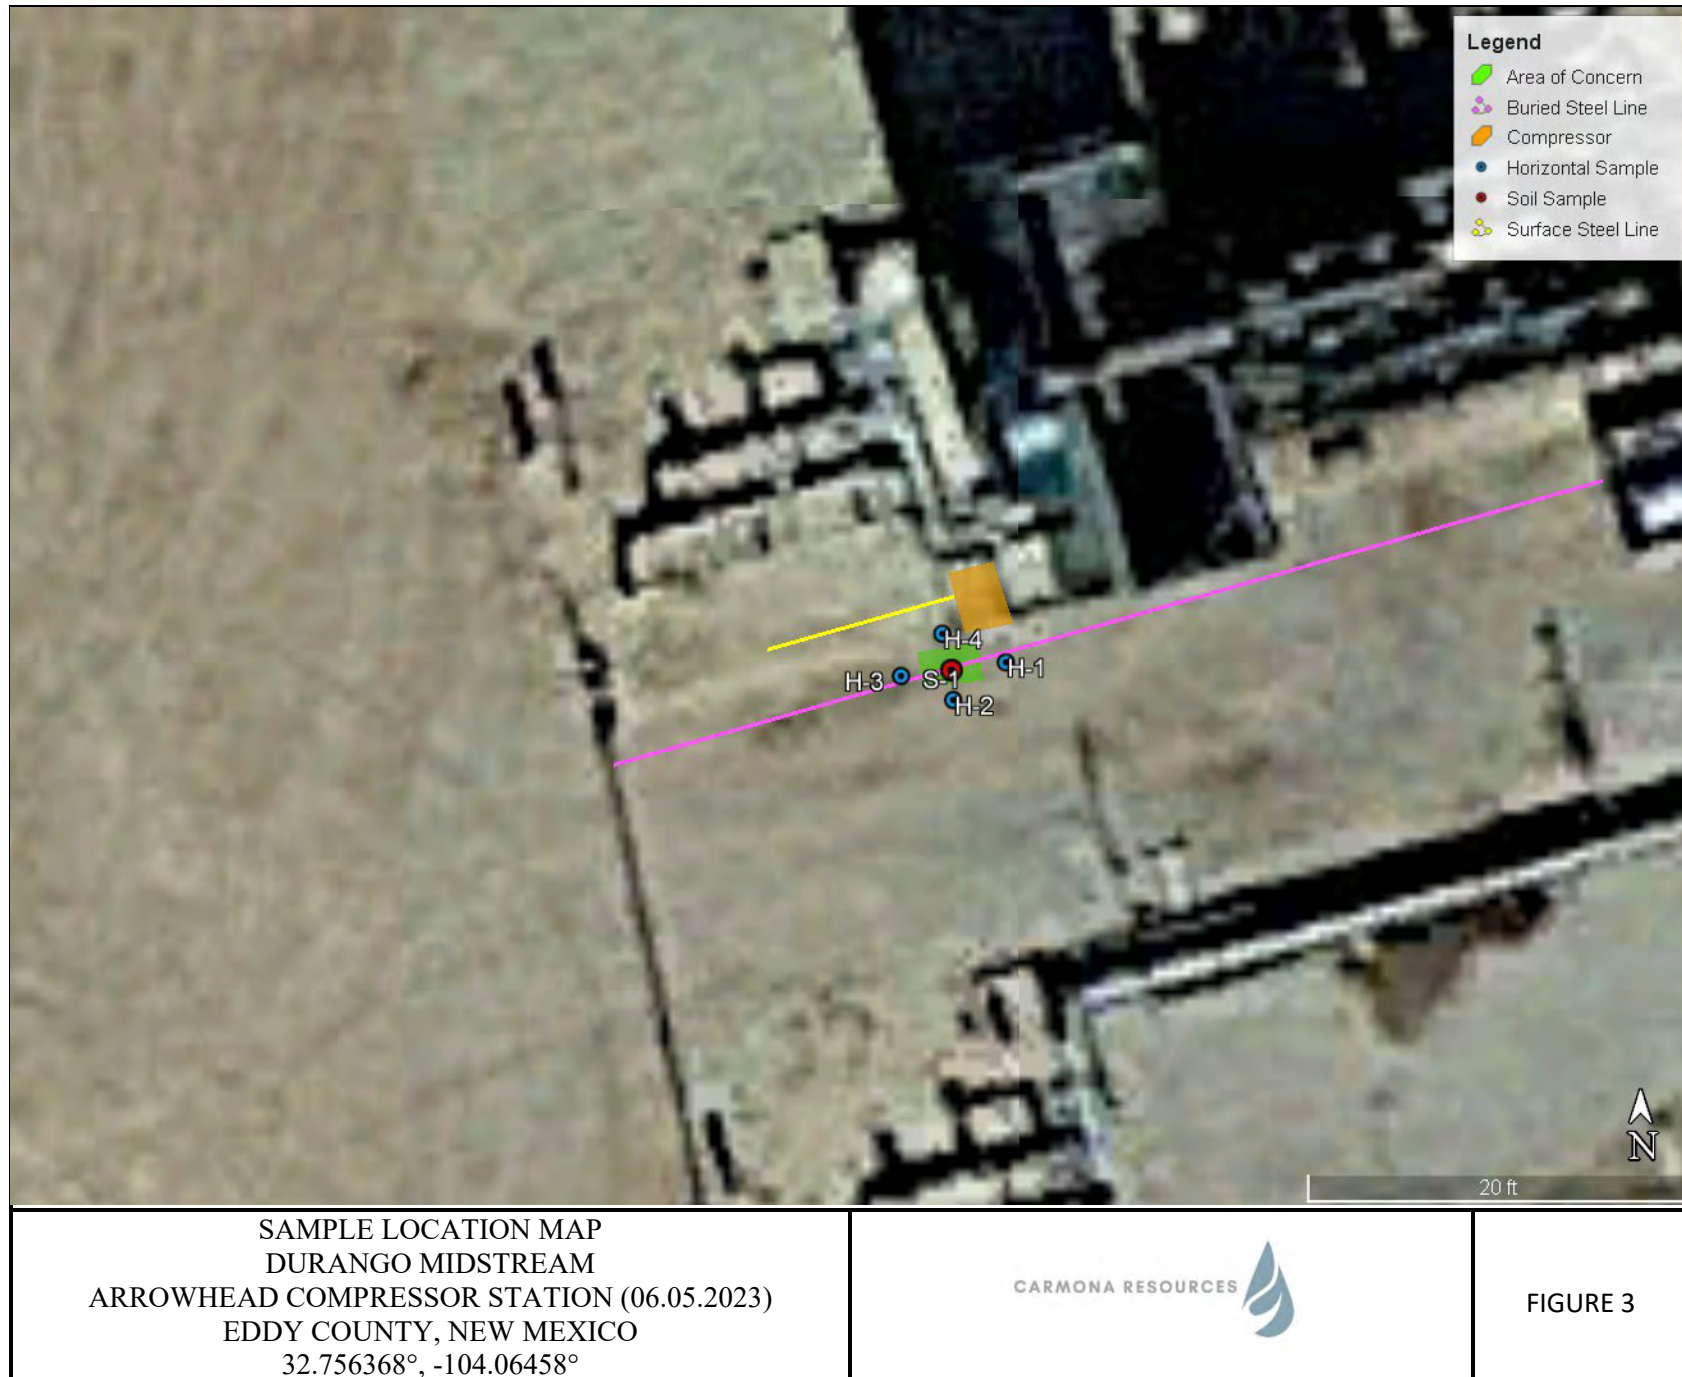
Refer to Table 1. See Figure 3 for the sample locations.

Based on the initial C-141 obtained from the New Mexico Oil Conservation Division (NMOCD), the release was discovered on June 5, 2023, caused by a weak spot in the pipeline due to line deterioration, releasing condensate. It resulted in approximately ten point seven (10.7) barrels of condensate, and zero (0) barrels of condensate were recovered. The impacted area is located on the pad, adjacent to a large compressor. Refer to Figure 3 for spill overview. The initial C-141 form is attached in Appendix C.

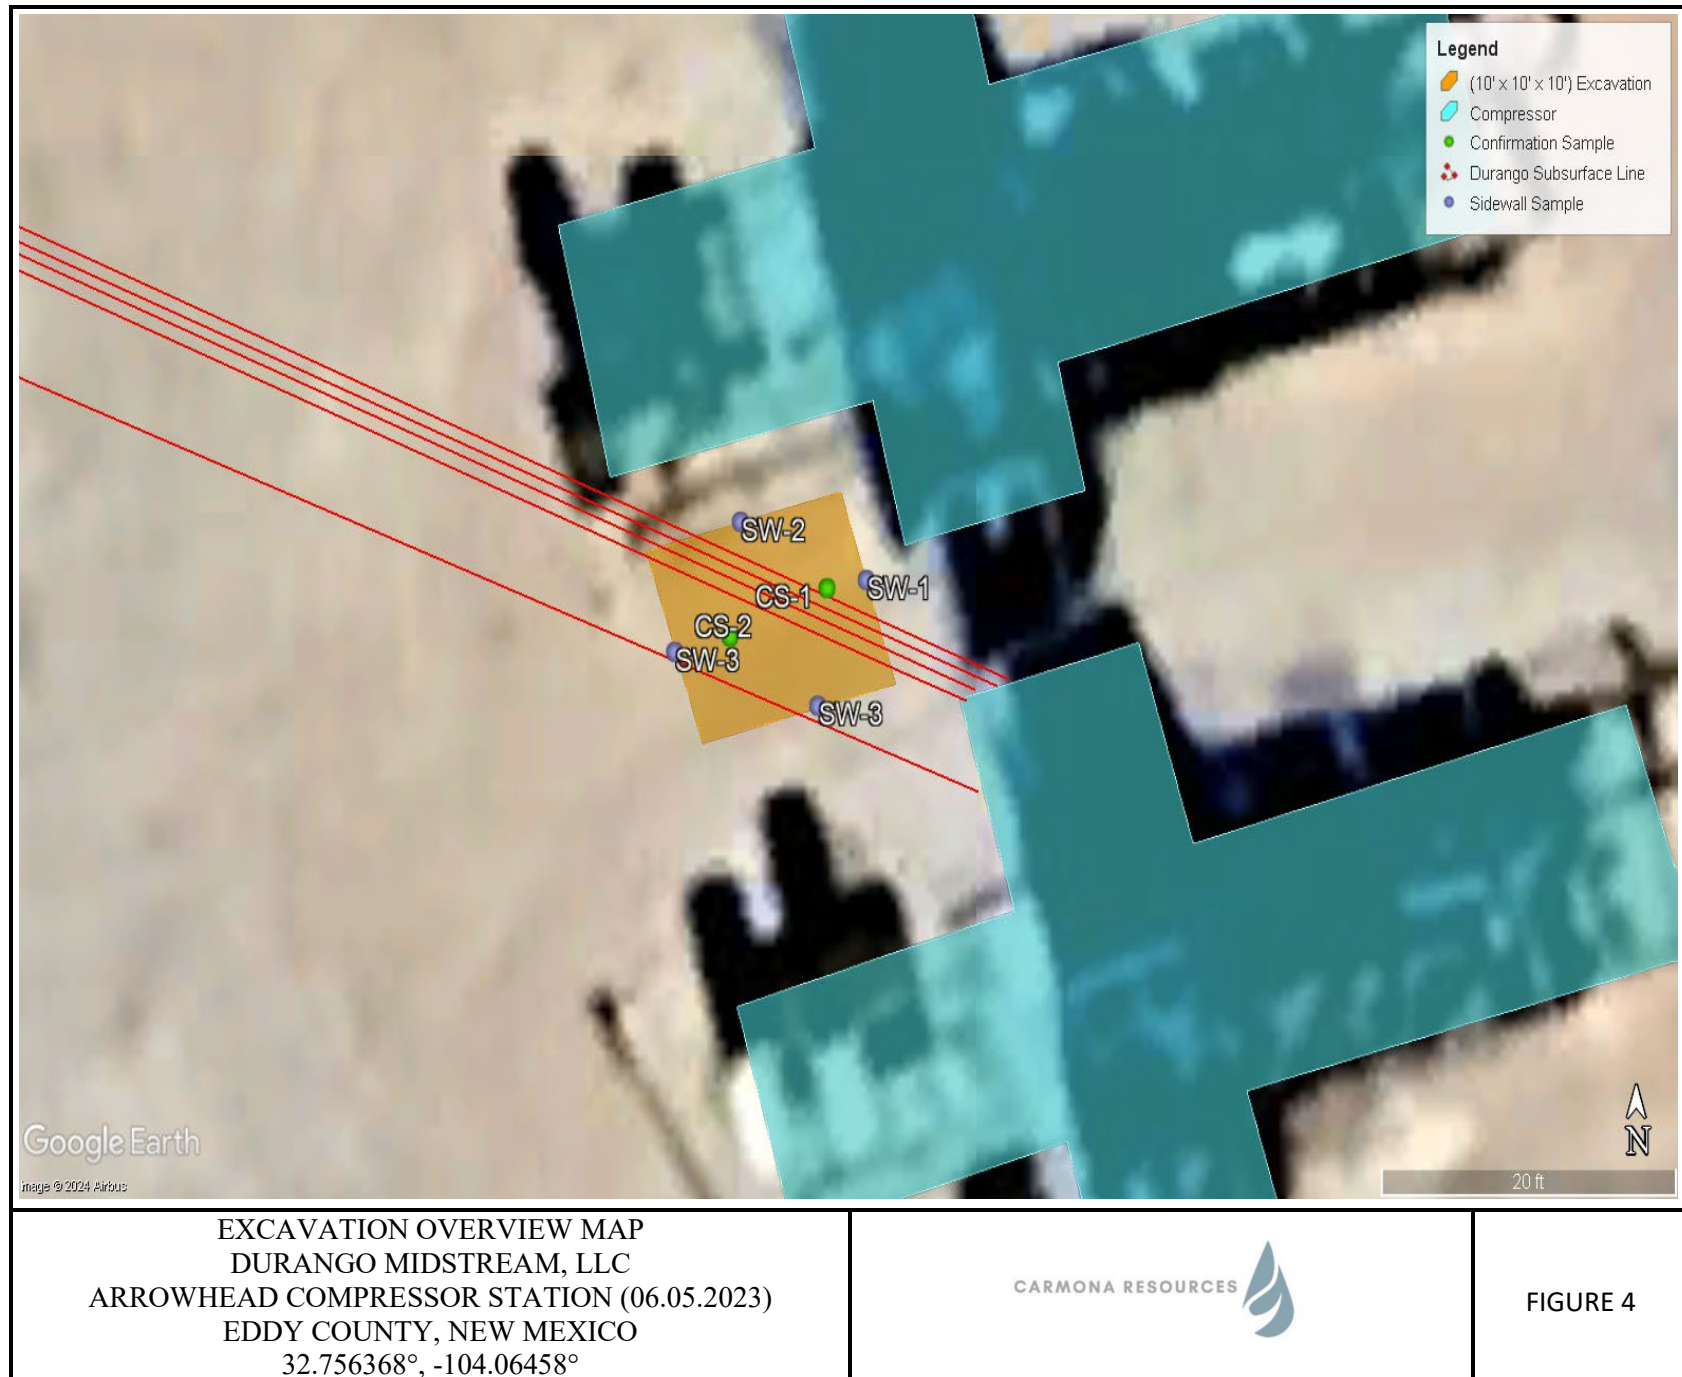
Carmona Resources personnel were onsite to supervise the remediation activities, collect confirmation samples, and document backfill activities. An area measuring (10' x 10' x 10') was excavated via hydro-vac to ensure all contaminants were safely excavated around and below subsurface lines in the area of concern. Before collecting composite confirmation samples, the NMOCD division office was notified via email on May 1, 2024, per Subsection D of 19.15.29.12 NMAC. See Appendix C. A total of two (2) floor confirmation samples were collected (CS-1 and CS-2), and four (4) sidewall samples (SW-1 through SW-4) were collected every 200 square feet to ensure the proper removal of the contaminated soils. All collected samples were analyzed for TPH analysis by EPA method 8015 modified, BTEX by EPA Method 8021B, and chloride by EPA method 4500. Copies of laboratory analysis and chain-of-custody documentation are included in Appendix E. The excavation depths and confirmation sample locations are shown in Figure 4. All final confirmation samples were below the regulatory requirements for TPH, BTEX, and chloride. Refer to Table 2.

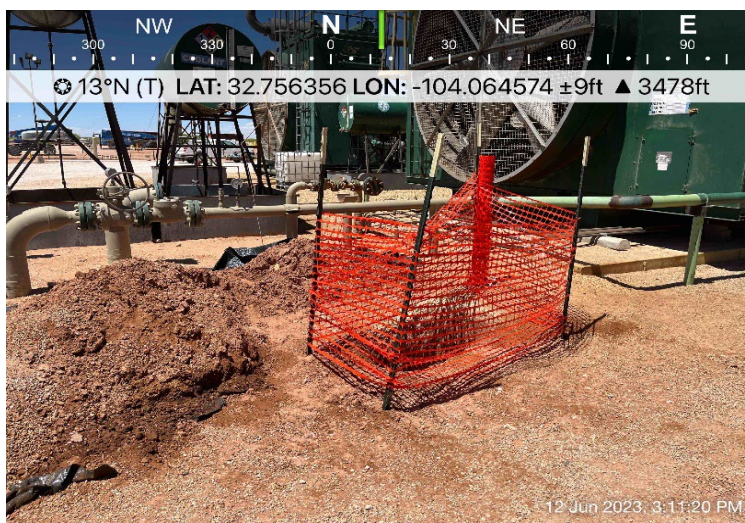
Photograph No. 1

View North, area of concern.

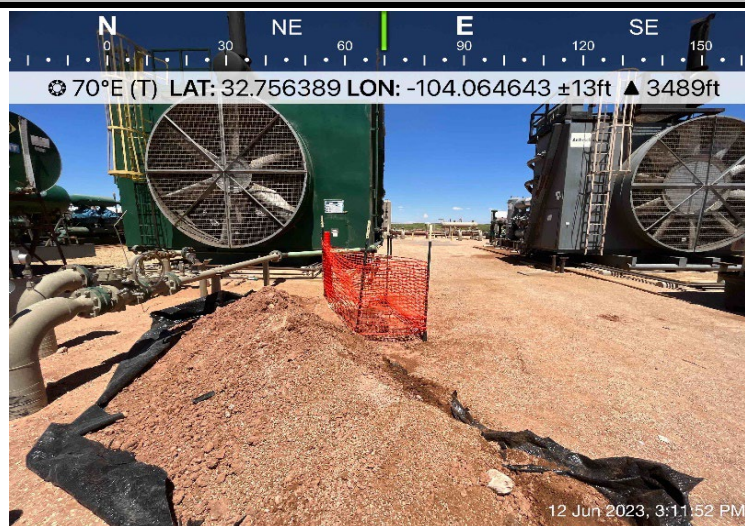
Photograph No. 2

View East, area of concern.

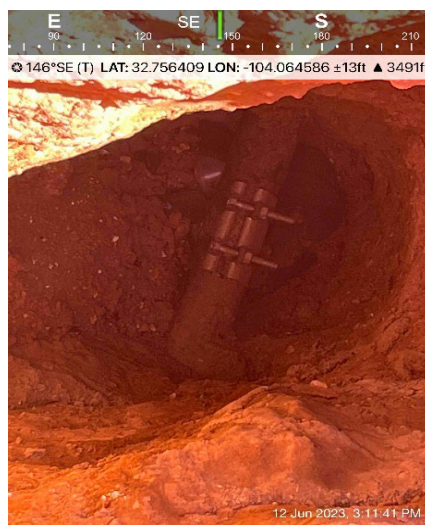
Photograph No. 3

View Southeast, area of sample point (S-1).

The area of S-1 is directly under facility equipment and infrastructure (compressor and flowlines). Due to safety concerns and lithology, Durango requested to defer the area of S-1 until reclamation efforts. The entire area has been horizontally defined. Vertical delineation was not achieved due to safety and access issues for sampling equipment. On January 5, 2024, the deferral request was denied for the following reason:

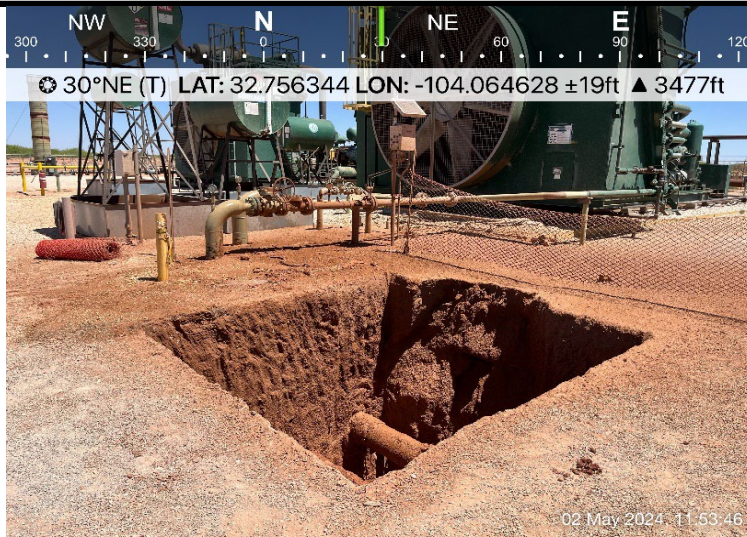
Photograph No. 4

View Northeast, of sample points CS-1 through CS-2, and SW-1 through SW-4

Once the remediation activities were completed, the excavated areas were backfilled with clean material to surface grade. Approximately 40 cubic yards of material were excavated and transported offsite for proper disposal.

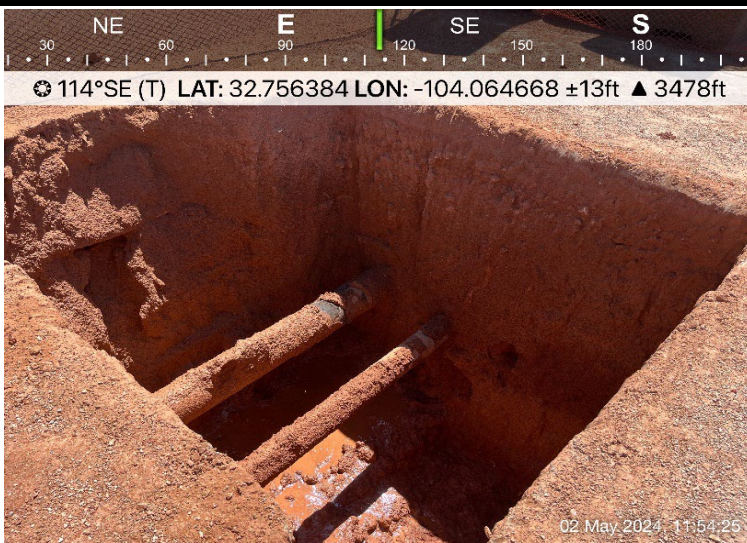
Photograph No. 5

View Southeast, of sample points CS-1 through CS-2, and SW-1 through SW-4

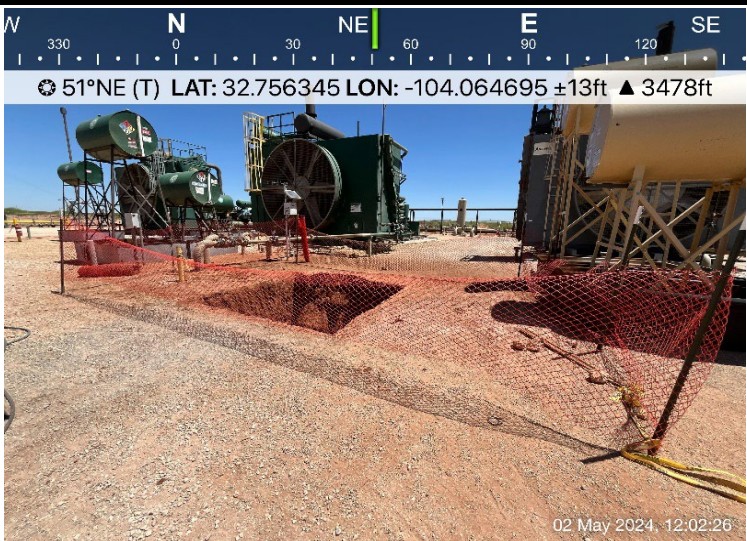
Photograph No. 6

View Northeast, of sample points CS-1 through CS-2, and SW-1 through SW-4
