**Re: Closure Request
PLU Phantom Banks 25-25-30
Incident Number NAPP2408649824
Eddy County, New Mexico**

Ensolum, LLC (Ensolum), on behalf of XTO Energy, Inc. (XTO), has prepared this *Closure Request* to document site assessment, excavation, and soil sampling activities performed at the PLU Phantom Banks 25-25-30 (Site) in Eddy County, New Mexico. The purpose of the site assessment, excavation, and soil sampling activities was to address impacts to soil resulting from a release of produced water at the Site. Based on the excavation activities and analytical results from the soil sampling events, XTO is submitting this *Closure Request*, describing remediation that has occurred and requesting closure for Incident Number NAPP2408649824.

XTO Energy, Inc
Closure Request
PLU Phantom Banks 25-25-30

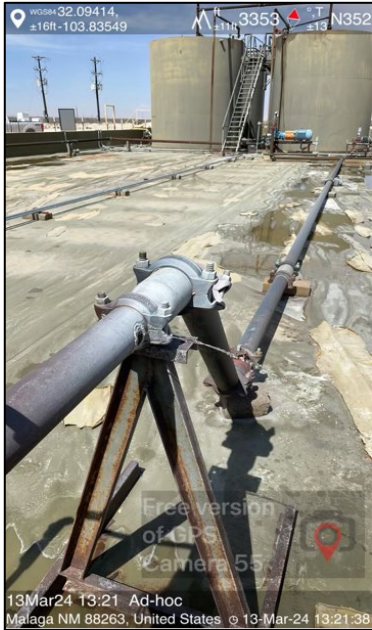
On March 13, 2024, a dump line clamp located above the containment barrier in the southeast corner of the tank battery released 11 barrels (bbls) of produced water into the lined containment and onto the east side of the pad. A vacuum truck was immediately dispatched to the Site to recover the free-standing fluids; approximately 10 bbls of produced water were recovered. XTO reported the release to the New Mexico Oil Conservation Division (NMOCD) and submitted a Form C-141 Application (Form C-141) on March 27, 2024. The release was assigned Incident Number NAPP2408649824.

Photograph: 1 Date: 03/13/2024
 Description: Point of release on containment edge
 View: North

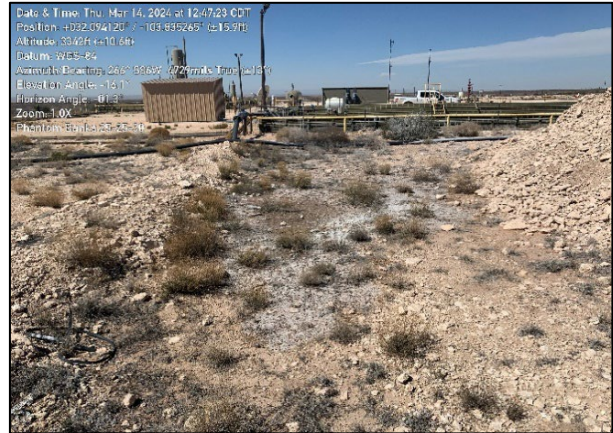
On March 14, 2024, immediately following the release, Ensolum personnel visited the Site to evaluate the release extent based on visual observations. The release extent was mapped utilizing a handheld Global Positioning System (GPS) unit and is depicted on Figure 2.

Photograph: 2 Date: 03/14/2024
 Description: Staining from release
 View: West

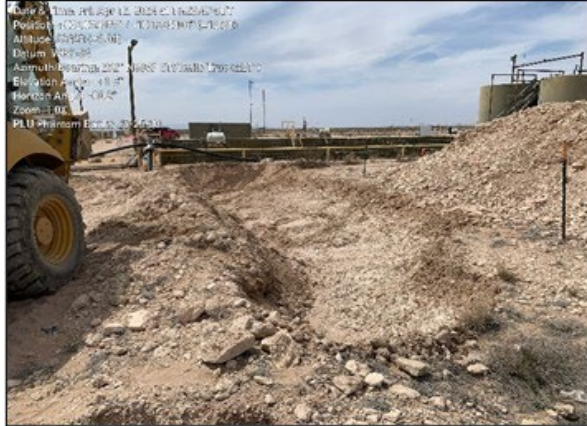
Photograph: 5 Date: 04/12/2024
 Description: Final excavation extent
 View: Northwest

On April 11 and April 12, 2024, Ensolum personnel were at the Site to oversee excavation activities. Impacted soil was excavated from the release area as indicated by visible staining and field screening results. Excavation activities were performed using a backhoe and transport vehicle. The excavation occurred within the fence/pasture boundary. The excavation was completed to depths ranging from 2 feet to 5 feet bgs. Photographic documentation of the excavation activities is included in Appendix B.

The excavation area measured approximately 580 square feet. A total of approximately 75 cubic yards of impacted soil was removed during the excavation activities. The impacted soil was transported and properly disposed of at the R360 Facility in Hobbs, New Mexico.

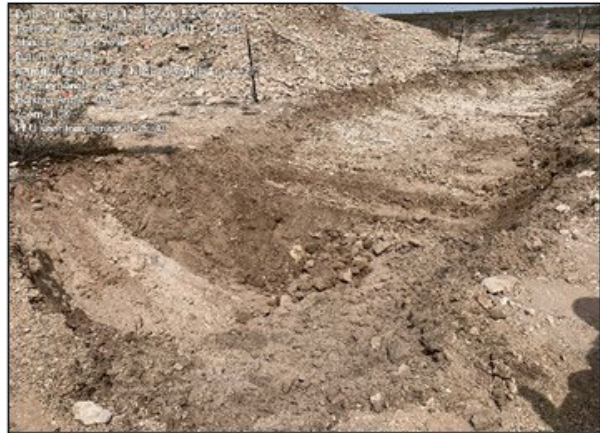
Photograph: 6 Date: 04/12/2024
 Description: Final excavation Extent
 View: Northeast

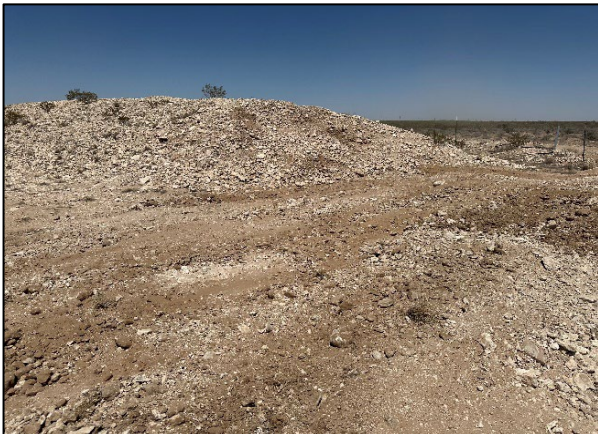
Photograph: 7 Date: 05/09/2024
 Description: Backfilled excavation
 View: Northeast

Site assessment and excavation activities were conducted at the Site to address the March 13, 2024, release of produced water. Laboratory analytical results for the confirmation soil samples, collected from the final excavation extent, indicated that all COCs were compliant with the Site Closure Criteria and reclamation requirement. Based on the soil sample analytical results, no further remediation was required. XTO has backfilled the excavation with material purchased locally and recontoured the Site to match pre-existing site conditions.

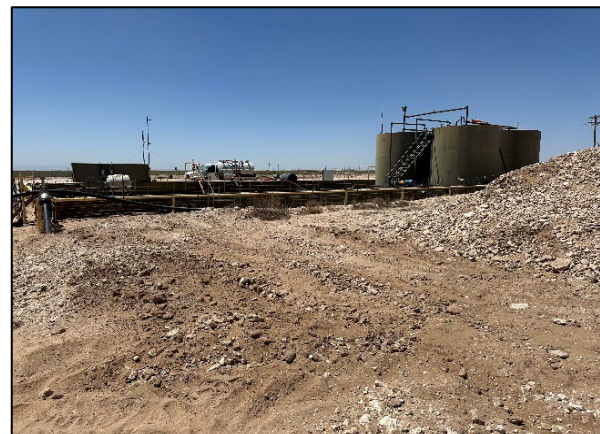
Photograph: 8 Date: 05/09/2024
 Description: Backfilled excavation
 View: Northwest
