**Closure Report**  
**Culebra Bluff Section 23 CTB (03.07.2024)**  
**Incident #: NAPP2407137317**  
**Eddy County, New Mexico**  
**Unit I Sec 23 T23S R28E**  
**32.28734°, -104.054515°**

**Crude Oil and Produced Water Release**  
**Point of Release: Valve malfunctioned when a vac truck incorrectly pushed fluid into separator instead of pulling fluid out of separator, causing a fluid release.**  
**Release Date: 03.07.2024**  
**Volume Released: 2 Barrels of Crude Oil & 13 Barrels of Produced Water**  
**Volume Recovered: 2 Barrel of Crude Oil & 10 Barrels of Produced Water**

**Re: Closure Report  
Culebra Bluff Section 23 CTB (03.07.2024)  
Chevron U.S.A., Inc.  
Site Location: Unit I, S23, T23S, R28E  
(Lat 32.28734°, Long -104.054515°)  
Eddy County, New Mexico**

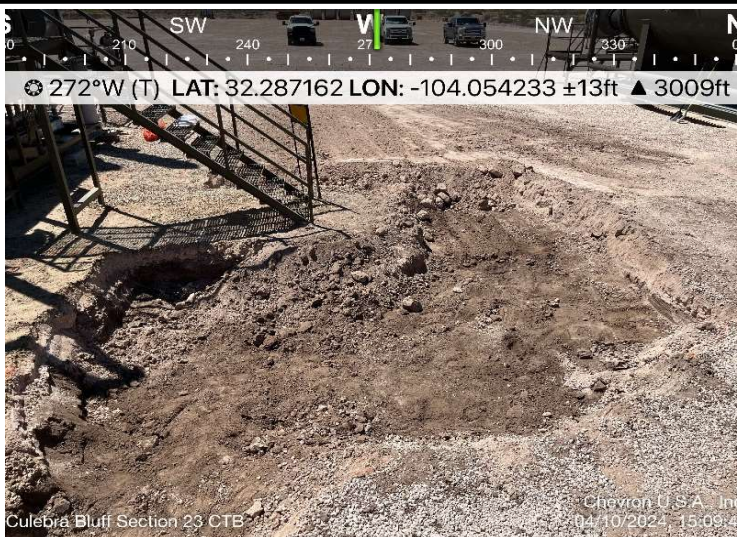
## Photograph No. 2

View West, Area of CS-1 though CS-3.

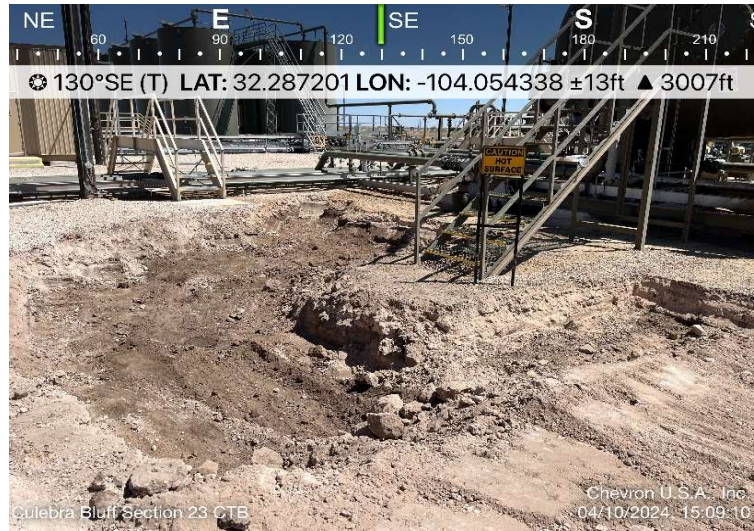
## Photograph No. 5

View Southeast, Area of CS-1 through CS-4.
