Re: Site Assessment, Remediation, and Closure Report

Government E #007 API No. 30-025-27896

NMOCD Ref. No. NAPP2410959069

Pima Environmental Services, LLC (Pima) has been contracted by Armstrong Energy Corporation to perform a spill assessment, remediation activities, and submit this closure report for a crude oil release at the Government E #007 (Government) site. The initial C-141 was submitted on April 24, 2024 (Appendix C). This incident was assigned Incident ID NAPP2410959069, by the New Mexico Oil Conservation Division (NMOCD).

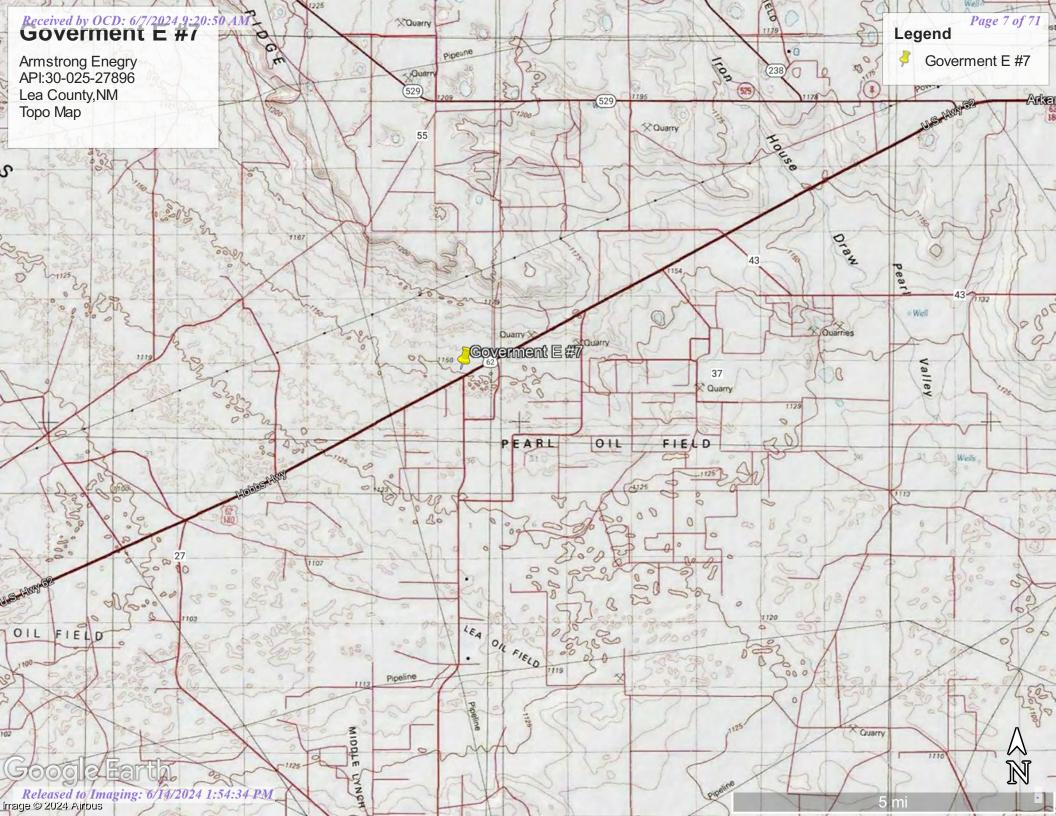
Based on the well water data from the New Mexico Office of the State Engineer water well (CP 00683 POD1), the depth to the nearest groundwater in this vicinity measures 28 feet below grade surface (BGS), positioned roughly 0.84 miles away from the Government, drilled on July 18, 1985. Conversely, as per the United States Geological Survey well water data (USGS323855103294001), the nearest groundwater depth in this region is recorded at 68 feet BGS, situated approximately 1.50 miles away from the Government, with the last gauge conducted on January 27, 1971. For detailed references to water surveys and the precise locations of water wells, please refer to Appendix A, inclusive of the relevant maps. Notably, the Government is situated within an area with a low potential for karst, as illustrated in Figure 3. Additionally, a comprehensive Topographic Map is available for reference in Figure 2.

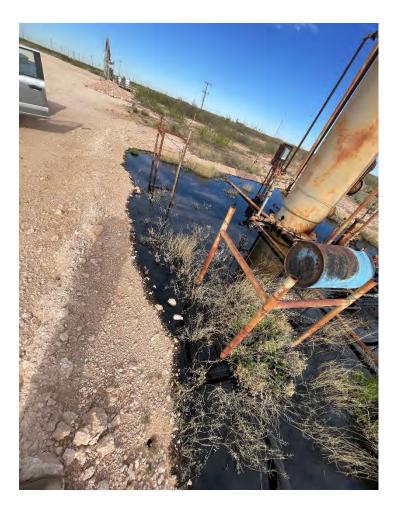
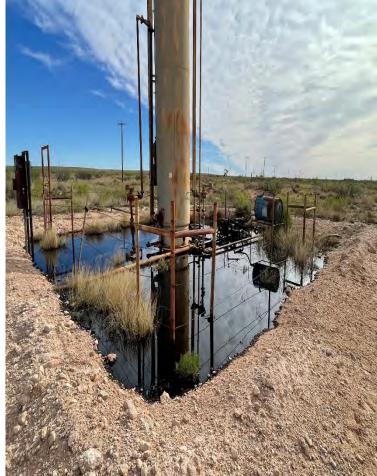
Initial Release:

NAPP2410959069: On April 17, 2024, a circulating line failure caused crude oil to be released from the storage tank into the unlined containment area located in the northeast corner of the engineered pad beneath the vertical separator. Upon discovery, the release area was secured, and the standing fluid was recovered using a vacuum truck. A total of 165 barrels of oil were released, with 65 barrels recovered, resulting in a loss of 100 barrels. All the fluid remained within the unlined containment and did not spill onto the engineered pad or neighboring pasture.

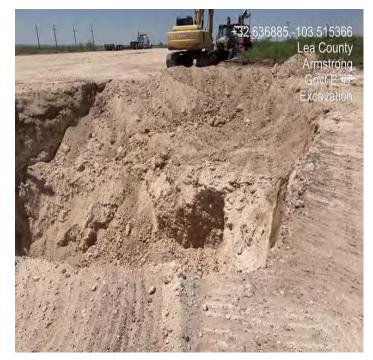
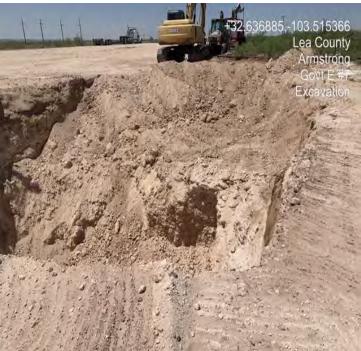
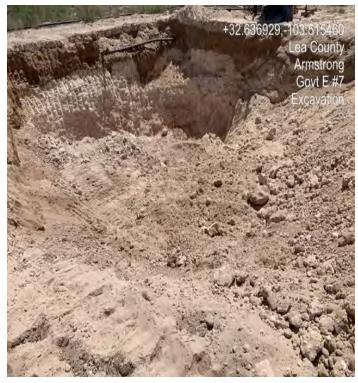
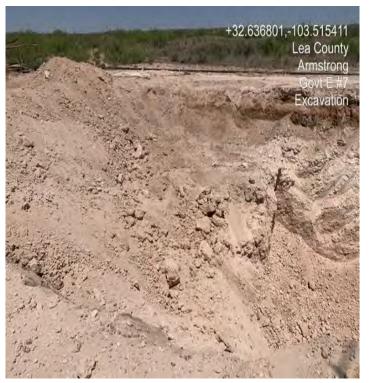
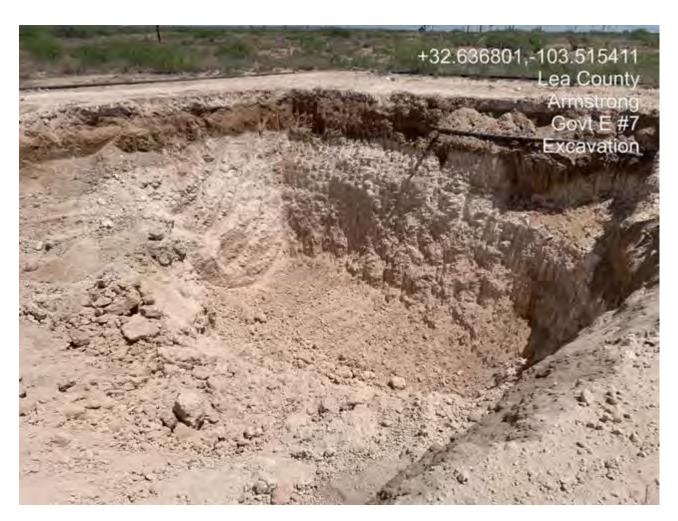
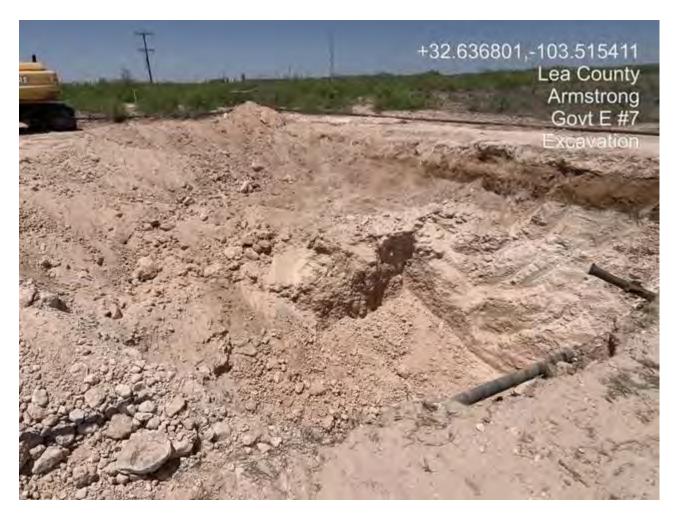
Excavation:

From April 18 to May 1, Armstrong Energy conducted an urgent excavation of the affected area within the unlined containment to prevent crude oil from seeping further into the soil. They used a track hoe and belly dumps to remove the contaminated material from the site. The excavation covered approximately 1,106 square feet and reached depths of 7 feet and 4 feet below ground surface (bgs). In total, 940 cubic yards of contaminated material were removed and transported to an NMOCD-approved landfill for disposal.
