Re: **Updated Remediation Work Plan**
San Juan 30-6 Unit 31A
Rio Arriba County, New Mexico
Hilcorp Energy Company
NMOCD Incident Number: nAPP2301160771

Ensolum, LLC (Ensolum), on behalf of Hilcorp Energy Company (Hilcorp), presents this *Updated Remediation Work Plan* associated with a release discovered at the San Juan 30-6 Unit 31A natural gas production well pad (Site). The Site is located on private land in Unit F, Section 33, Township 30 North, Range 6 West in Rio Arriba County, New Mexico (Figure 1).

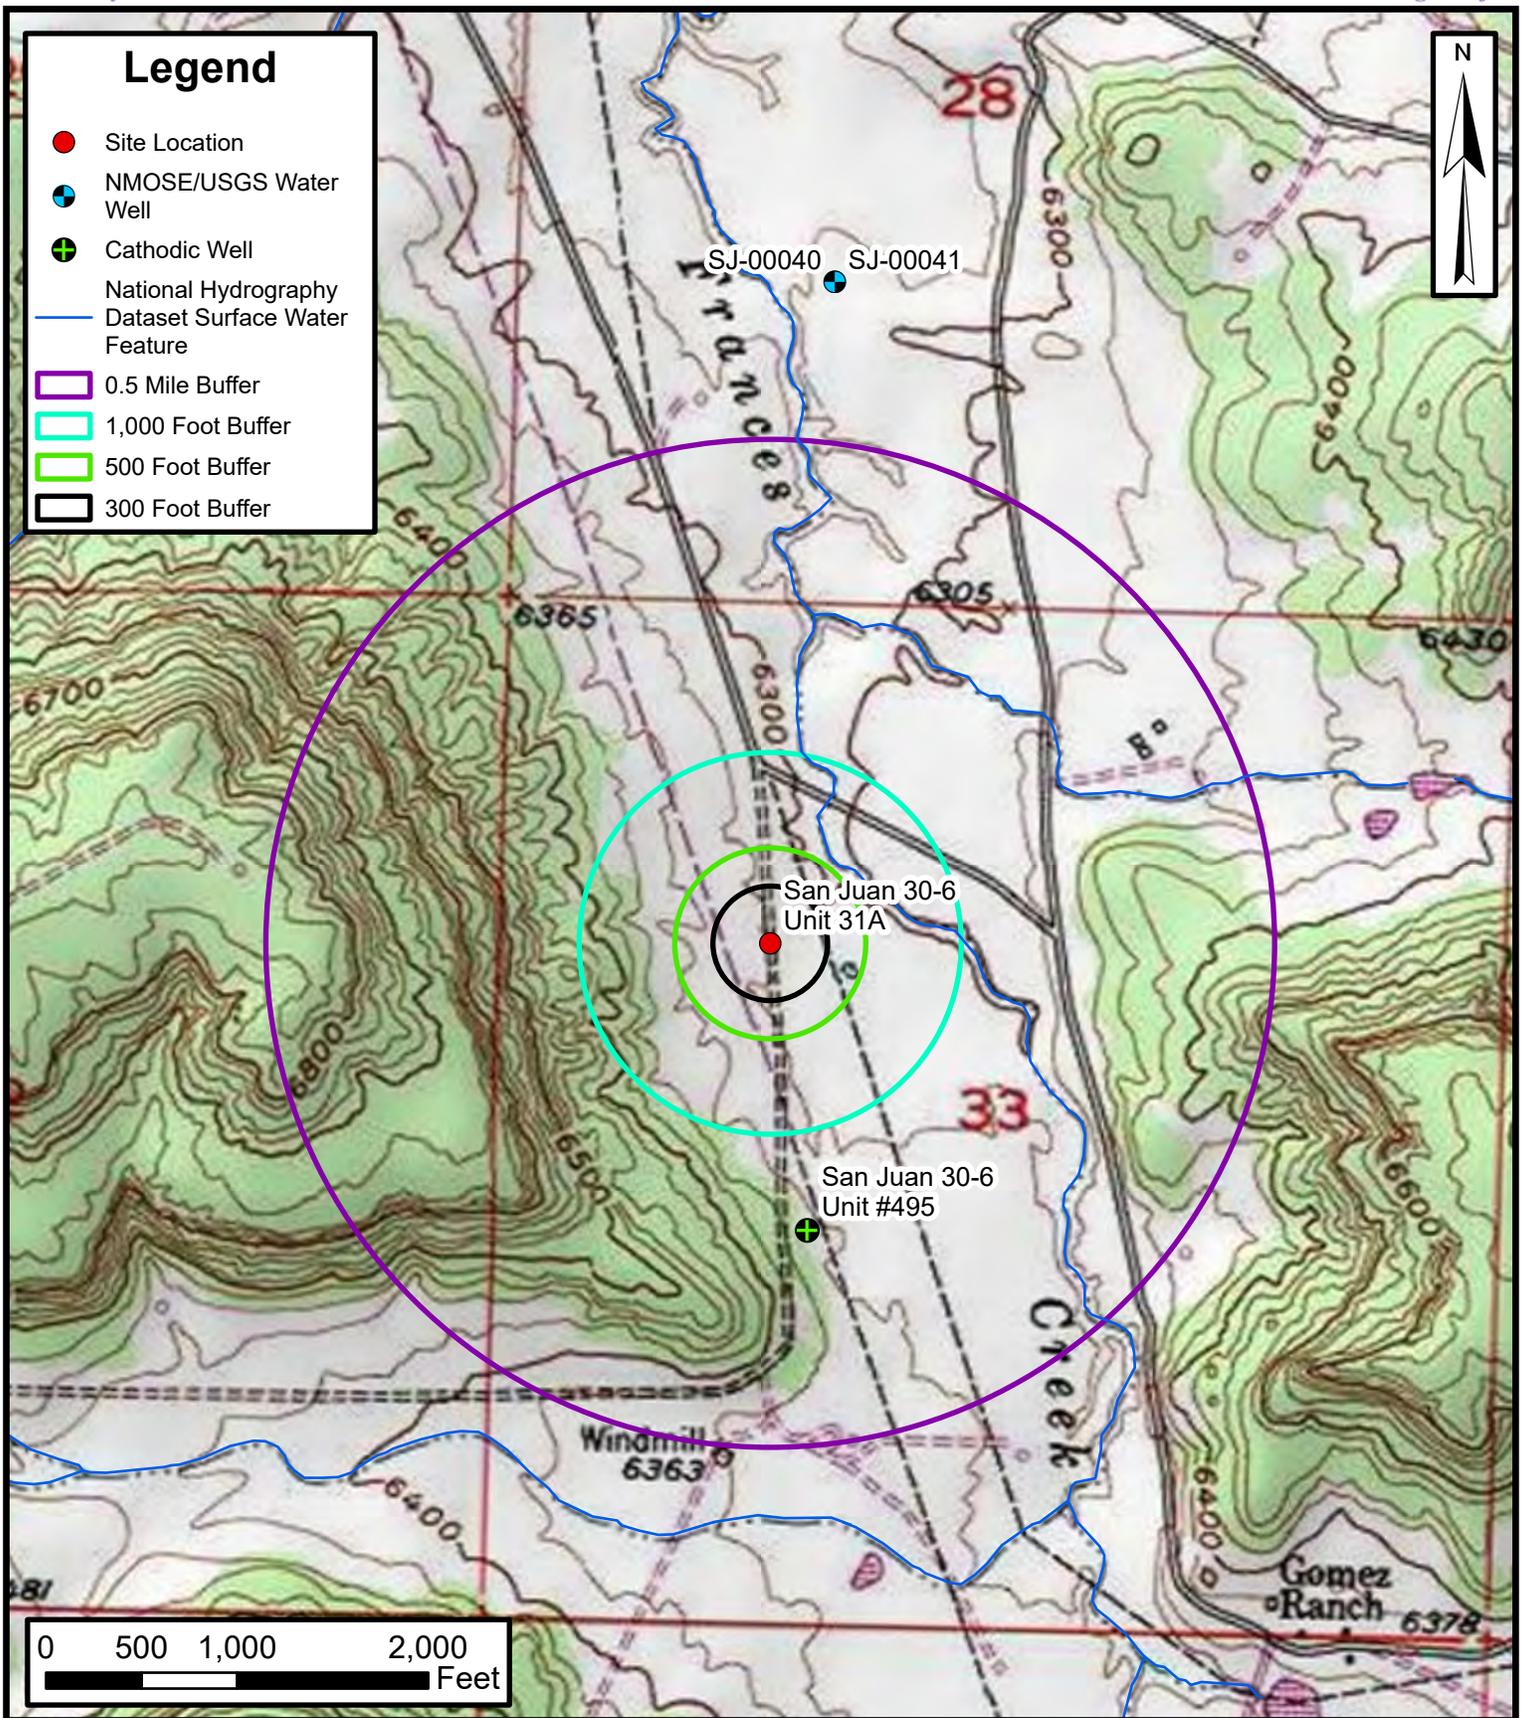
FIGURE
1

Site Receptor Map
San Juan 30-6 Unit 31A
Hilcorp Energy Company
Unit F, Sec 33, T30N, R06W
36.77139, -107.47258
Rio Arriba County, New Mexico

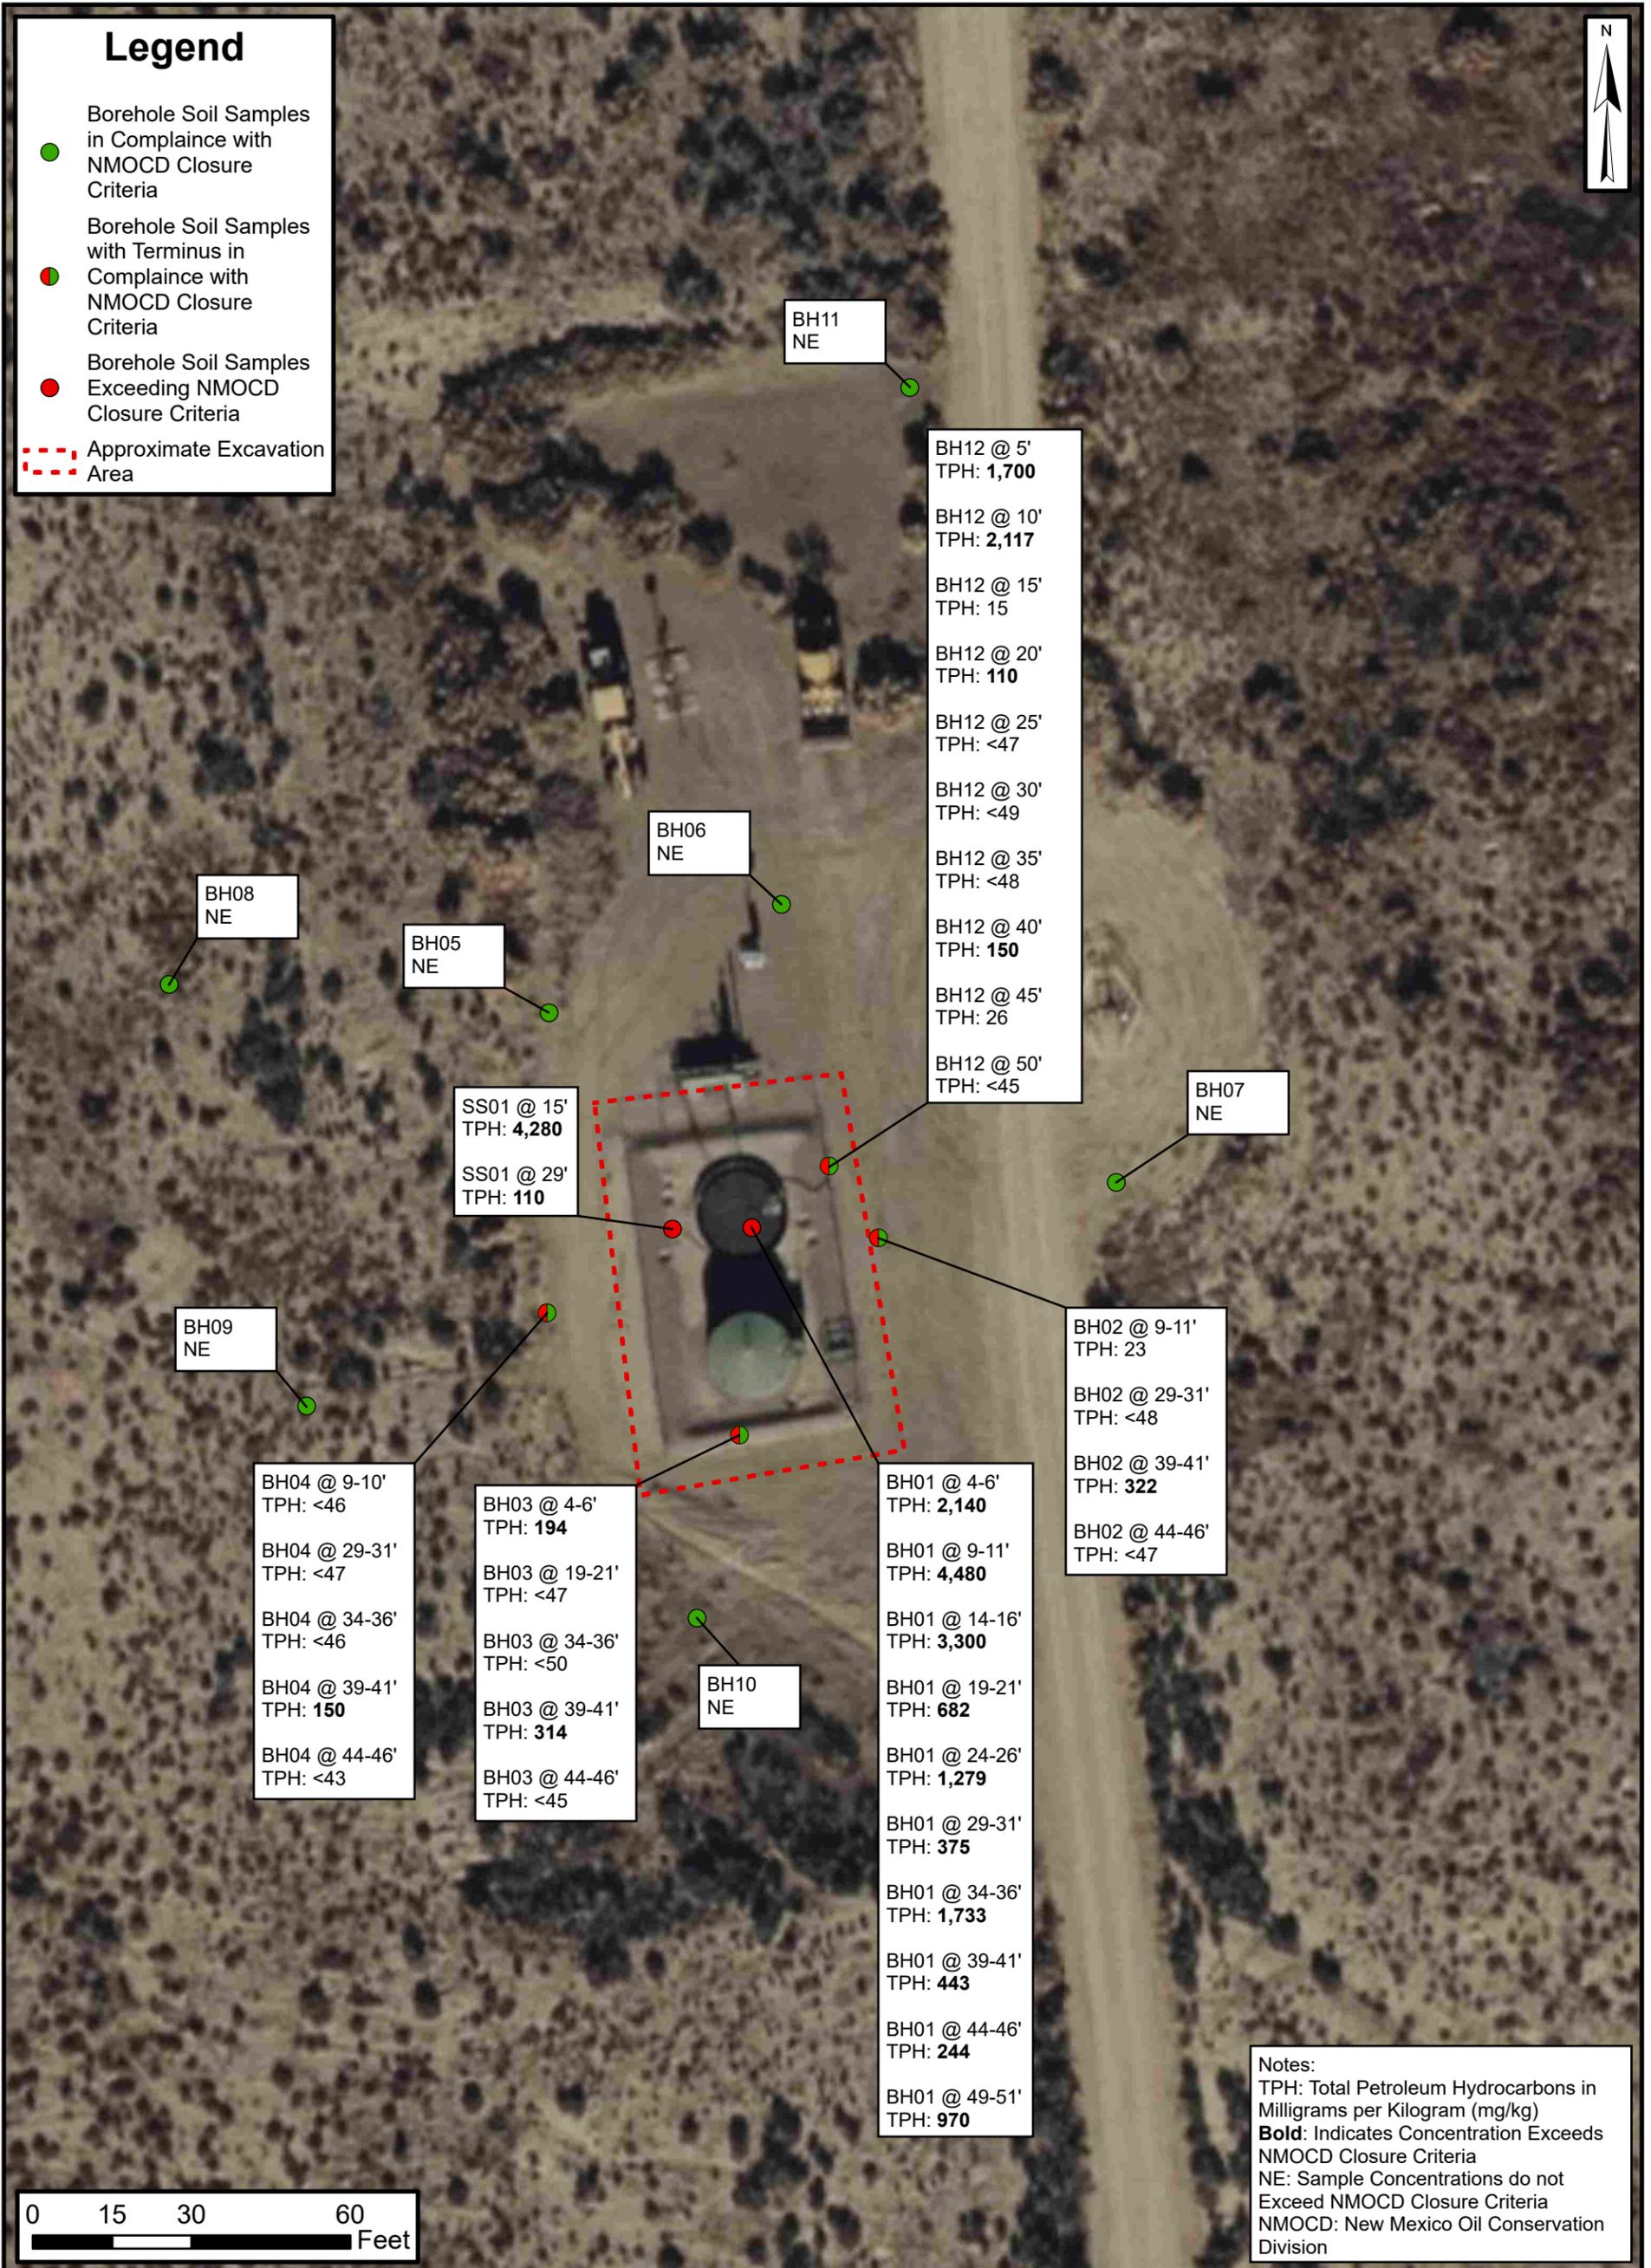
FIGURE
2

Delineation Soil Analytical Results

Soil composition at the Site generally consisted of silty/clayey sand containing lenses of silt and clay, underlain by silty clay and clay with varying quantities of fine-grained sand. Elevated PID values and field indications of petroleum hydrocarbons (including odors and/or staining) were only observed in borehole BH12 during the January 2024 drilling work. Concentrations of total BTEX and total TPH exceeding the NMOCD Table I Closure Criteria were detected at borehole BH12 between depths of 5 feet and 40 feet bgs. BTEX and TPH concentrations were compliant with applicable Closure Criteria in all samples collected from borings BH08 through BH11. Analytical laboratory results for delineation soil samples, including previously analyzed samples, are summarized in Table 1 and on Figure 2. Complete soil sample laboratory analytical reports are attached as Appendix D.

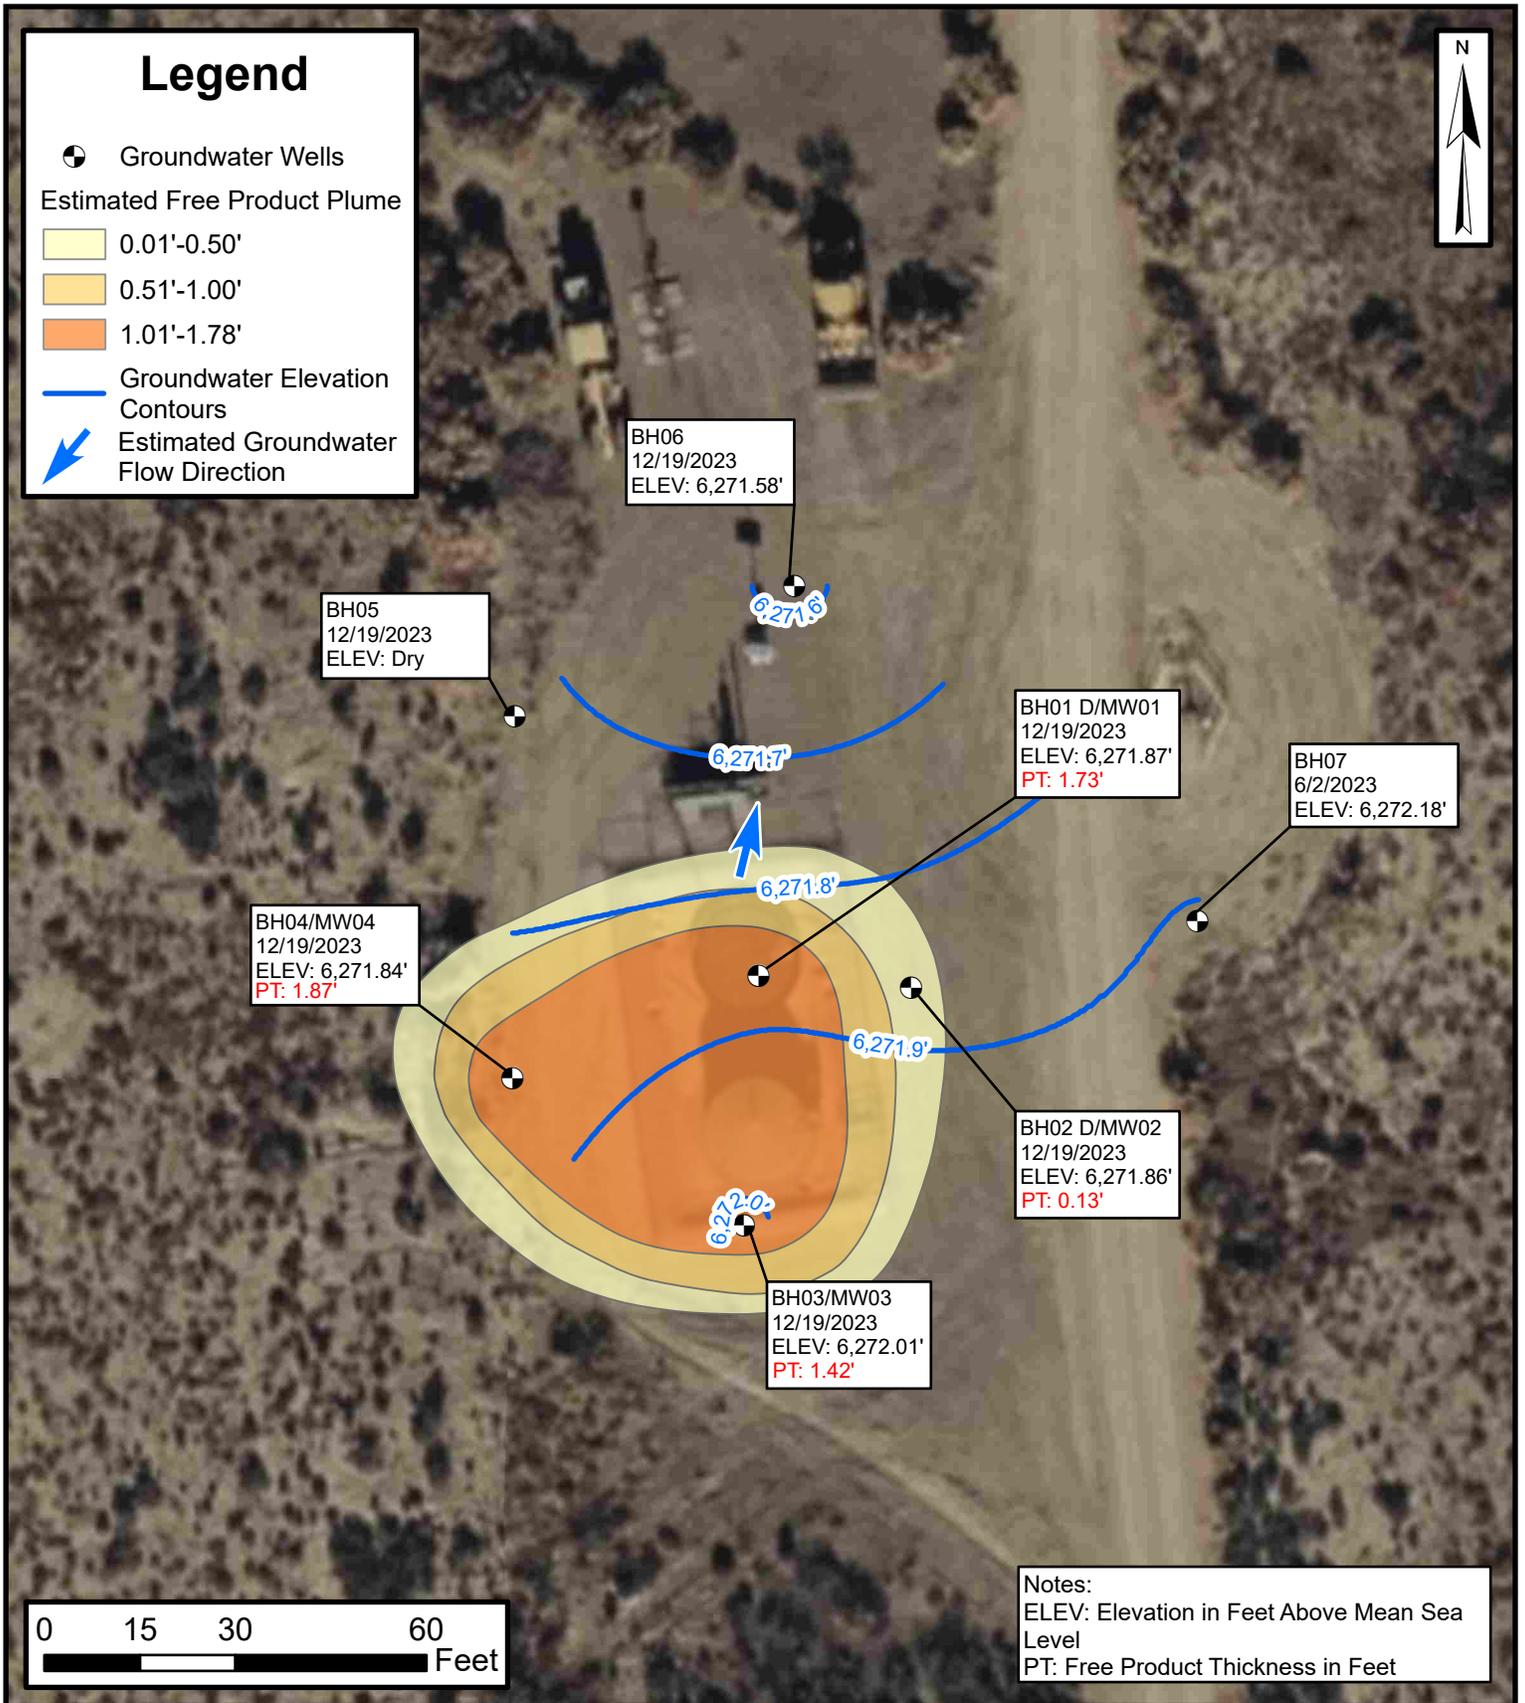
**FIGURE
3**

**Groundwater Potentiometric Surface Map
(December 2023)**
 San Juan 30-6 Unit 31A
 Hilcorp Energy Company
 Unit F, Sec 33, T30N, R06W
 36.77139, -107.47258
 Rio Arriba County, New Mexico

Initial groundwater conditions were assessed at the Site on June 2, 2023. Quarterly groundwater sampling began in December 2023 and samples were collected in December 2023, January 2024, and May 2024. Prior to sampling, depth to PSH and depth to groundwater were measured in all wells using an oil/water interface probe in order to calculate groundwater elevations and assess the inferred groundwater flow direction. During all sampling events, wells MW01, MW02, MW03, MW04, and MW12 contained measurable or trace volumes of PSH. When PSH was present, a correction factor of 0.8 was applied to the elevation to account for the depression of the water column caused by the presence of overlying PSH. Additionally, monitoring well MW05 has been dry during all sampling events and not sampled. As previously noted, the total depth of well MW05 is approximately 5 feet higher in elevation than indicated on the borehole log. It appears the borehole caved in as the augers were removed and the well screen was unable to be installed at the terminus of the borehole. Table 3 presents a summary of groundwater elevations and thickness of PSH measured at the Site. Potentiometric surface maps with calculated groundwater elevations and inferred groundwater flow direction are shown on Figures 3, 4, and 5.

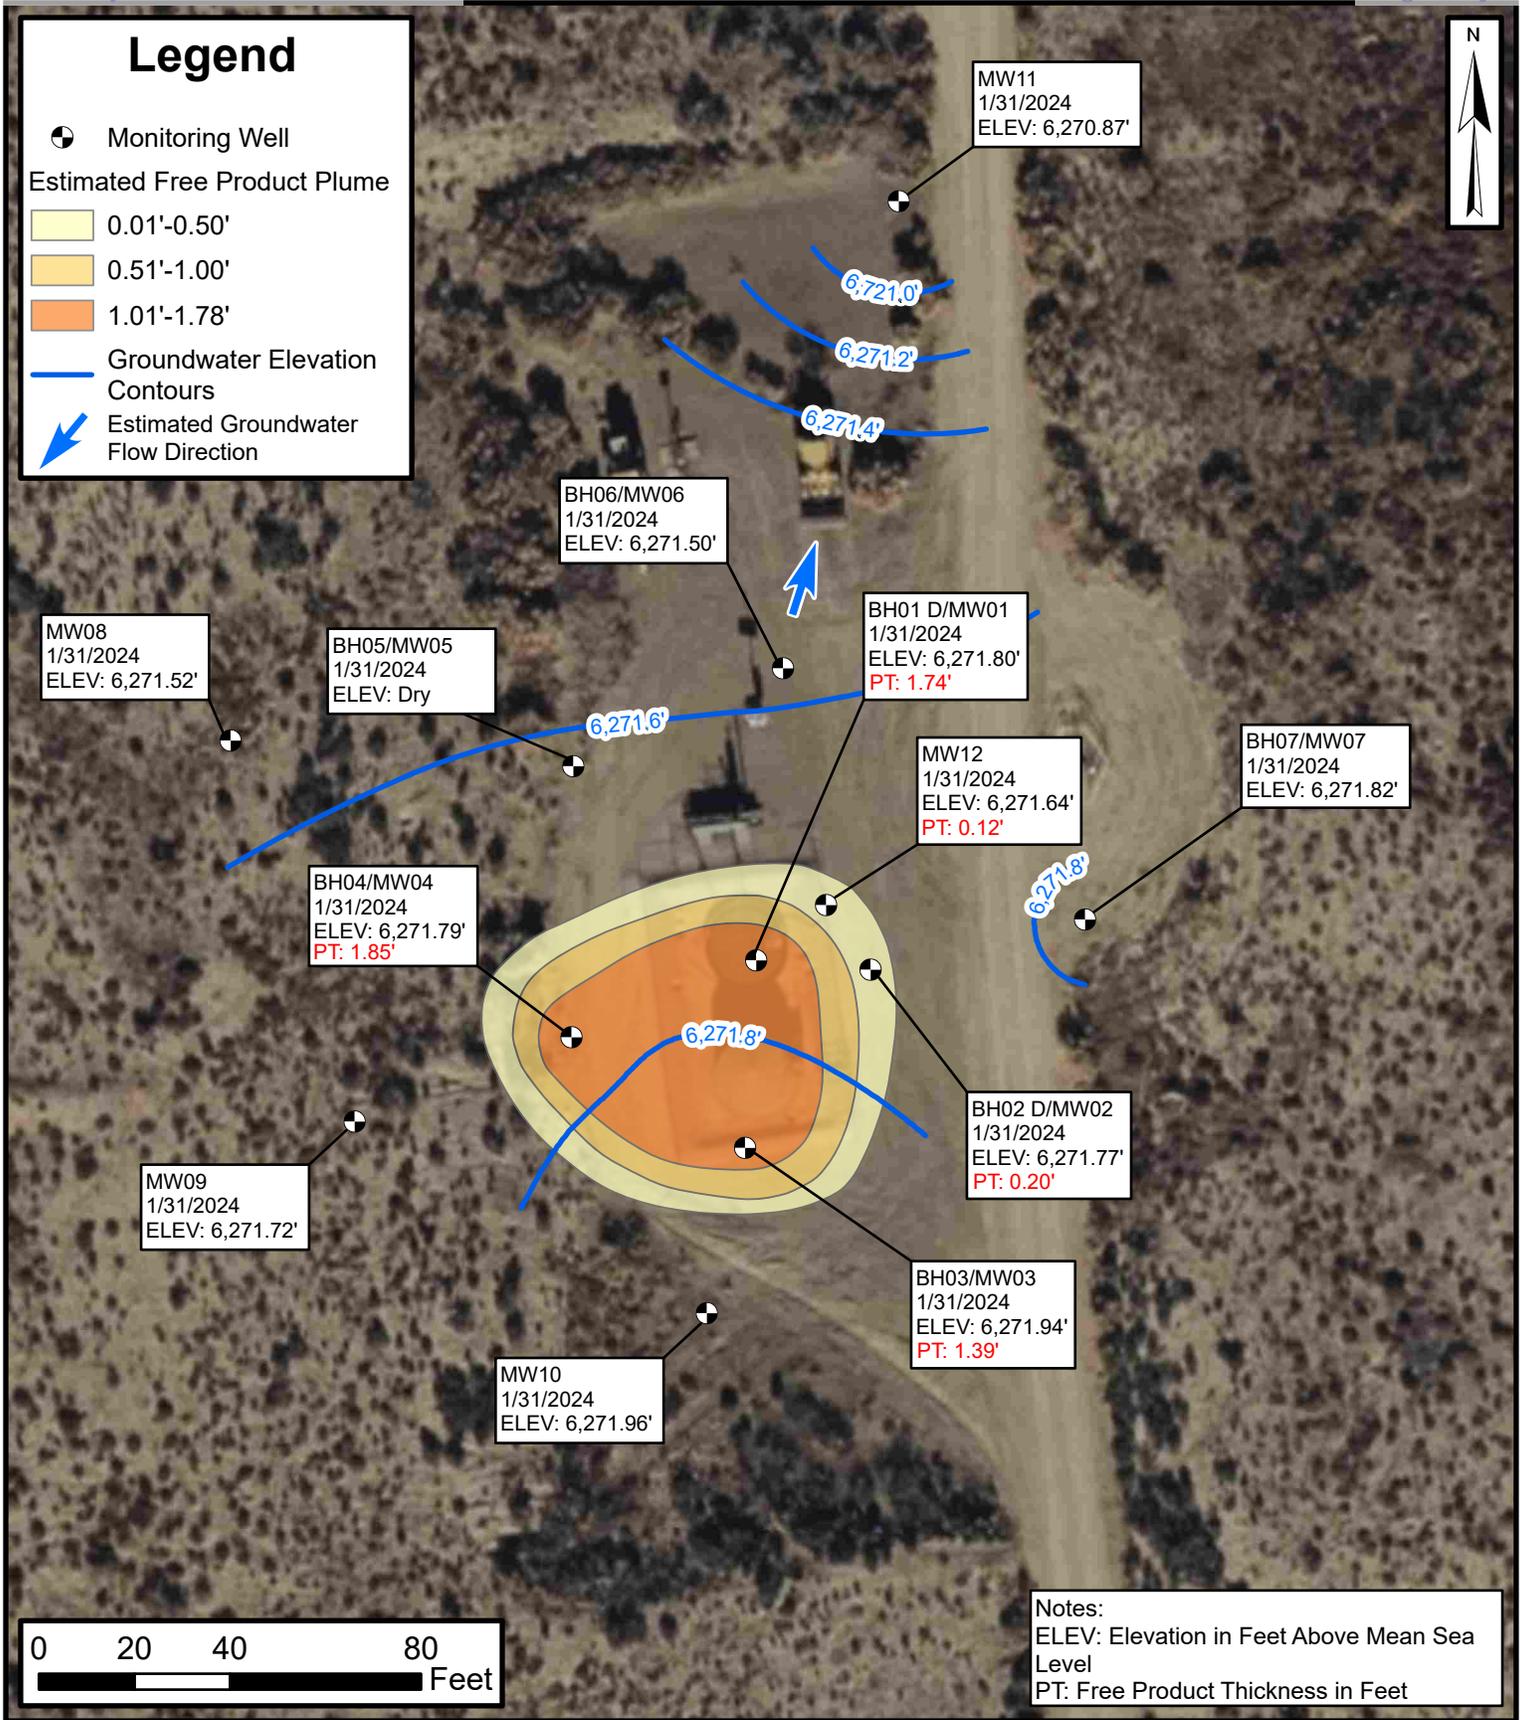
FIGURE 4

Groundwater Potentiometric Surface Map (January 2024)
 San Juan 30-6 #31A
 Hilcorp Energy Company
 Unit F, Sec 33, T30N, R06W
 36.77139, -107.47258
 Rio Arriba County, New Mexico

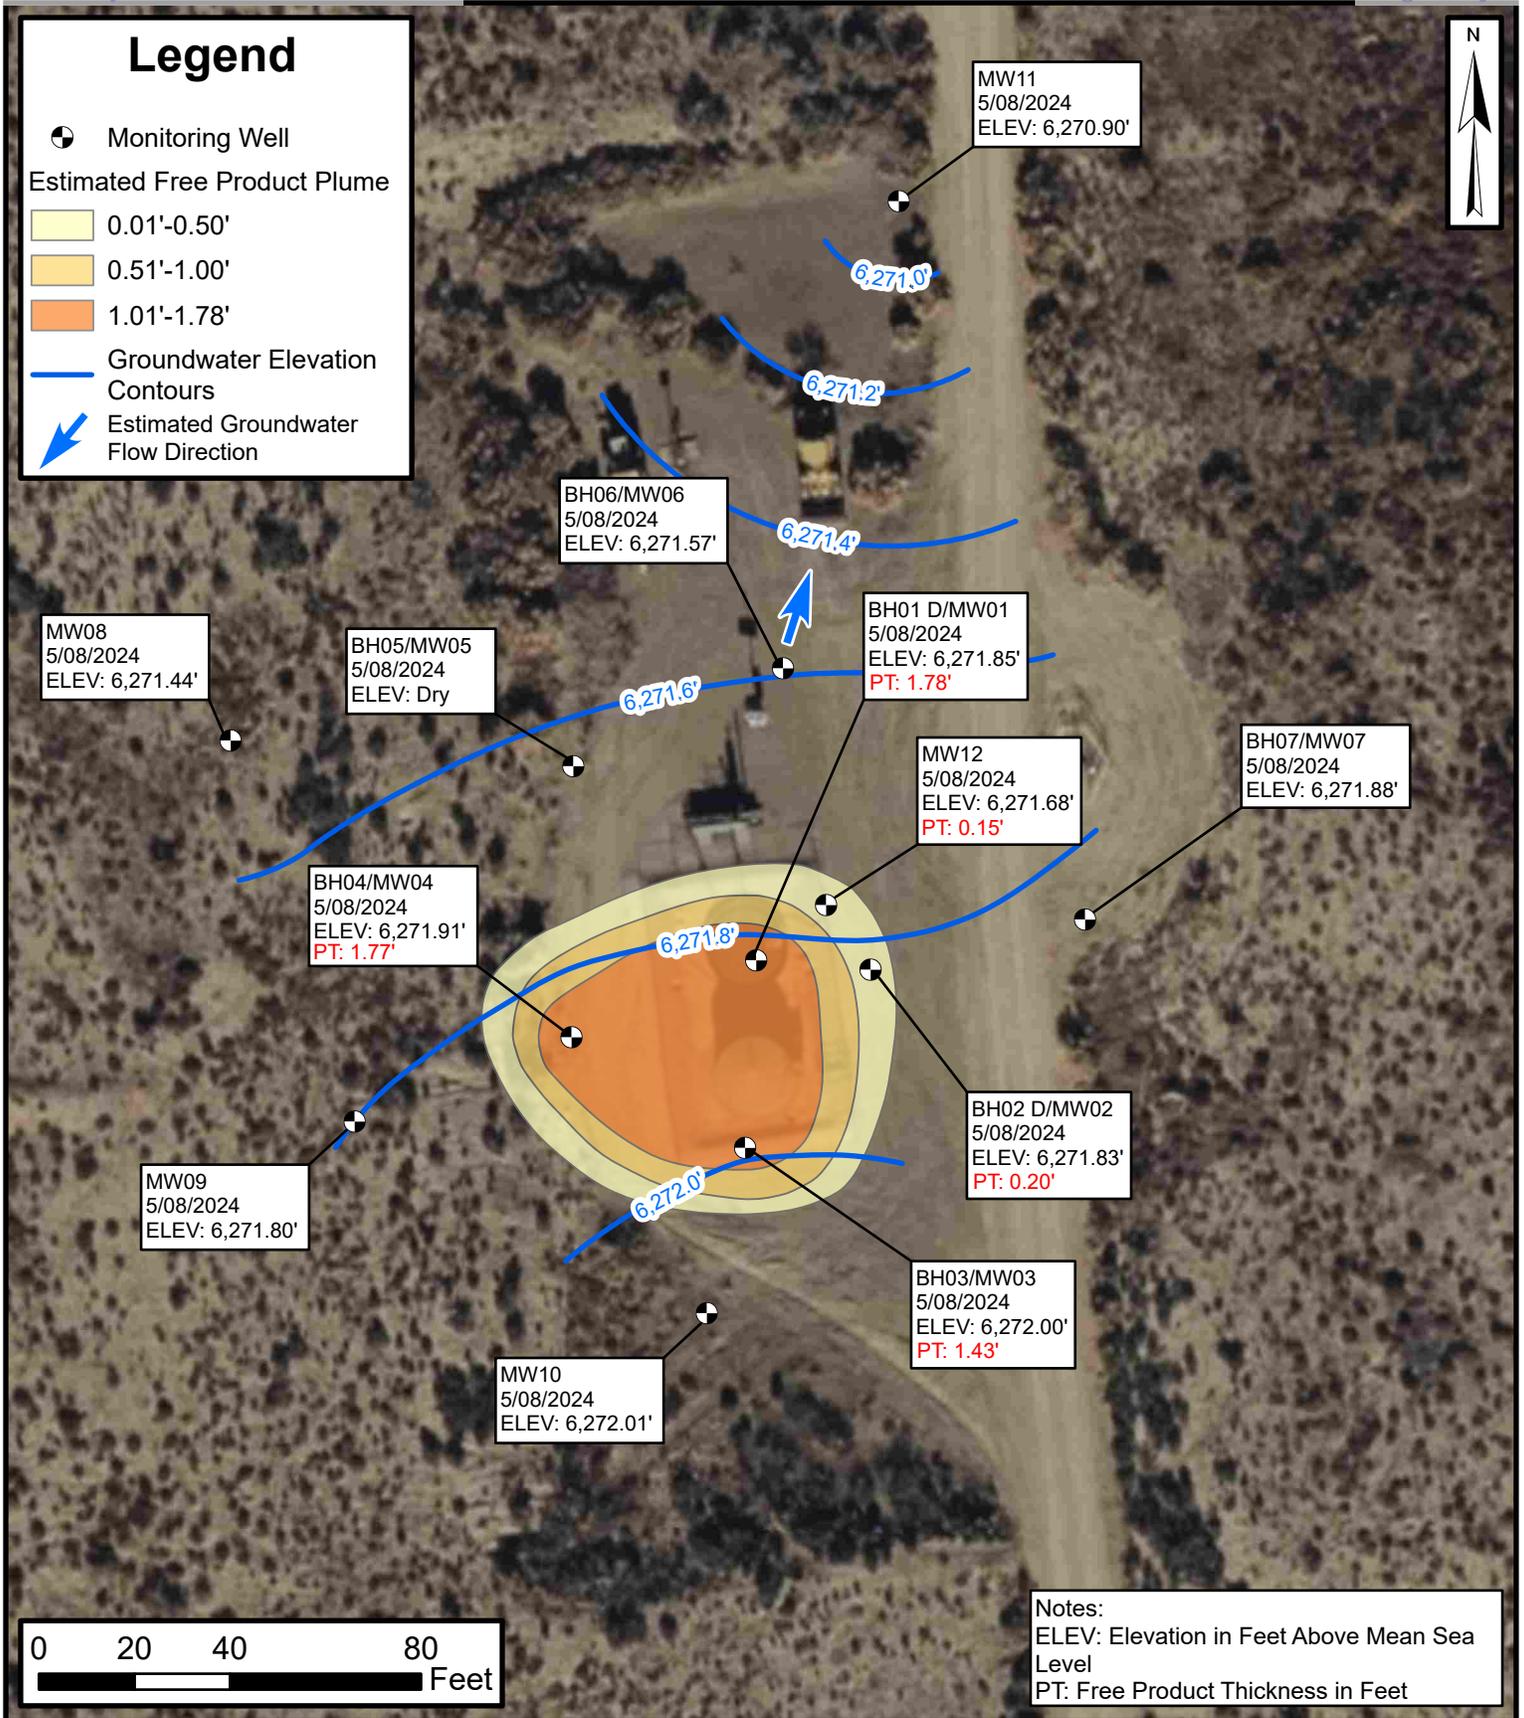
FIGURE
5

Groundwater Potentiometric Surface Map (May 2024)

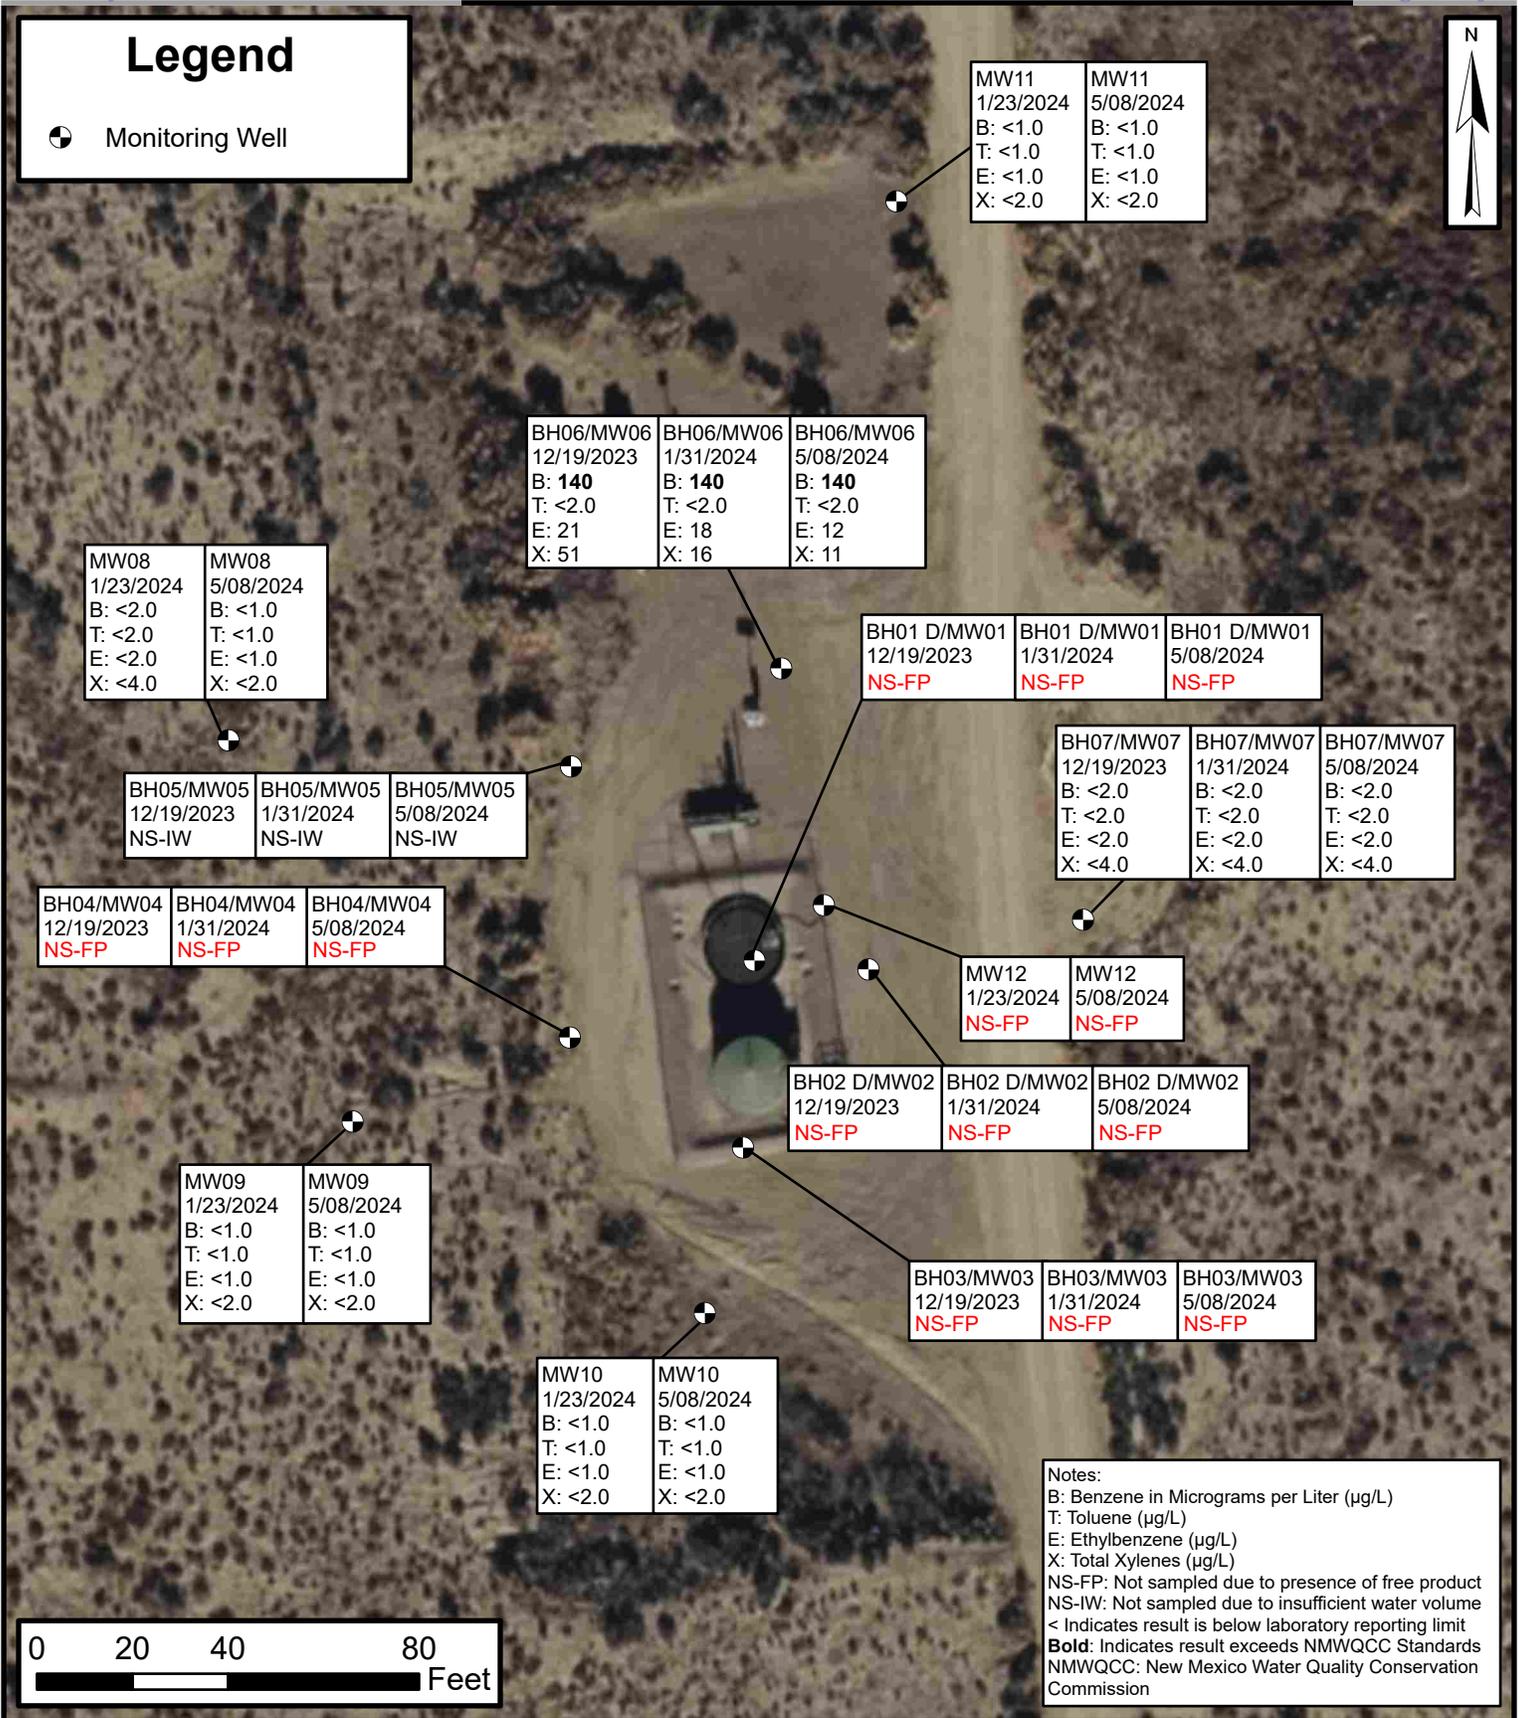
FIGURE
6

Groundwater Analytical Results

Analytical results from groundwater samples indicated benzene concentrations exceeded the NMWQCC standard in well MW06 during the December 2023, January 2024, and May 2024 sampling events. All other concentrations of BTEX constituents from analyzed samples from wells MW07, MW08, MW09, MW10, and MW11 were compliant with the applicable NMWQCC standards during all sampling events. A summary of groundwater analytical results is presented in Table 4 and on Figure 6. Complete laboratory analytical reports are attached in Appendix F.
