**Re: Closure Request
PLU 20 Brushy Draw CTB
Incident Number NAPP2402643356
Eddy County, New Mexico**

XTO Energy, Inc
Closure Request
PLU 20 Brushy Draw CTB

XTO Energy, Inc
PLU 20 Brushy Draw CTB
Incident Number: NAPP2402643356
Unit L, Sec 20, T25S, R30E
Eddy County, New Mexico

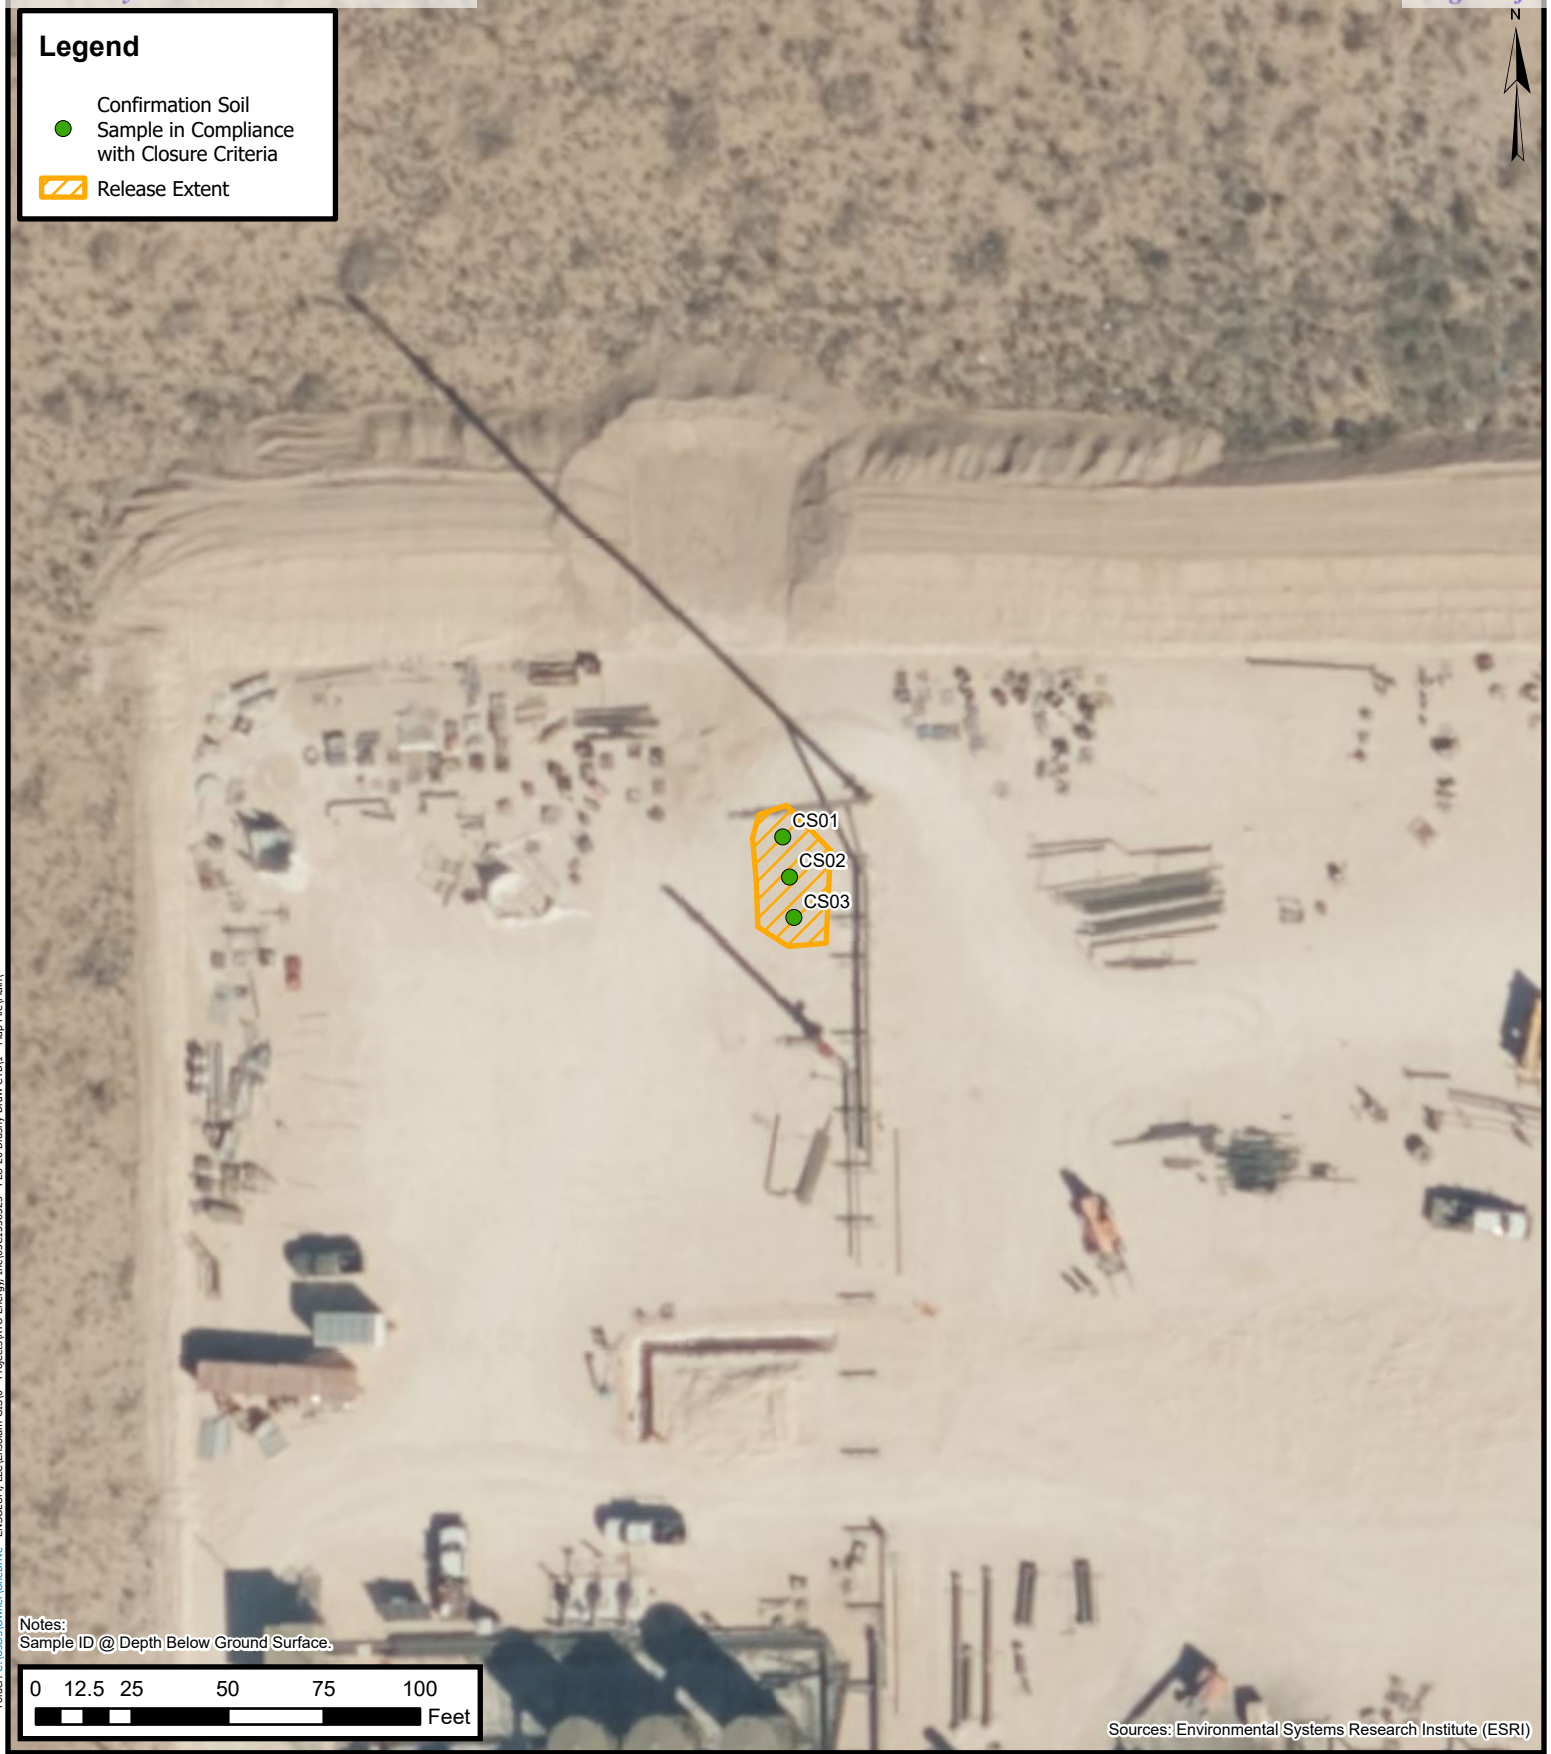
FIGURE
2

On July 10, 2024, following confirmed access to the Site, Ensolum personnel returned to the Site. The scorched soil was scraped and removed from the release extent. Following the scrape, 5-point composite soil samples were collected at least every 200 square feet within the release extent. The 5-point composite samples were collected by placing five equivalent aliquots of soil into a 1-gallon, resealable plastic bag and homogenizing the samples by thoroughly mixing. Three confirmation soil samples, CS01 through CS03, were collected within the release extent at 0.3 feet bgs, to confirm the absence of impacted soil. The confirmation soil samples were field screened for volatile organic compounds (VOCs) utilizing a calibrated photoionization detector (PID) and chloride utilizing Hach® chloride QuanTab® test strips. The soil sample locations were mapped utilizing a handheld GPS unit and the release extent and soil sample locations are depicted in Figure 2.

Confirmation Soil Sample Locations

Laboratory analytical results for confirmation soil samples CS01 through CS03 indicated that all COC concentrations were compliant with the Site Closure Criteria and the strictest Table I Closure Criteria. Laboratory analytical results are summarized in Table 1 and the complete laboratory analytical reports are included as Appendix D.

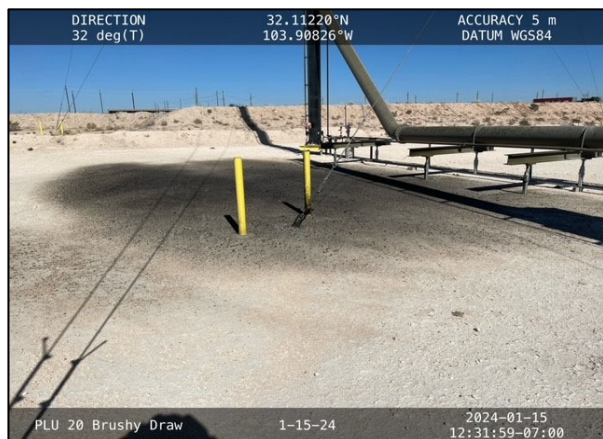
Photograph: 1 Date: 1/15/2024
Description: Scorching soil from fire
View: Northwest

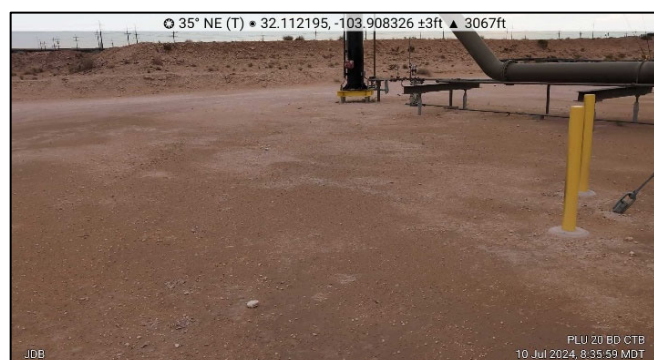
Photograph: 3 Date: 7/10/2024
Description: Confirmation soil sampling activities following removal of scorching soil
View: Northeast

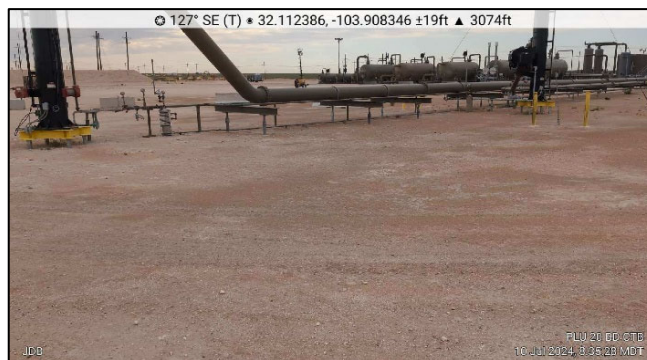
Photograph: 4 Date: 7/10/2024
Description: Confirmation soil sampling activities following removal of scorching soil
View: Southeast
