Incident ID	nAPP2225255046
District RP	
Facility ID	
Application ID

Based on laboratory analytical results and field activities conducted to date, Etech recommends Mewbourne Oil Company, provide copies of this *Remediation Summary & Soil Closure Request* to the appropriate agencies and request closure be granted to the Wellspring Paduca release site.

Figure 1
 Topographic Map
 Mewbourne Oil Company
 Wellspring Paduca SWD Booster
 GPS: 32.072257, -103.718906
 Lea County

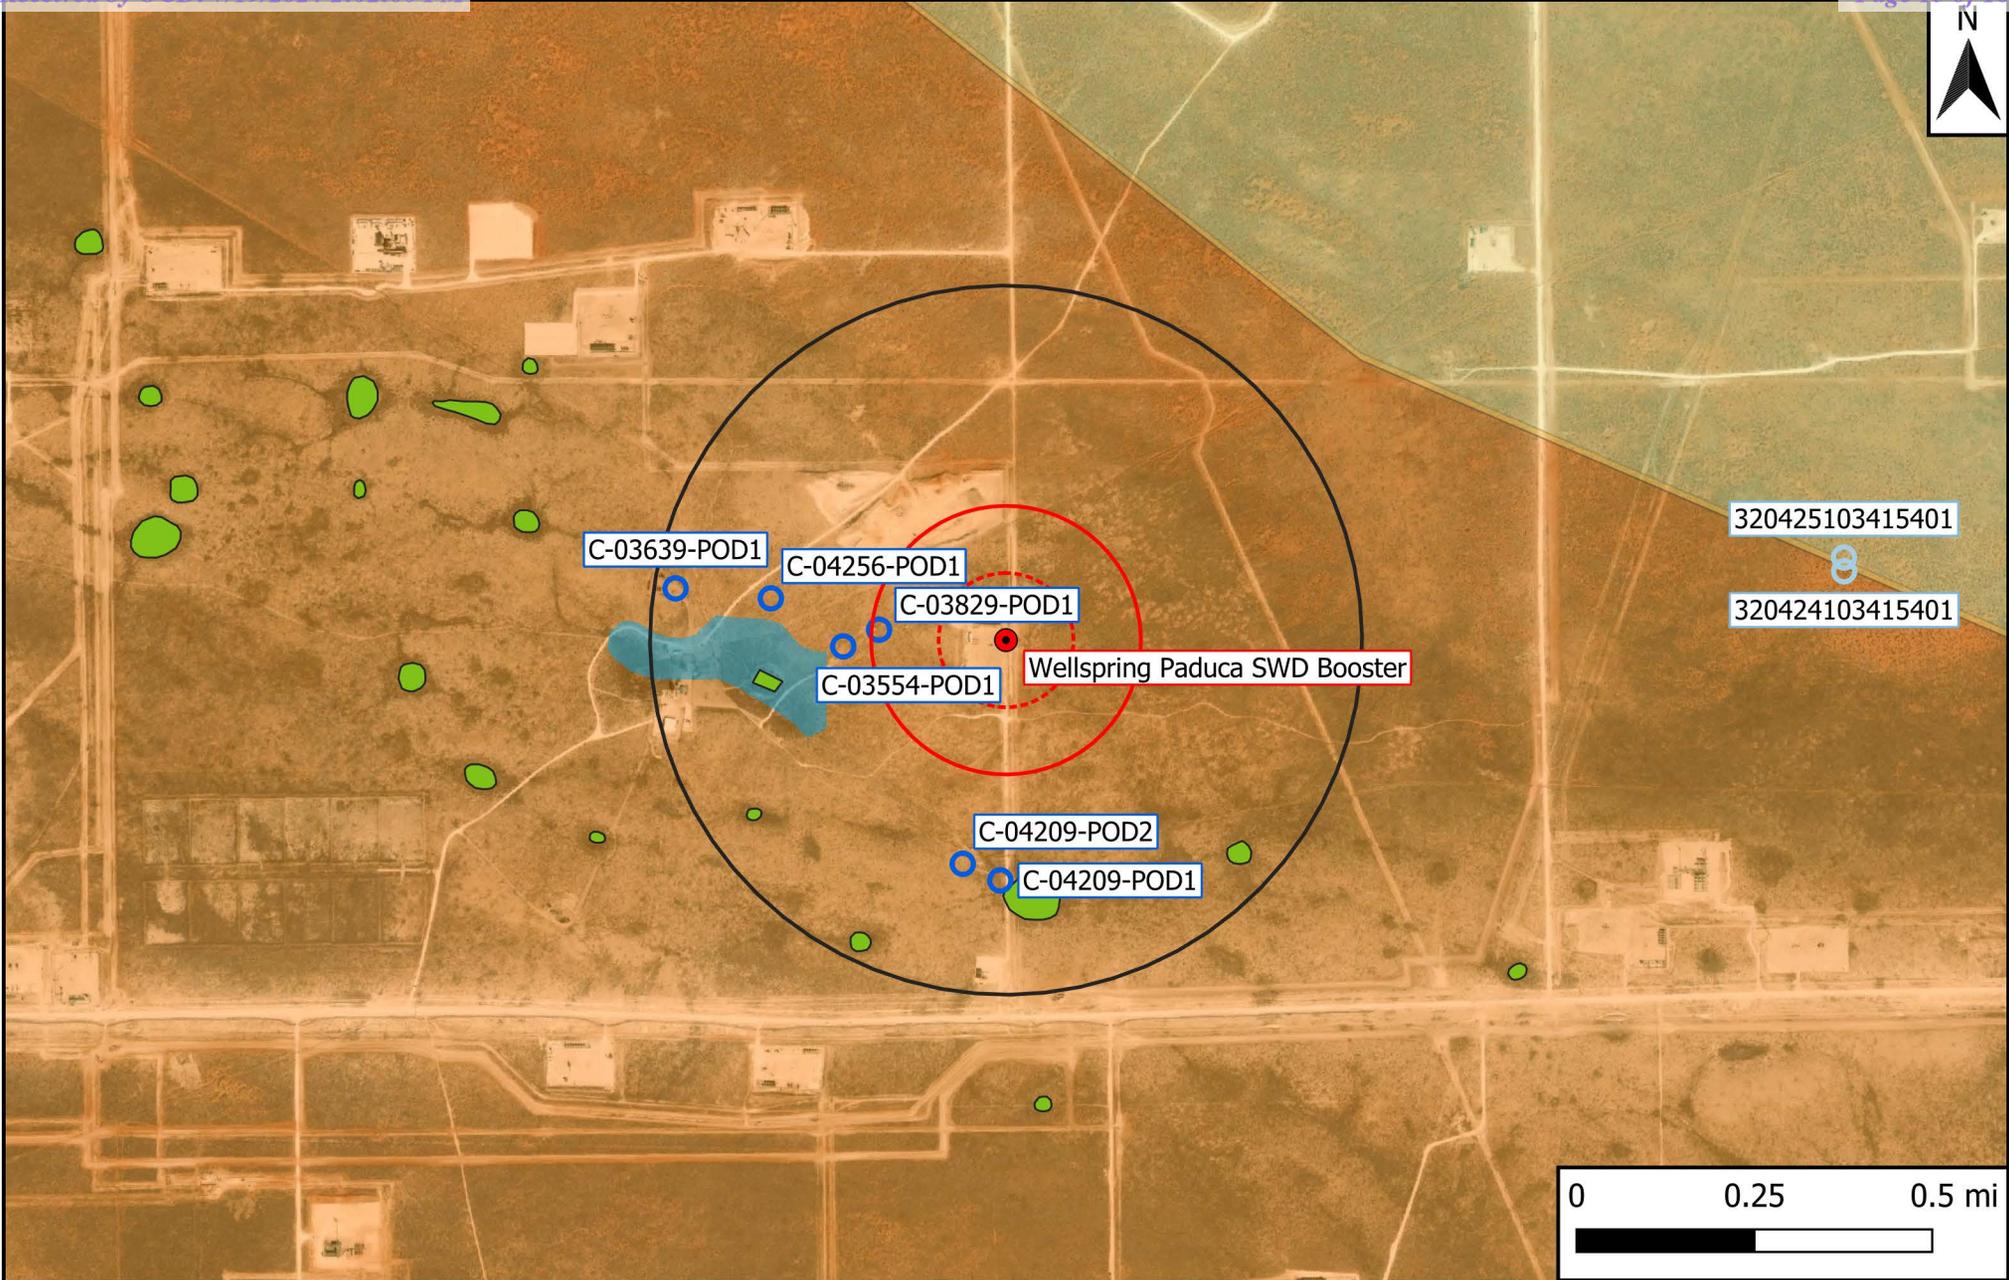
Figure 2
 Site Characterization Map
 Mewbourne Oil Company
 Wellspring Paduca SWD Booster
 GPS: 32.072257, -103.718906
 Lea County

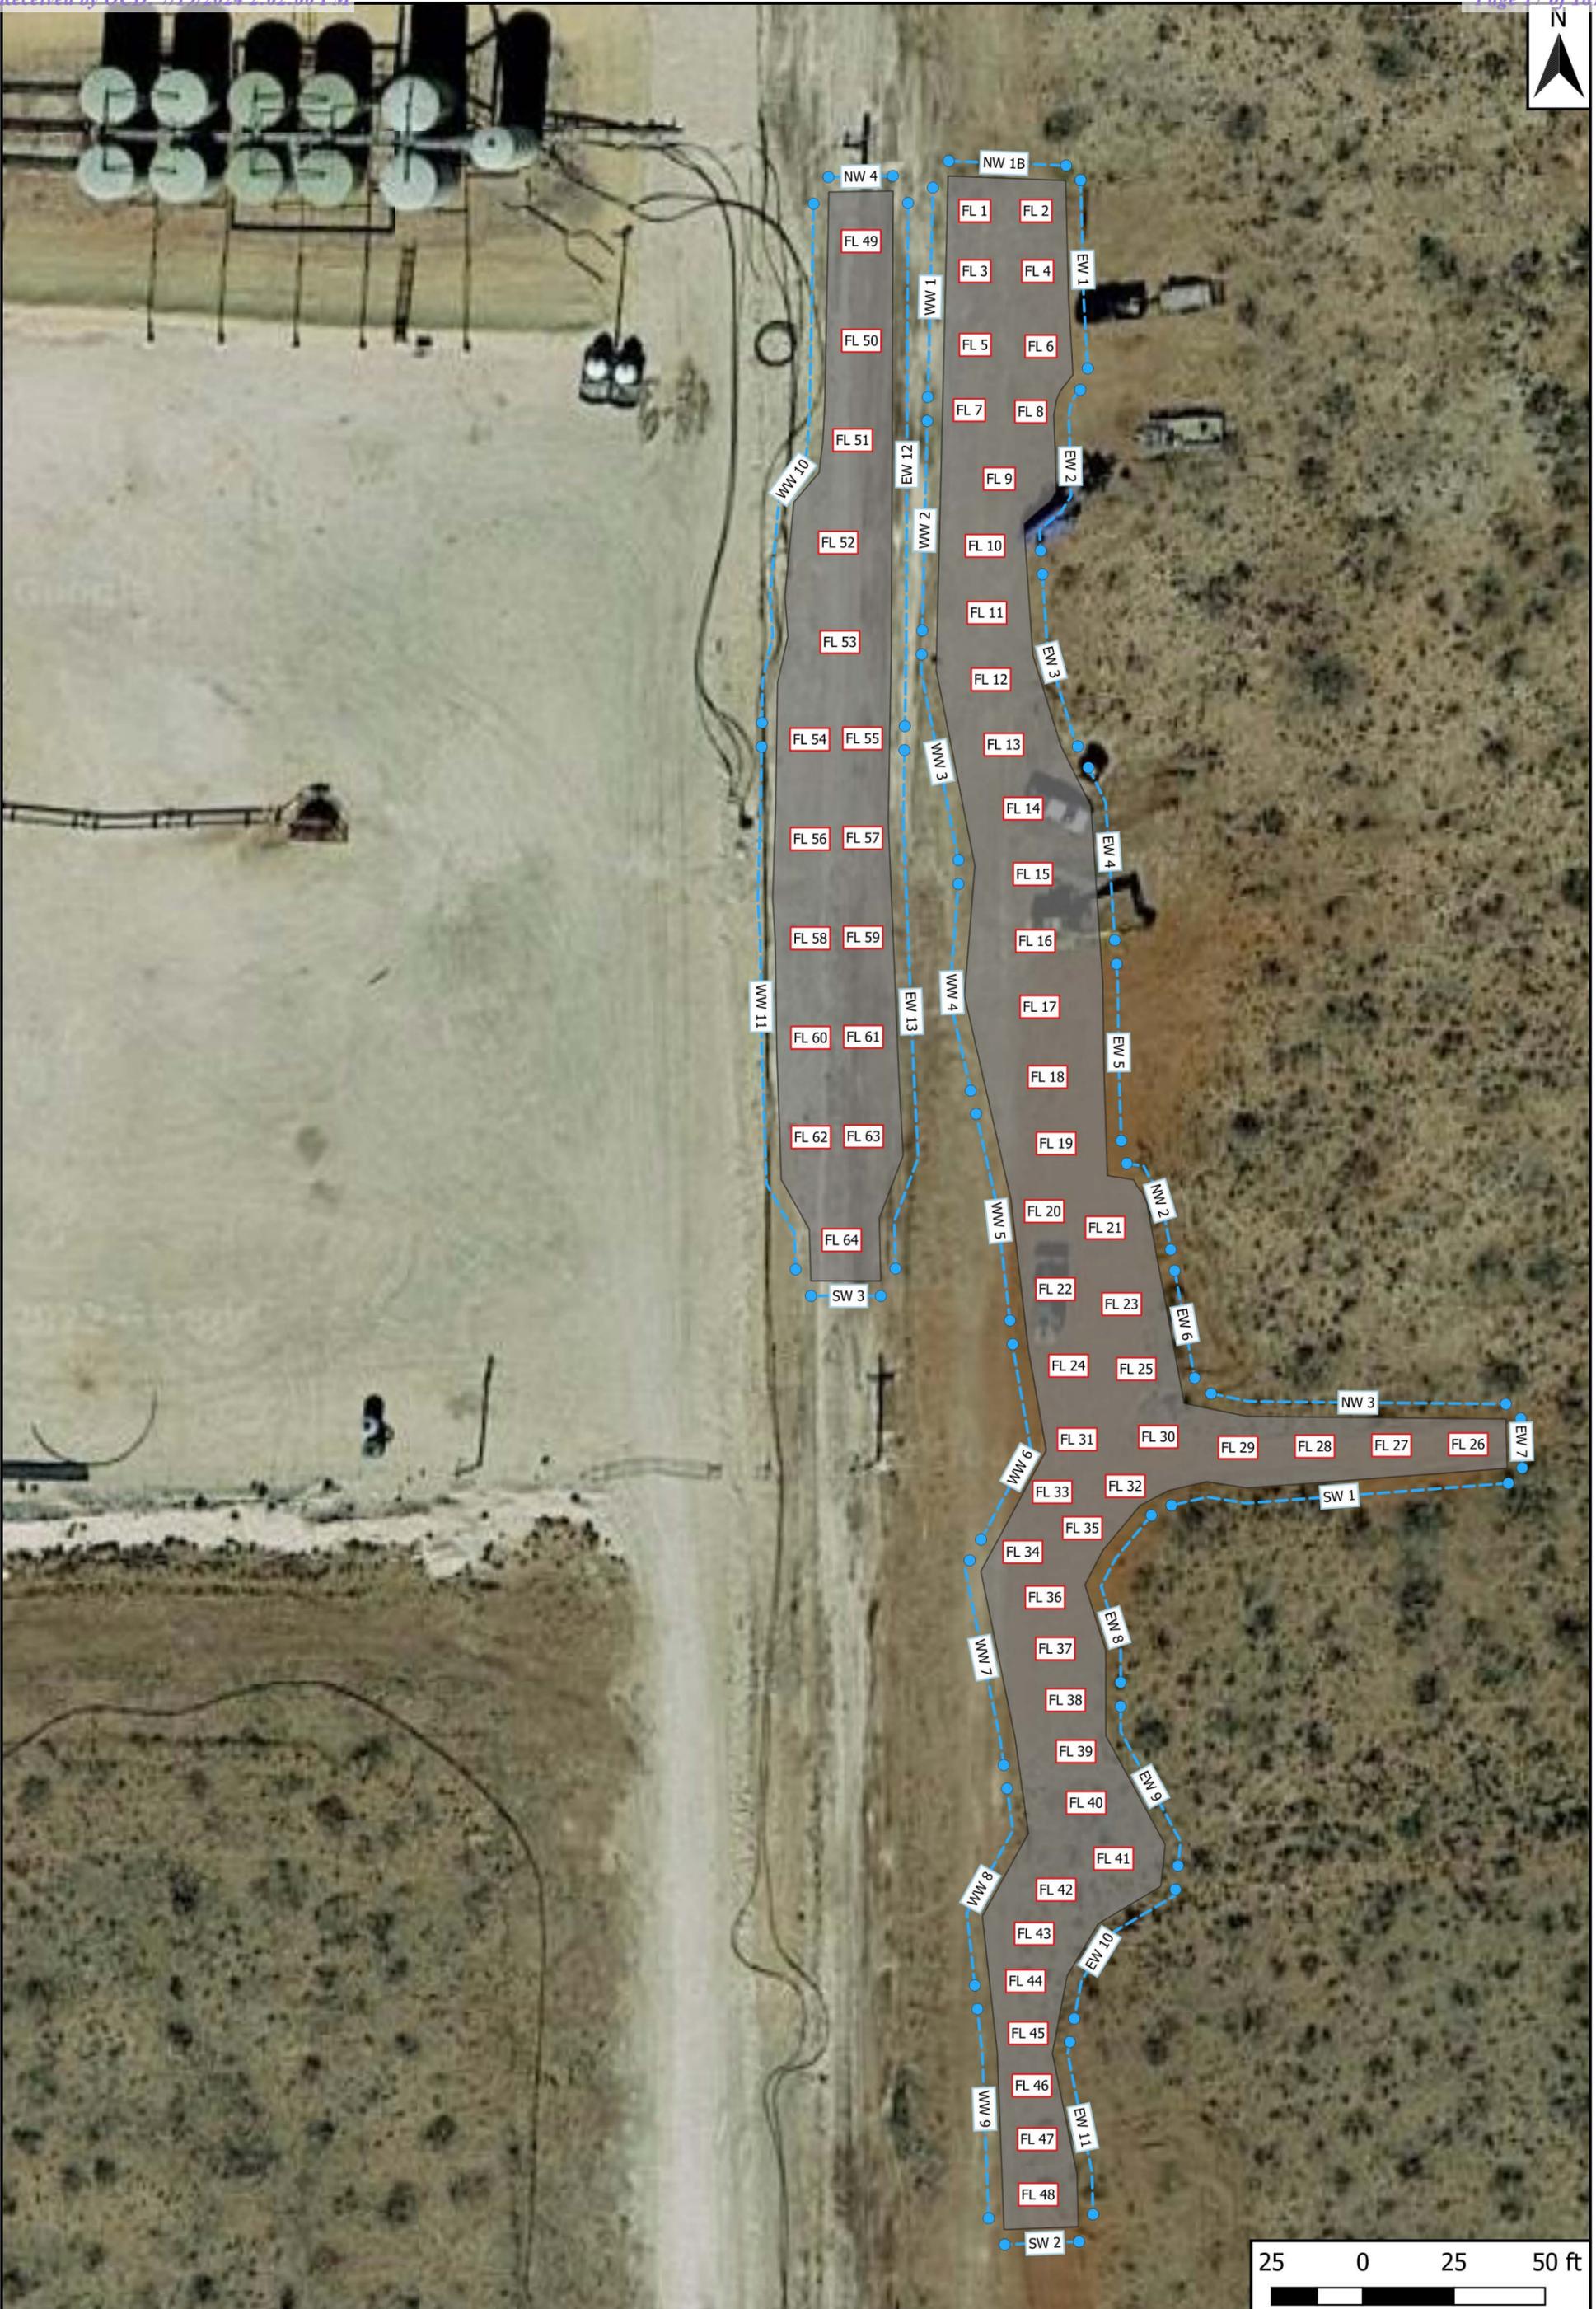
Site & Sample Location Map

Figure 3
 Site & Sample Location Map
 Mewbourne Oil Company
 Wellspring Paduca SWD Booster
 GPS: 32.072257, -103.718906
 Lea County

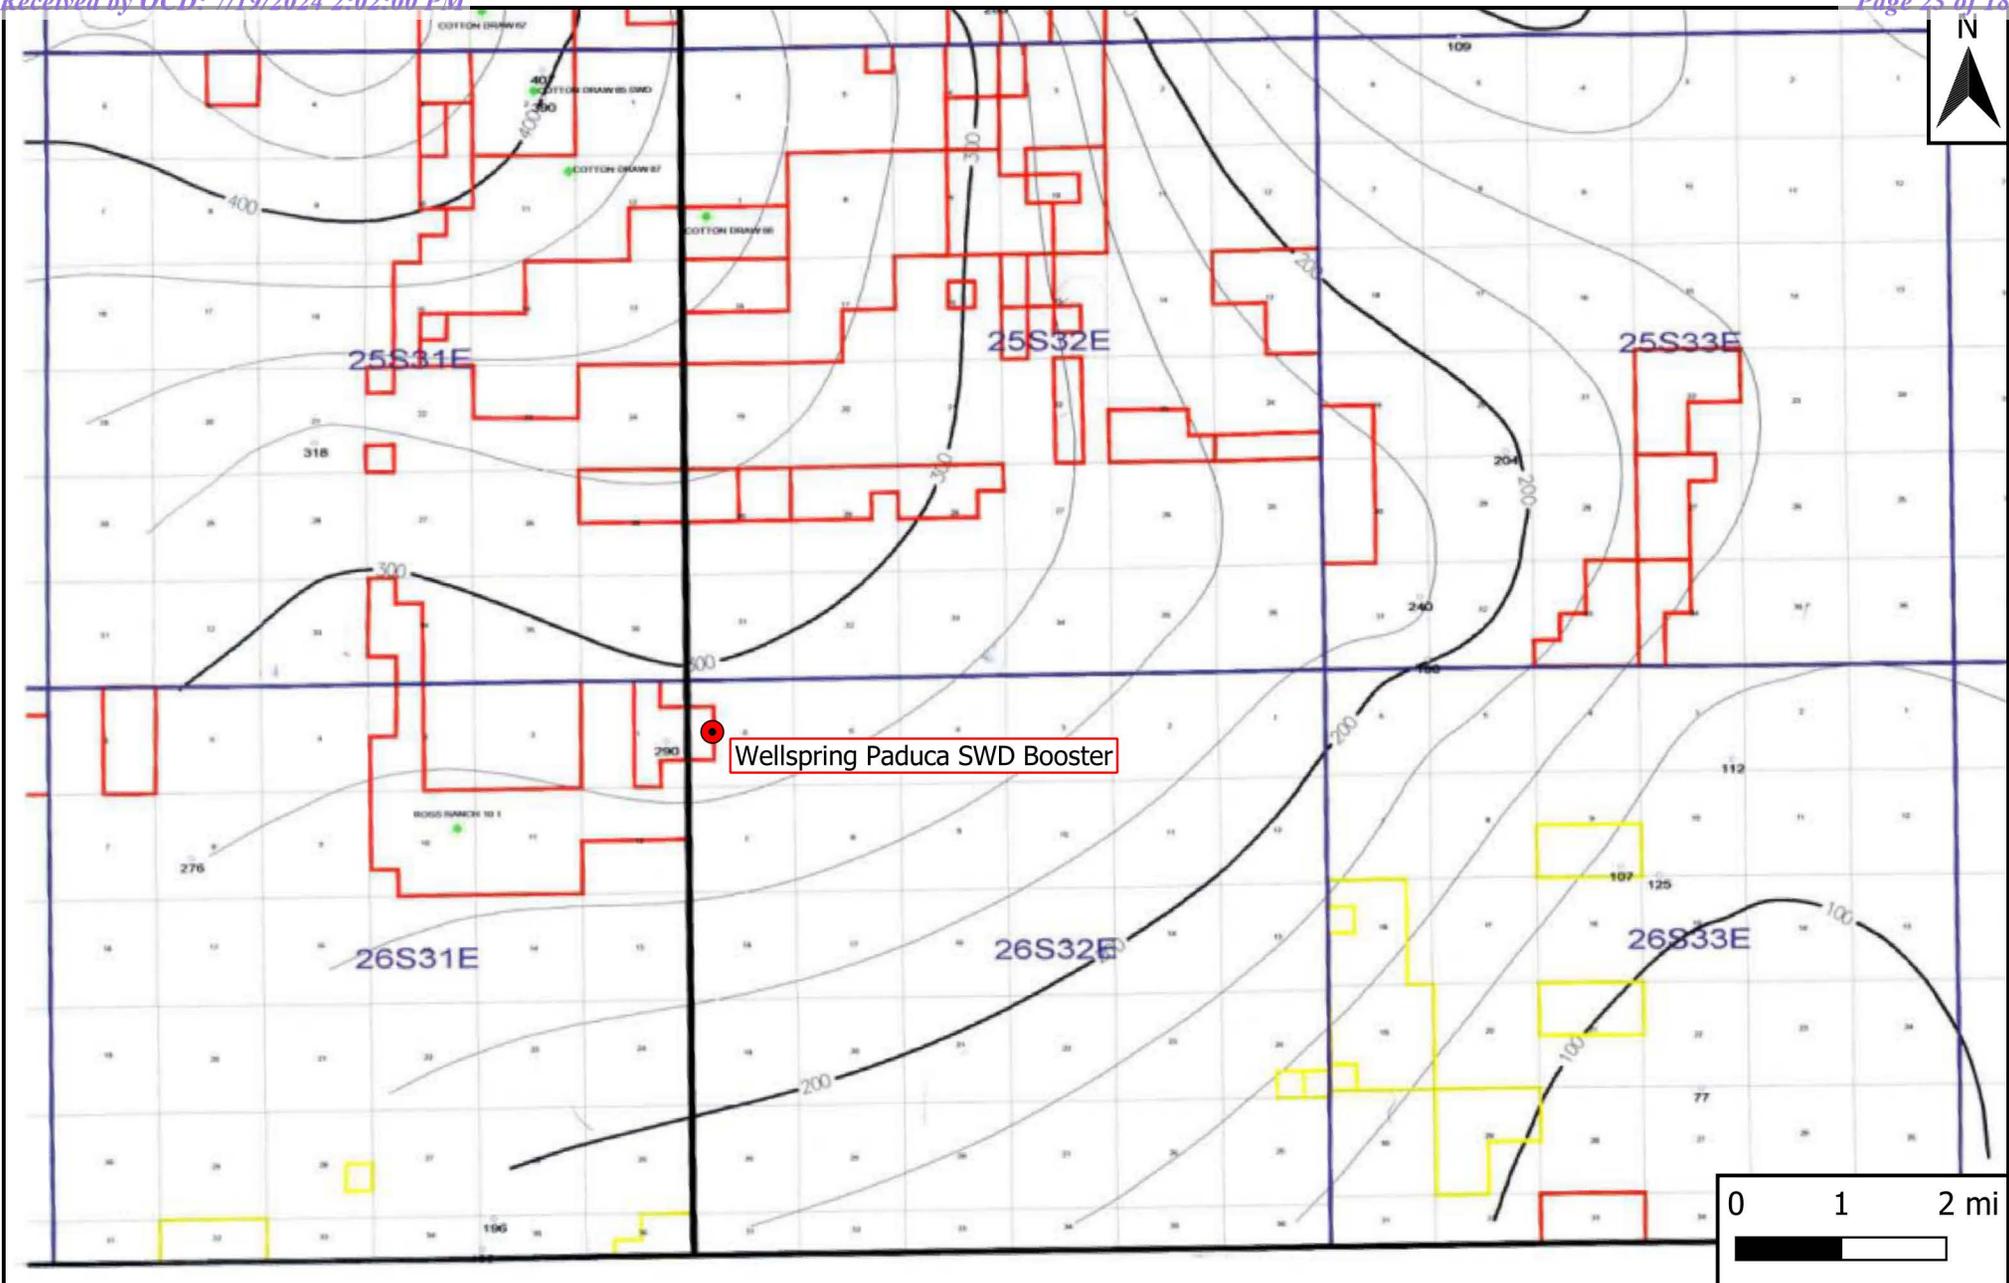
Figure 4
 Inferred Depth to Groundwater Trend Map
 Mewbourne Oil Company
 Wellspring Paduca SWD Booster
 GPS: 32.072257, -103.718906
 Lea County

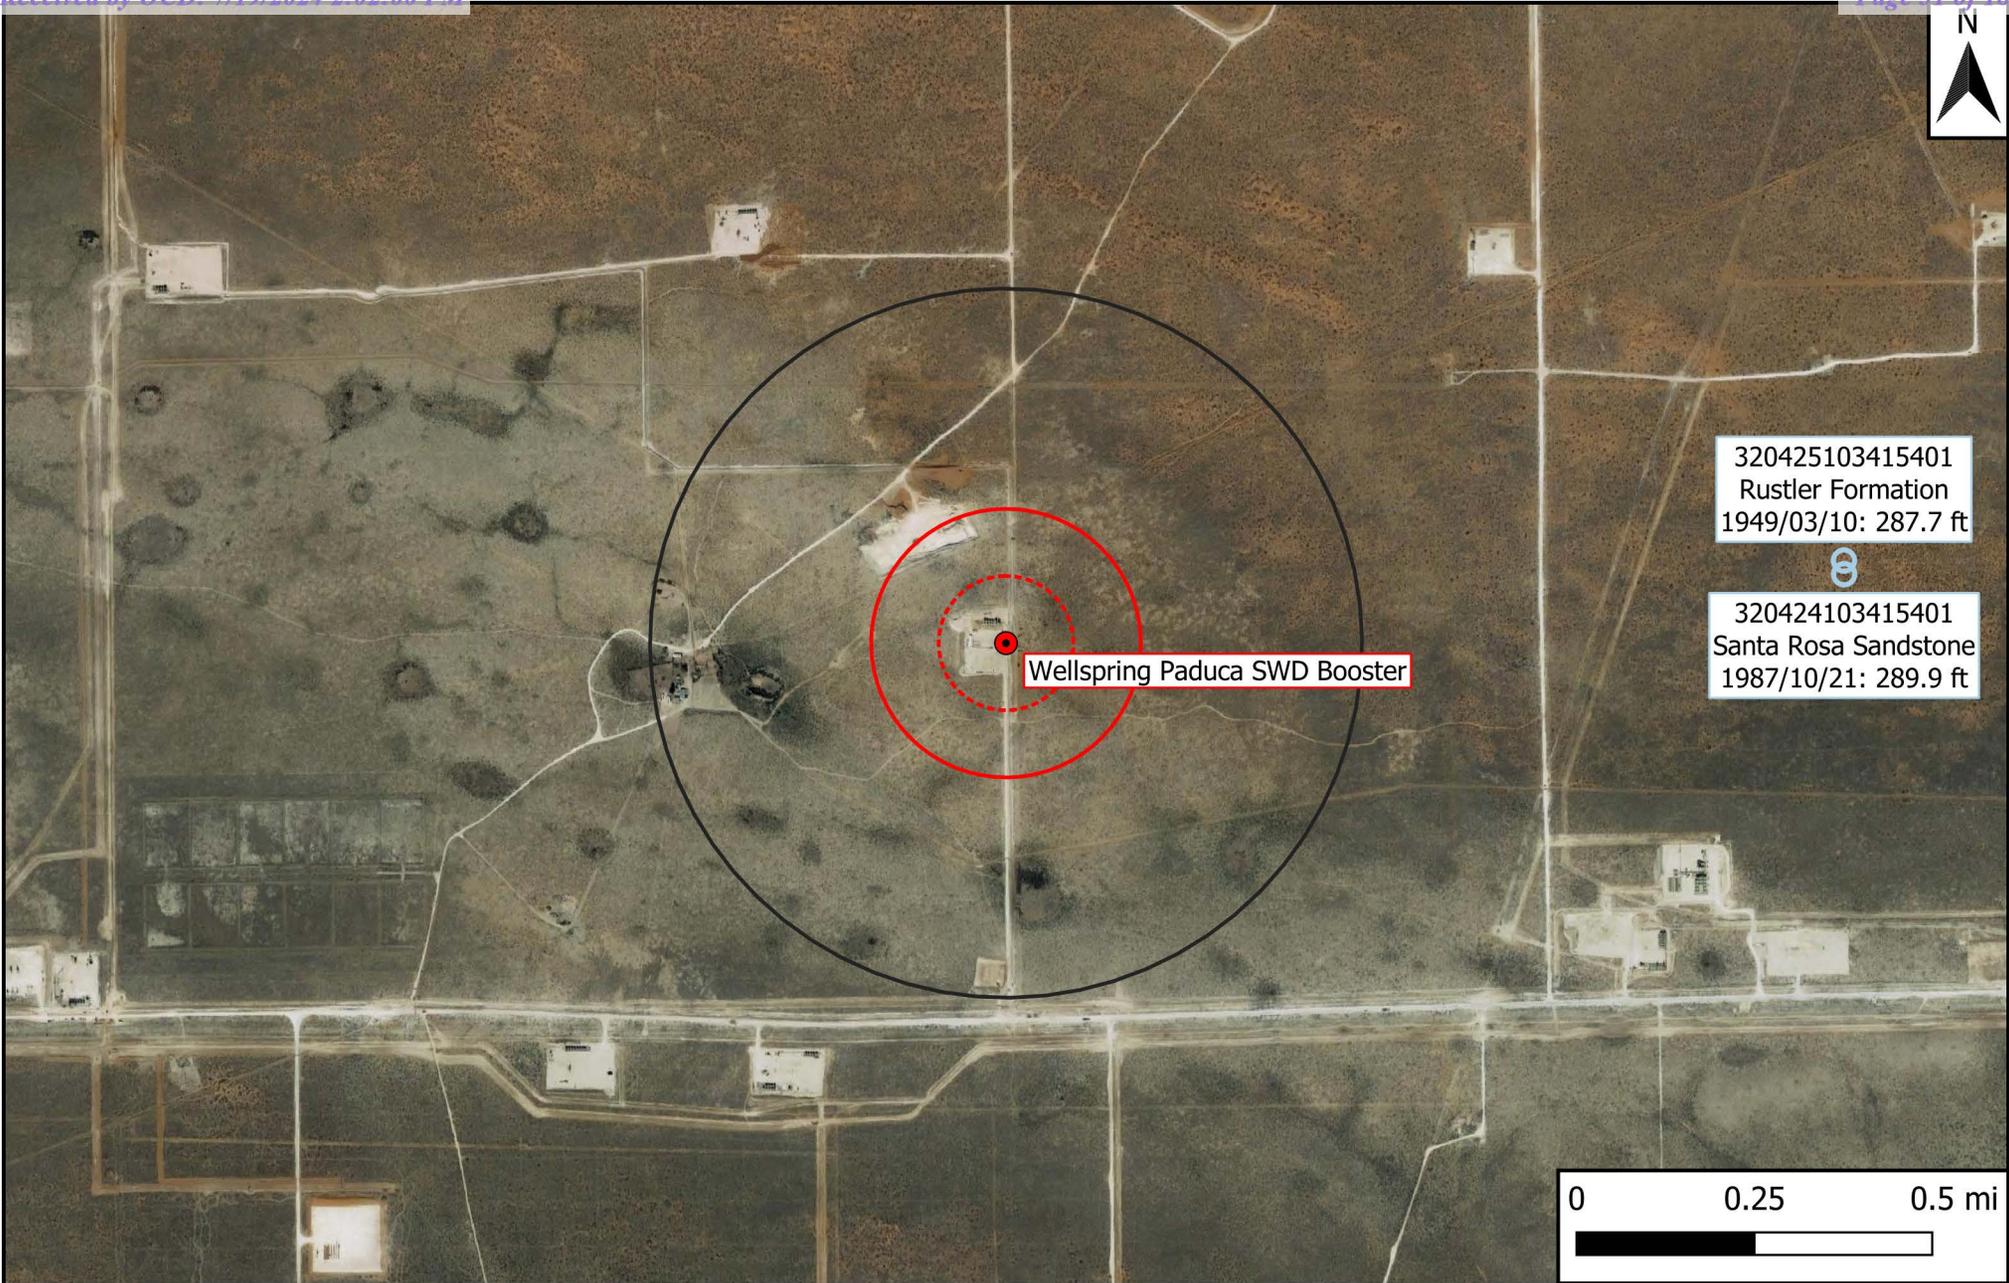
Figure 5
 USGS Well Proximity Map
 Mewbourne Oil Company
 Wellspring Paduca SWD Booster
 GPS: 32.072257, -103.718906
 Lea County

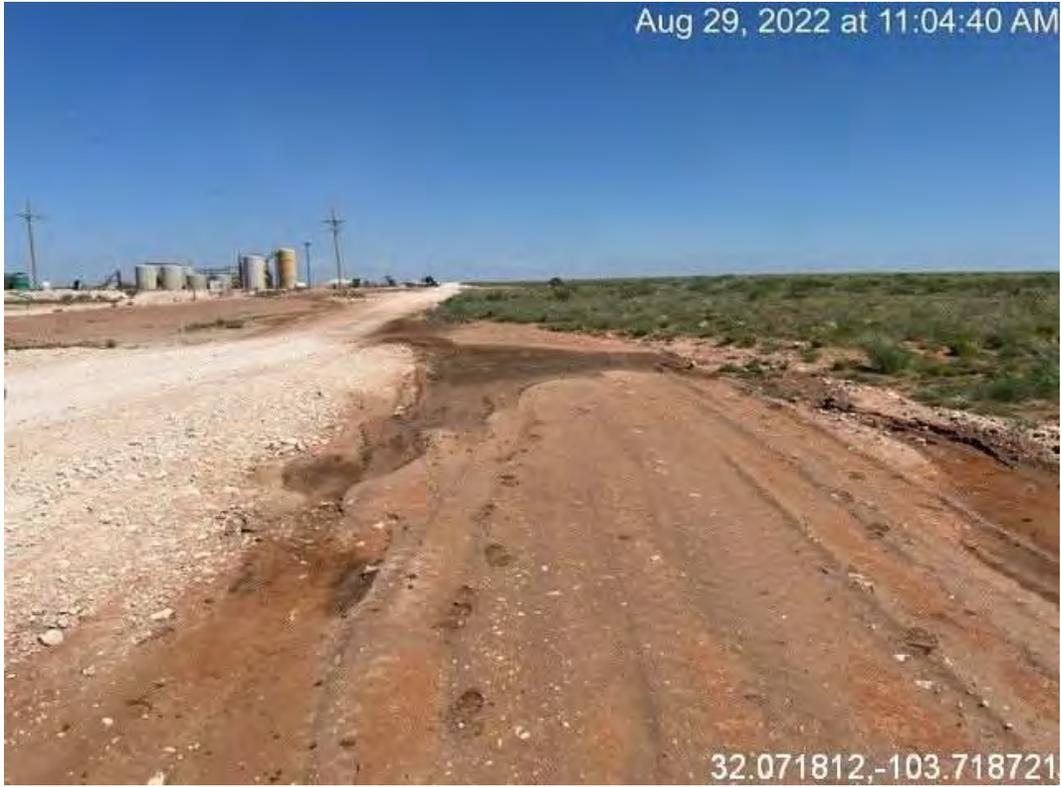
Photo Number: 1

Photo Direction: North	
Photo Description: View of the affected area.

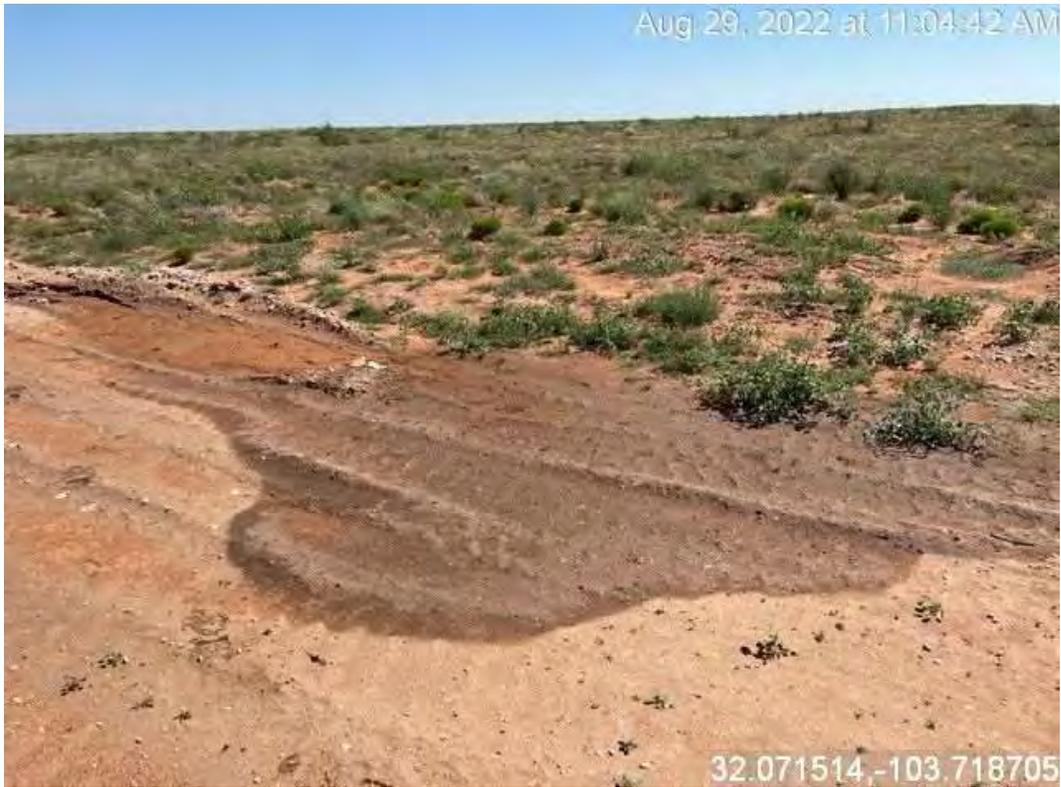
Photo Number: 2

Photo Direction: Northeast	
Photo Description: View of the affected area.

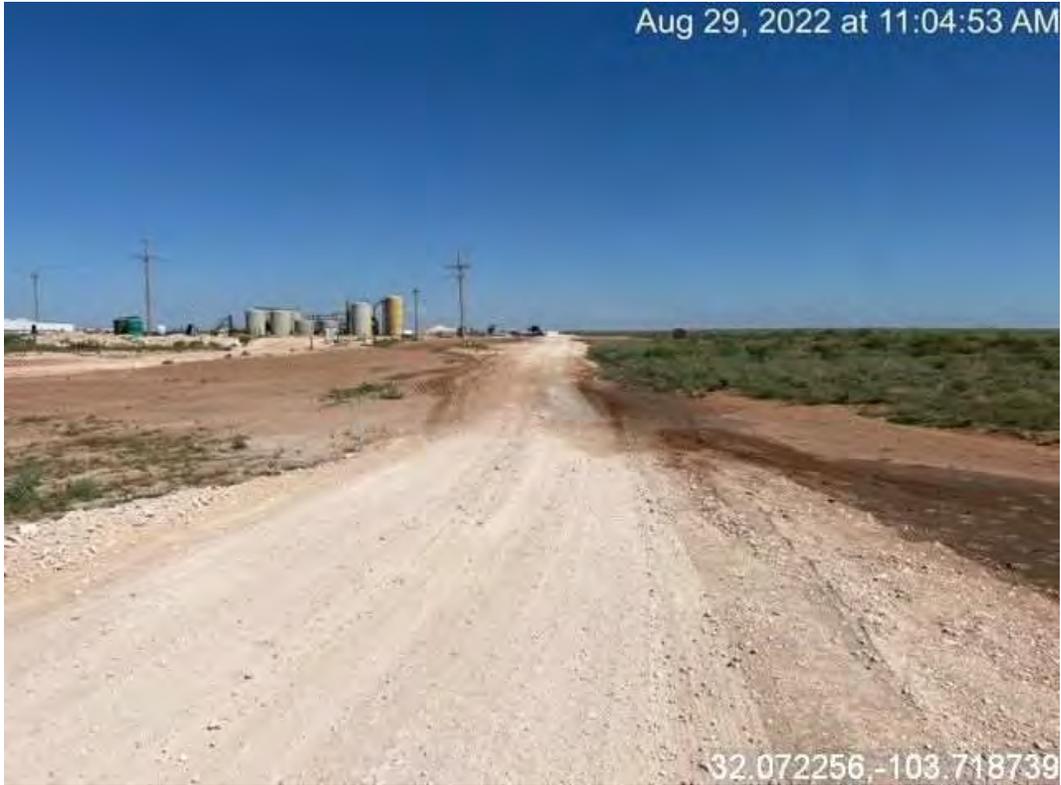
Photo Number: 3

<p>Aug 29, 2022 at 11:04:53 AM</p> <p>32.072256, -103.718739</p>
Photo Direction: North	
Photo Description: View of the affected area.

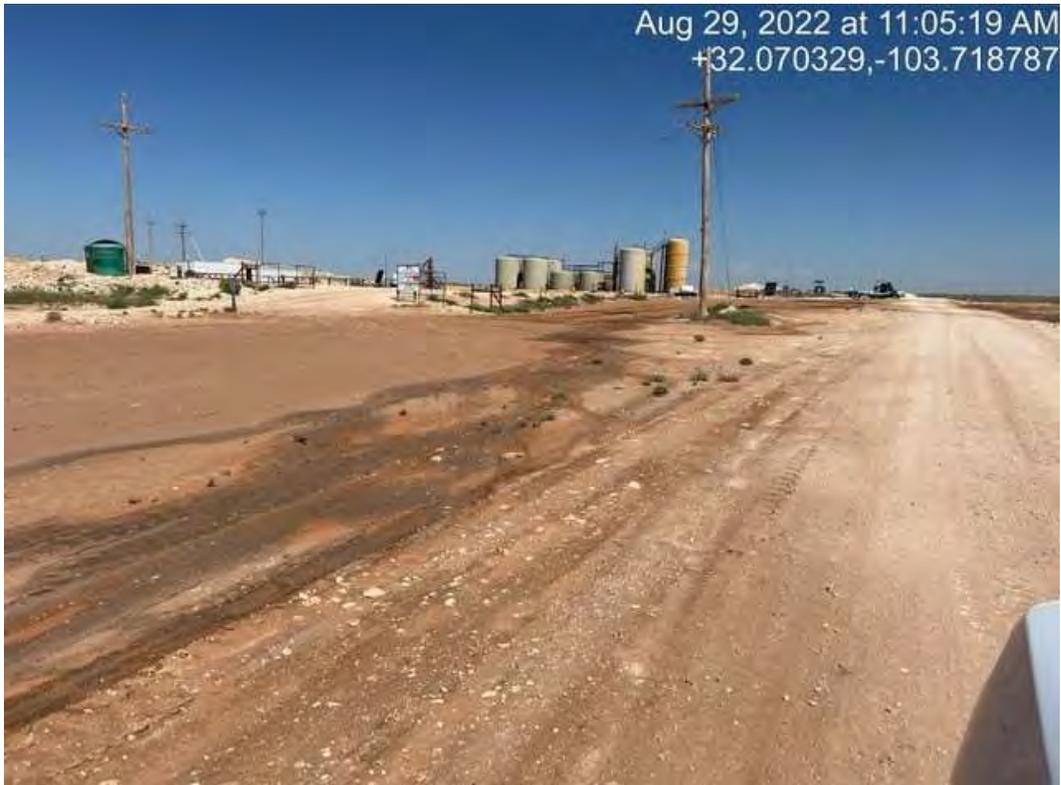
Photo Number: 4

<p>Aug 29, 2022 at 11:05:19 AM</p> <p>+32.070329, -103.718787</p>
Photo Direction: North-Northwest	
Photo Description: View of the affected area.

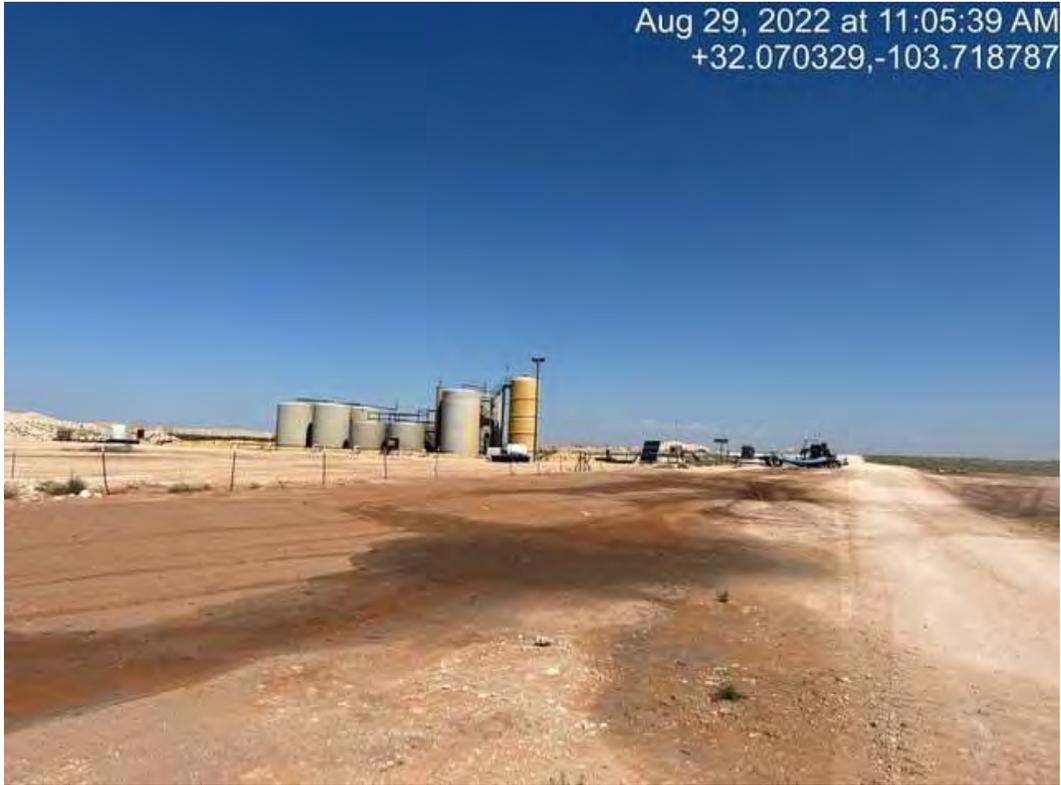
Photo Number: 5

Photo Direction: North-Northwest	
Photo Description: View of the affected area.

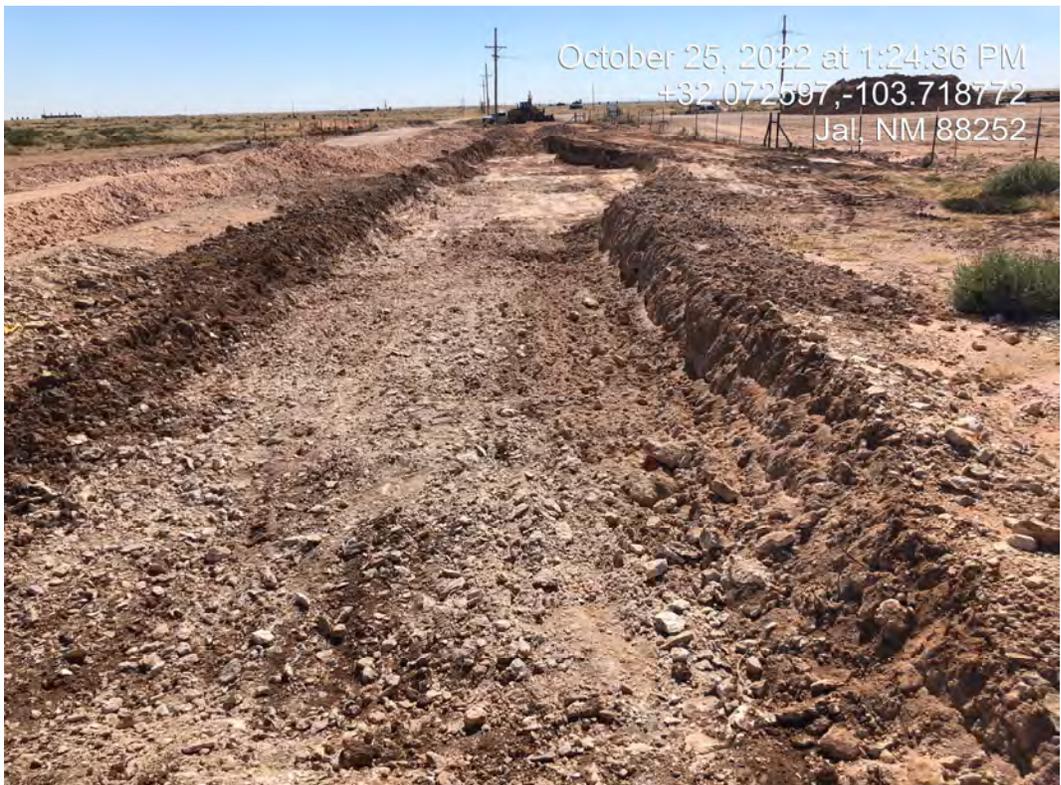
Photo Number: 6

Photo Direction: South	
Photo Description: View of the excavated area.

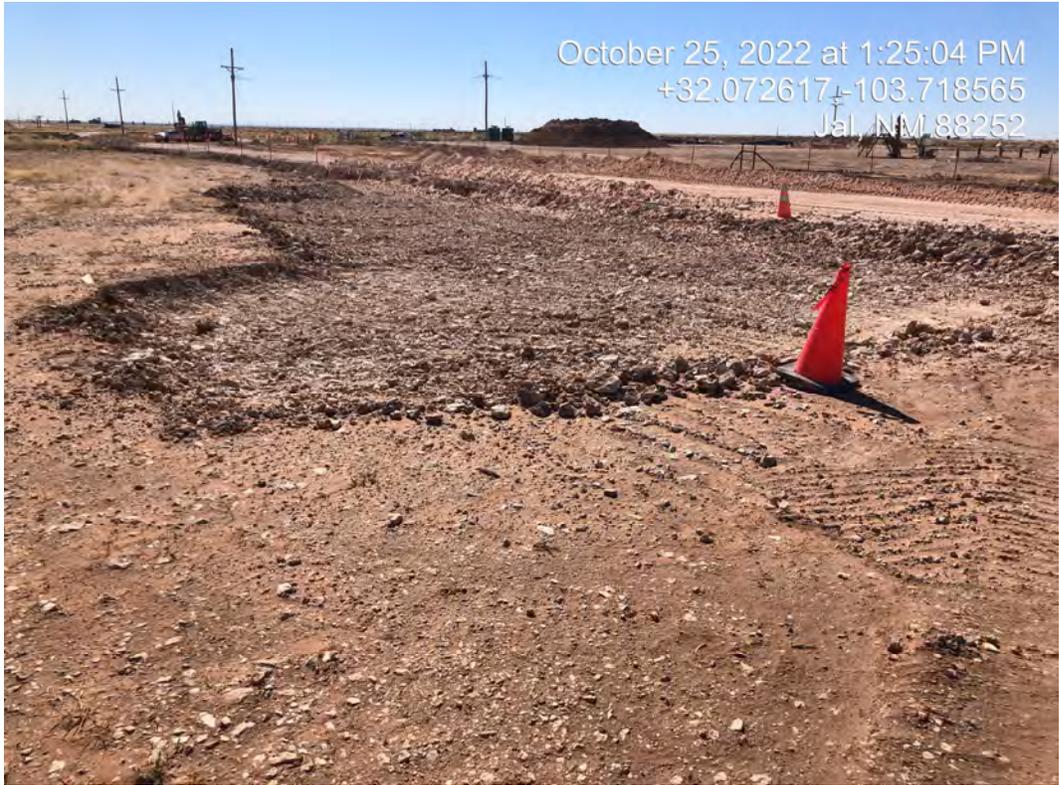
Photo Number: 7

<p>October 25, 2022 at 1:25:04 PM +32.072617,-103.718565 Jal, NM 88252</p>
Photo Direction: Southwest	
Photo Description: View of the excavated area.

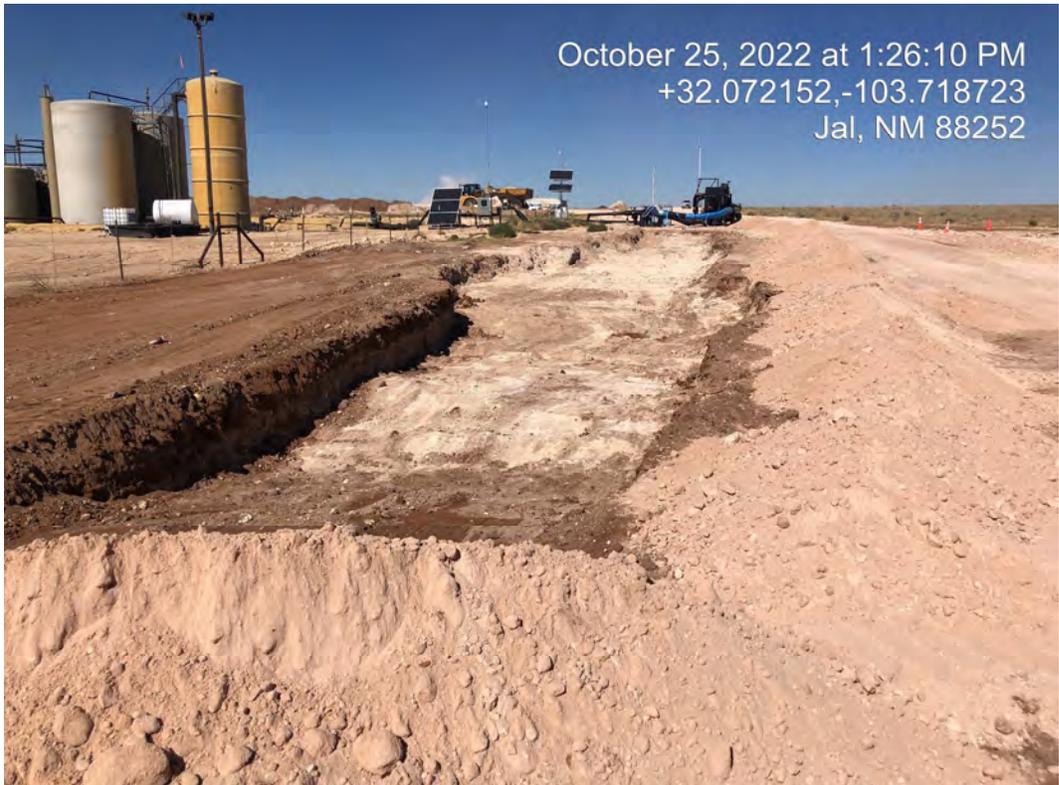
Photo Number: 8

<p>October 25, 2022 at 1:26:10 PM +32.072152,-103.718723 Jal, NM 88252</p>
Photo Direction: North-Northwest	
Photo Description: View of the excavated area.

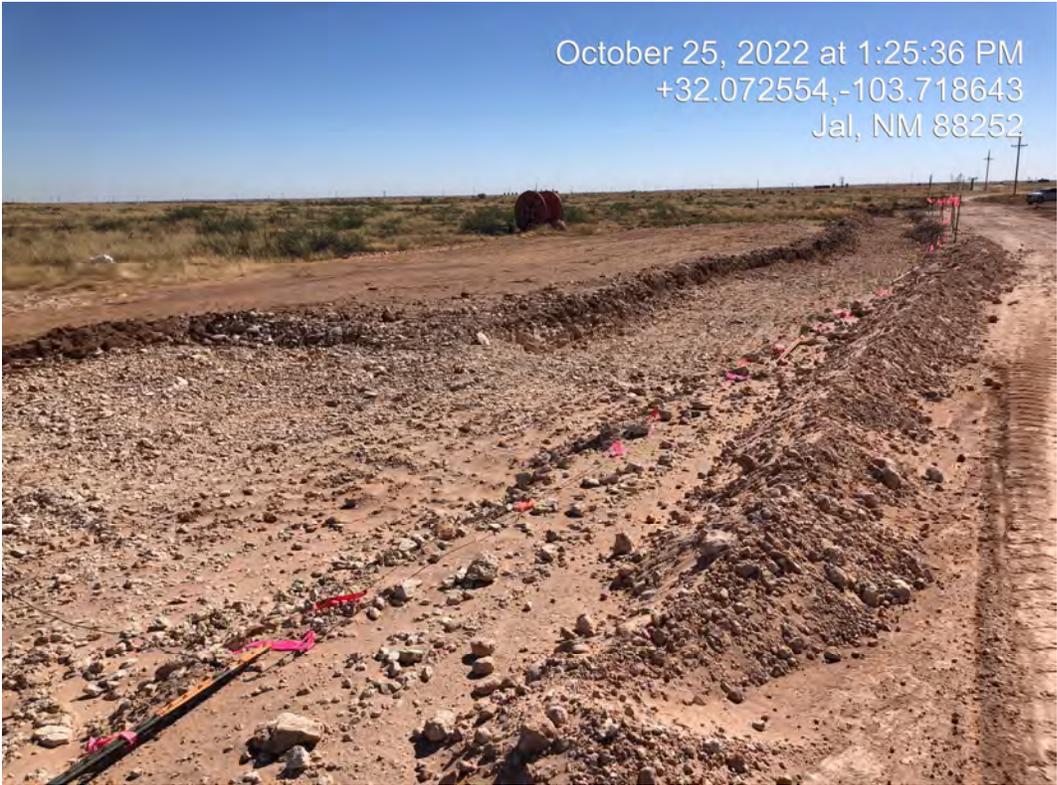
Photo Number: 9

<p>October 25, 2022 at 1:25:36 PM +32.072554,-103.718643 Jal, NM 88252</p>
Photo Direction: South-Southeast	
Photo Description: View of the excavated area.

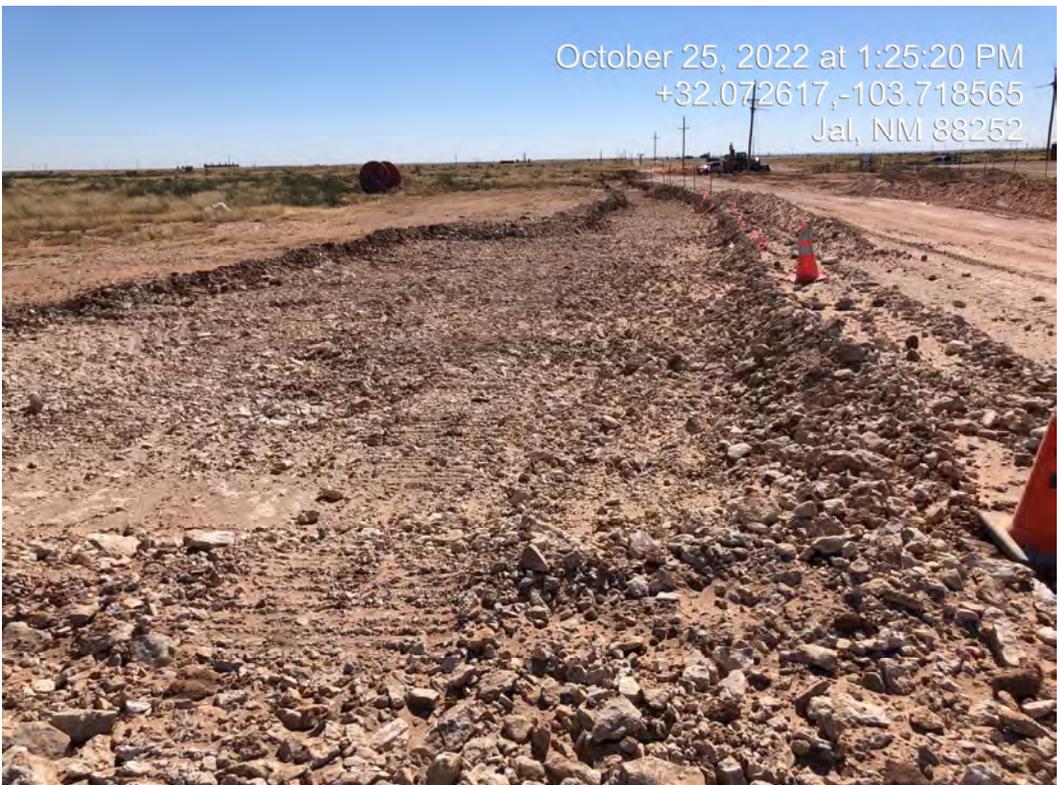
Photo Number: 10

<p>October 25, 2022 at 1:25:20 PM +32.072617,-103.718565 Jal, NM 88252</p>
Photo Direction: South	
Photo Description: View of the excavated area.

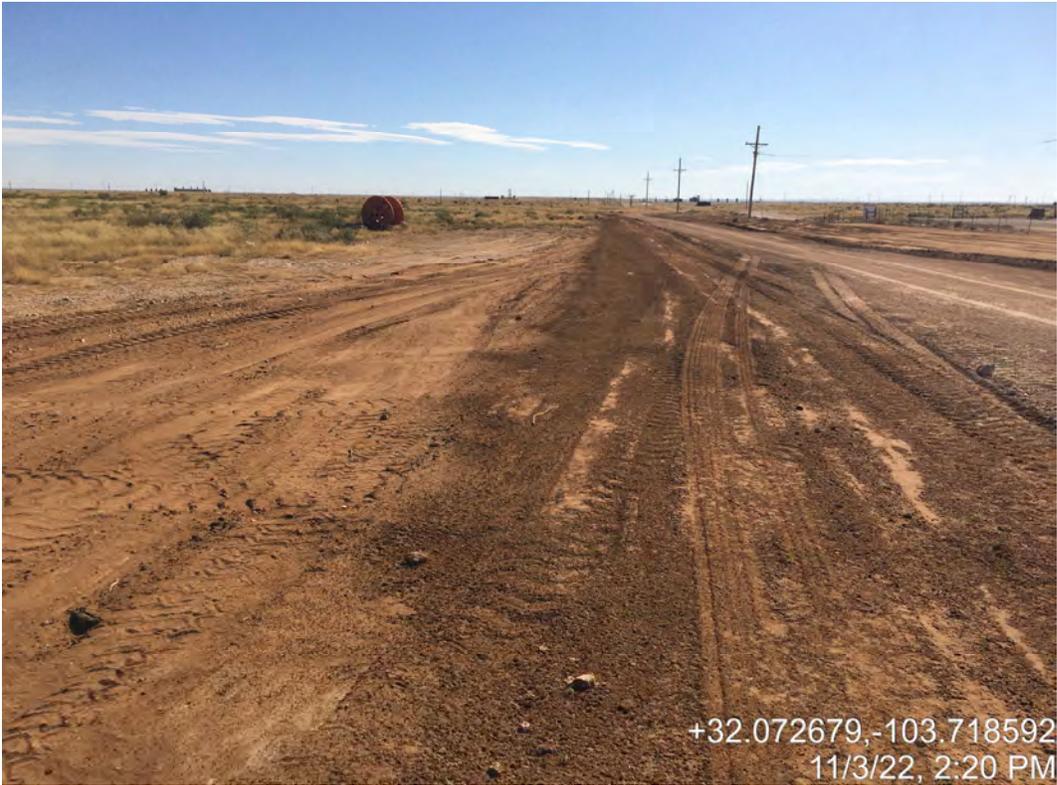
Photo Number: 11

<p data-bbox="1096 926 1469 997">+32.072679,-103.718592 11/3/22, 2:20 PM</p>
Photo Direction: South	
Photo Description: View of the remediated area after backfill and regrading.

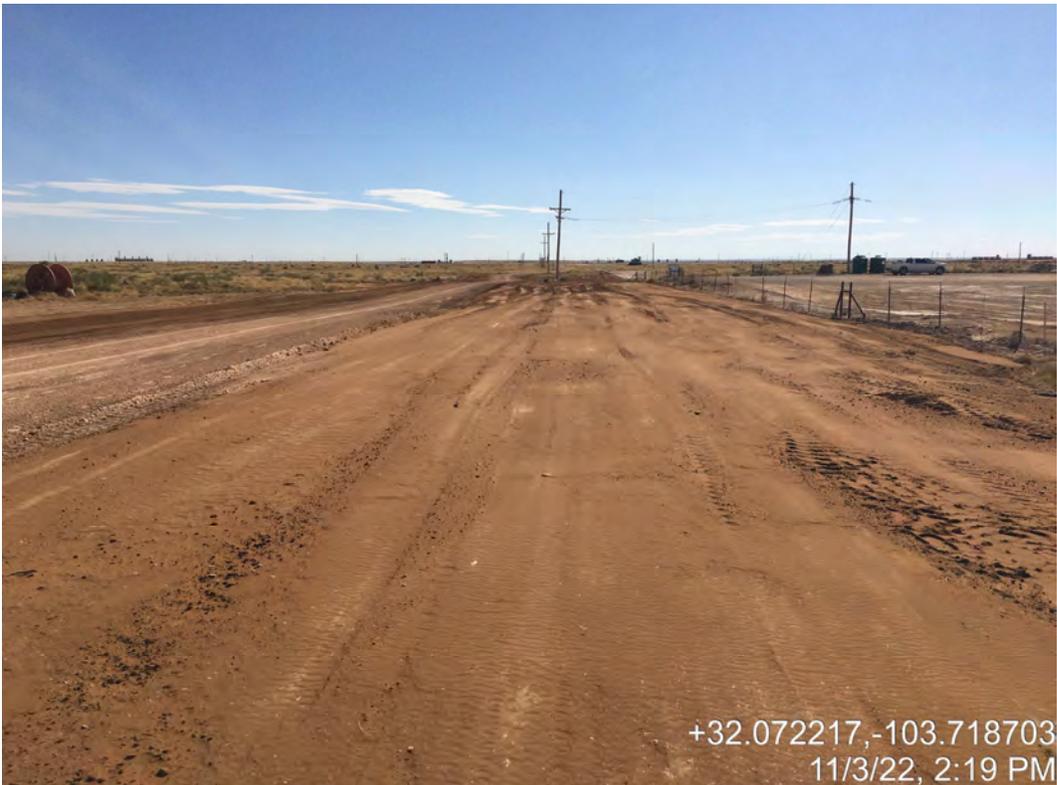
Photo Number: 12

<p data-bbox="1096 1810 1469 1881">+32.072217,-103.718703 11/3/22, 2:19 PM</p>
Photo Direction: South	
Photo Description: View of the remediated area after backfill and regrading.

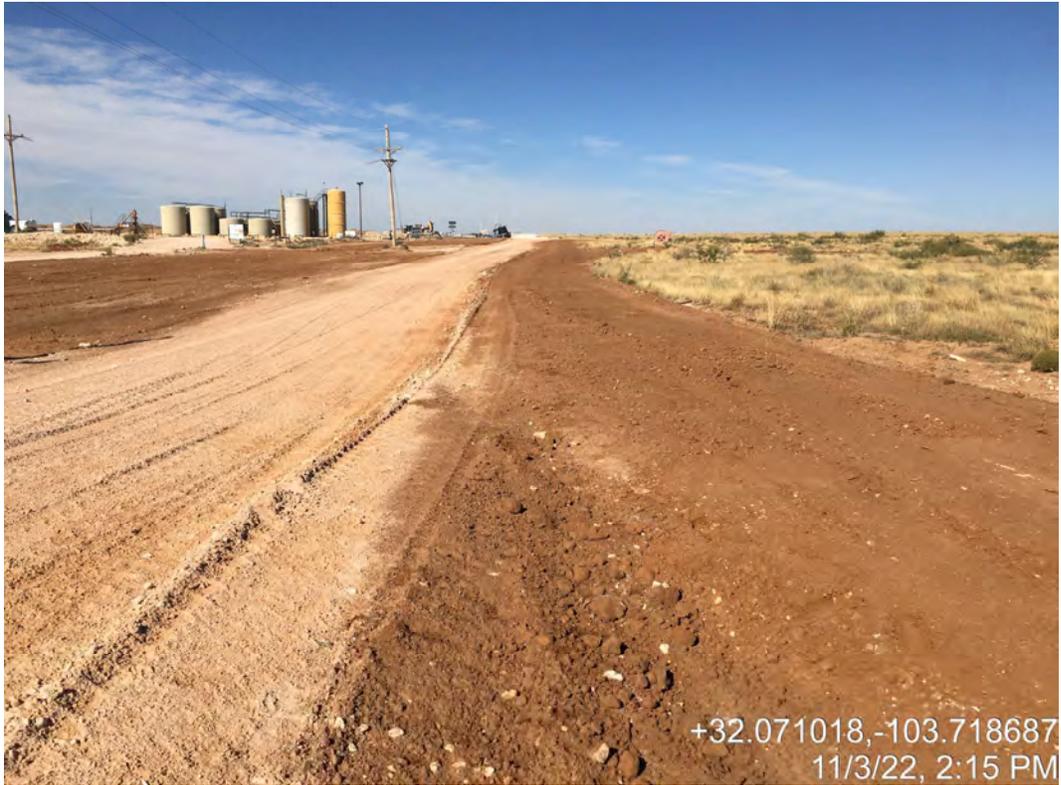
Photo Number: 13

<p data-bbox="1096 926 1471 997">+32.071018,-103.718687 11/3/22, 2:15 PM</p>
Photo Direction: North	
Photo Description: View of the remediated area after backfill and regrading.
