Incident ID	nAPP2225255046
District RP	
Facility ID	
Application ID

Based on laboratory analytical results and field activities conducted to date, Etech recommends Mewbourne Oil Company, provide copies of this *Remediation Summary & Soil Closure Request* to the appropriate agencies and request closure be granted to the Wellspring Paduca release site.

Figure 1
 Topographic Map
 Mewbourne Oil Company
 Wellspring Paduca SWD Booster
 GPS: 32.072257, -103.718906
 Lea County

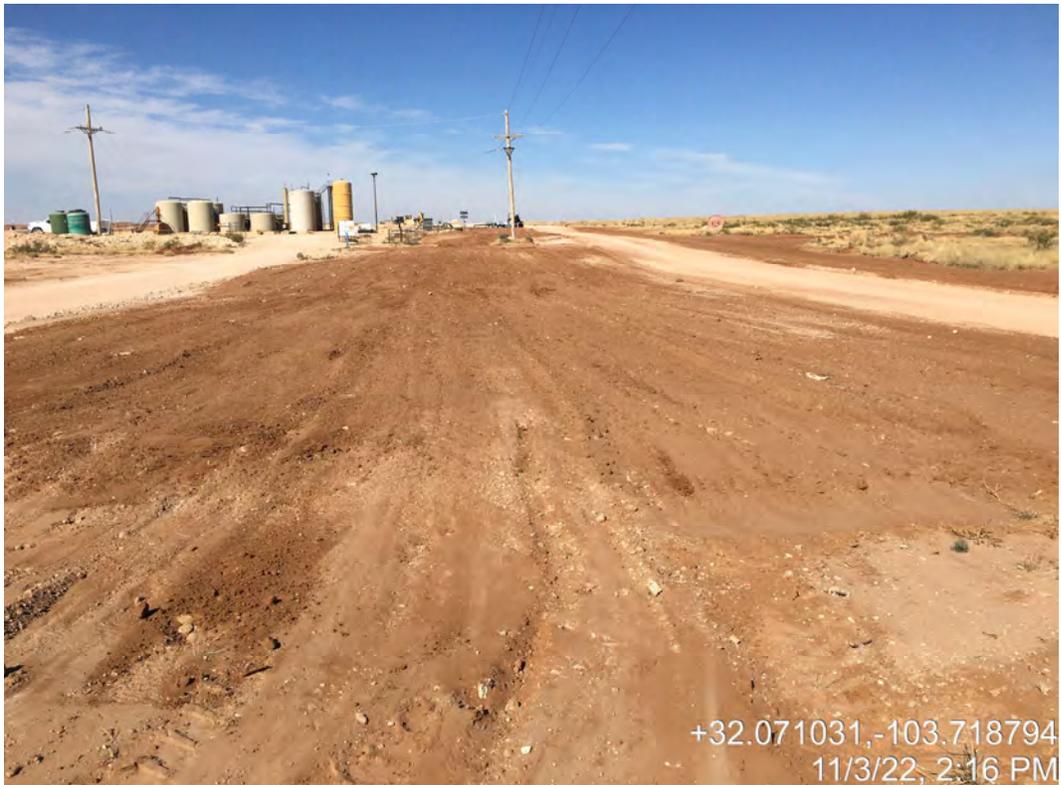
Photo Number: 14

<p data-bbox="1096 1810 1471 1881">+32.071031,-103.718794 11/3/22, 2:16 PM</p>
Photo Direction: North	
Photo Description: View of the remediated area after backfill and regrading.

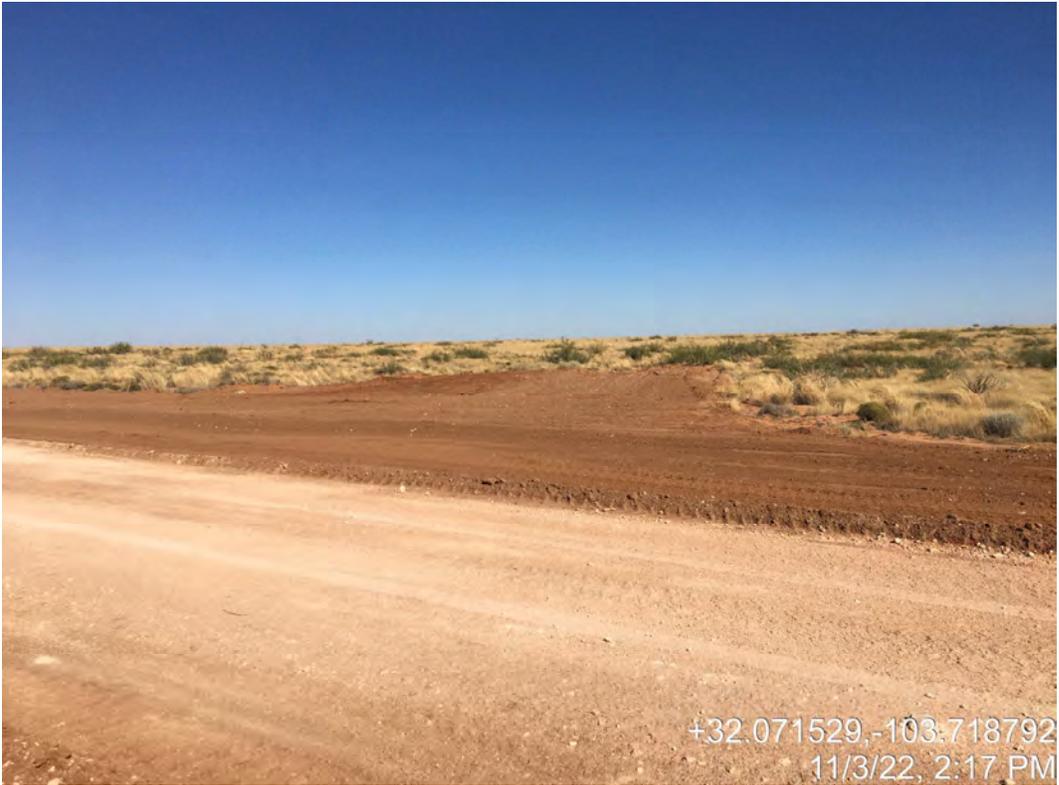
Photo Number: 15

<p data-bbox="1096 926 1471 997">+32.071529,-103.718792 11/3/22, 2:17 PM</p>
Photo Direction: East-Northeast	
Photo Description: View of the remediated area after backfill and regrading.

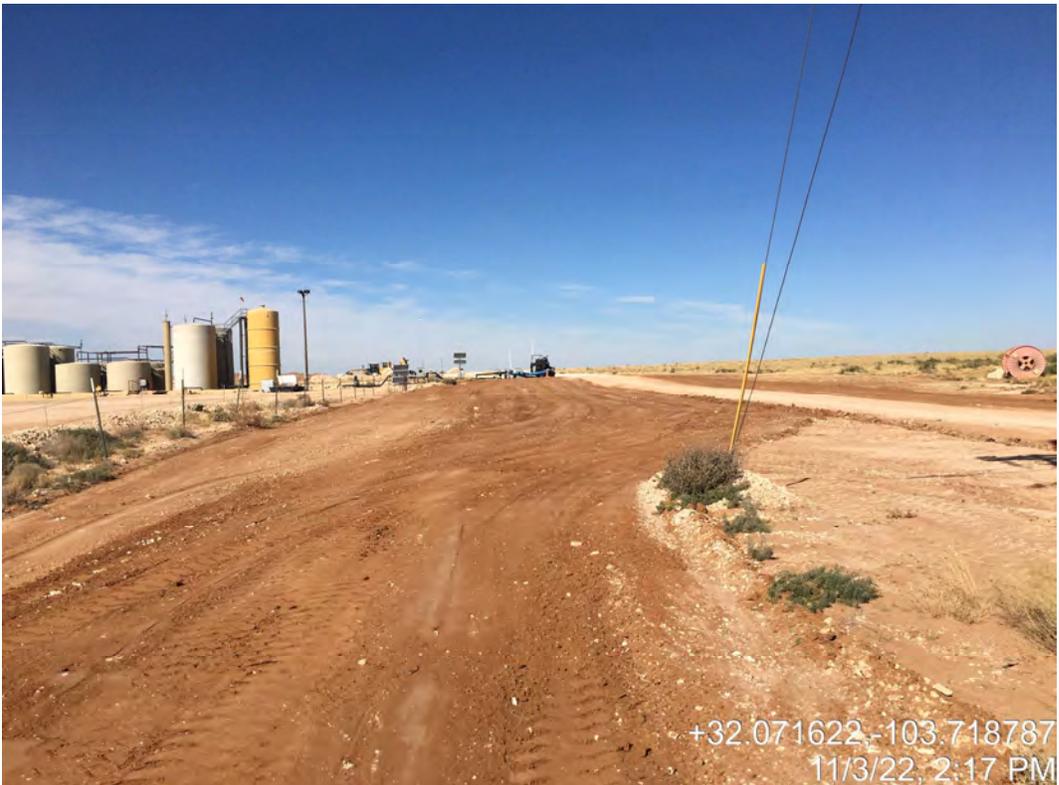
Photo Number: 16

<p data-bbox="1096 1810 1471 1881">+32.071622,-103.718787 11/3/22, 2:17 PM</p>
Photo Direction: North-Northeast	
Photo Description: View of the remediated area after backfill and regrading.
