**Re: Remediation Work Plan**

San Juan 29-6 Unit 86  
Rio Arriba County, New Mexico  
Hilcorp Energy Company  
NMOCD Incident No: nAPP2401932449

Ensolum, LLC (Ensolum), on behalf of Hilcorp Energy Company (Hilcorp), presents this *Remediation Work Plan* (Work Plan) for a release at the San Juan 29-6 Unit 86 natural gas production well (Site). The Site is located on private land in Unit N, Section 27, Township 29 North, Range 6 West, Rio Arriba County, New Mexico (Figure 1). This proposed Work Plan includes a summary of delineation activities performed at the Site and the proposed remediation of impacted soil originating from the release of condensate and produced water.

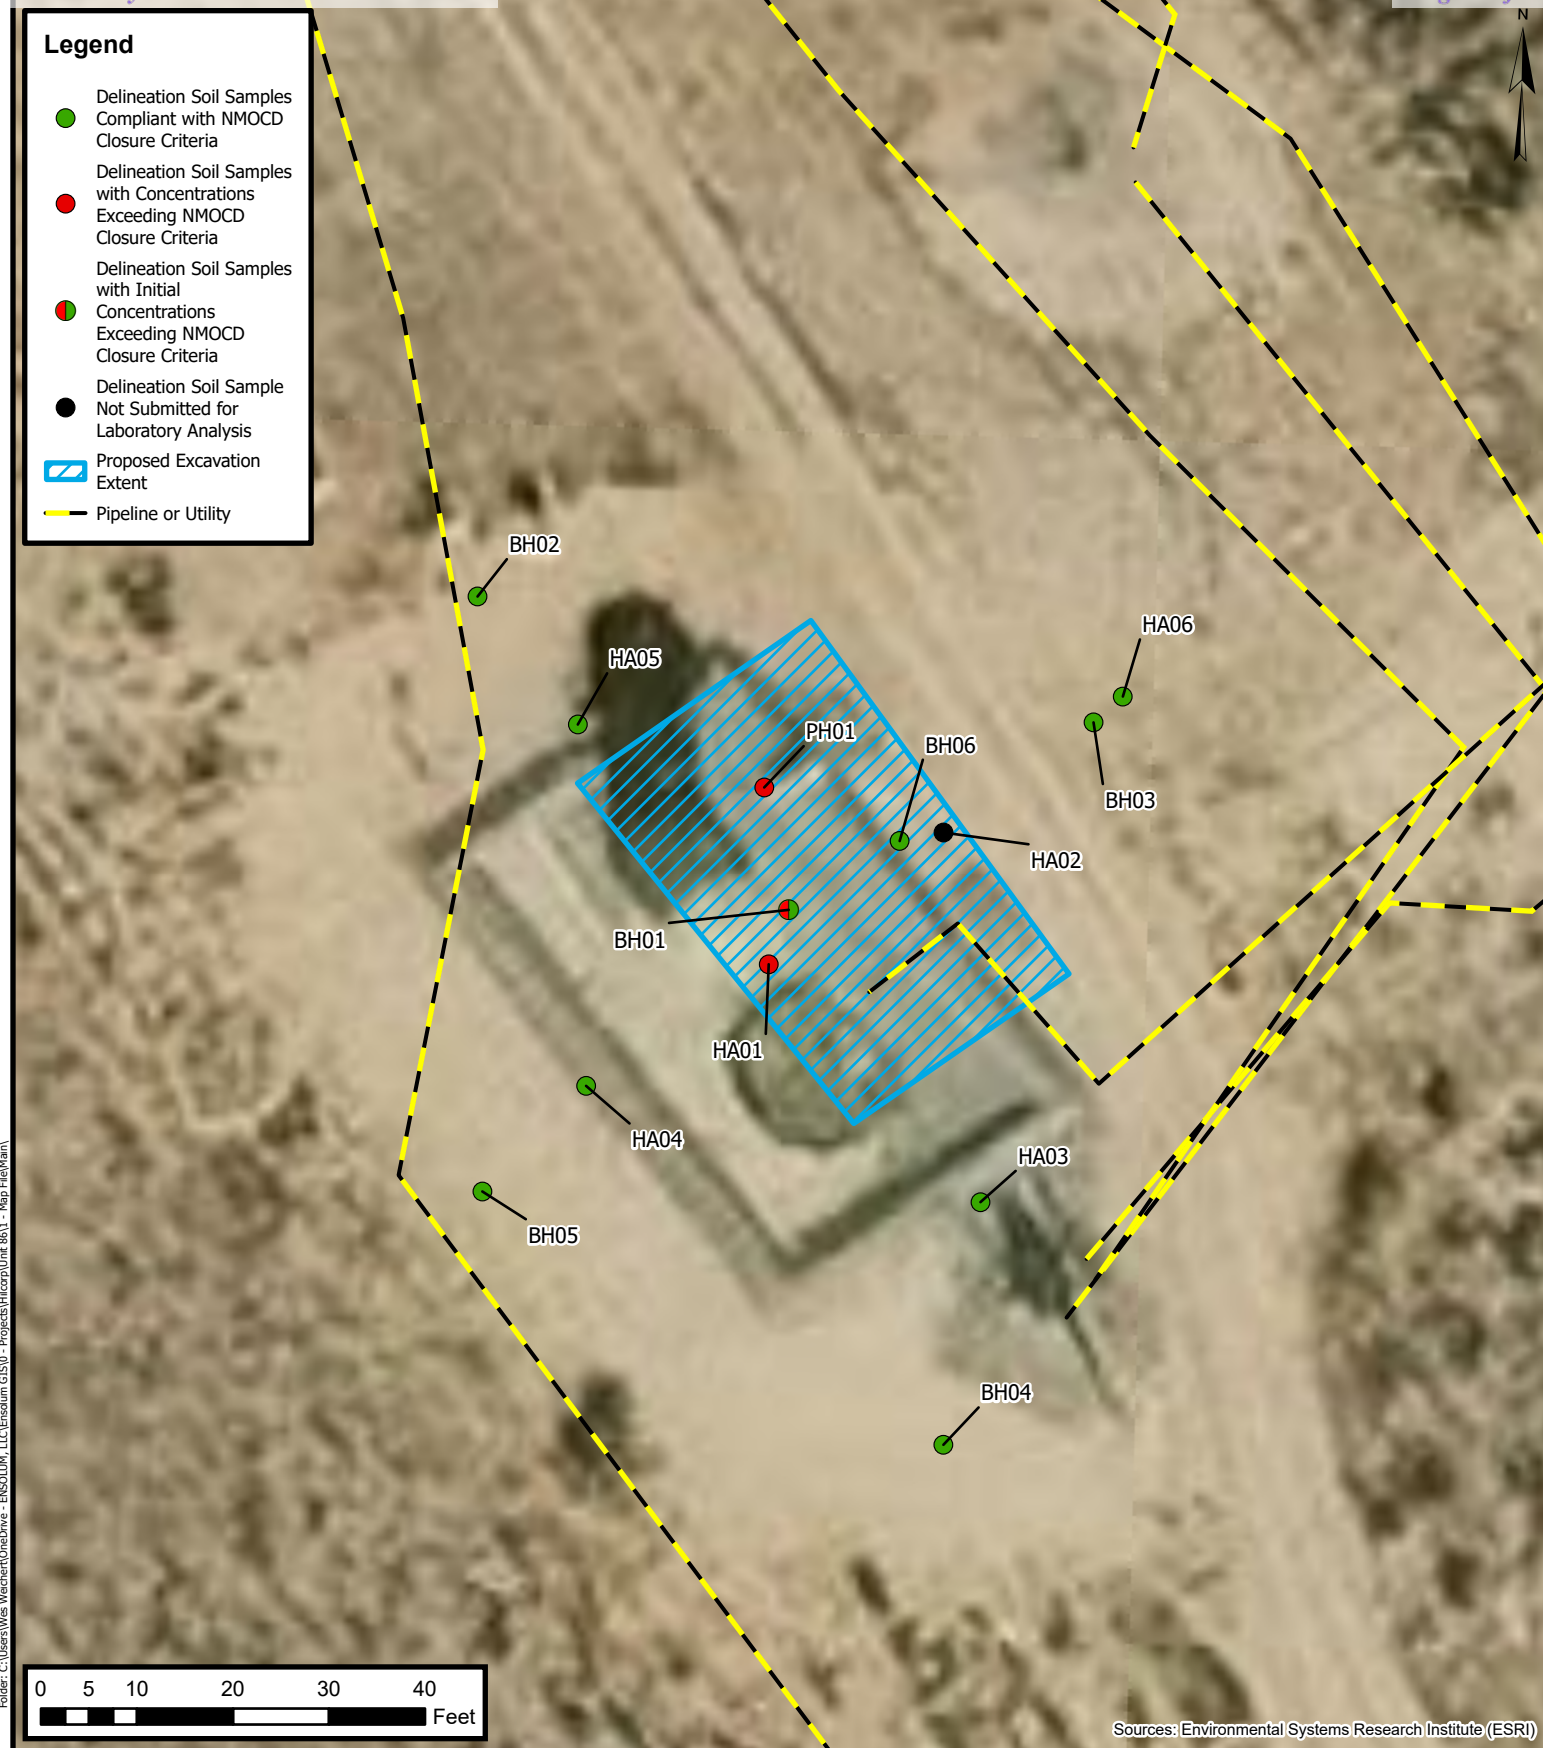
**FIGURE  
2**

Ensolum personnel conducted initial delineation potholing activities with a hand auger on January 30, 2024. Sampling location HA01 was advanced within the center of the secondary containment berm to a depth of 1.5 feet bgs. Sampling locations HA02 through HA06 were advanced to a depth of 0.5 feet bgs in all cardinal directions surrounding the berm as depicted in

Figure 2. Hand auger refusal was encountered between 0.5 feet and 1-foot bgs at all locations. During delineation activities, Ensolum field screened for the presence of volatile organic compounds (VOCs) using a calibrated photoionization detector (PID). Soil composition consisted of medium to coarse sand interbedded with clay and fine sand.

## Delineation Soil Sample Locations and Proposed Excavation Extent

Based on soil sampling results described above, it is estimated that impacted soil is present at the Site between the ground surface to a depth of approximately 10 feet bgs. Of note, analytical results from potholes PH01 and PH02 indicate TPH impacted soil is present to depth up to 19 feet bgs; however, based on the extensive sampling performed during the drilling effort, sample results indicate that impacted soil is only present to depths of approximately 10 feet bgs. It is believed that during the advancement of the potholes, impacted soil from the top 10 feet sloughed into the pothole as it was advanced and this impacted soil was incidentally included in the samples collected at depth. Analytical results also indicate TPH impacted soil is likely limited to areas within the immediate vicinity of the secondary containment berm with an approximate areal extent of 1,600 square feet.

Due to the limited vertical and lateral extent of soil impacts, the SVE system will not undergo pilot testing, and the SVE wells will be abandoned. To meet NMOCD Closure Criteria, Hilcorp plans to excavate TPH-impacted soil to the approximate extent shown on Figure 2. Impacted soil will be excavated and transported off-Site for treatment at a Hilcorp registered small landfarm (to be approved by the BLM and NMOCD Permitting Group). Based on delineation results, approximately 600 cubic yards of impacted soil is present at the Site requiring excavation and treatment/disposal.

Once field screening indicates impacted soil has been removed, 5-point composite soil samples will be collected at least every 200 square feet from the floor and sidewalls of the excavation. The 5-point composite samples will be collected by placing five equivalent aliquots of soil into a 1-gallon, resealable plastic bag and homogenizing the samples by thoroughly mixing. Based on previous analytical results and no prior Closure Criteria exceedances of chloride, Hilcorp is requesting soil samples only be analyzed for TPH and BTEX during confirmation sampling. Once confirmed impacted soil has been removed, the excavation will be backfilled with clean soil and recontoured to match pre-existing conditions at the Site.

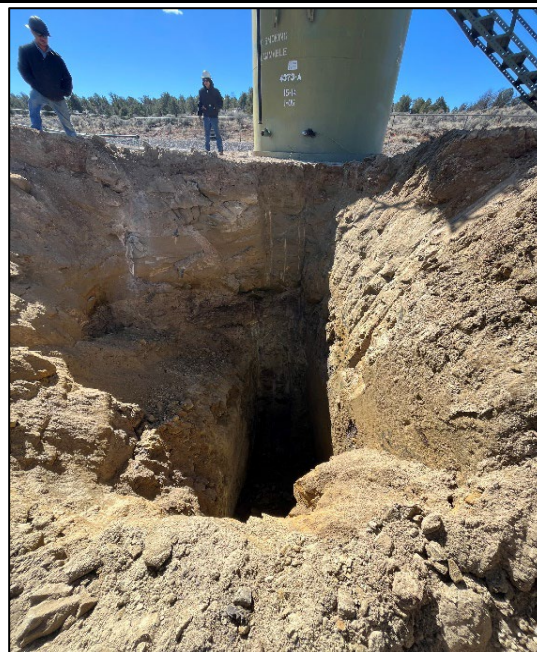
Photograph: 2  
Description: Pothole PH02  
View: West

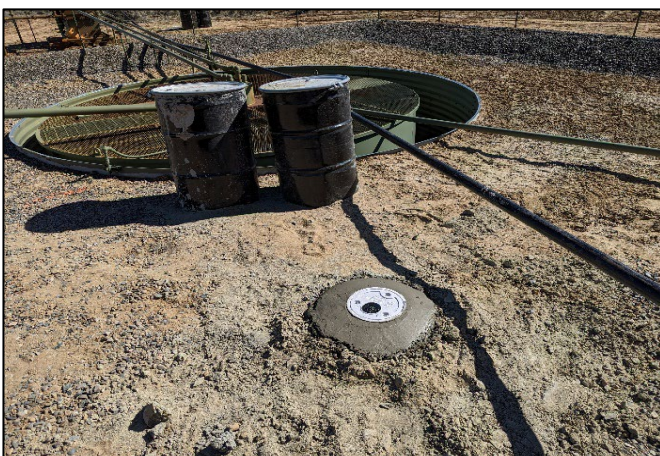
Photograph: 3  
Description: Boring BH01 completed as SVE well  
View: South

Based on field screening results, SVE wells were installed in boreholes BH01, BH03, BH04, BH05, and BH06. Screen intervals were strategically picked based on field screening results and visual impacts. Photographs taken during delineation activities are also provided in Appendix C. Soil samples locations are presented on Figure 2. Sampling notifications provided to the NMOCD are included as Appendix D.

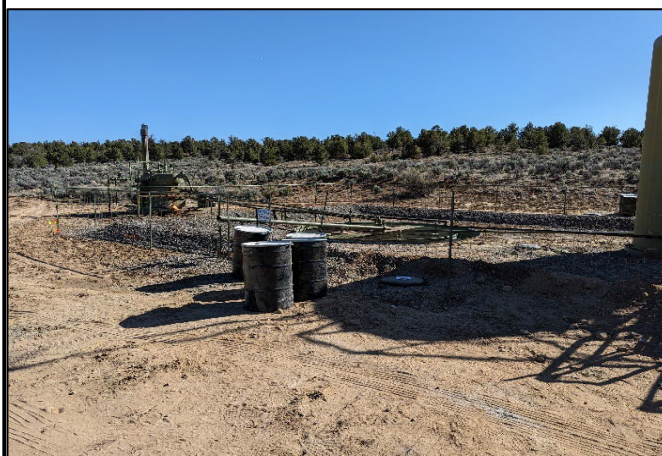
Photograph: 4  
Description: Borings BH01 and BH06 as SVE wells  
View: Southwest
