**Re: Closure Request  
Brushy Draw 30-31 Federal Battery  
Incident Number nAPP2413031273  
Eddy County, New Mexico**

Ensolum, LLC (Ensolum) on behalf of XTO Energy, Inc. (XTO), has prepared this *Closure Request* to document site assessment, excavation, and soil sampling activities at the Brushy Draw 30-31 Federal Battery (Site). The purpose of the site assessment and soil sampling activities was to assess for the presence or absence of impacts to soil following a release of produced water and crude oil onto the well pad. Based on field observations, field screening activities, and soil sample laboratory analytical results, XTO is submitting this *Closure Request*, describing site assessment, delineation, and excavation activities that have occurred and requesting remediation closure for Incident Number nAPP2413031273.

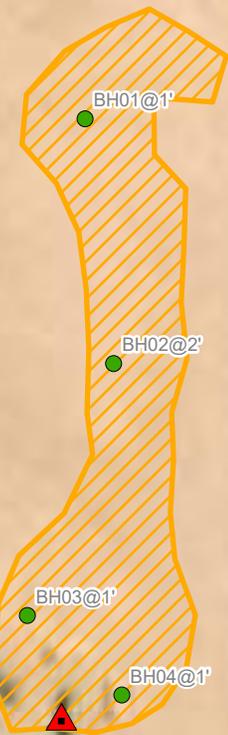
- Delineation Soil Sample in Compliance with Closure Criteria
- Release Extent
- ▲ Point of Release

Notes:  
 Sample ID @ Depth Below Ground Surface.  
 Samples in Gray removed during excavation activities.

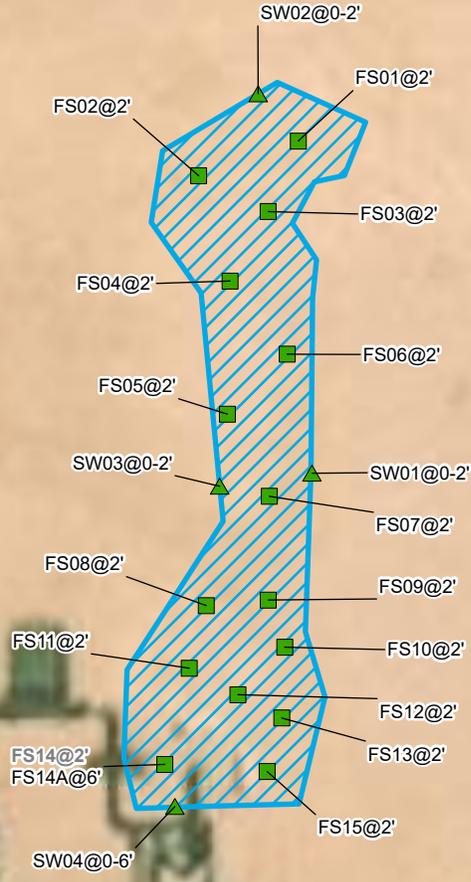
- Excavation Floor Sample in Compliance with Closure Criteria
- ▲ Excavation Sidewall Sample in Compliance with Closure Criteria
- Excavation Extent

Notes:  
 Sample ID @ Depth Below Ground Surface.  
 Grey text indicate soil sample was removed during excavation activities.

Impacted soil was excavated from the release area as indicated by visible staining and elevated field screenings. Excavation activities were performed using a trackhoe and transport vehicle. The excavation occurred on the well pad near the production equipment. To direct excavation activities, Ensolum personnel screened soil for VOCs and chloride. Following removal of impacted soil, Ensolum personnel collected 5-point composite soil samples representing no more than 200 square feet from the floor and sidewalls of the excavation. The 5-point composite soil samples were collected by placing five equivalent aliquots of soil into a 1-gallon, resealable plastic bag and homogenizing the samples by thoroughly mixing. Confirmation floor soil samples, FS01 through FS15, were collected from the floor of the excavation at depths ranging from 2 feet to 6 feet bgs. Confirmation sidewall soil samples SW01 through SW04 were collected from the sidewalls of the excavation at depths ranging from ground surface to 6 feet bgs. The confirmation soil samples were collected, handled, and analyzed following the same procedures as described above. The excavation extent and confirmation soil sample locations are presented on Figure 3.

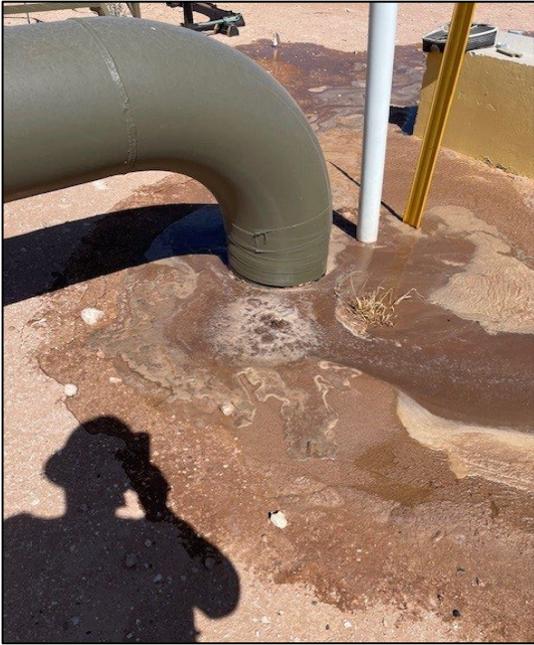
Photograph: 1 Date: 5/7/2024  
Description: Release point area.  
View: Northwest

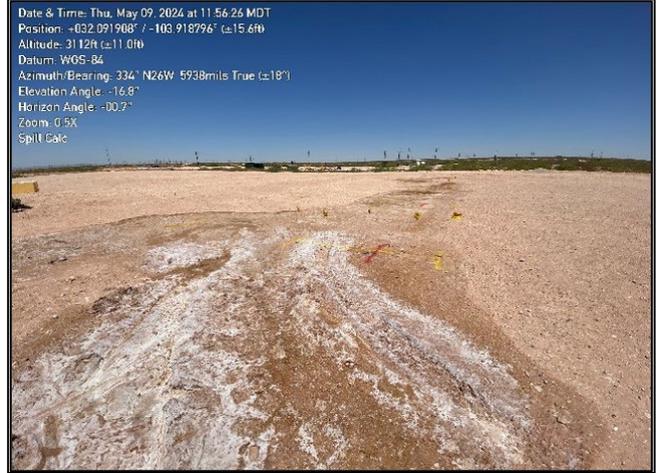
Photograph: 2 Date: 5/9/2024  
Description: Surficial staining, release extent area.  
View: North

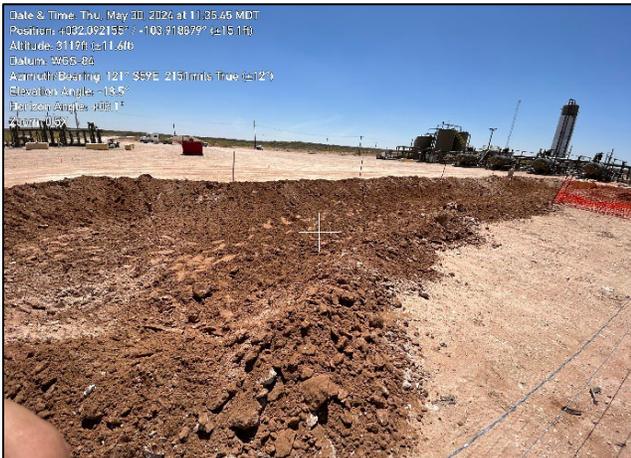
Photograph: 3 Date: 5/30/2024  
Description: Northern excavation extent.  
View: Southeast

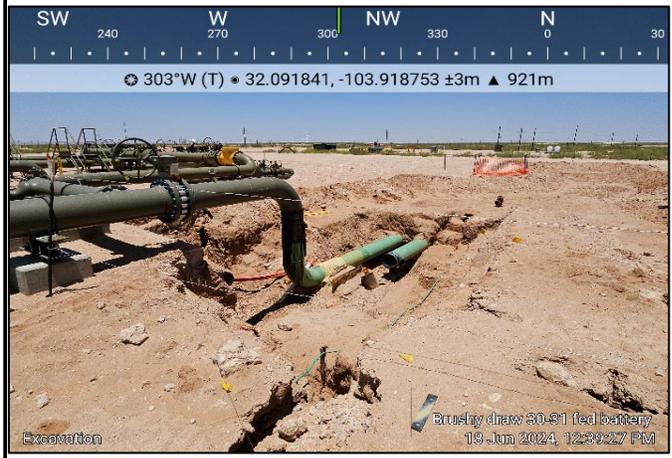
Photograph: 4 Date: 6/18/2024  
Description: Final excavation extent.  
View: Northwest

Site assessment, delineation, and excavation activities were conducted at the Site to address the May 7, 2024, release of produced water and crude oil. Laboratory analytical results for all confirmation soil samples collected from the final excavation extent indicated that all COC concentrations were compliant with the Closure Criteria. Based on soil sample analytical results, no further remediation was required. XTO will backfill the excavation with material purchased locally and recontour the Site to match pre-existing Site conditions.
