Incident # **nAPP2322350630**

The CJ Holder 500S is in Unit L, Section 31, Township 29 North, Range 13 West, San Juan County, New Mexico.

RE: The cause of the release was determined that the water transfer line was cracked and resulted in the release inside the lined berm area, however the release overtopped the berm. The estimated release volume was 62 BBLS and 60 BBLS were recovered via water truck.

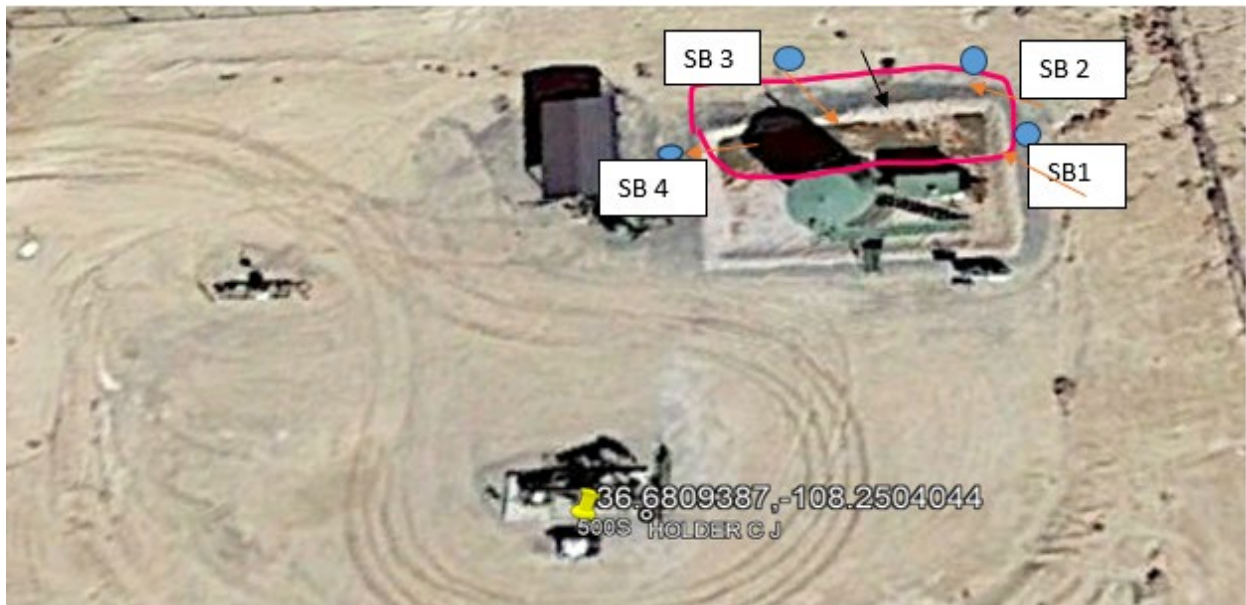
Sample Area

● = Sample points to 2' bgs

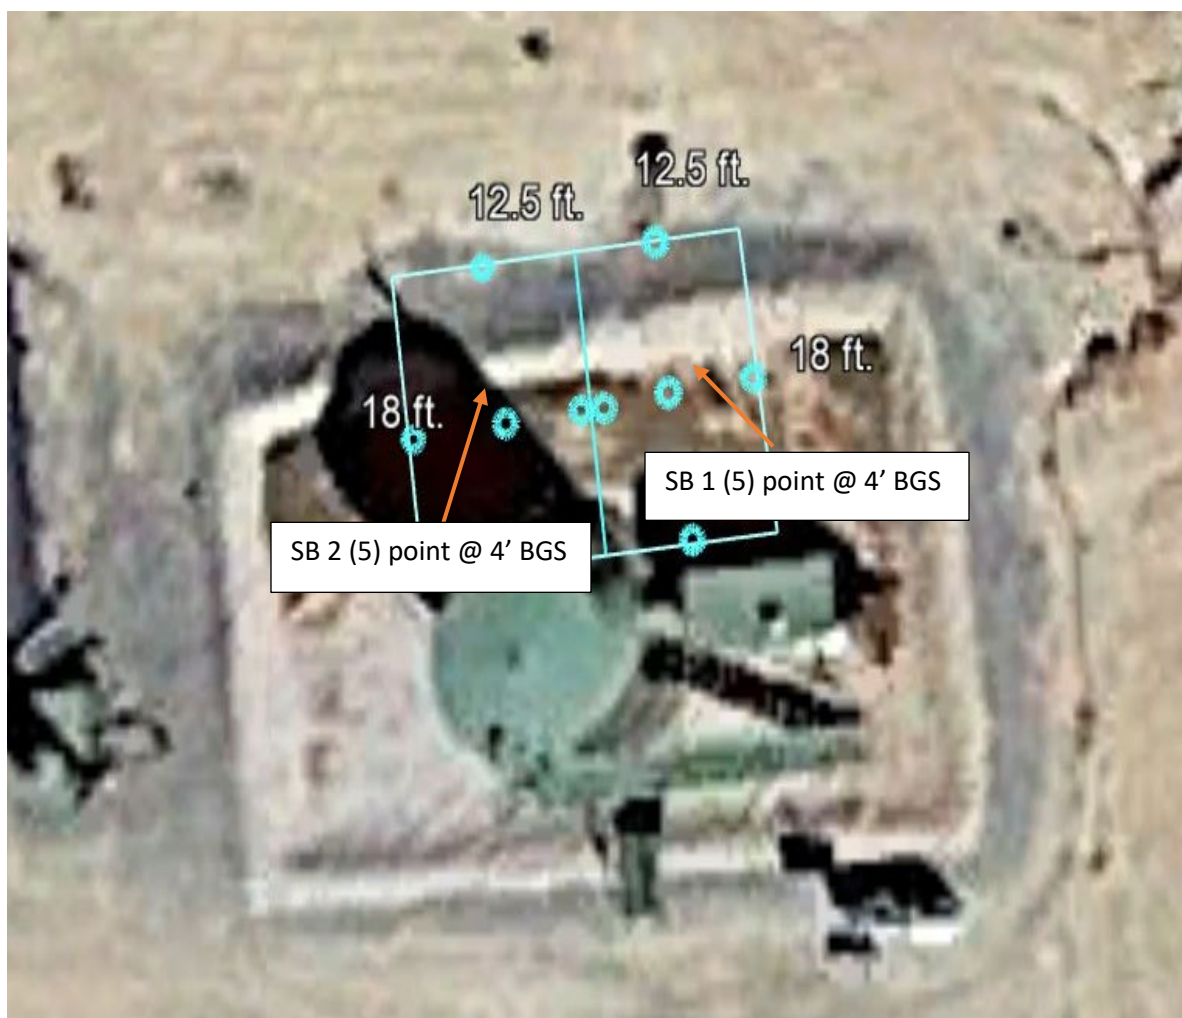
LOGOS delineated the area to 4' Bgs to determine the extent of the chloride concentration.

● = Delineation points to 4' Bgs Sample Results were below regulatory standards.
