**Re: Closure Request
Raider CS
Incident Number nAPP2415554067
Eddy County, New Mexico**

Ensolum, LLC (Ensolum) on behalf of XTO Energy, Inc. (XTO), has prepared this Closure Request to document site assessment and soil sampling activities performed at the Raider CS (Site). The purpose of the site assessment and soil sampling activities was to assess for the presence or absence of impacts to soil resulting from a equipment fire at the Site. Based on the field observations, field screening activities, and soil sample laboratory analytical results, XTO is submitting this *Closure Request* describing site assessment and composite soil sampling activities that have occurred and requesting no further action for Incident Number nAPP2415554067.

XTO Energy, Inc
Raider CS

Incident Number: nAPP2415554067
Unit G, Sec 36, T23S, R29E
Eddy County, NM

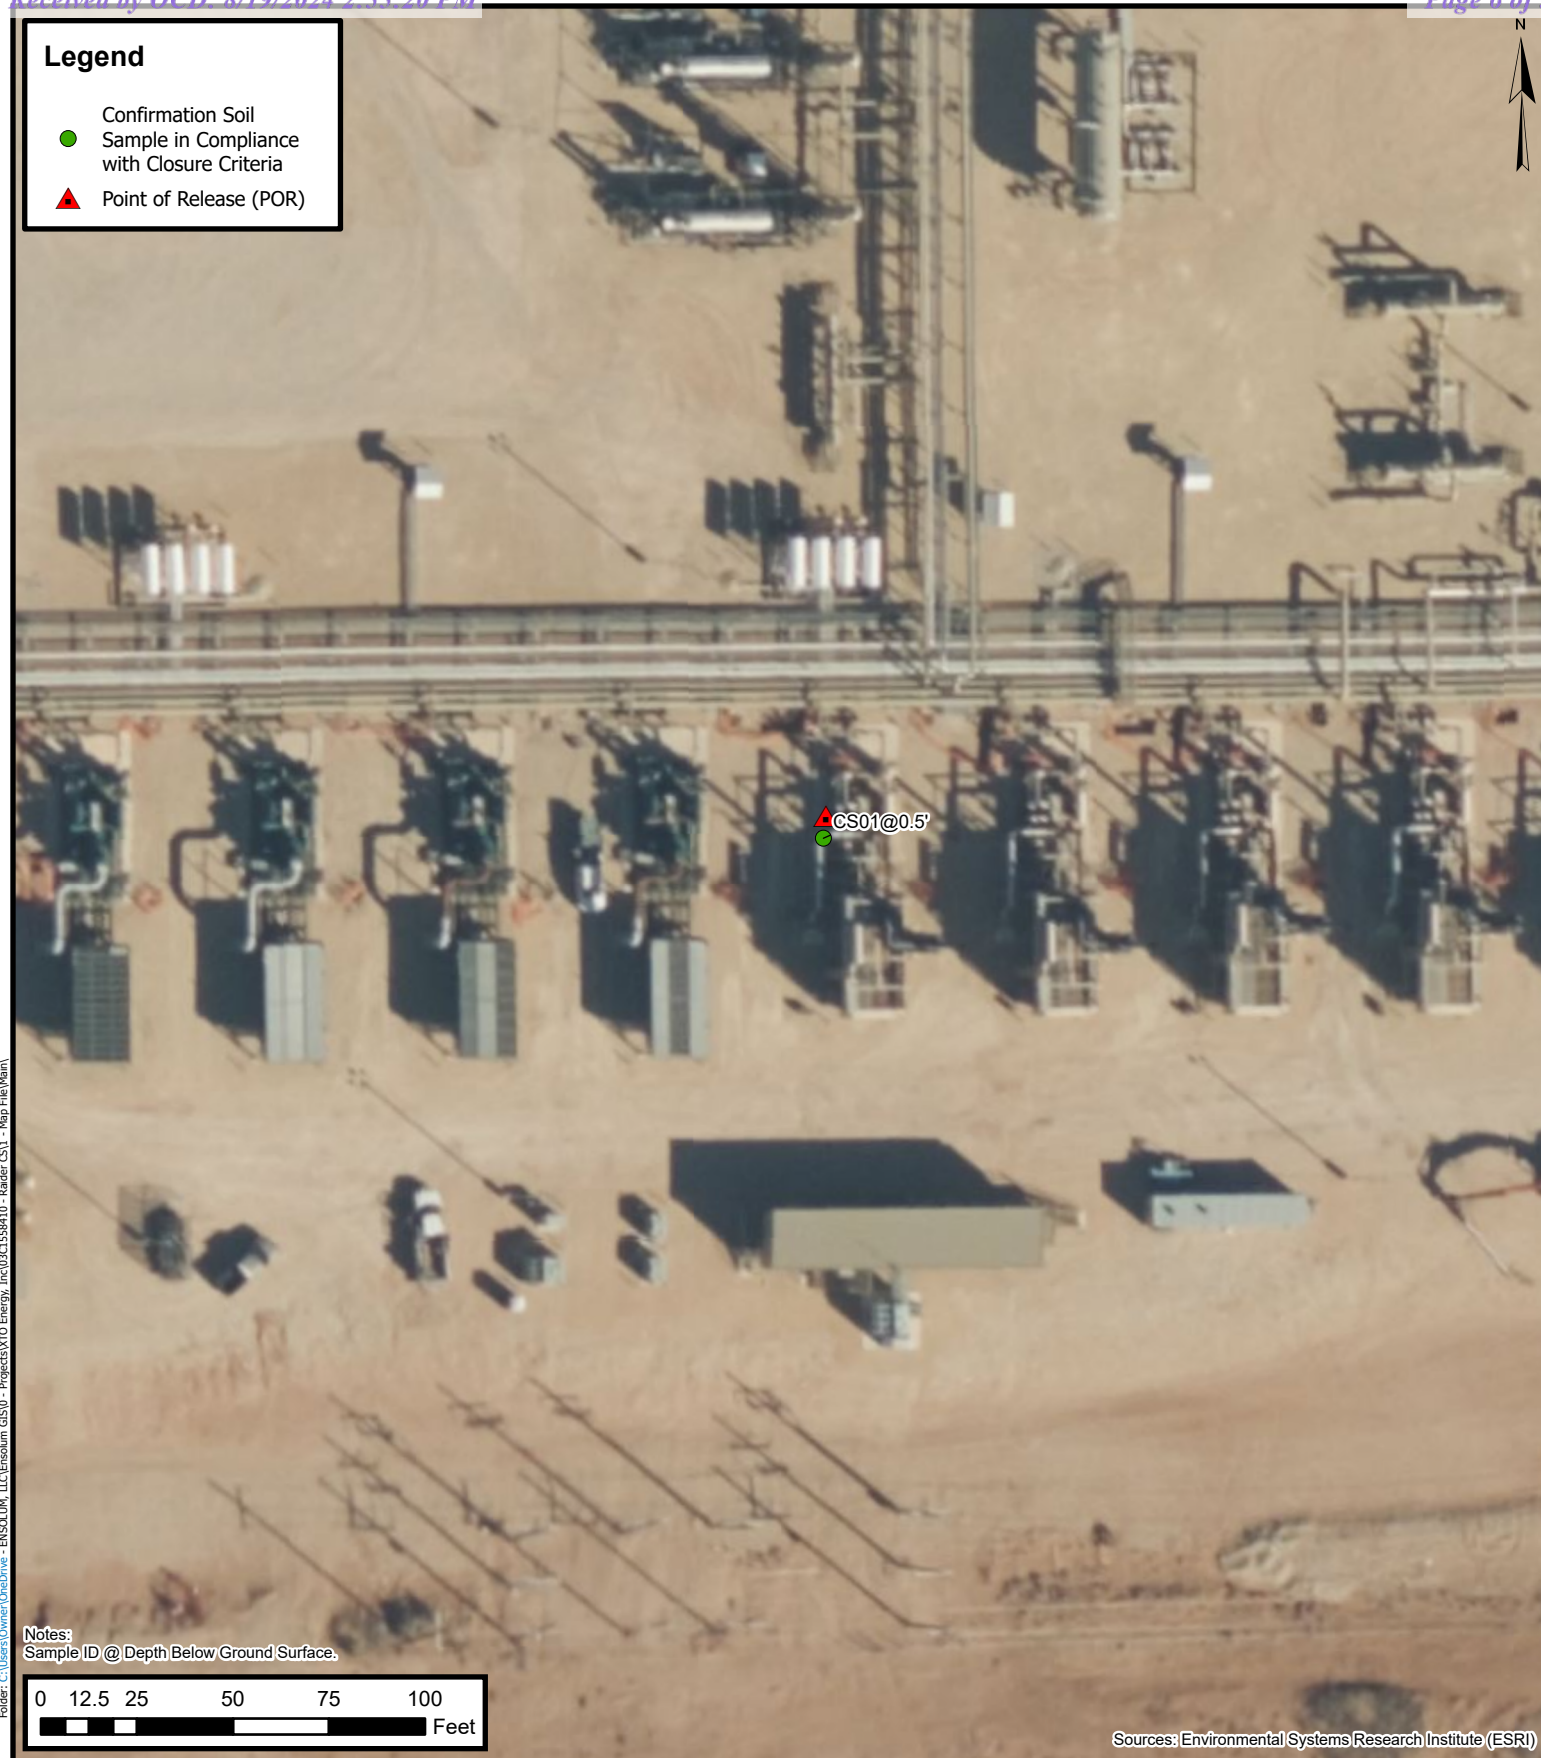
FIGURE**2**

On June 21, 2024, Ensolum personnel returned to the Site to complete composite sampling of the ground surface nearest the source of the fire. One composite confirmation soil sample (CS01) was collected from the ground surface to assess for the presence or absence of impacted soil. The preliminary soil sample was field screened for volatile organic compounds (VOCs) utilizing a calibrated photoionization detector (PID) and chloride utilizing Hach® chloride QuanTab® test strips. The composite soil sample location is depicted on Figure 2.

**Confirmation Soil Sample Locations**

Laboratory analytical results for confirmation soil sample CS01 indicated that benzene, BTEX, TPH, and chloride concentrations were compliant with the Site Closure Criteria. Laboratory analytical results are summarized in Table 1 and the complete laboratory analytical reports are included as Appendix D.

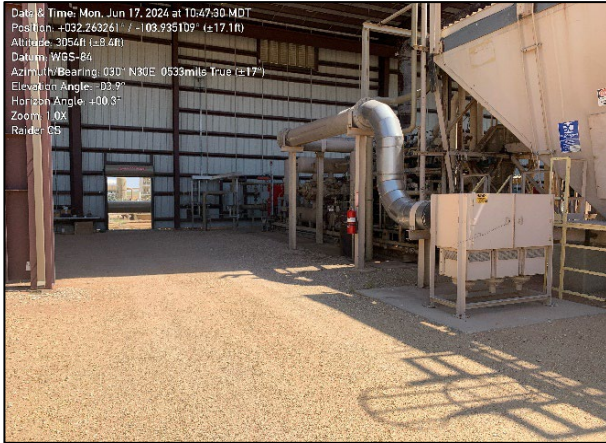
Photograph: 1 Date: 6/17/2024
Description: Compressor related to fire
View: Northeast

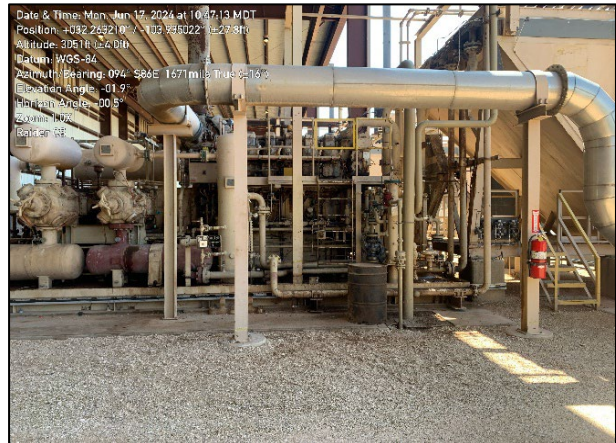
Photograph: 2 Date: 6/17/2024
Description: Source of the release
View: Southeast

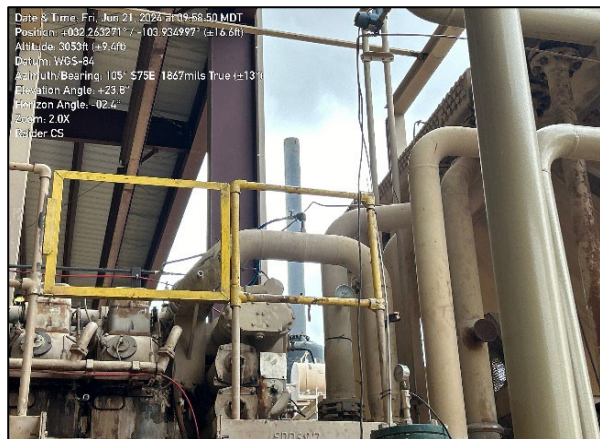
On May 27, 2024, an antifreeze/coolant line disconnected from the compressor causing a small fire from the exhaust. There was no fluids or fire believed to reach the ground surface. There were no fluids to recover. XTO reported the release via email to the New Mexico Oil Conservation Division (NMOCD) on June 3, 2024, and submitted an Initial C-141 Application (C-141) the same day. The release was assigned Incident Number nAPP2415554067.

Photograph: 3 Date: 6/21/2024
Description: Antifreeze line that disconnected
View: Southeast
