Re: Delineation Report and Closure Request

San Juan 31-6 Unit 230 Rio Arriba County, New Mexico Hilcorp Energy Company NMOCD Incident No: nAPP2412835625

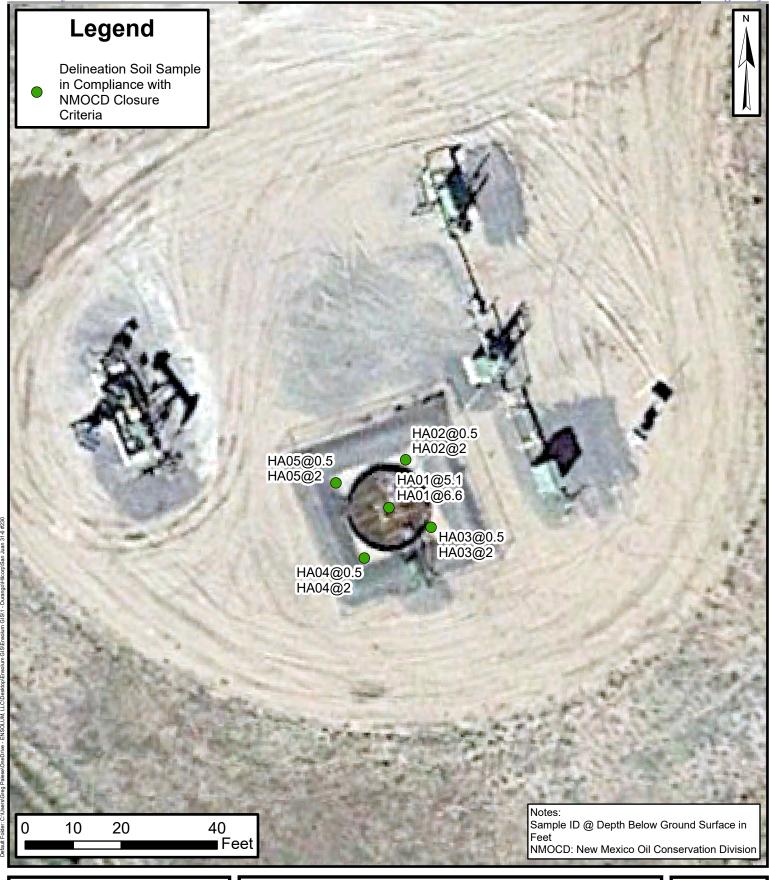
Soil Sample Locations Map

On May 16, 2024, Hilcorp retained Ensolum to screen and collect delineation soil samples from a total of five locations at the Site. Sample location HA01 was advanced at the base of the BGT cellar located approximately 4.8 feet below the well pad ground surface. Soil samples were subsequently collected via hand auger at 0.3 feet and 2.5 feet below the cellar surface. Sample locations HA02, HA03, HA04, and HA05 were advanced approximately 1-foot outside of the BGT cellar from the well pad ground surface and soil samples were collected via hand auger at 0.5 feet and 2 feet bgs. Sample locations are shown in Figure 2. Photographs taken during field activities are attached as Appendix C.

Laboratory results detected chloride at four sample locations HA01, HA02, HA03, and HA05 and ranged from below the laboratory detection limit of less than 60 mg/kg (HA03 @0.5, HA03 @2, and HA04 @2) and 270 mg/kg (HA02 @2). Concentrations for COCs were compliant with NMOCD Table I Closure Criteria, as well as the reclamation requirement in all delineation samples. A summary of laboratory analytical results is presented in Table 1, and complete laboratory analytical reports are attached as Appendix D.

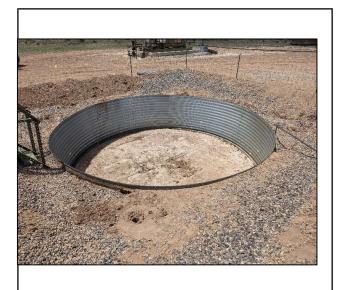
Photograph: 5 Date: 5/16/2024

Description: Northwest view of BGT tank

View: Northwest
