**Re: Liner Inspection and Closure Request  
ConocoPhillips  
Gin and Tectonic Federal 5 O South CTB Release  
Unit Letter O, Section 5, Township 24 South, Range 32 East  
Lea County, New Mexico  
Incident ID# NAPP2419036870**

Liner Inspection and Closure Report  
August 6, 2024

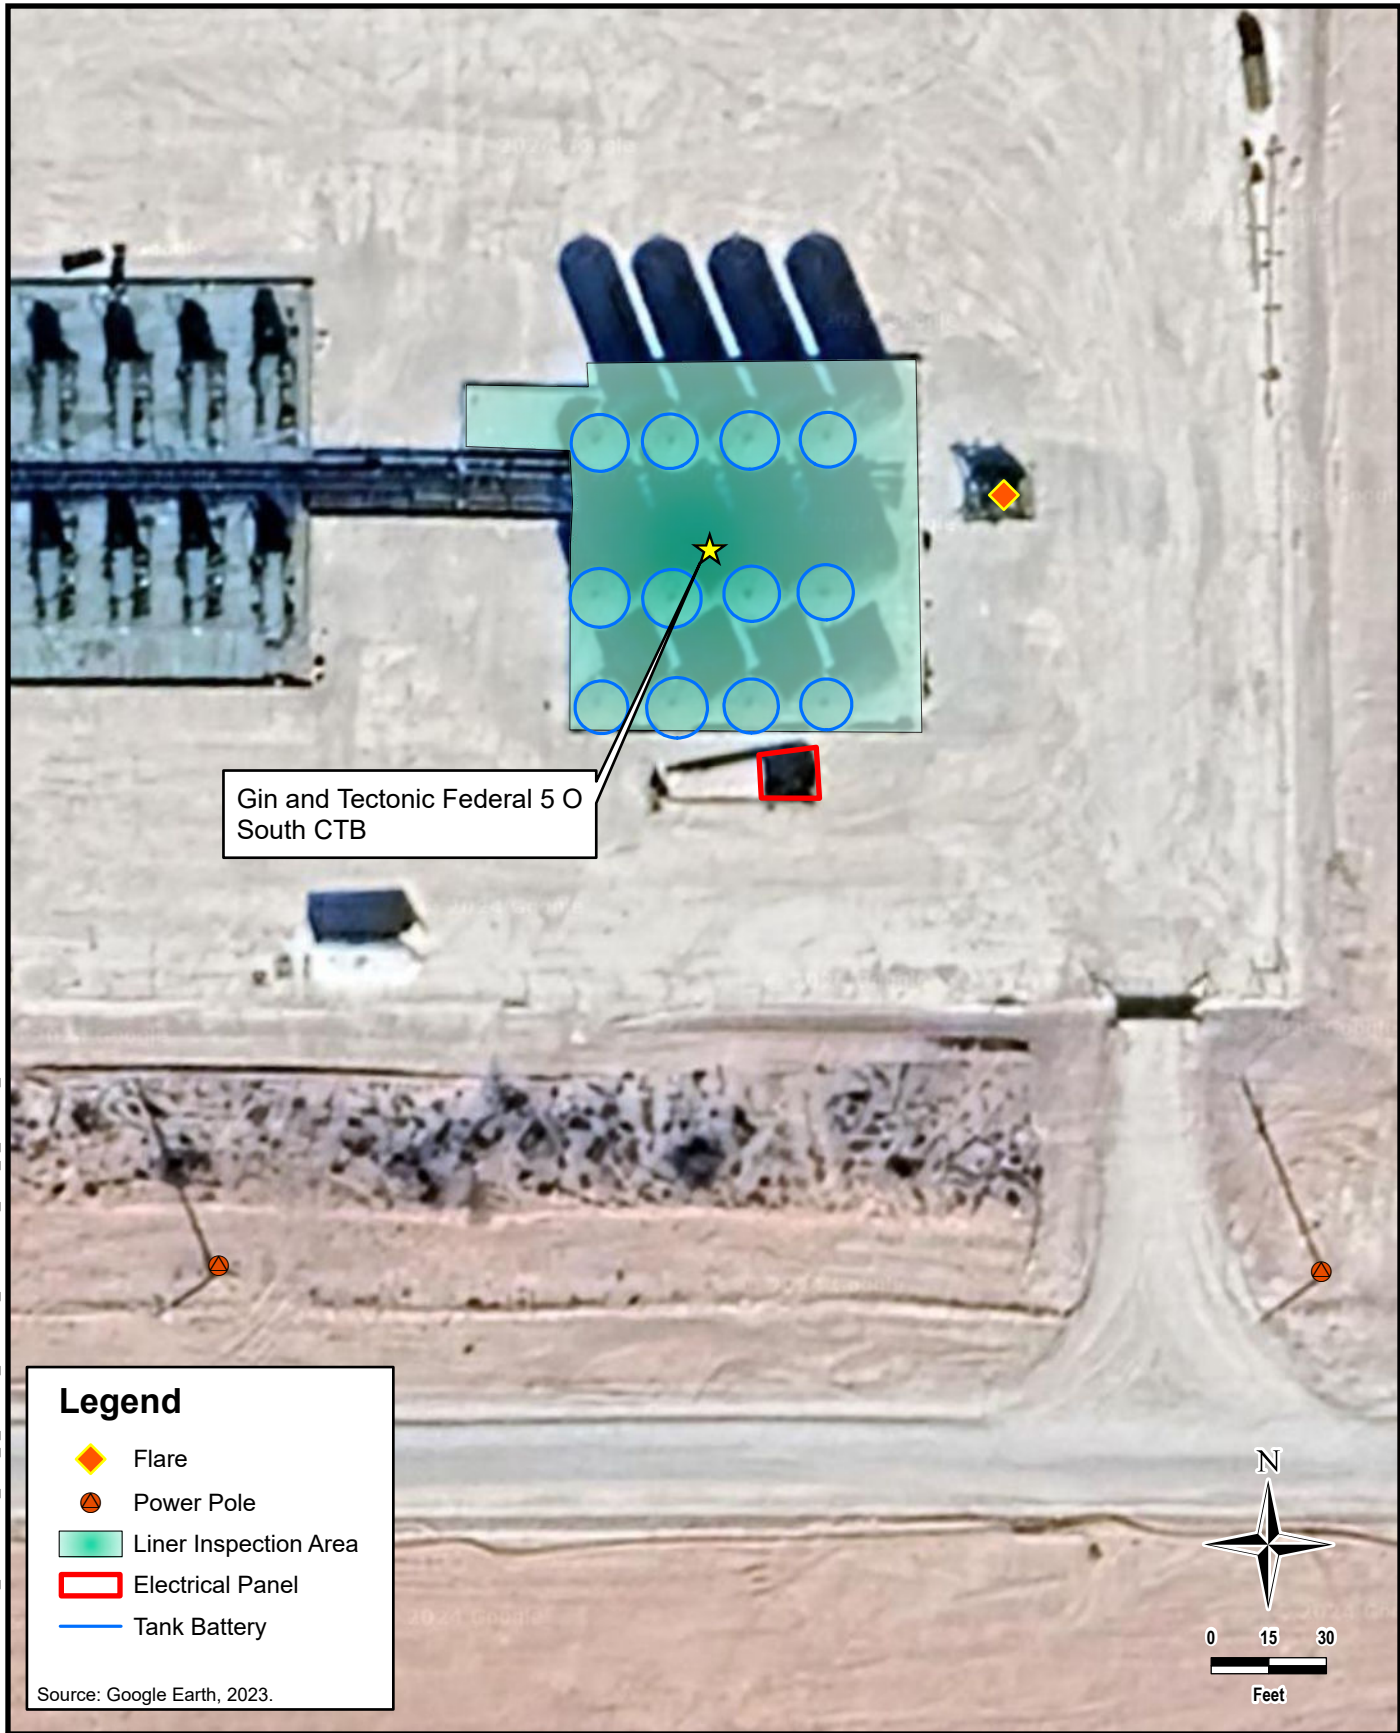
**3**

**GIN AND TECTONIC FEDERAL 5 O SOUTH CTB  
APPROXIMATE RELEASE EXTENT AND LINER INSPECTION AREA**

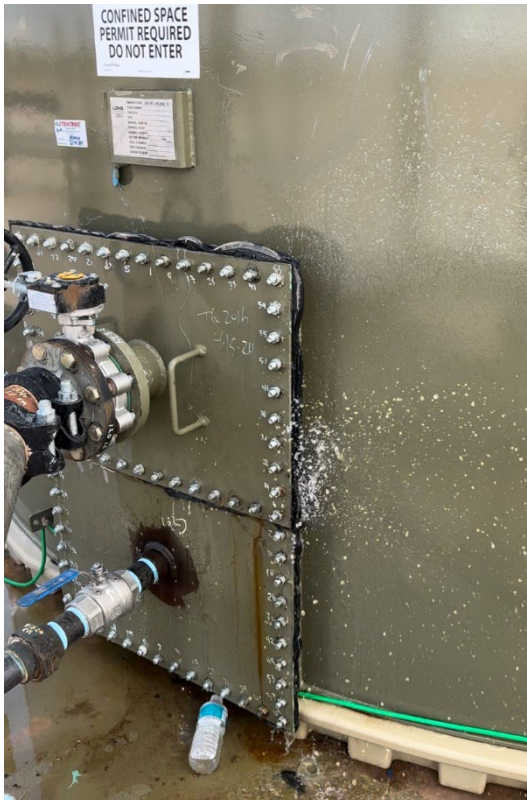
| TETRA TECH, INC.<br>PROJECT NO.<br>212C-MD-03561 | DESCRIPTION | View of approximate release point. | 1 |

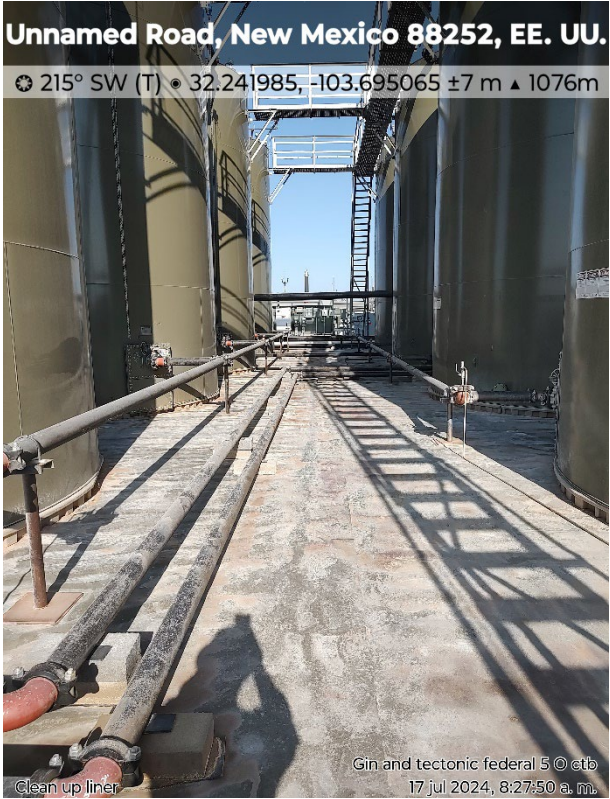
| TETRA TECH, INC.<br>PROJECT NO.<br>212C-MD-03561 | DESCRIPTION | View southwest. View of liner following pressure washing activities | 3 |

Prior to conducting the liner inspection, ConocoPhillips representatives pressure washed the liner on July 17, 2024. Photographic documentation following the pressure washing activities are included in Appendix D. On July 25, 2024, Tetra Tech personnel performed an inspection of the liner within the containment area of the Gin and Tectonic Federal 5 O South CTB Tank Battery. This work was completed to verify the integrity of the liner. The liner was observed to underlie the entirety of the tank battery containment area. The liner was intact with no visible rips or tears and encompassed by an approximately 2-foot-tall muscle wall. The liner extended up the muscle wall and was anchored on the interior. At the time of the inspection, the liner was intact and had the ability to contain the documented release. Photographic documentation of the liner inspection is included in Appendix D.

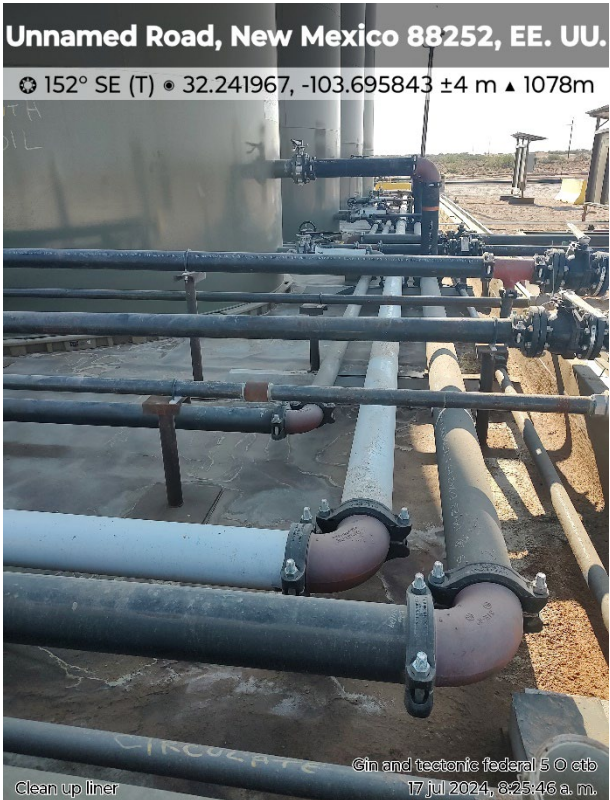
| TETRA TECH, INC.<br>PROJECT NO.<br>212C-MD-03561 | DESCRIPTION | View southeast. View of liner following pressure washing activities. | 4 |

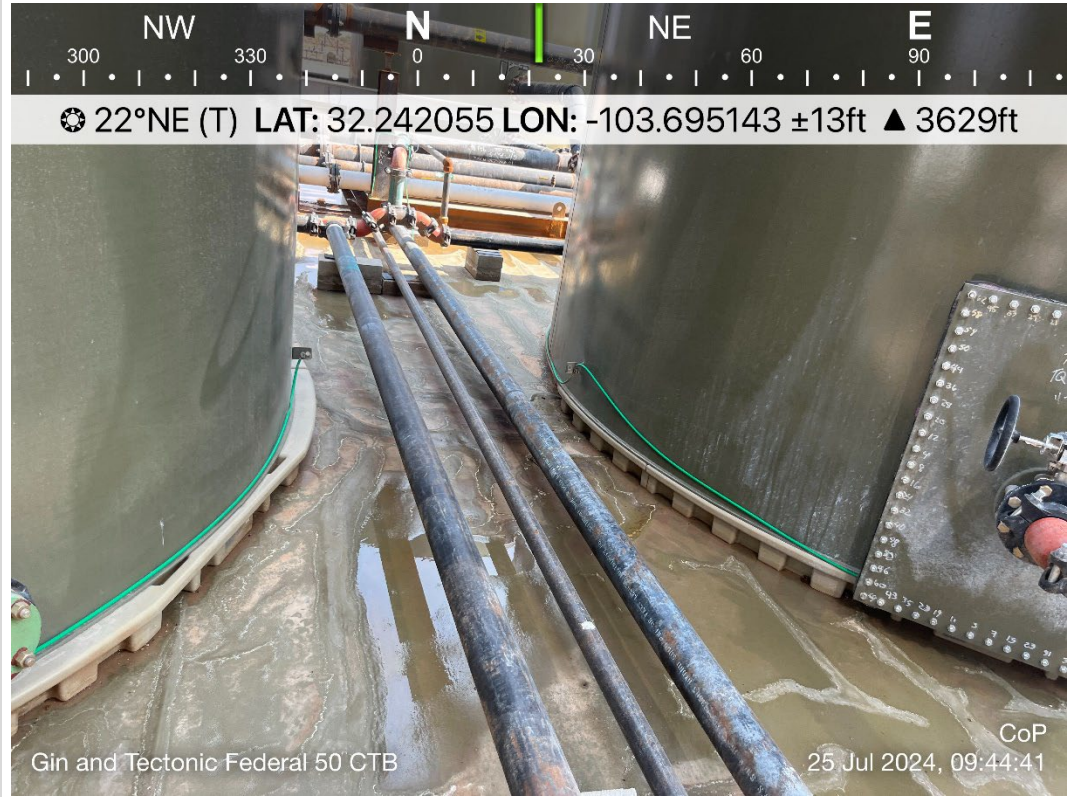
| TETRA TECH, INC.<br>PROJECT NO.<br>212C-MD-03561 | DESCRIPTION | View north. View of liner integrity. | 7 |

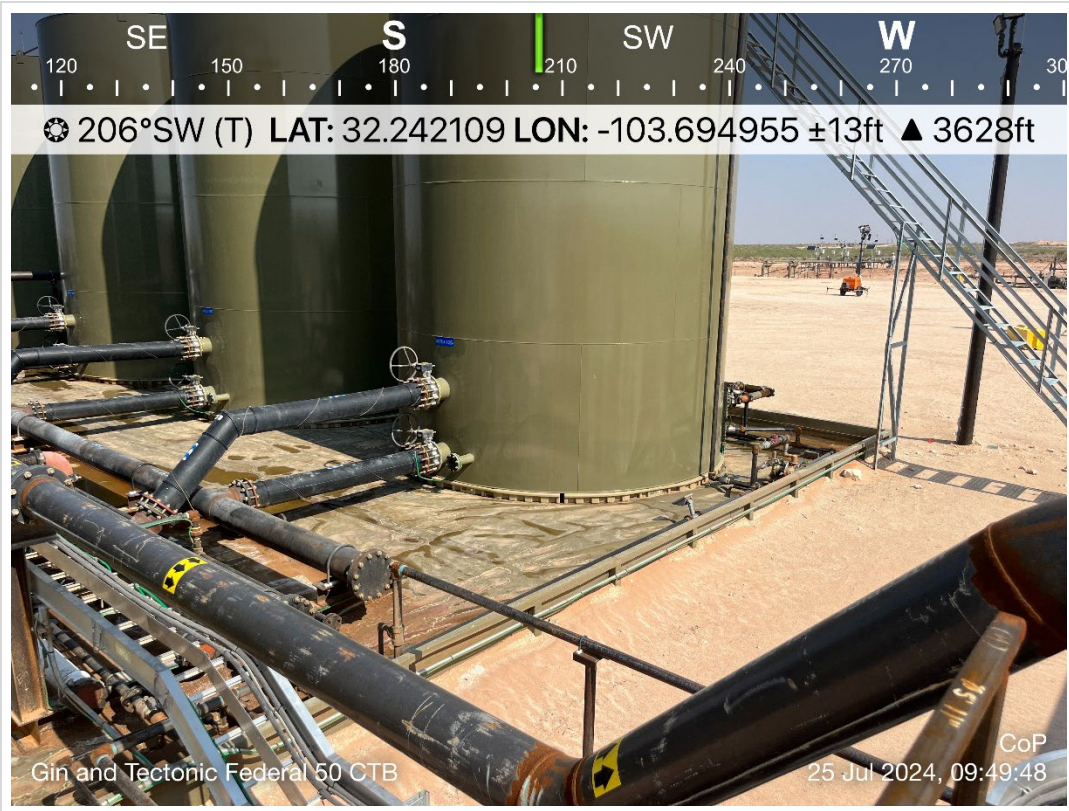
| TETRA TECH, INC.<br>PROJECT NO.<br>212C-MD-03561 | DESCRIPTION | View south southwest. View of liner integrity. View of facility conditions. | 8 |

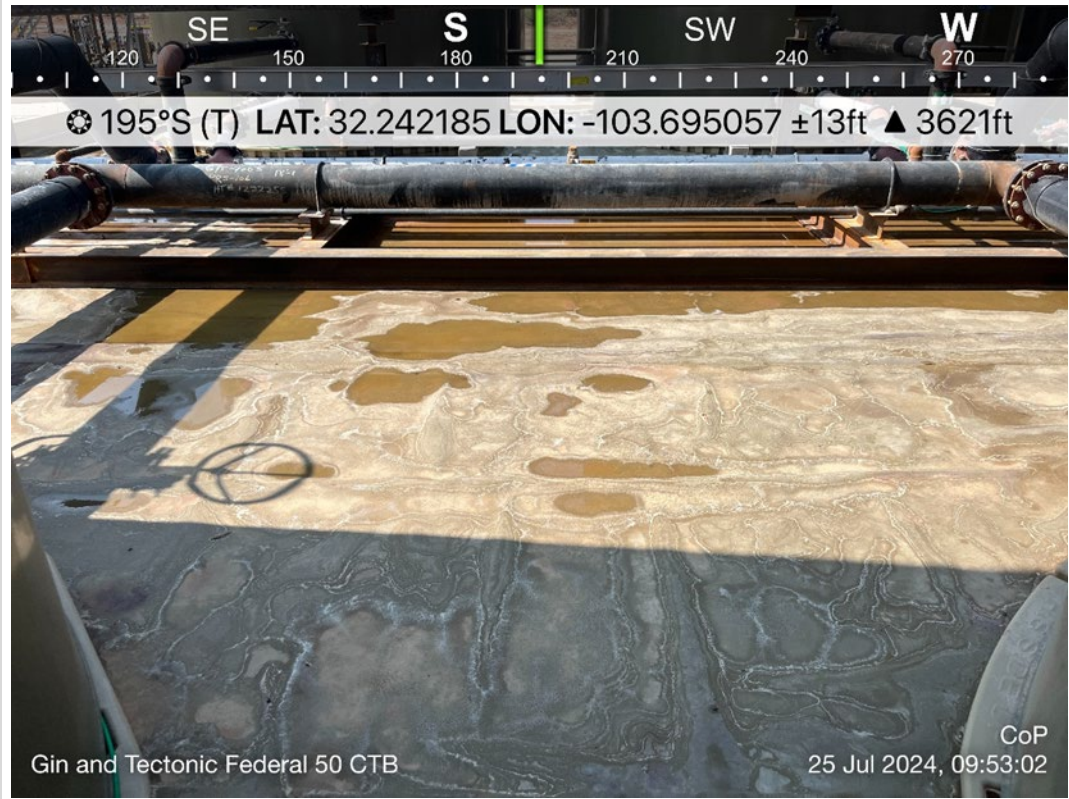
| TETRA TECH, INC.<br>PROJECT NO.<br>212C-MD-03561 | DESCRIPTION | View south. View of liner and ponded rainwater. View of facility and equipment. | 9 |

This portion of Lea County (area of the Gin and Tectonic Federal 5 O South CTB) experienced multiple rain events after the initial cleaning but prior to the official liner inspection. Photographs of the liner during the inspection indicate areas of standing rainwater from these weather events. It should be recognized that photographs collected after the pressure washing activities indicate no fluids on the liners as these activities occurred prior to the rain events. Nonetheless, the standing fluid observed in the official liner inspection photographs lend further evidence to the integrity of the liner as a competent fluid barrier.

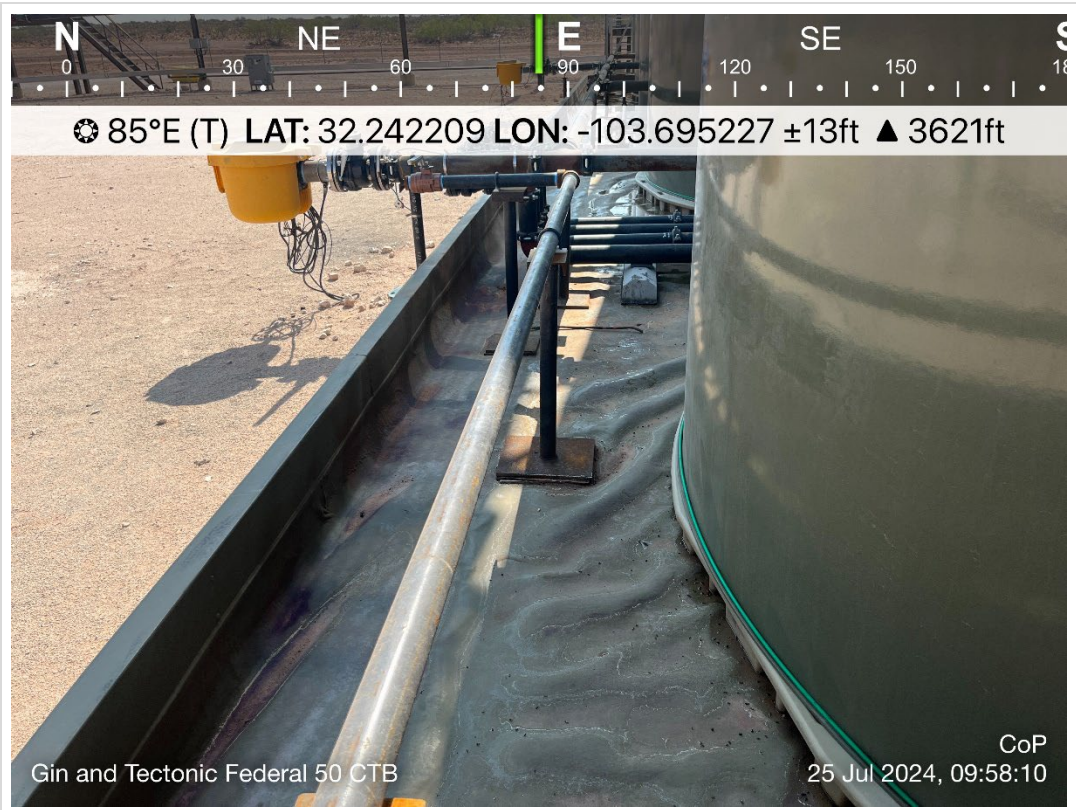
| TETRA TECH, INC.<br>PROJECT NO.<br>212C-MD-03561 | DESCRIPTION | View east. View of liner integrity and muscle wall. No staining observed outside of the lined facility. | 10 |

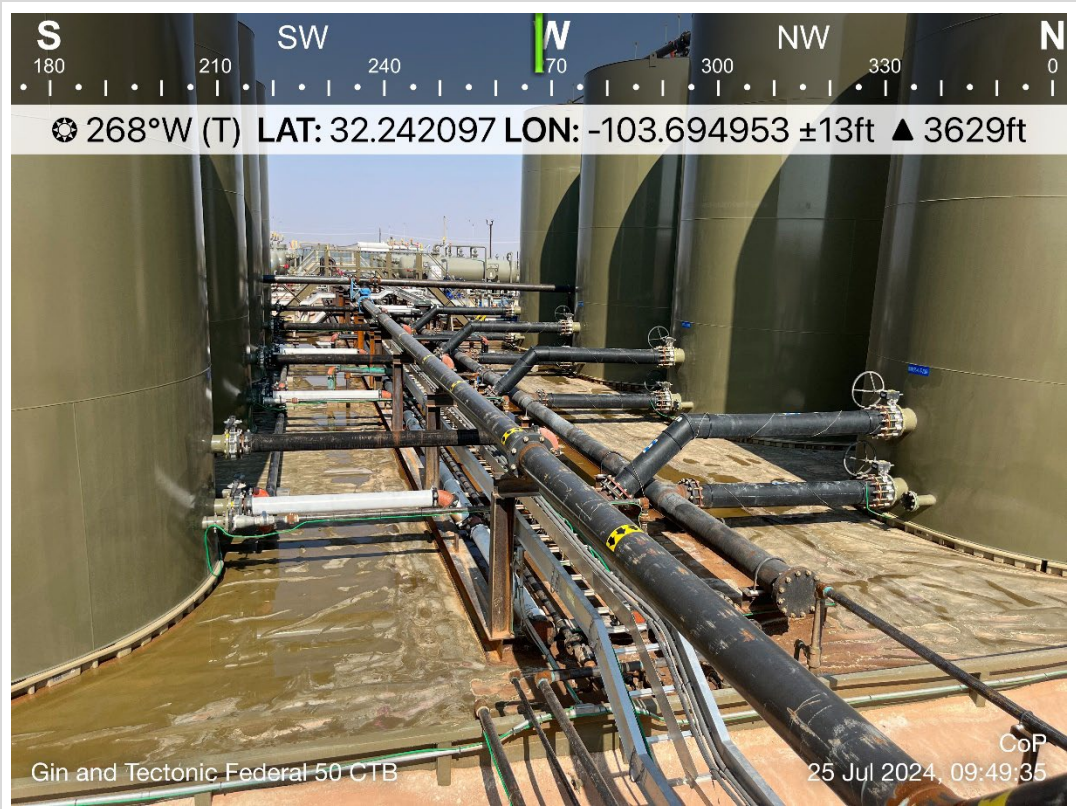
| TETRA TECH, INC.<br>PROJECT NO.<br>212C-MD-03561 | DESCRIPTION | View west. View of liner integrity and ponded rainwater. View of facility and equipment. | 11 |

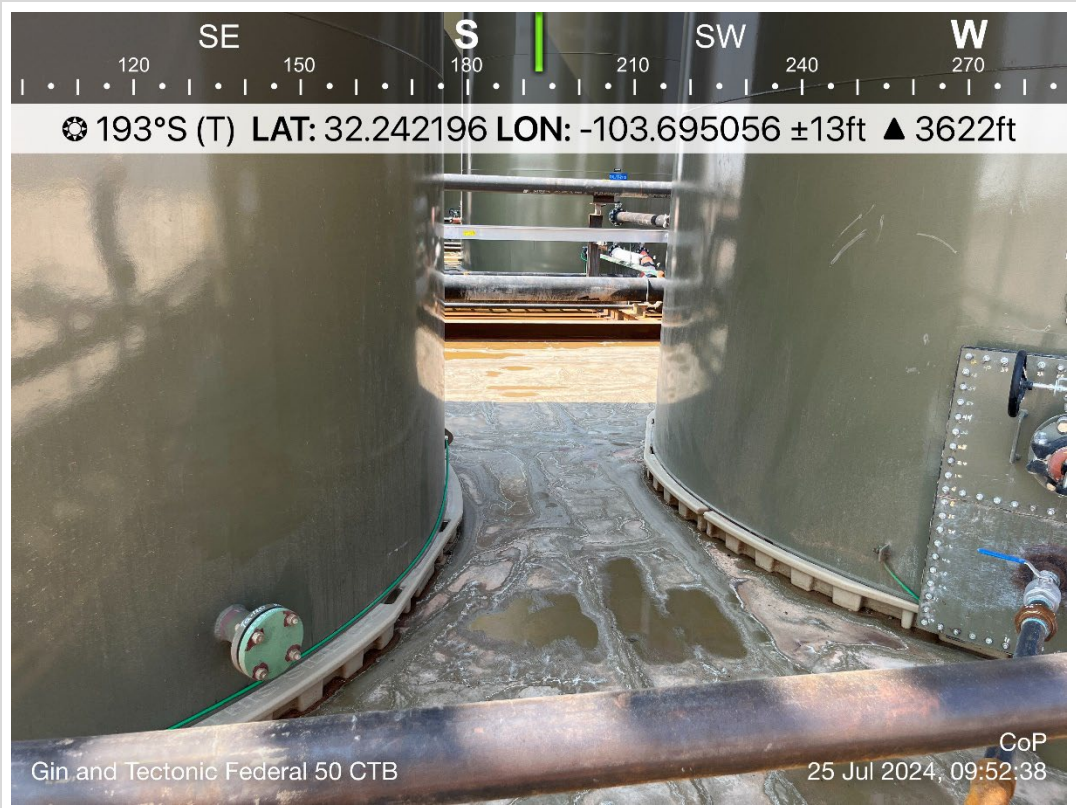
| TETRA TECH, INC.<br>PROJECT NO.<br>212C-MD-03561 | DESCRIPTION | View south. View of liner integrity. No rips or tears observed. | 12 |

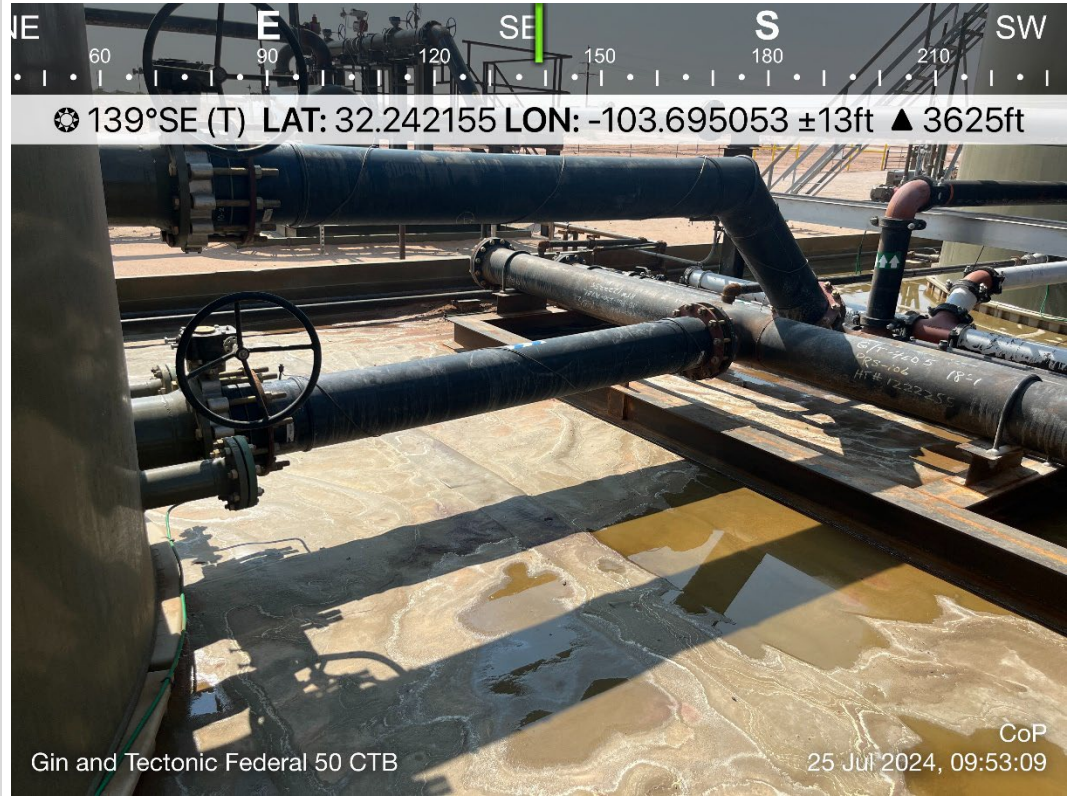
| TETRA TECH, INC.<br>PROJECT NO.<br>212C-MD-03561 | DESCRIPTION | View southeast. View of liner integrity and ponded rainwater. View of facility and equipment. | 13 |

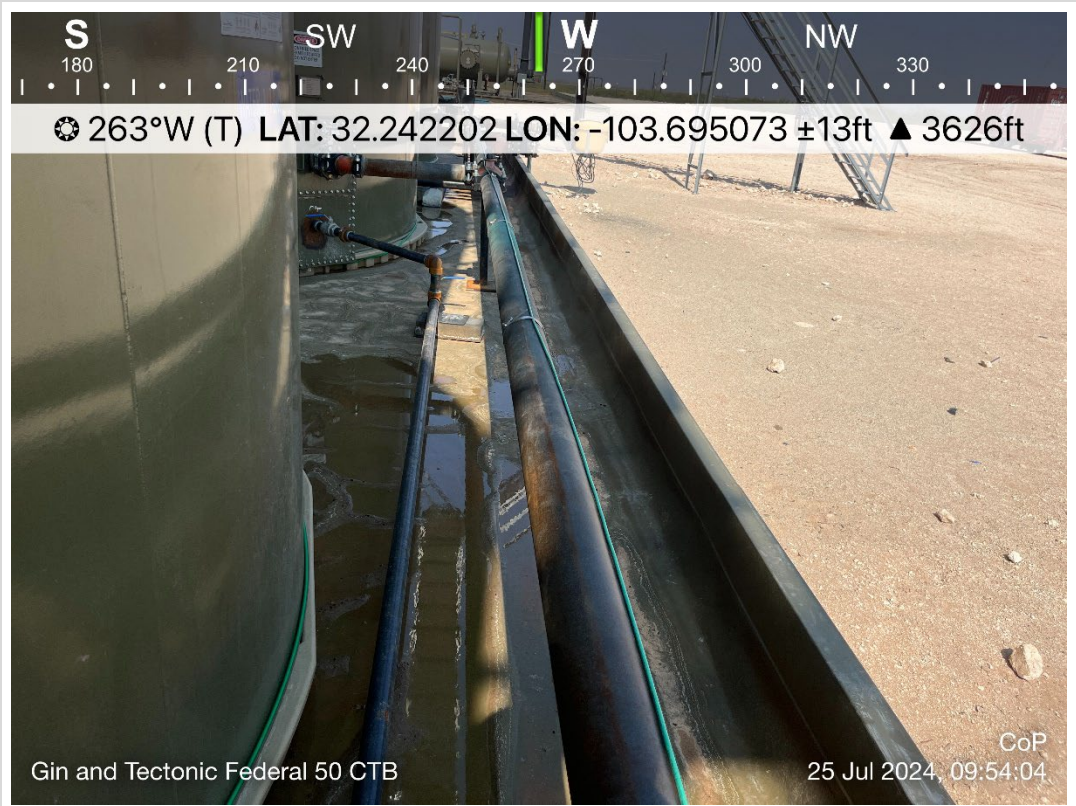
| TETRA TECH, INC.<br>PROJECT NO.<br>212C-MD-03561 | DESCRIPTION | View west. View of liner integrity and muscle wall. No staining observed outside of the lined facility. Ponded rainwater observed. | 14 |

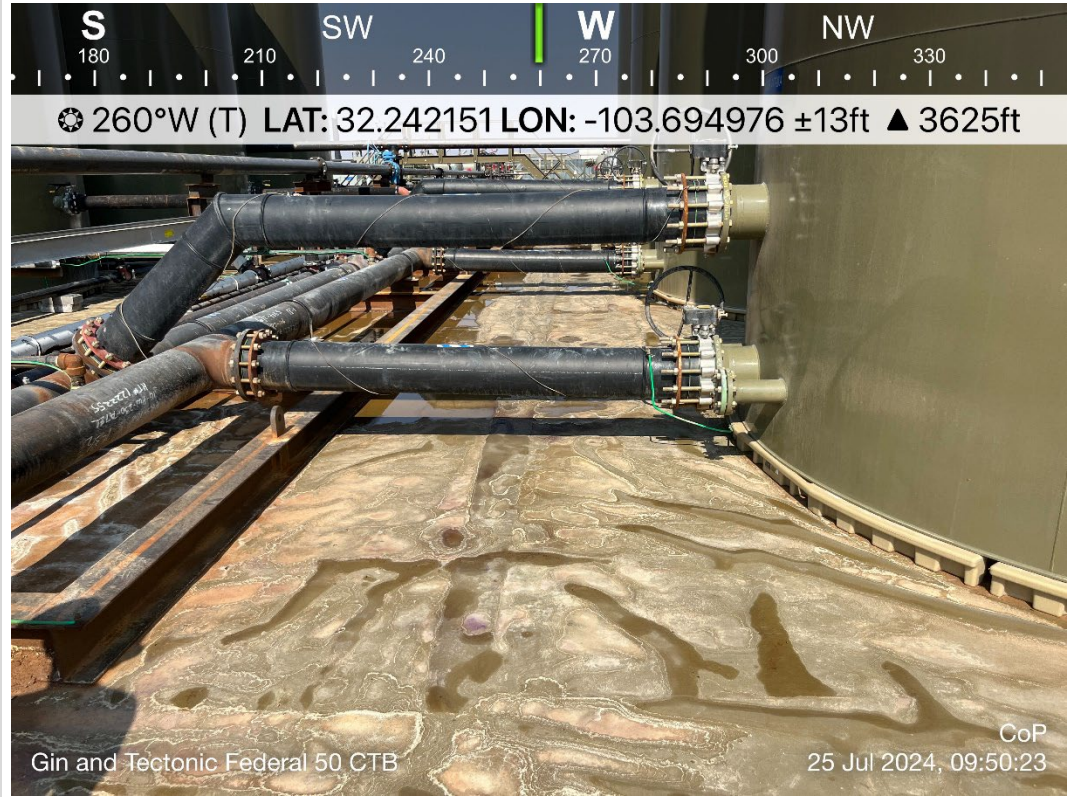
| TETRA TECH, INC.<br>PROJECT NO.<br>212C-MD-03561 | DESCRIPTION | View west. View of liner integrity. No rips or tears observed. Rainwater observed. | 15 |

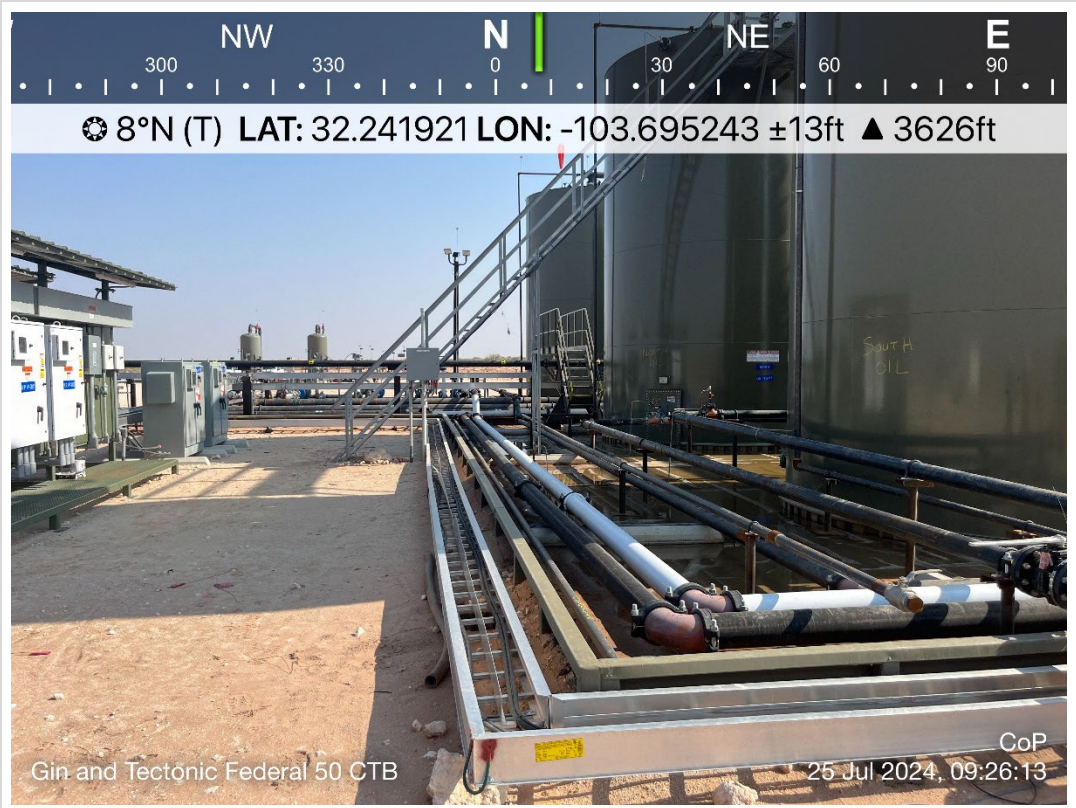
| TETRA TECH, INC.<br>PROJECT NO.<br>212C-MD-03561 | DESCRIPTION | View north. View of muscle wall. No staining observed outside of the lined facility. | 16 |

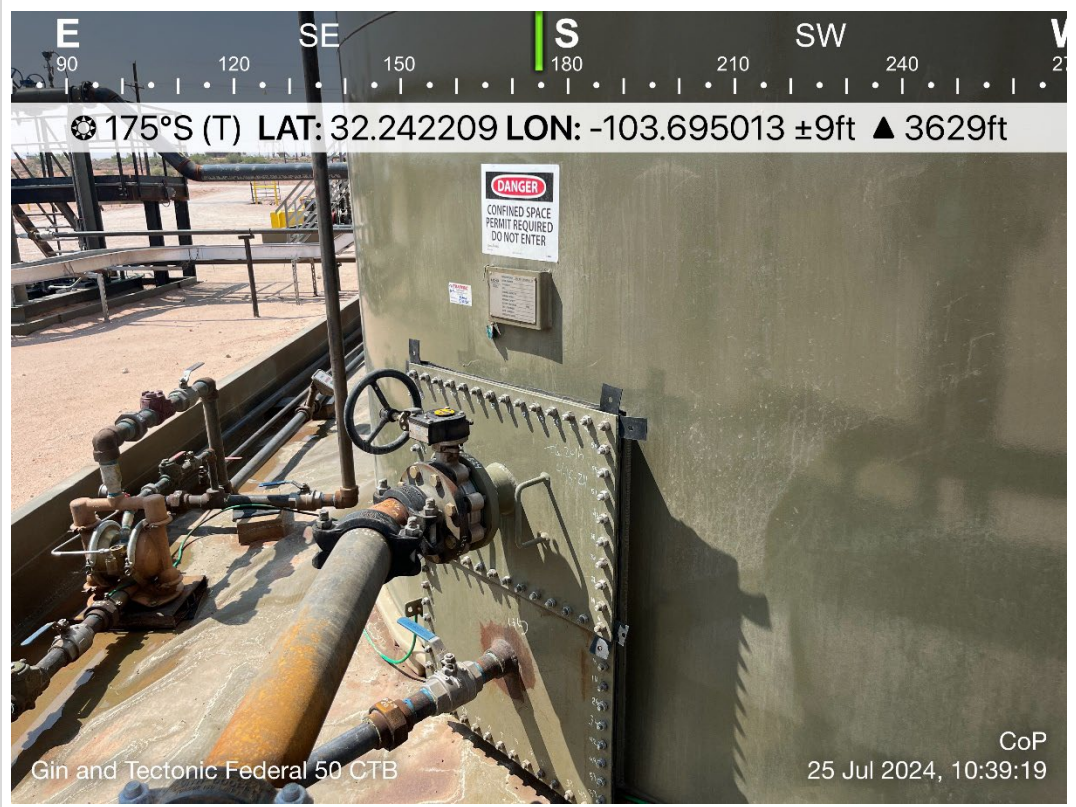
| TETRA TECH, INC.<br>PROJECT NO.<br>212C-MD-03561 | DESCRIPTION | View south. View of liner integrity. | 17 |

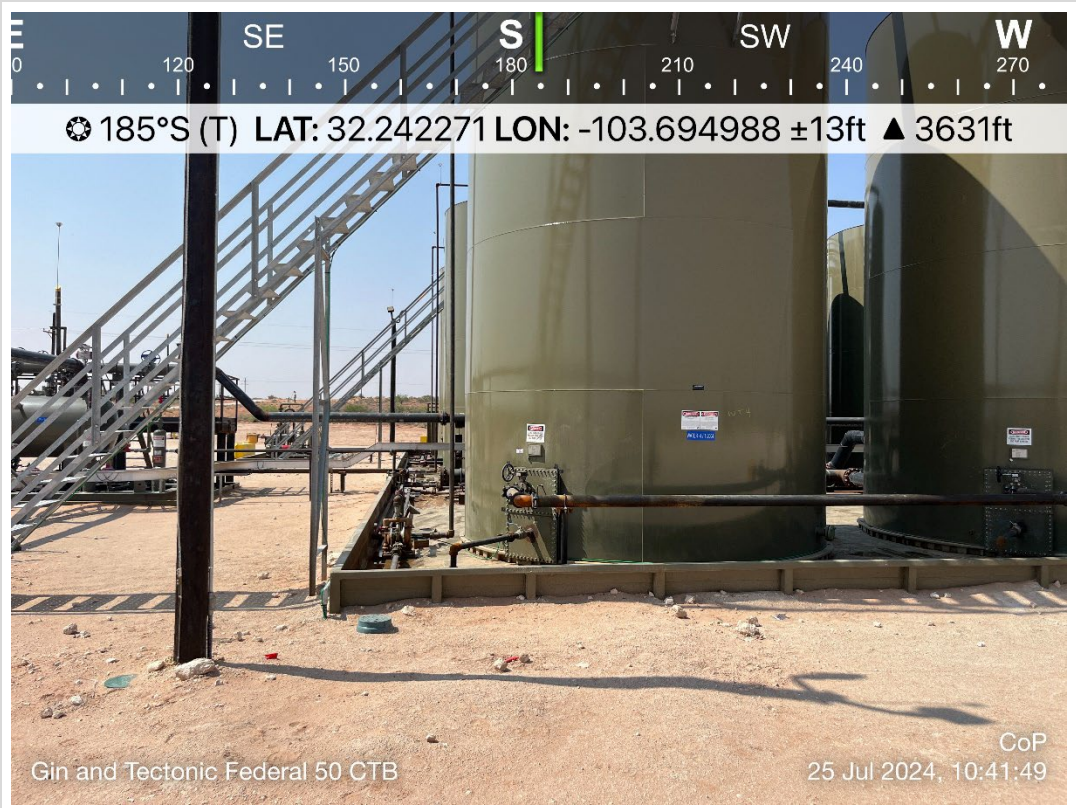
| TETRA TECH, INC.<br>PROJECT NO.<br>212C-MD-03561 | DESCRIPTION | View south. View of liner integrity and muscle wall. No staining observed outside of the lined facility. | 18 |
