REMEDIATION CLOSURE REPORT

Incident ID nJMW1331940873

Burton Flat 48

Prepared By:
Pima Environmental Services, LLC

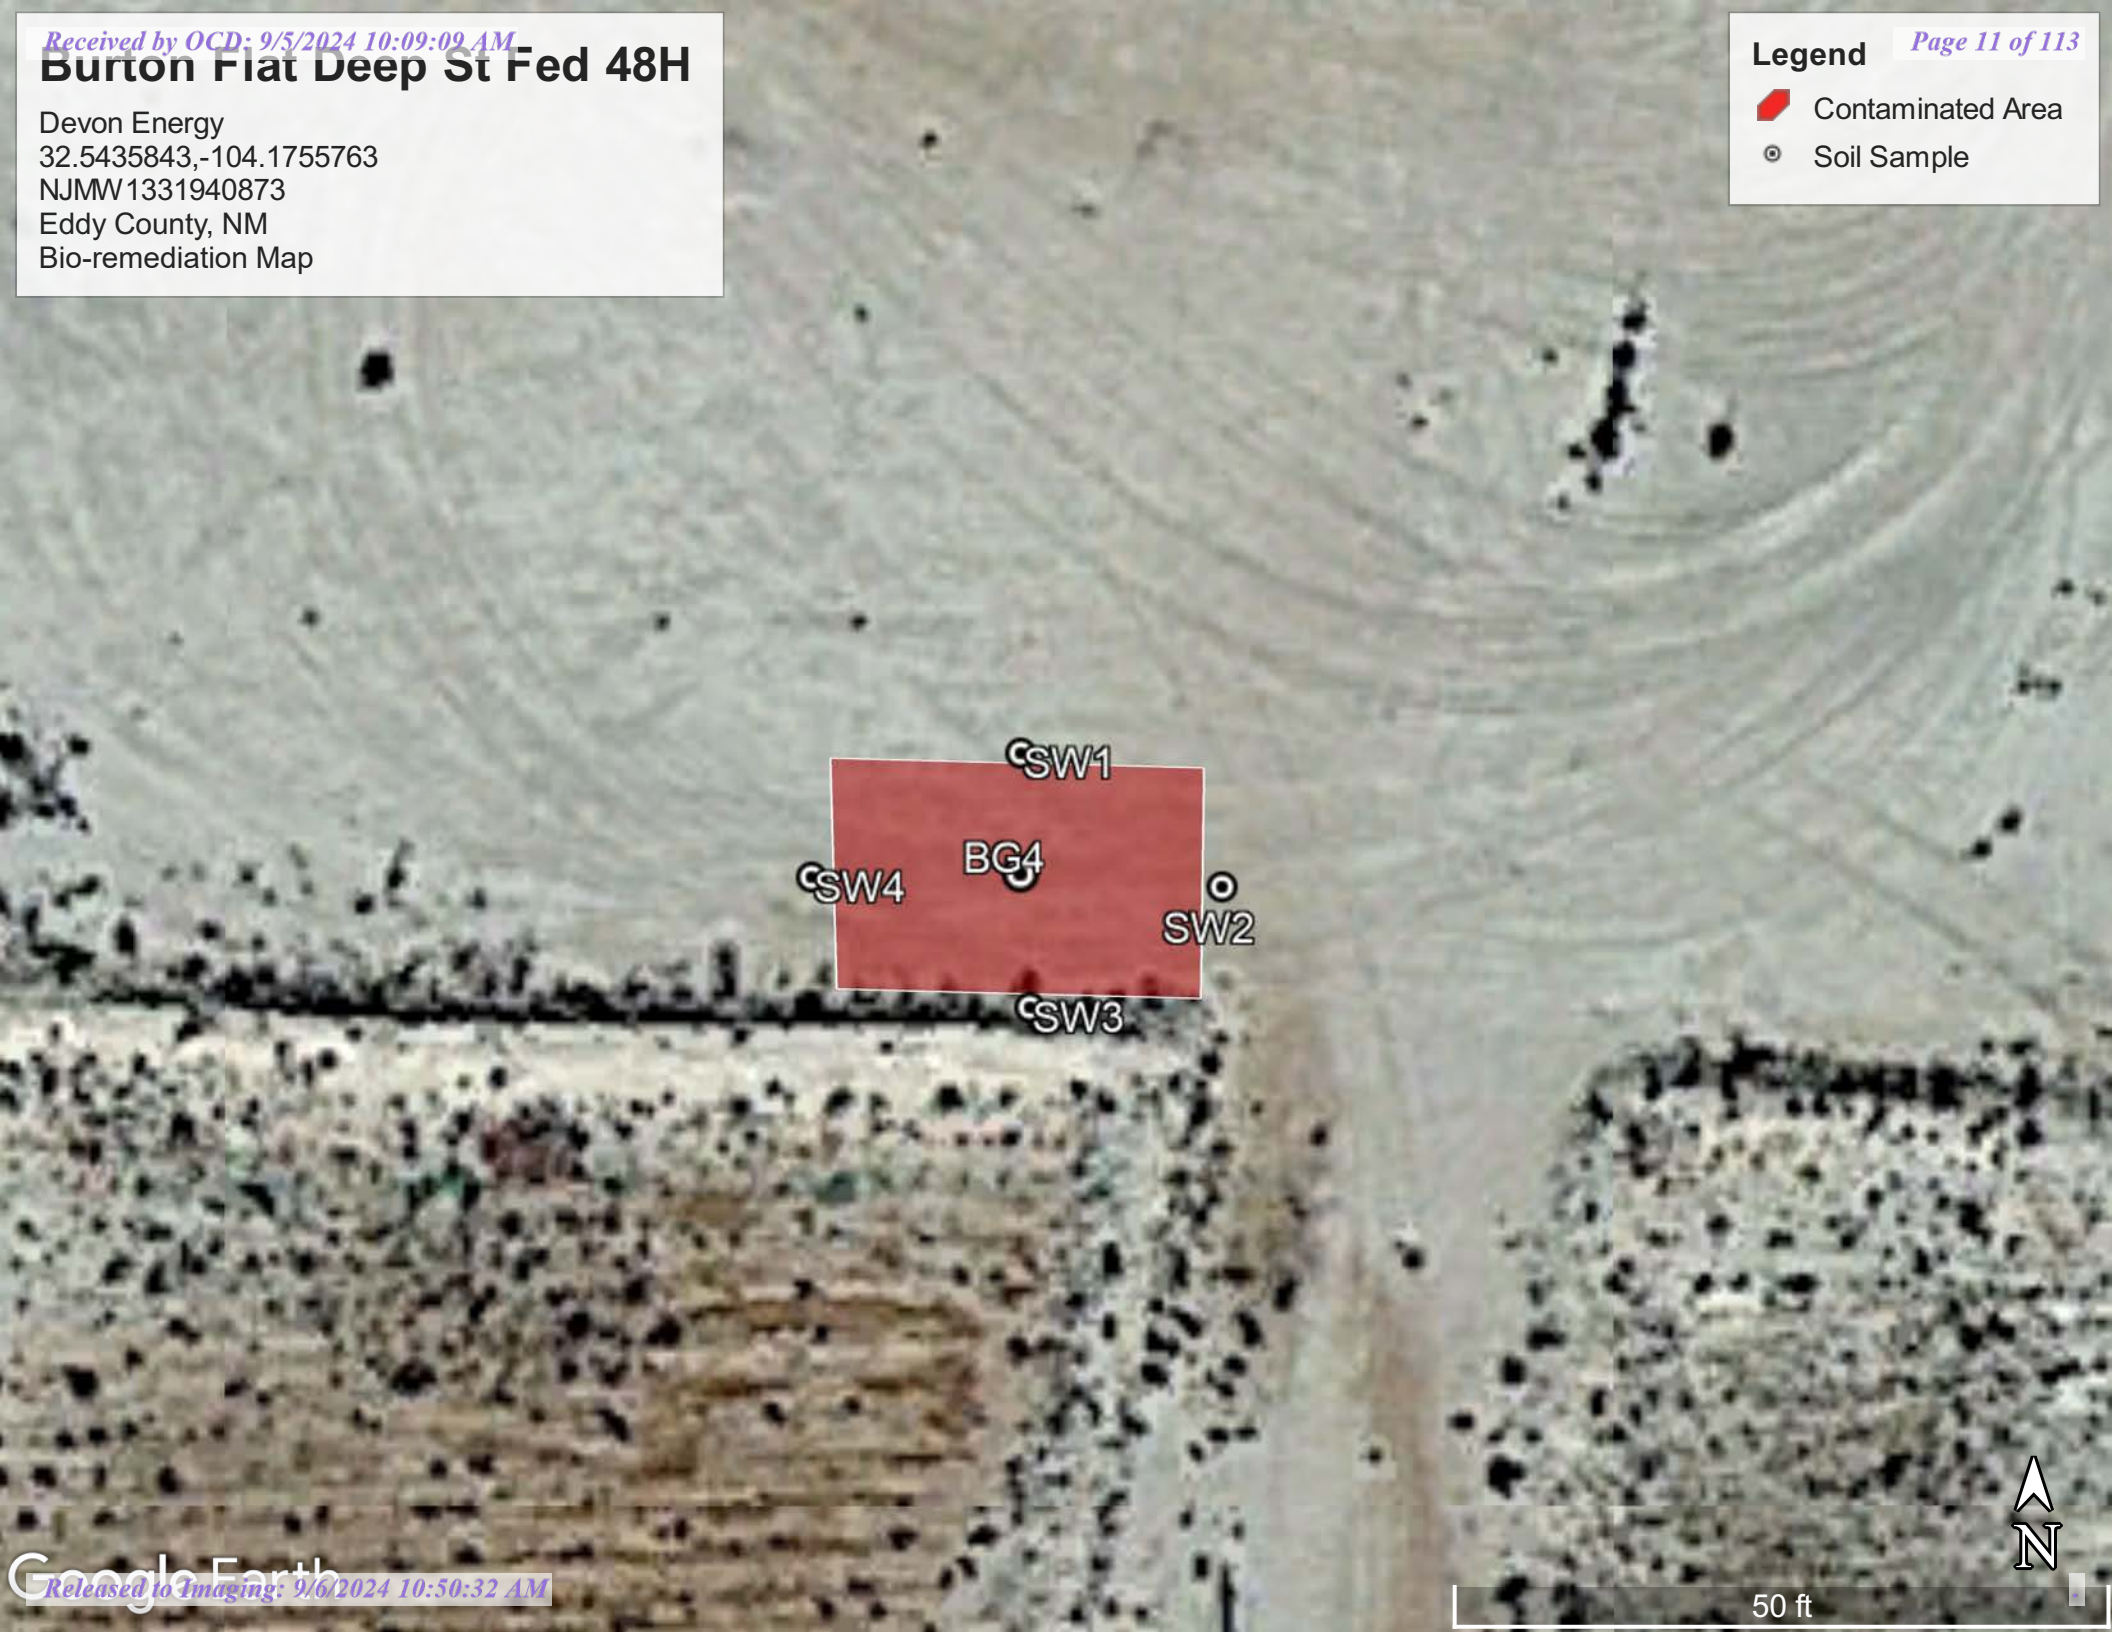
Figure 5- Bio-remediation Map

Devon Energy
32.5435843,-104.1755763
NJMW1331940873
Eddy County, NM
Bio-remediation Map

Contaminated Area
-

Soil Sample

review and make the required correction(s) prior to resubmitting. If you have any questions why this application was rejected or believe it was rejected in error, please contact me prior to submitting an additional C-141." A Bio-remediation Map can be found in Figure 5.

On June 28, 2024, Pima and the Devon construction department mobilized personnel and equipment to the site to begin removing all the soil previously treated by the bioremediation method. A 400 square foot area surrounding the original BG4 sample point was excavated by mechanical equipment to a depth of 1' bgs. After Devon submitted a 48-Hour sampling notification (Appendix C), Pima personnel collected confirmation samples from the excavation. Composite base samples were collected from 2 sample points and a composite wall sample was collected from the walls of the excavation. The samples were immediately put on ice, jarred, and delivered to Envirotech Labs for official testing. All samples were analyzed for all constituents listed on Table 1 19.15.29.12 NMAC. The results of this sampling event can be seen in the following data table. A Confirmation Sample Map can be found in Figure 6.

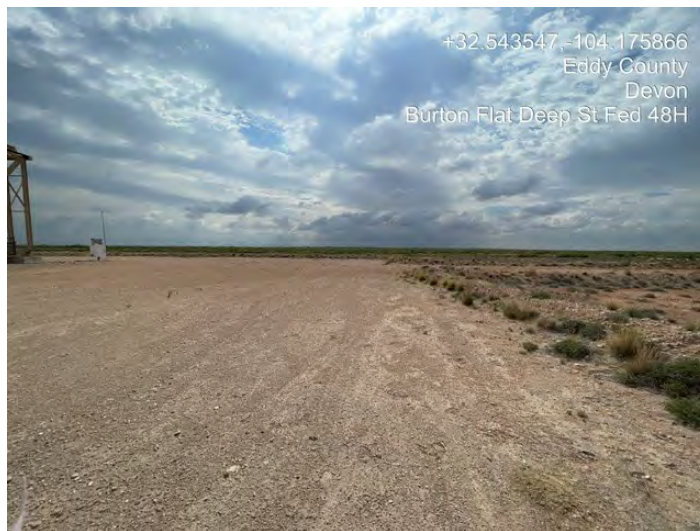
Photograph No. 2

Description: West side of area looking east

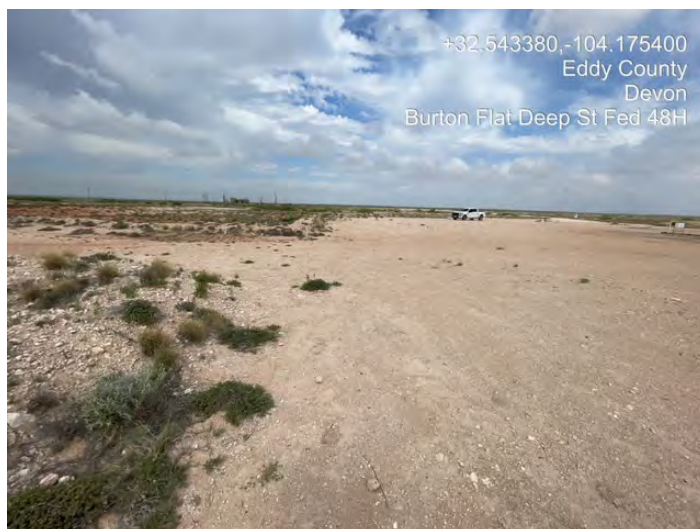
Photograph No. 3

Description: East side of area looking west

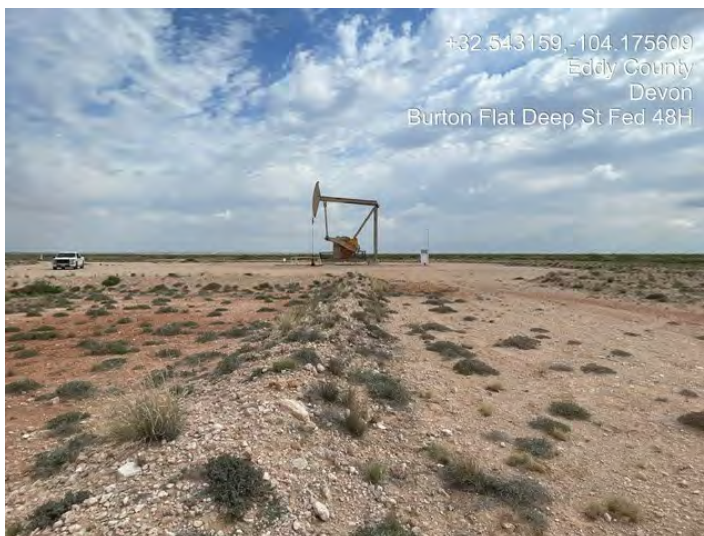
Photograph No. 4

Description: South side of area looking north

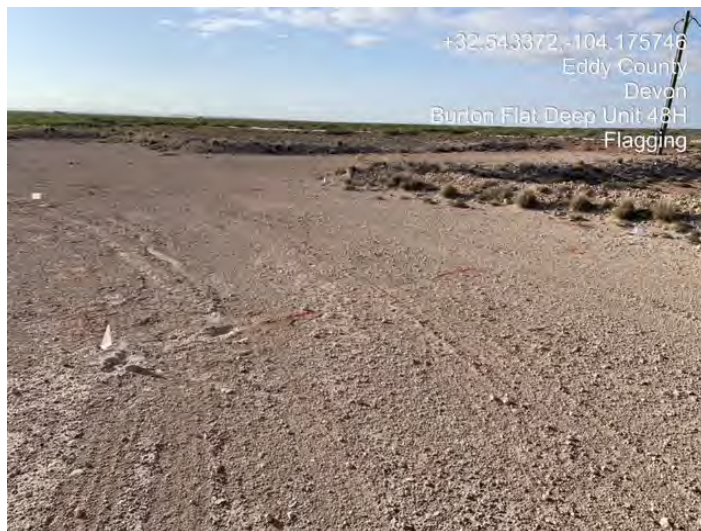
Photograph No. 6

Description: Flagging site for excavation

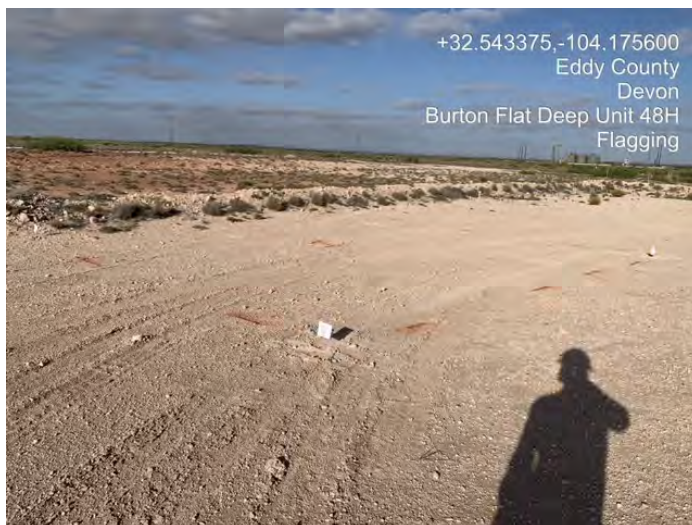
Photograph No. 7

Description: Flagging site for excavation

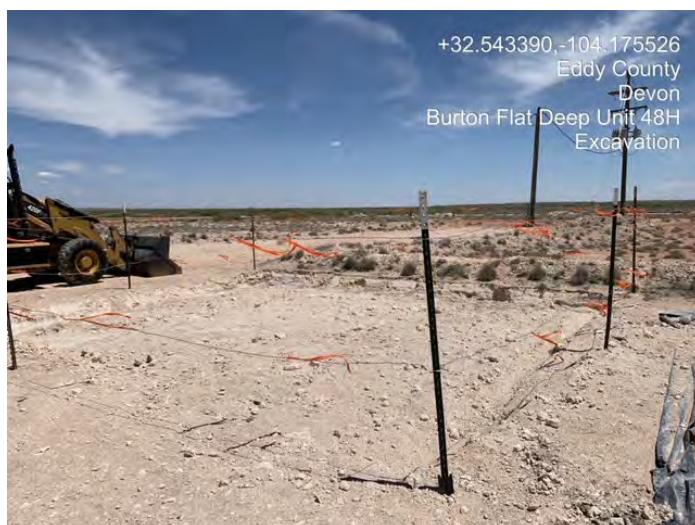
Photograph No. 8

Description: Beginning excavation

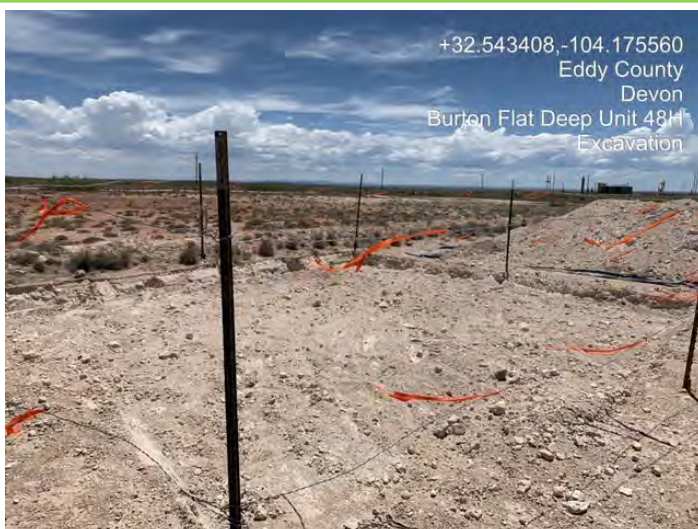
Photograph No. 9

Description: Excavation progress

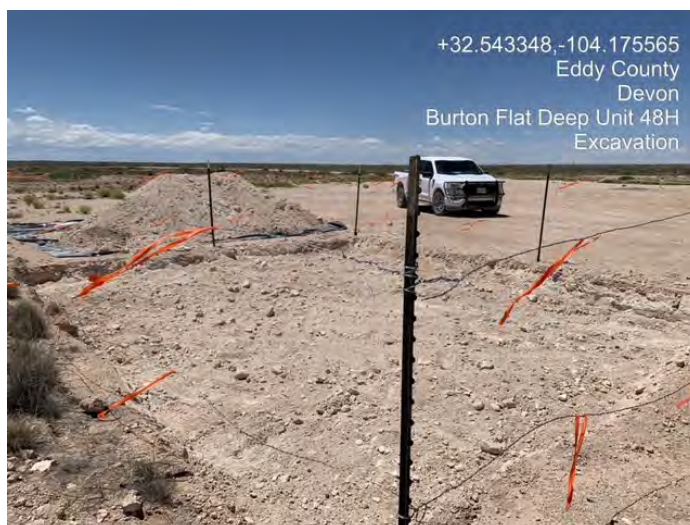
Photograph No. 10

Description: Excavation progress 2

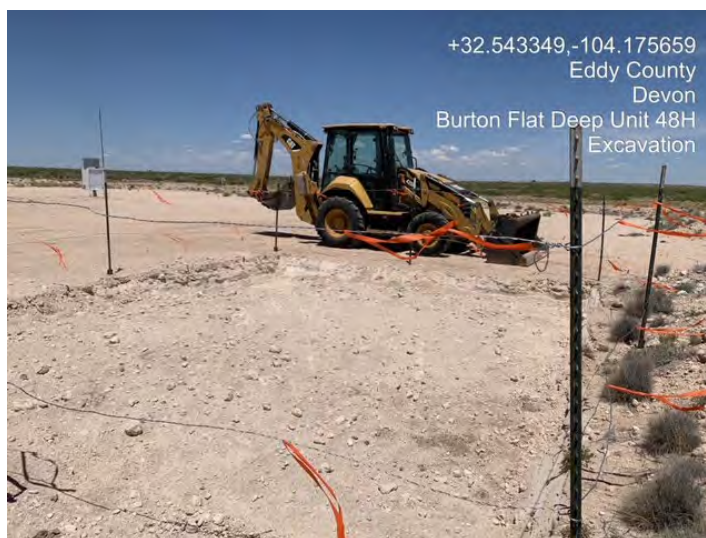
Photograph No. 11

Description: Confirmation sample collection

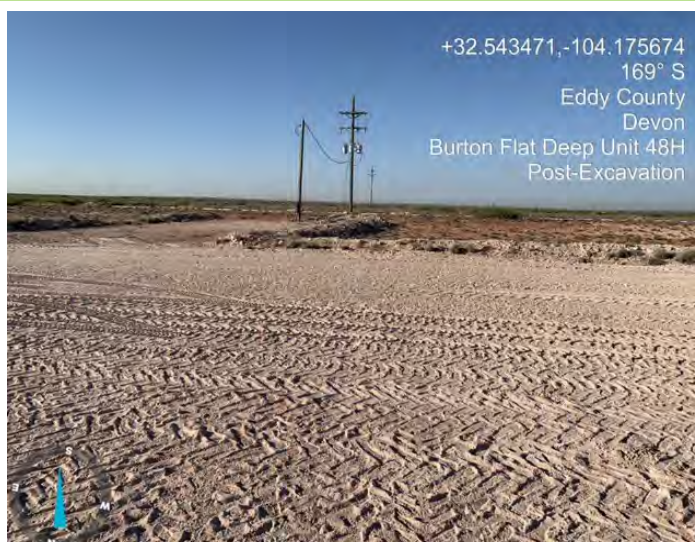
Photograph No. 12

Description: Final post-backfill

Based on these lab results, the contaminant levels for all samples collected are under the regulatory limits according to the <50' depth to groundwater section of Table 1 19.15.29.12 NMAC. This excavation sufficiently removed all previously bioremediated soil. Clean, fresh backfill material was brought in to backfill the excavation. The area was repacked and back dragged to match the surrounding pad.

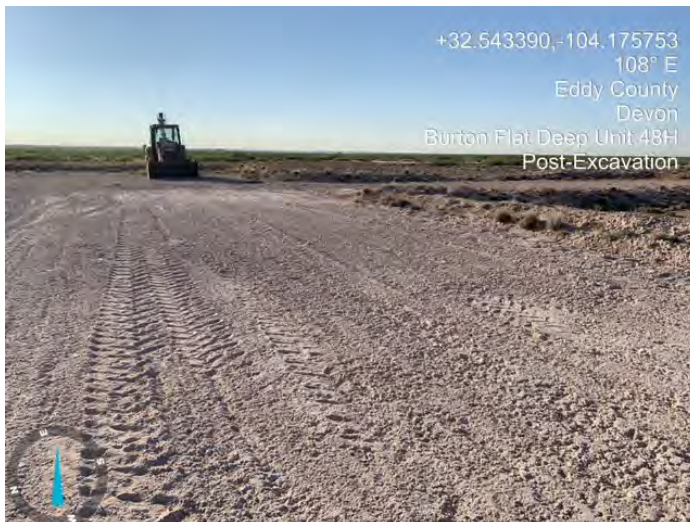
Photograph No. 13

Description: Final post-backfill

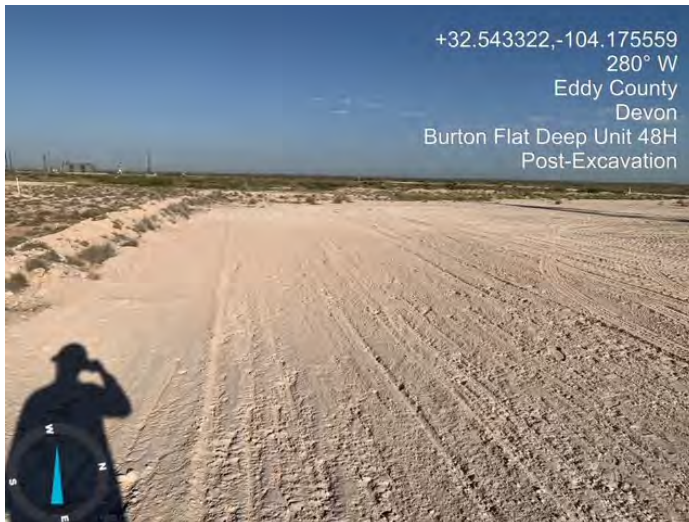
Photograph No. 14

Description: Final post-backfill
