## REMEDIATION CLOSURE REPORT

**Burton Flat 48**

API # 30-015-40518

Prepared By:  
Pima Environmental Services, LLC

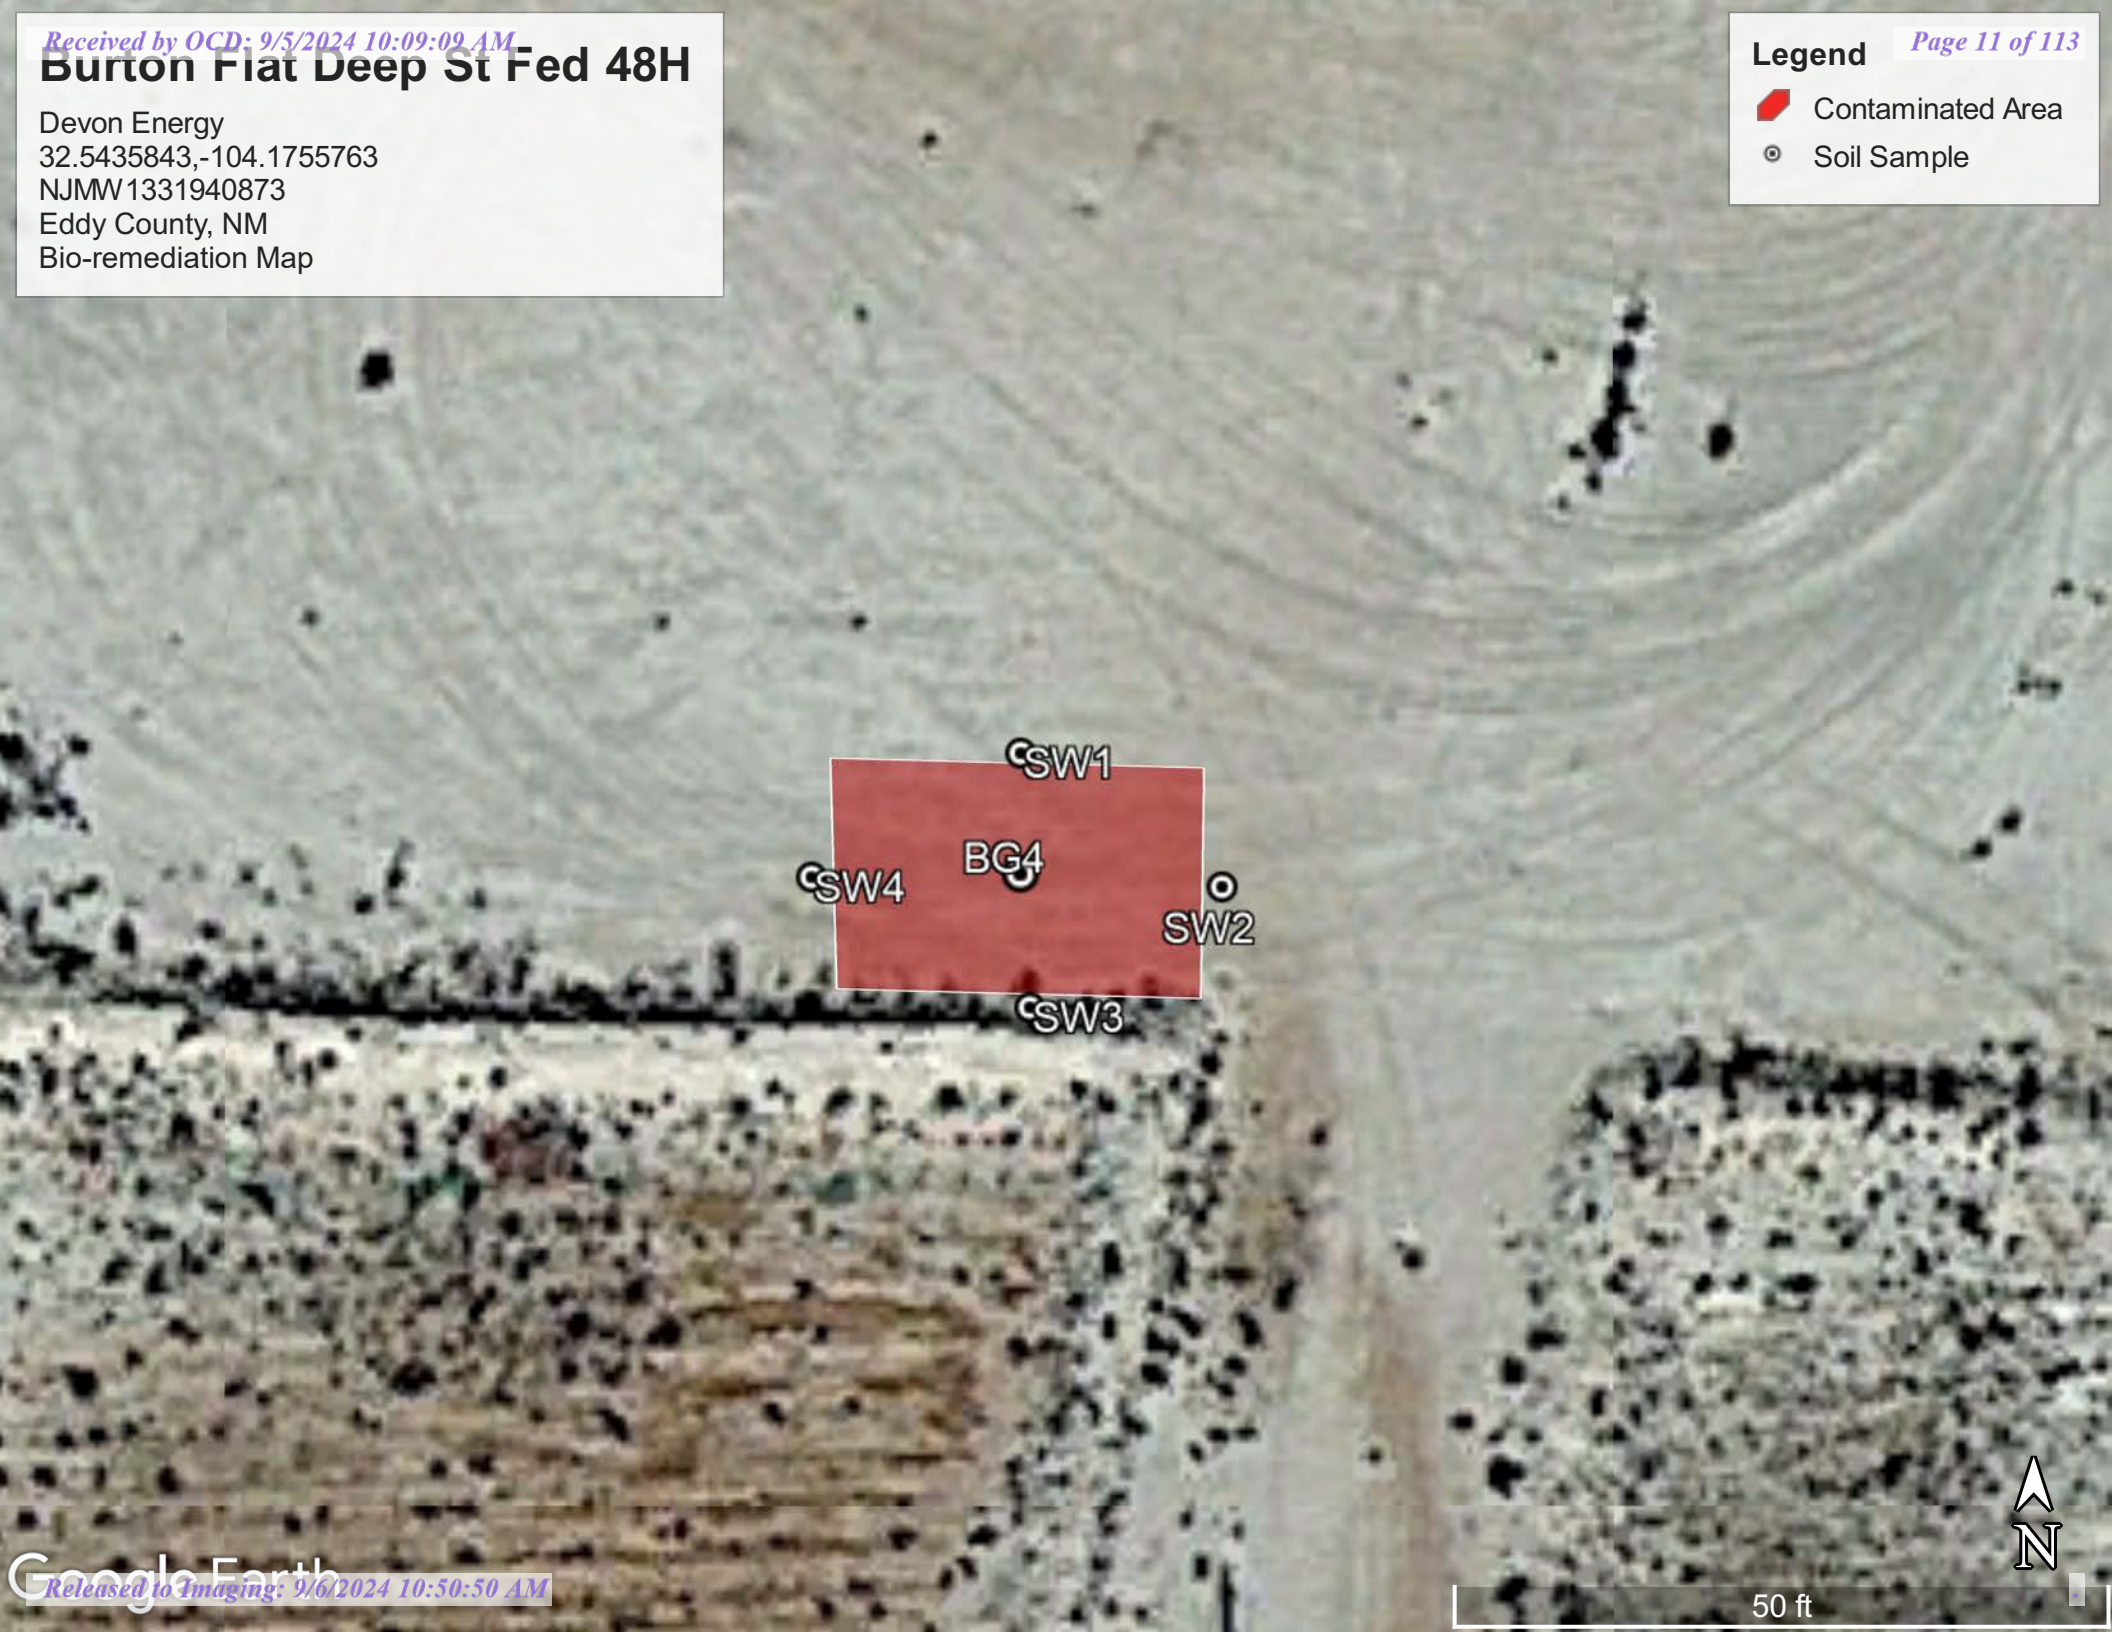
Figure 5- Bio-remediation Map

Devon Energy  
32.5435843,-104.1755763  
NJMW1331940873  
Eddy County, NM  
Bio-remediation Map

Contaminated Area
-

Soil Sample

review and make the required correction(s) prior to resubmitting. If you have any questions why this application was rejected or believe it was rejected in error, please contact me prior to submitting an additional C-141." A Bio-remediation Map can be found in Figure 5.

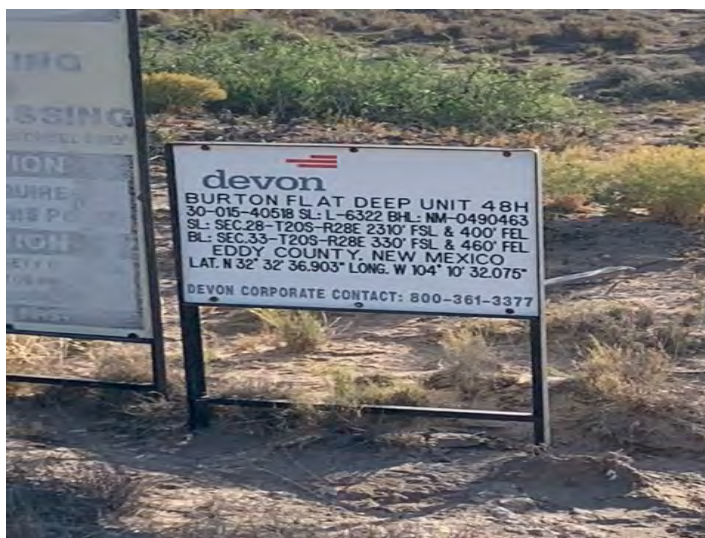
### Photograph No. 1

Description: Lease Sign

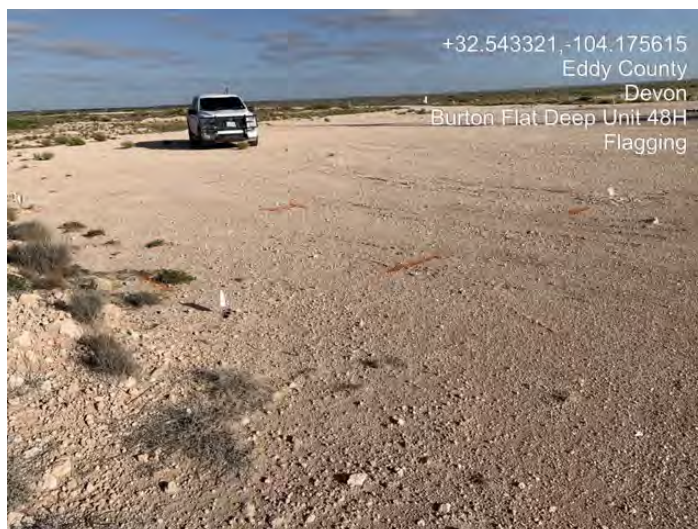
### Photograph No. 6

**Description:** Flagging site for excavation

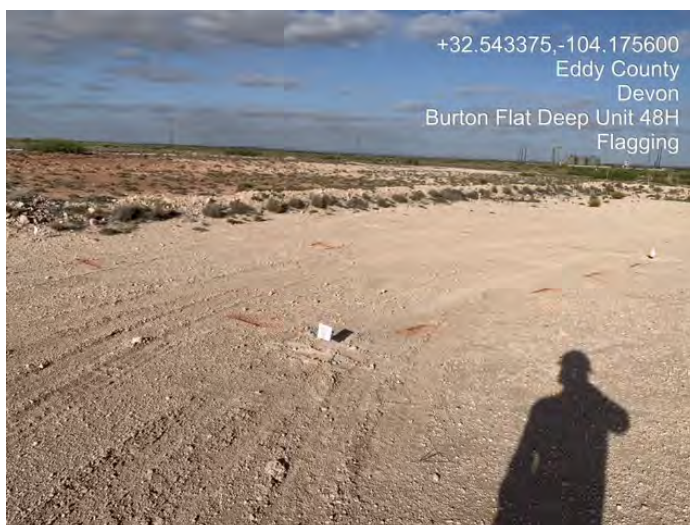
### Photograph No. 7

**Description:** Flagging site for excavation

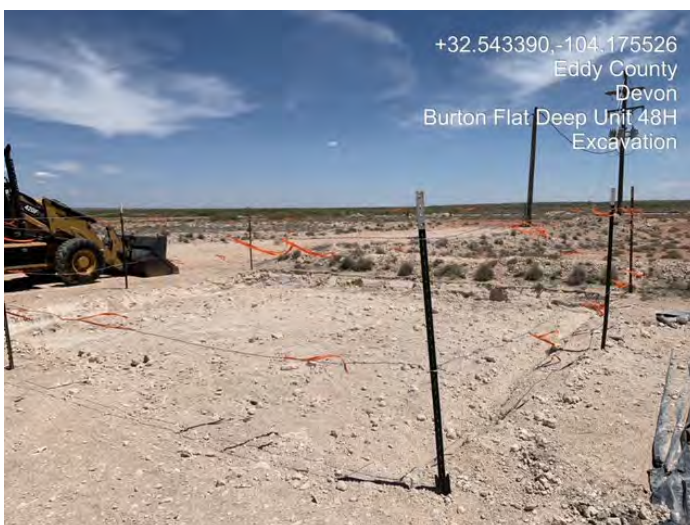
### Photograph No. 8

**Description:** Beginning excavation

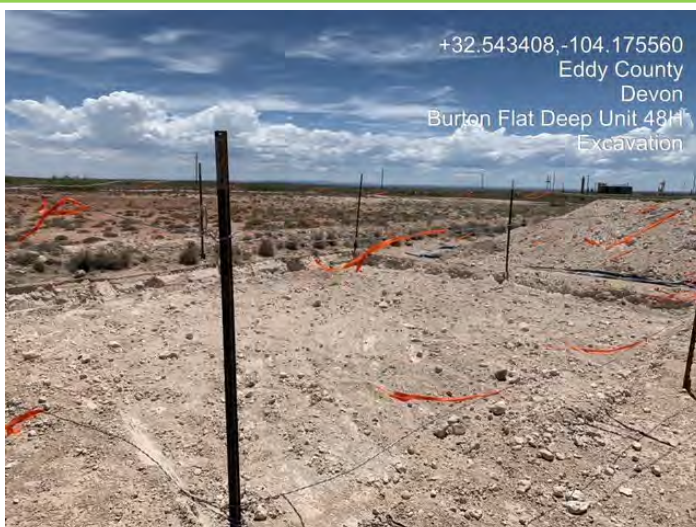
### Photograph No. 9

**Description:** Excavation progress

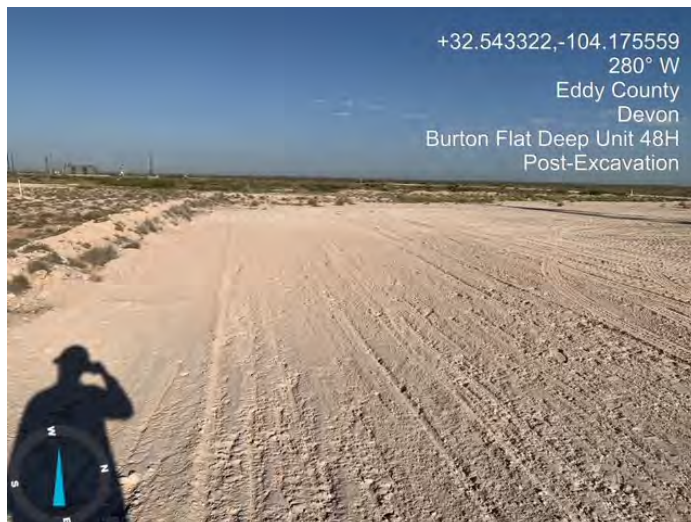
### Photograph No. 14

**Description:** Final post-backfill
