Release Notification and Corrective Action

NAB1521257588 **OPERATOR** ☒ Initial Report ☐ Final Report

Name of Company: BOPCO, L.P. 2100737	Contact: Tony Savoie
Address: 522 W. Mermod, Suite 704 Carlsbad, N.M. 88220	Telephone No. 575-887-7329
Facility Name: JRU-10	Facility Type: Exploration and Production

Project: 012918003	XTO Energy, Inc. James Ranch Unit #10 Battery

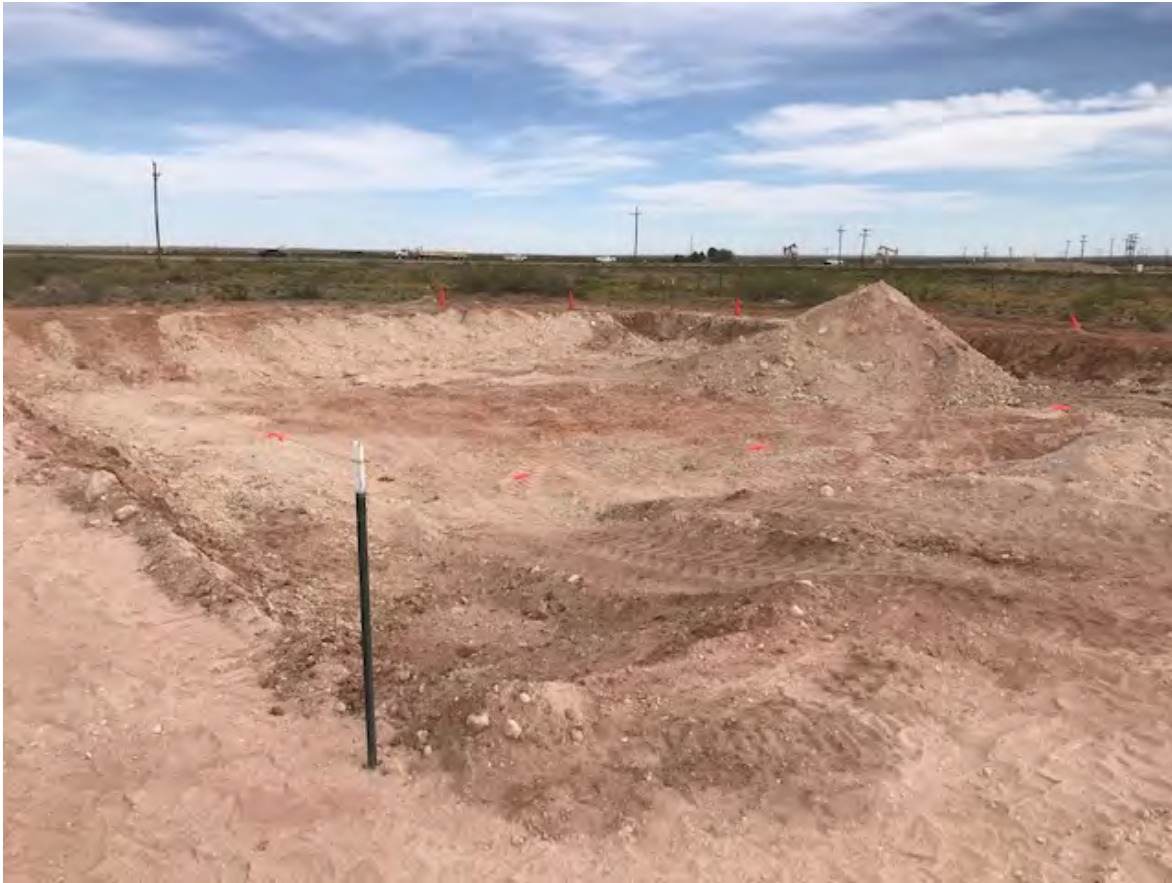
View of the open excavation.

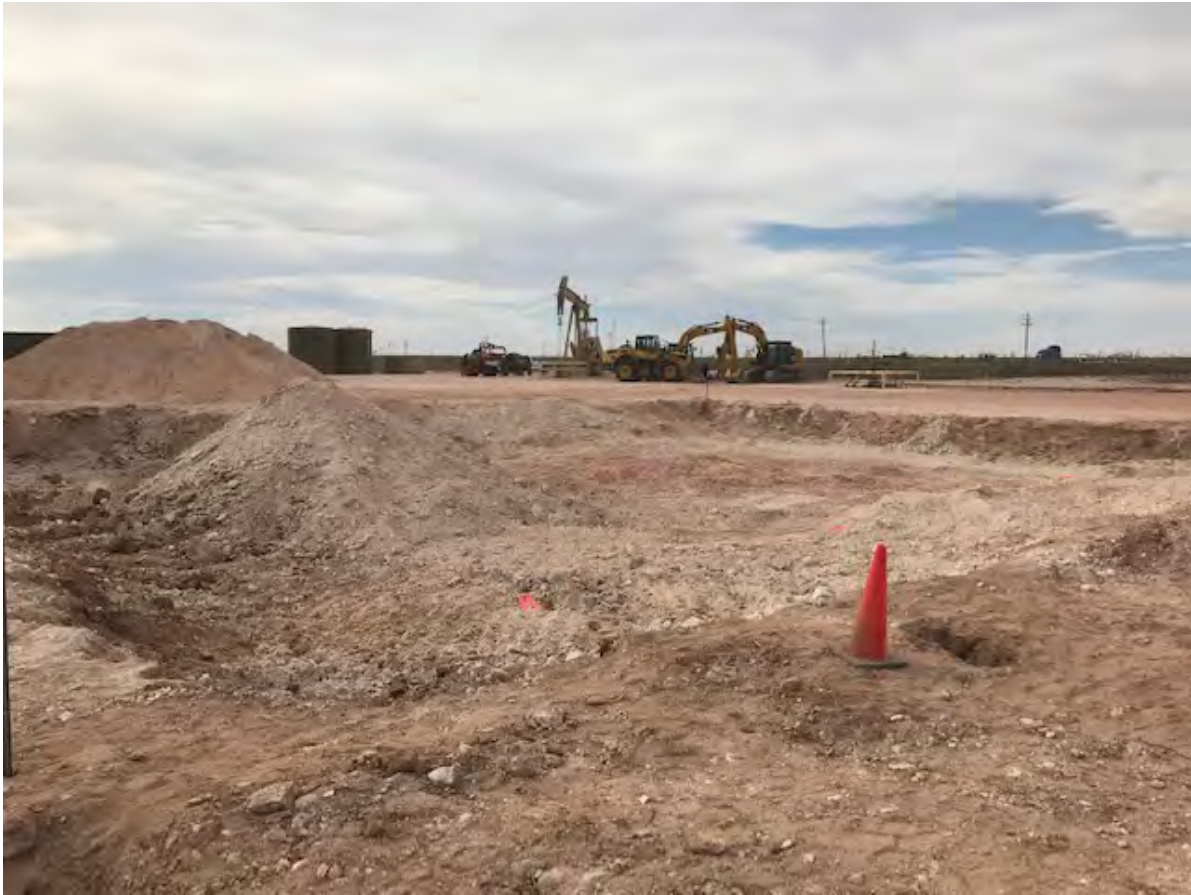
View of the open excavation.
