# SITE ASSESSMENT & CLOSURE REPORT

Devon Energy  
**Bell Lake 19 State 3H**  
Incident ID: NTO1417636911

Prepared By:  
Pima Environmental Services, LLC.

**Re: Site Assessment, and Closure Report**  
**Bell Lake 19 State 3H**  
**API No. 30-025-41516**  
**GPS: Latitude 32.1964722 Longitude -103.6089478**  
**UL –O Section 19, T24S, R33E**  
**Lea County, NM**  
**NMOCD Ref. No. NT01417636911**

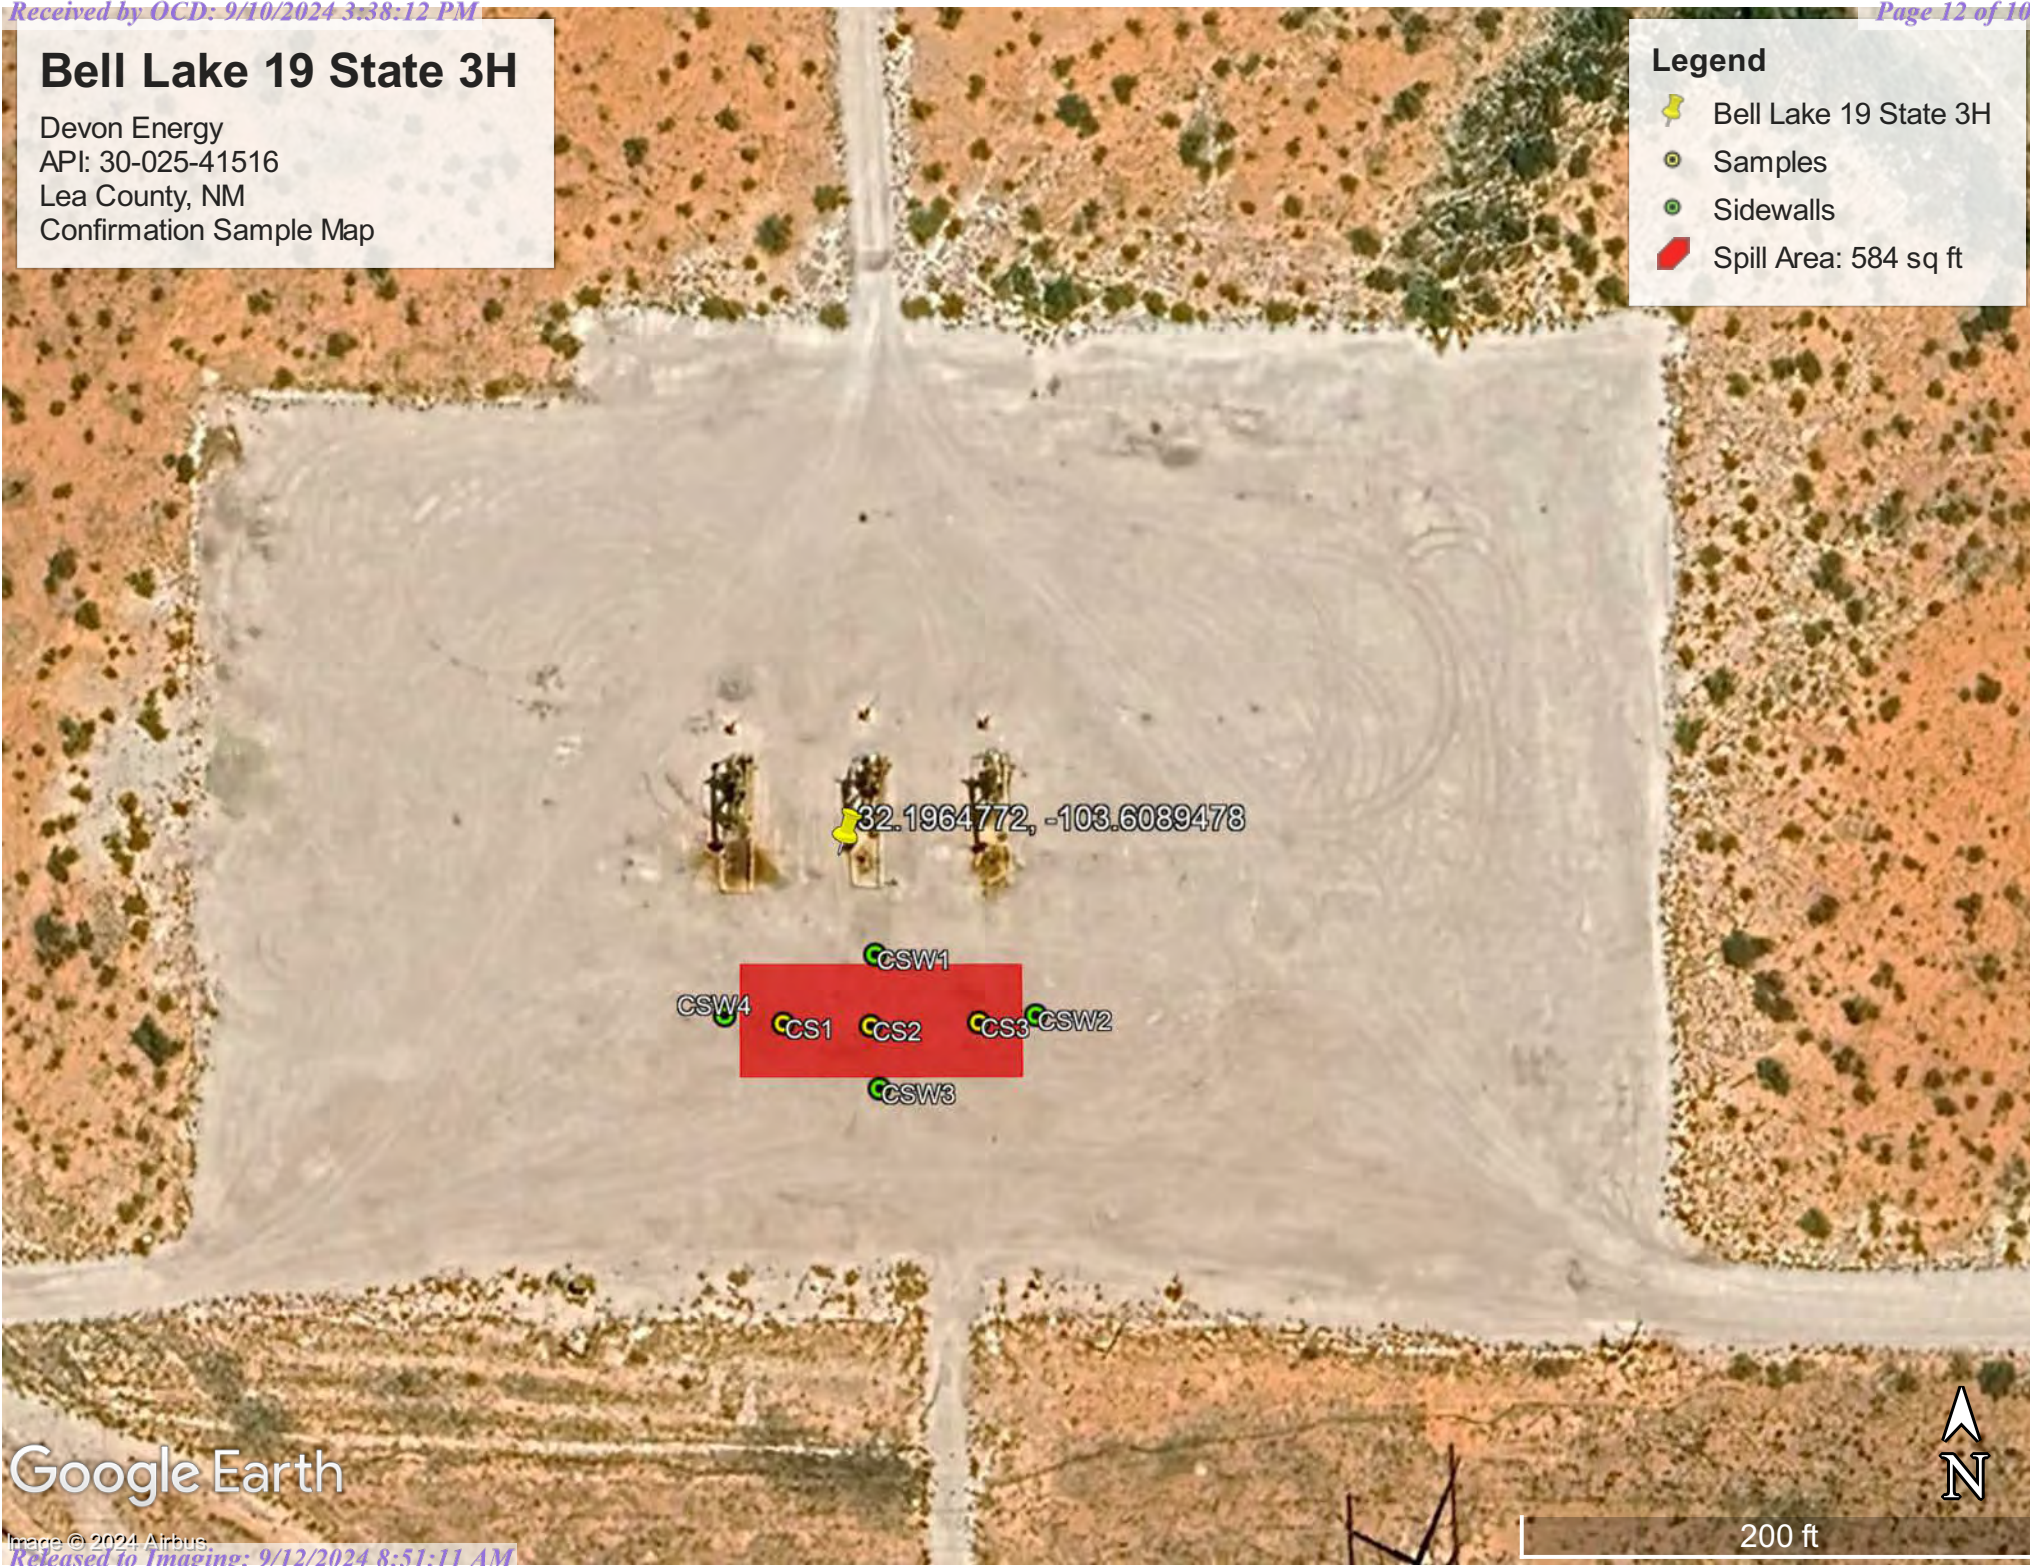
5-Confirmation Sample Map

On August 15, 2024, in response to the rejected closure report, a Pima field technician was dispatched to the Bell Lake to conduct a confirmation sampling event, after submitting a 48-hour sampling notification (Appendix C). Three bottom samples labeled CS1-CS3 were collected at surface, 1', 2', 3', and 4' of the impacted areas. Four 5-point composite sidewall samples from 0', 1', 2', 3', 4' BGS labeled CSW1-CSW4 were collected. Each sample represented a surface area of no more than 200 ft<sup>2</sup>. The laboratory results of this sampling event can be found in the following data table. A Confirmation Sample Map can be found in Figure 5.

Based on the sample results, the bottoms and sidewalls were below NMOCD Closure Criteria 19.15.29 NMAC. See Appendix D for Photographic Documentation.

Spill Area: 584 sq ft
