**From:** Mike Stubblefield <mike@rthicksconsult.com>  
**Sent:** Monday, July 31, 2017 11:59 AM  
**To:** Weaver, Crystal, EMNRD  
**Cc:** Billings, Bradford, EMNRD; Bratcher, Mike, EMNRD; 'Michael Barrett'; 'Jerry Smith'; 'Randall Hicks'; 'Kristin Pope'  
**Subject:** ASAU 150 Trunk line release monitor well sampling

On behalf of Lime Rock Resources, R.T. Hicks Consultants, Ltd. submits the report and proposal for the above-referenced site. The following report summarizes data collected thus far and proposes actions to characterize and mitigate potential environmental impact caused by this release with the aim of closure of the regulatory file.

Aerial Photograph Showing the Release Site in  
 Relation to the Pecos River and the Rio Penasco  
 Limerock Resources: ASAU Tank Release

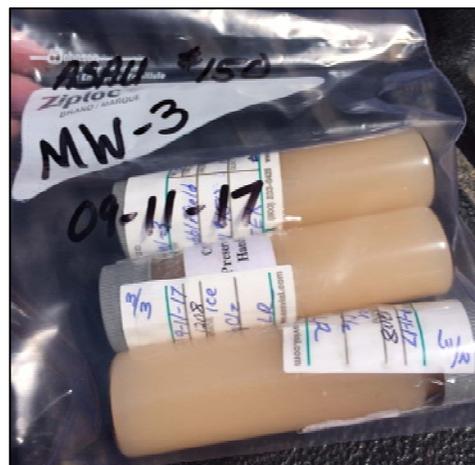
- Depth to water (from TOC) was measured at 47.95 feet.
- Two full bailers were purged by slowly lowering the bailer into the top 1 foot of column.
- The third bailer for the sample was observed to be turbid/silty. As specified in the Plan, we waited at least two hours before sampling again.
- We returned to this well and repeated the procedure and obtained a sample at 12:08 pm. The sample was again observed to be silty, as shown in the adjacent photograph.

Silty samples from MW-3

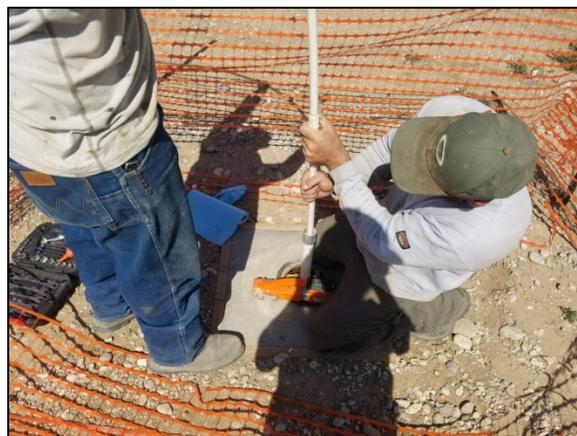
- Ms. Weaver stated that NMOCD requests a product thickness measurement in this well.
- We explained that after consistently measuring approximately 6 inches of product thickness, a 1-inch "measuring tube" was installed to facilitate accurate DTW measurements (adjacent photograph). Since installation of the sampling tube, we are unable to measure the product.
- DTW was measured in the sampling tube at 52.98 feet on September 11, 2017.

Installation of "Measuring tube" in MW-1

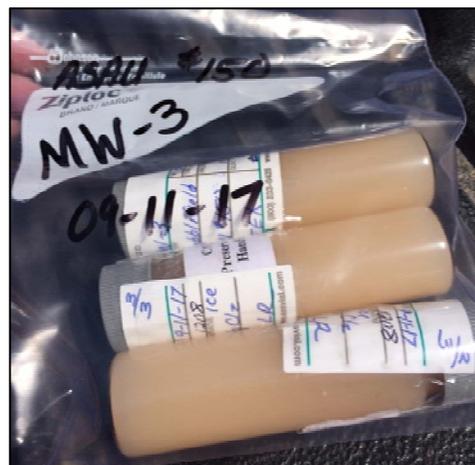
- Depth to water (from TOC) was measured at 47.95 feet.
- Two full bailers were purged by slowly lowering the bailer into the top 1 foot of column.
- The third bailer for the sample was observed to be turbid/silty. As specified in the Plan, we waited at least two hours before sampling again.
- We returned to this well and repeated the procedure and obtained a sample at 12:08 pm. The sample was again observed to be silty, as shown in the adjacent photograph.

Silty samples from MW-3

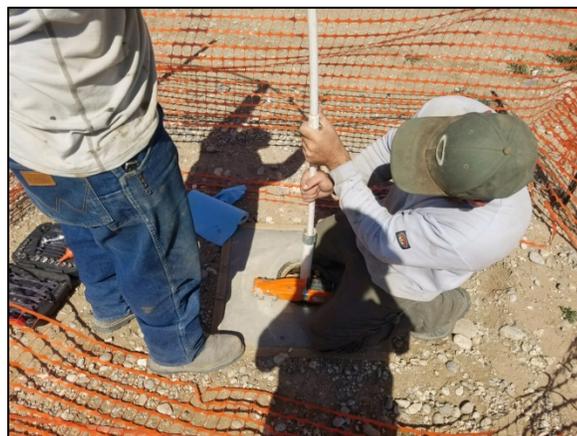
- Ms. Weaver stated that NMOCD requests a product thickness measurement in this well.
- We explained that after consistently measuring approximately 6 inches of product thickness, a 1-inch "measuring tube" was installed to facilitate accurate DTW measurements (adjacent photograph). Since installation of the sampling tube, we are unable to measure the product.
- DTW was measured in the sampling tube at 52.98 feet on September 11, 2017.

Installation of "Measuring tube" in MW-1

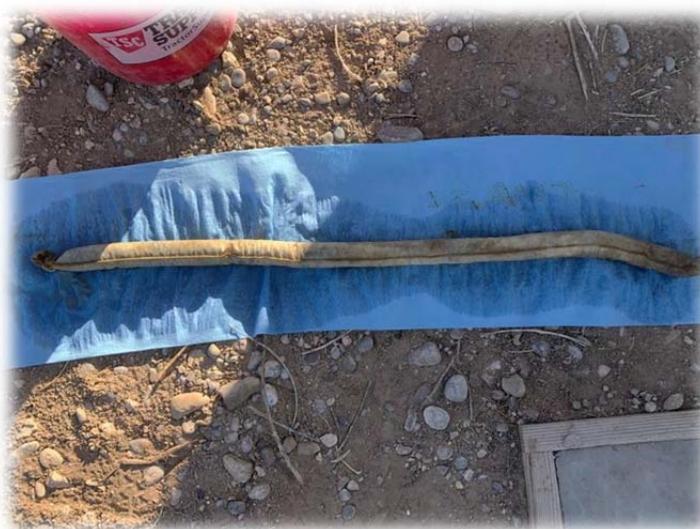
Compliance samples for the 2018 first quarter were collected on January 23, 2018 using a bailer due to a failure of the low-flow pump. As presented in Table 1, benzene concentrations increased markedly in all three wells samples. Passive recovery of LNAPL in MW-1 is ongoing and observations and measurements are summarized in Table 2. Average thickness of LNAPL remains relatively consistent at 0.25 feet or 3 inches. We intend to continue this system of recovery unless the amount of LNAPL increases and causes this system to be inadequate. We will then propose a more suitable recovery method to NMOCD.

Stained sock removed from MW-1 on 2/20/2018

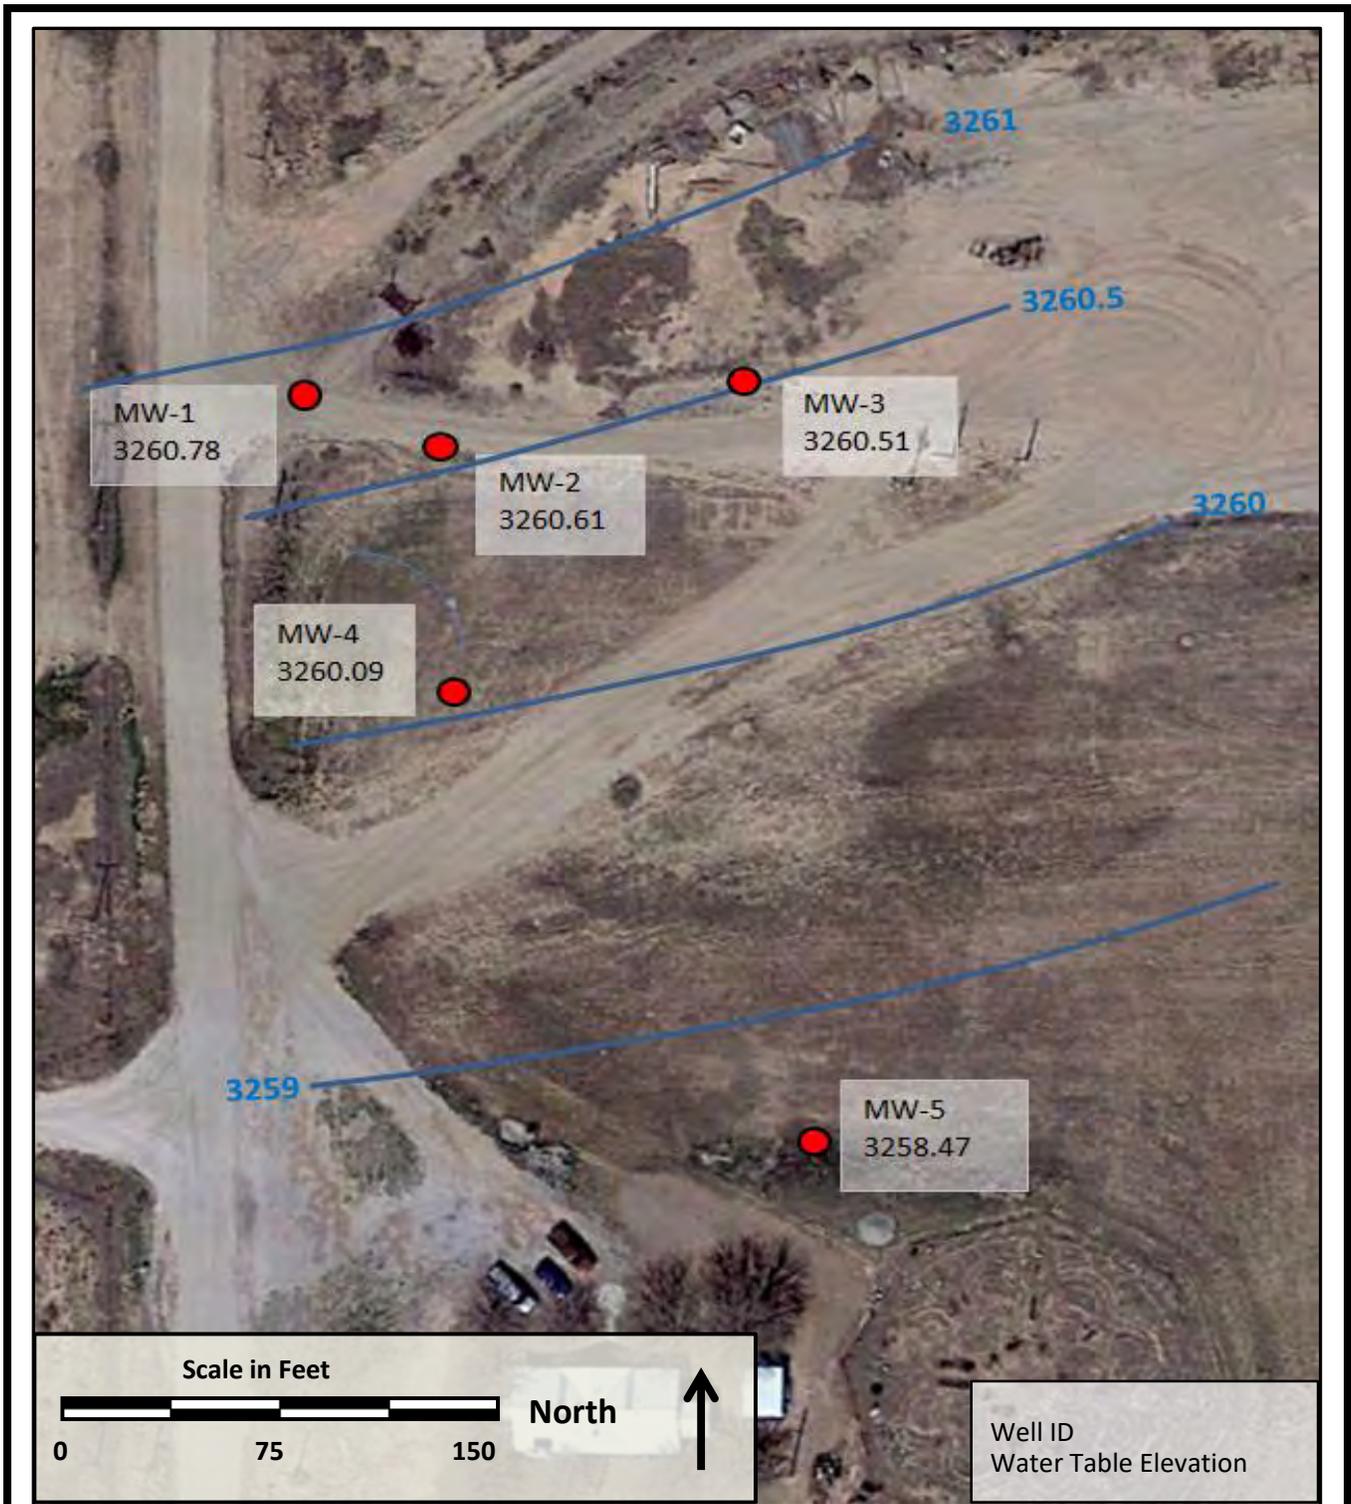
R.T. Hicks Consultants, Ltd 901 Rio Grande Blvd NW Suite F-142 Albuquerque, NM 87104 505-266-5004	Water Table Contours August 2018 Sampling	Plate 5
	Lime Rock Resources: ASAU Release	November, 2018

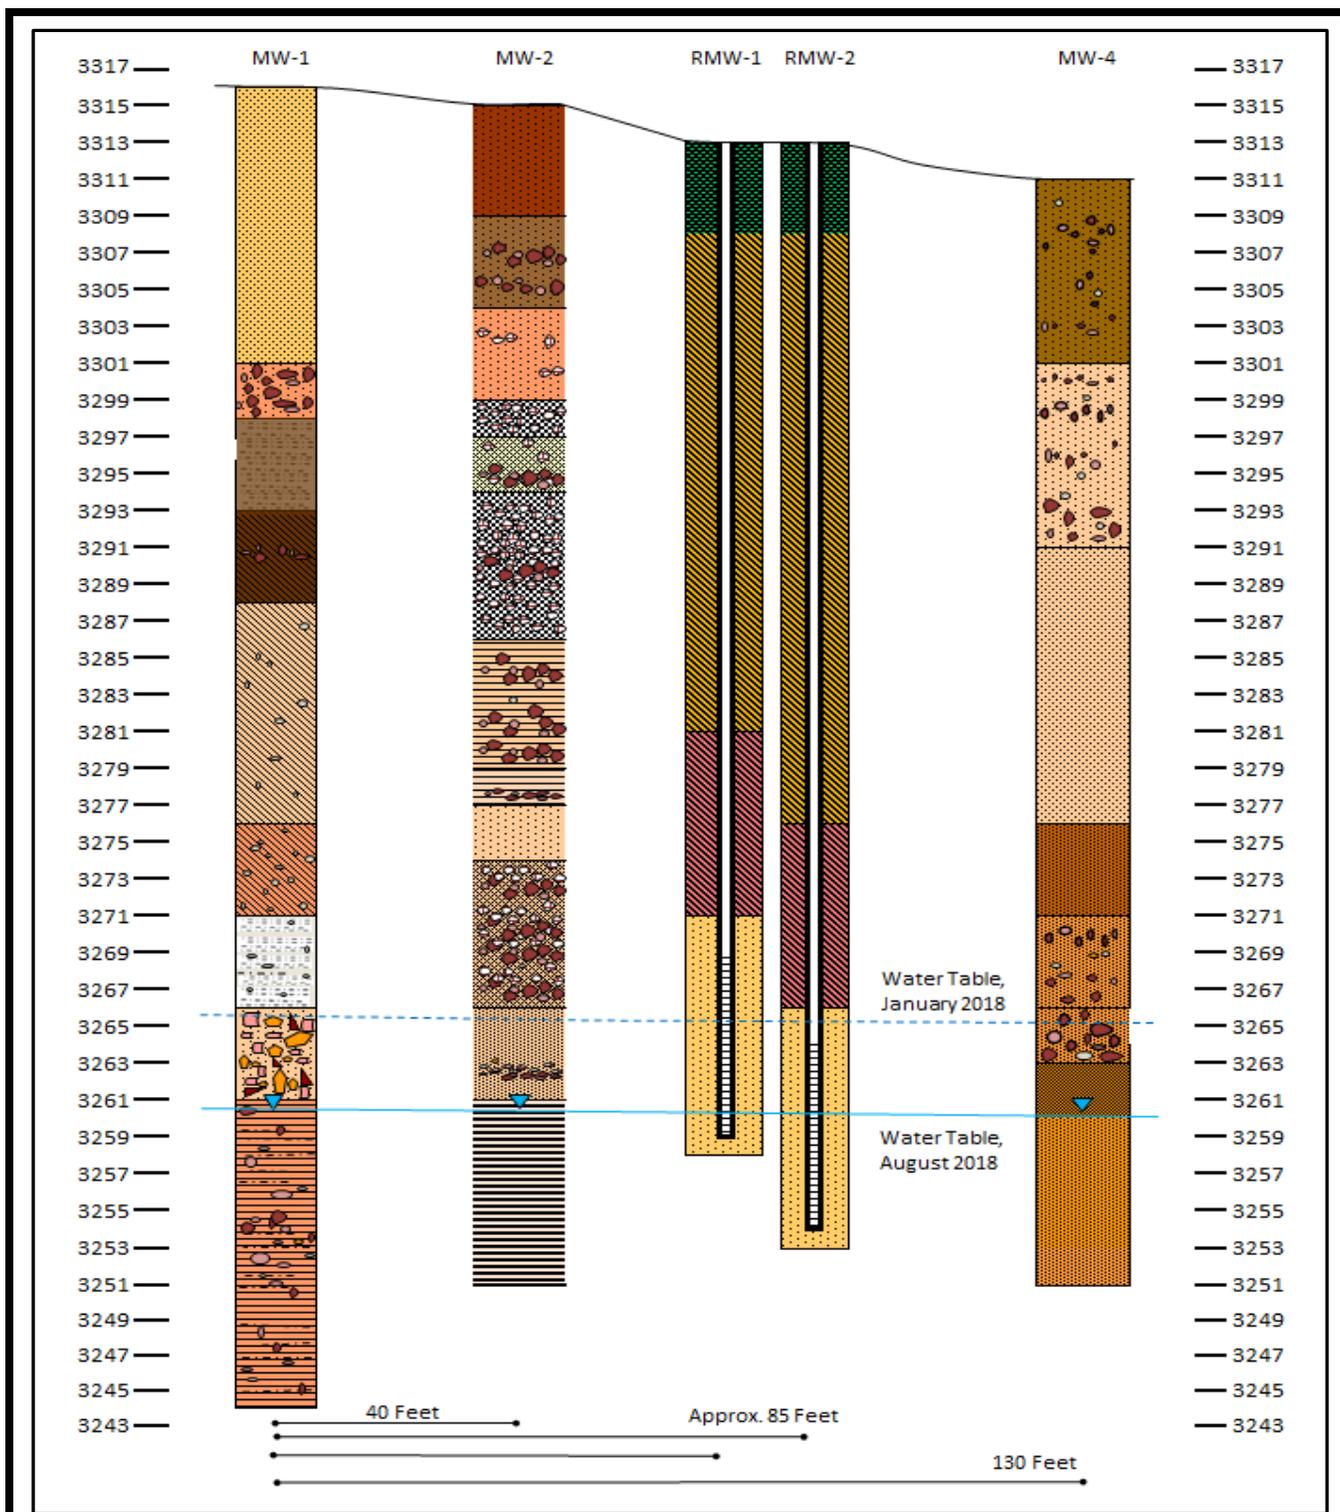
<p>R.T. Hicks Consultants, Ltd          901 Rio Grande Blvd NW          Suite F-142          Albuquerque, NM 87104          505-266-5004</p>	<p><b>Cross Section Parallel to Groundwater Flow, MW-1          through MW-4 With Proposed Remediation Wells</b></p>	<p><b>Plate 6a</b></p>
	<p><b>Lime Rock Resources: ASAU Release</b></p>	<p><b>November, 2018</b></p>

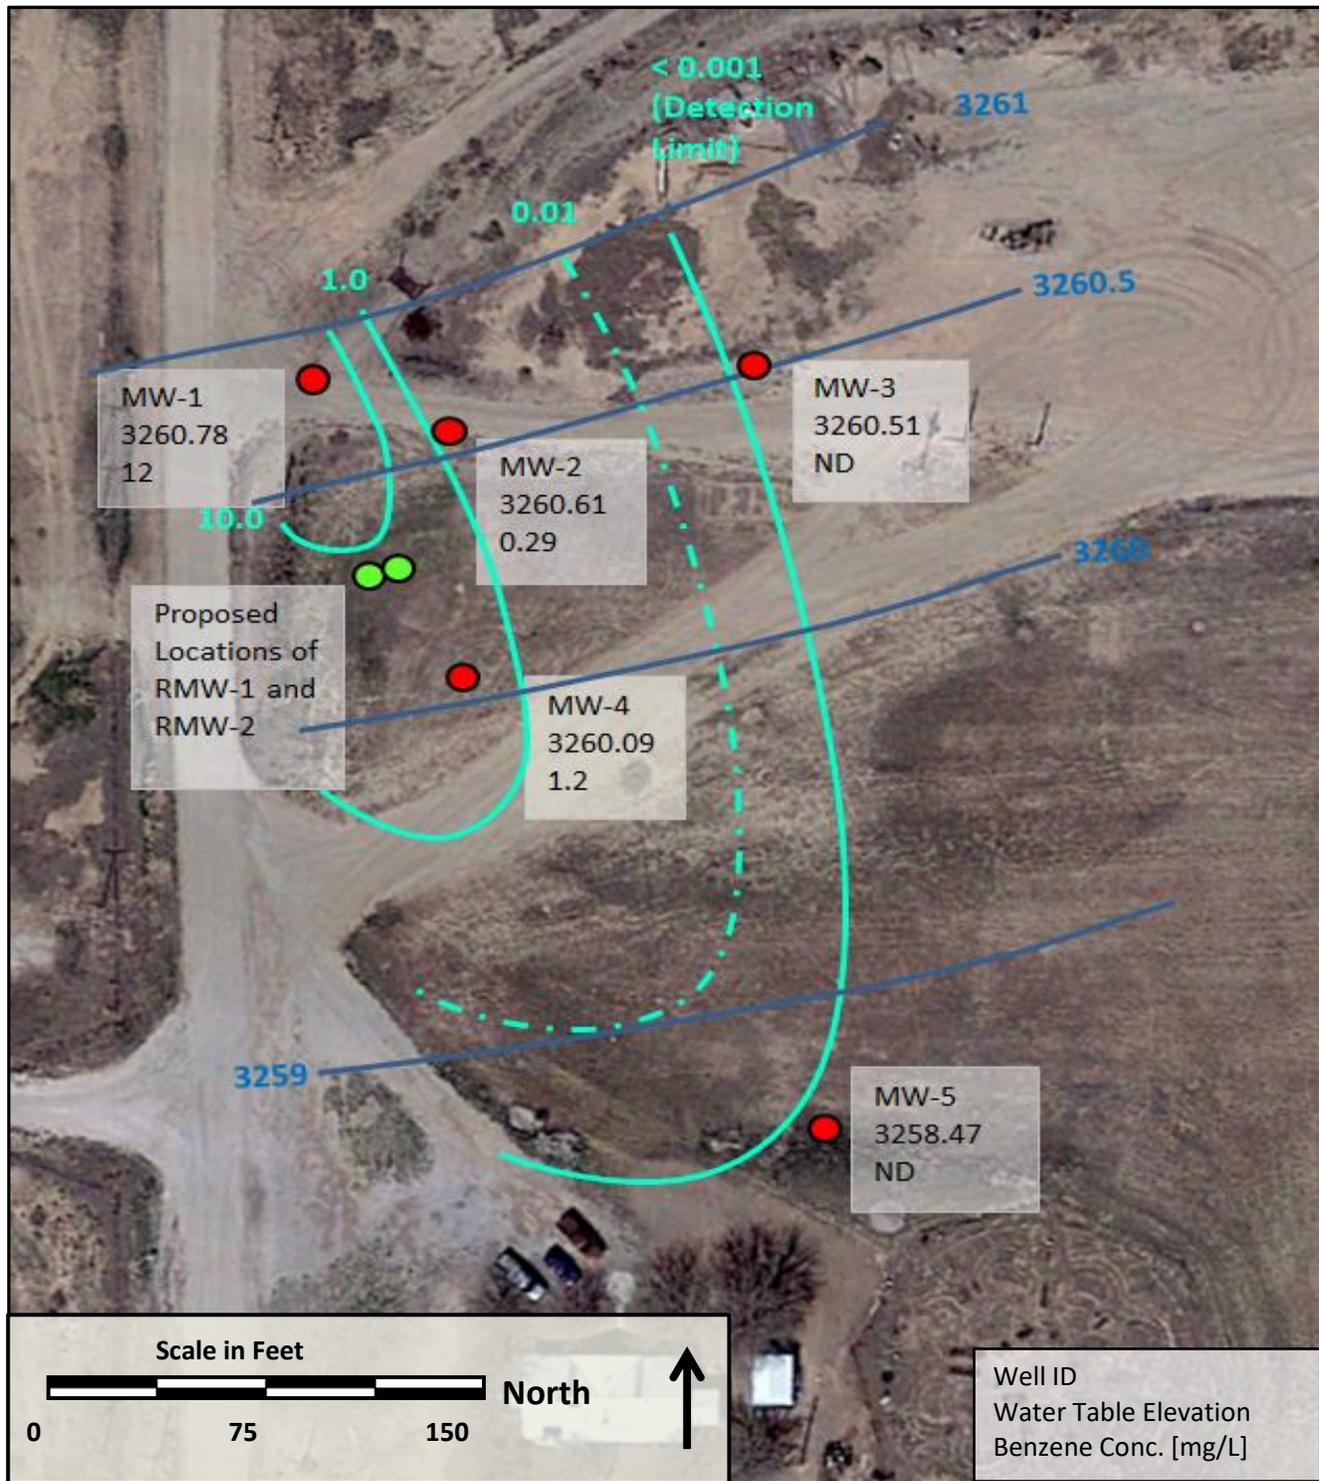
R.T. Hicks Consultants, Ltd 901 Rio Grande Blvd NW Suite F-142 Albuquerque, NM 87104 505-266-5004	<b>Benzene Concentration Contours</b> <b>August 2018 Sampling</b> <b>(Logarithmic Scale Contours)</b>	<b>Plate 8</b>
	Lime Rock Resources: ASAU Release	November, 2018

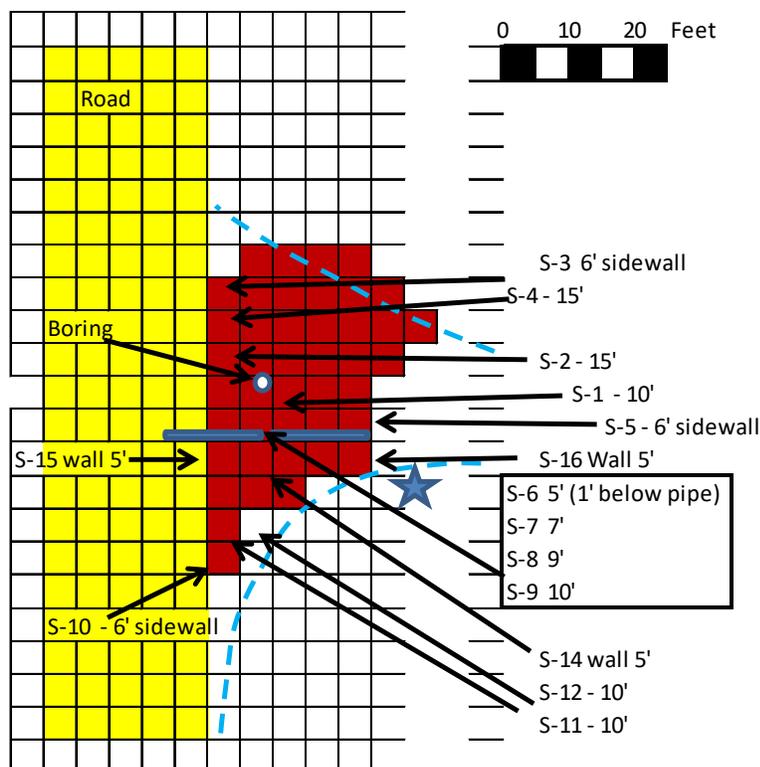
Figure 1 is a scale sketch map showing the general extent of the excavation the location of the soil boring and general location of samples. Figures 2-4 at the end of this submission are photographs of the extent of excavation and the placement of the liner.

Figure 1: Scaled drawing of release excavation (red), location of pipeline (dark blue), Eddy County Road (yellow) and edge of lease road (dashed light blue). General location of samples and boring are shown. The blue star is the proposed location of a groundwater monitoring well discussed later in this submission.

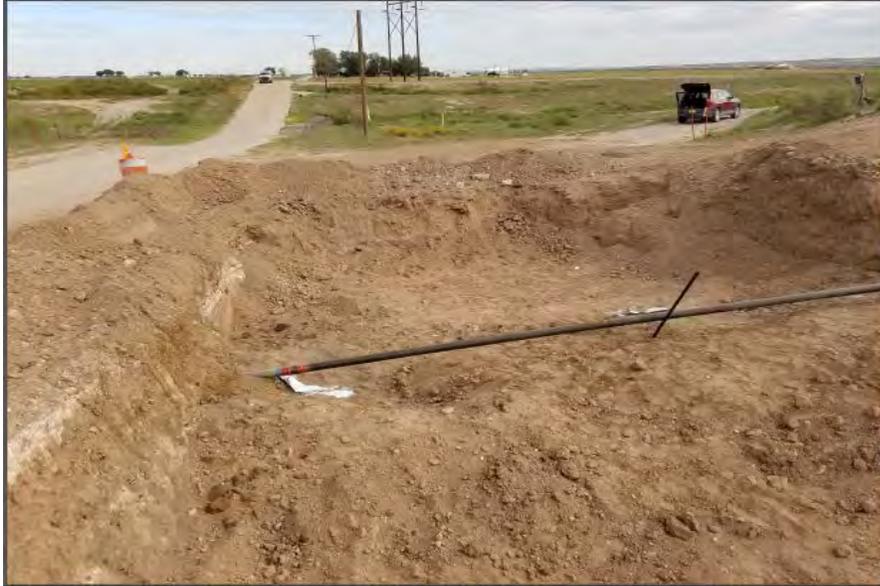
Excavated area before placing liner looking to north

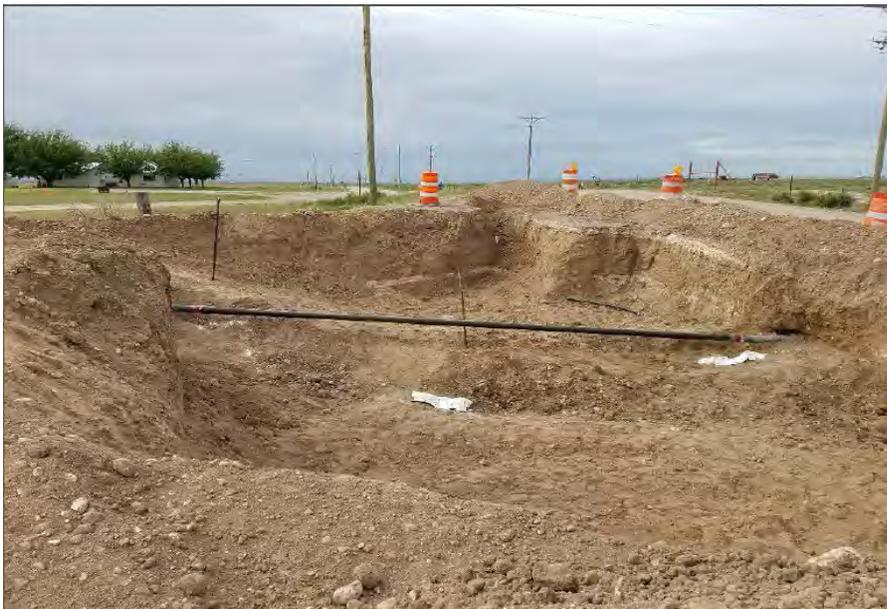
Excavated area before placing liner looking to south

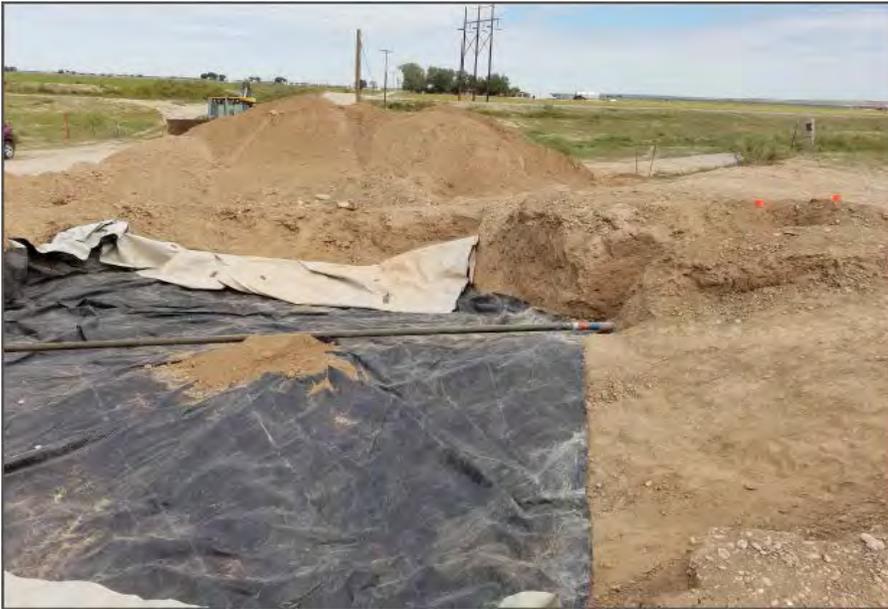
Excavated area after placing liner looking to north

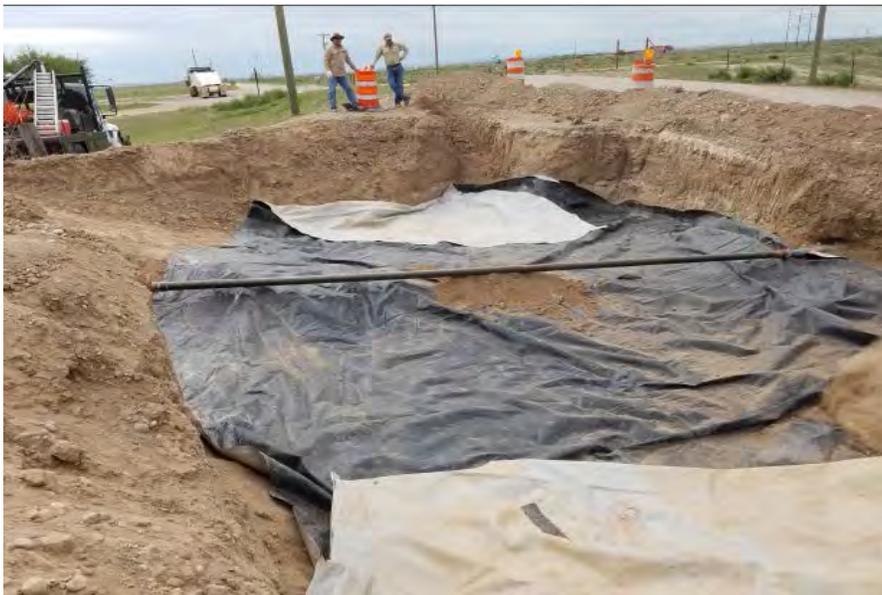
Excavated area after placing liner looking to south

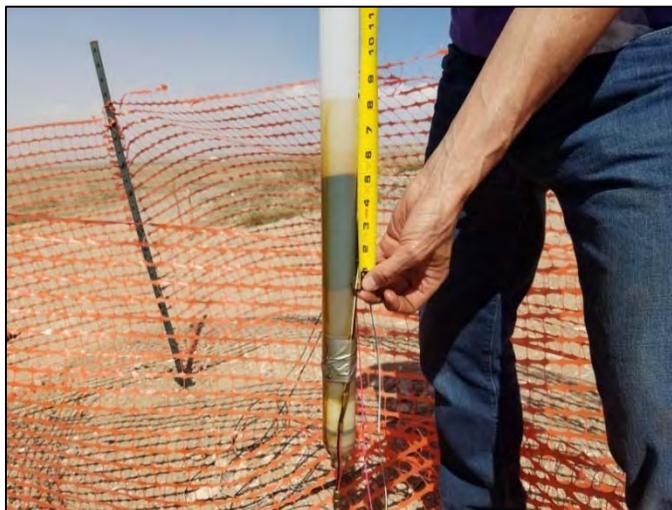
**3/23/2017: LNAPL at MW-1**

The well was developed and then sampled; however, light non-aqueous phase liquids (LNAPL) was observed on the water surface during the first sampling event and since installation. On March 23 Hicks Consultants measured approximately 6 inches of LNAPL in the well as shown in the photograph above. Evaluation of nearby wells suggests an east-southeast groundwater gradient as depicted on Figure 1. On May 2 Hicks Consultants performed a baildown test<sup>2</sup> at the monitoring well to determine LNAPL transmissivity within the well and the surrounding groundwater. At the time of the test, we used an electronic oil/water indicator and found the depth to LNAPL was 51.1 feet below surface and depth to water was 51.62 feet. Thus, equilibrium LNAPL thickness is 0.52 feet or 6.24 inches. Results of this test will be used to evaluate treatment/remediation

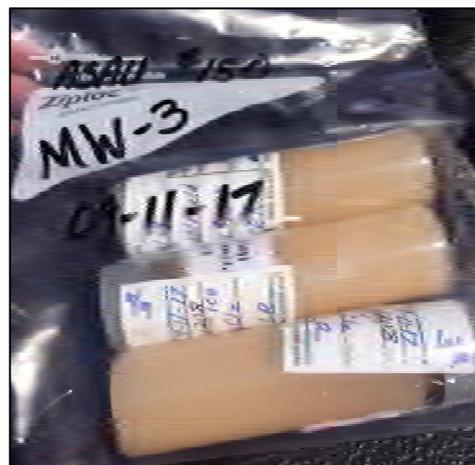
- Depth to water (from TOC) was measured at 47.95 feet.
- Two full bailers were purged by slowly lowering the bailer into the top 1 foot of column.
- The third bailer for the sample was observed to be turbid/silty. As specified in the Plan, we waited at least two hours before sampling again.
- We returned to this well and repeated the procedure and obtained a sample at 12:08 pm. The sample was again observed to be silty, as shown in the adjacent photograph.

Silty samples from MW-3

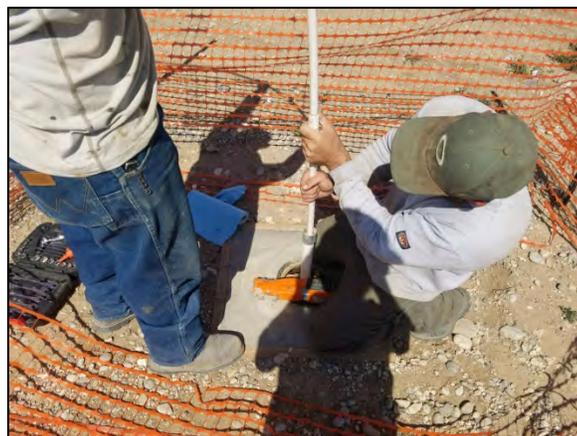
- Ms. Weaver stated that NMOCD requests a product thickness measurement in this well.
- We explained that after consistently measuring approximately 6 inches of product thickness, a 1-inch "measuring tube" was installed to facilitate accurate DTW measurements (adjacent photograph). Since installation of the sampling tube, we are unable to measure the product.
- DTW was measured in the sampling tube at 52.98 feet on September 11, 2017.

Installation of "Measuring tube" in MW-1

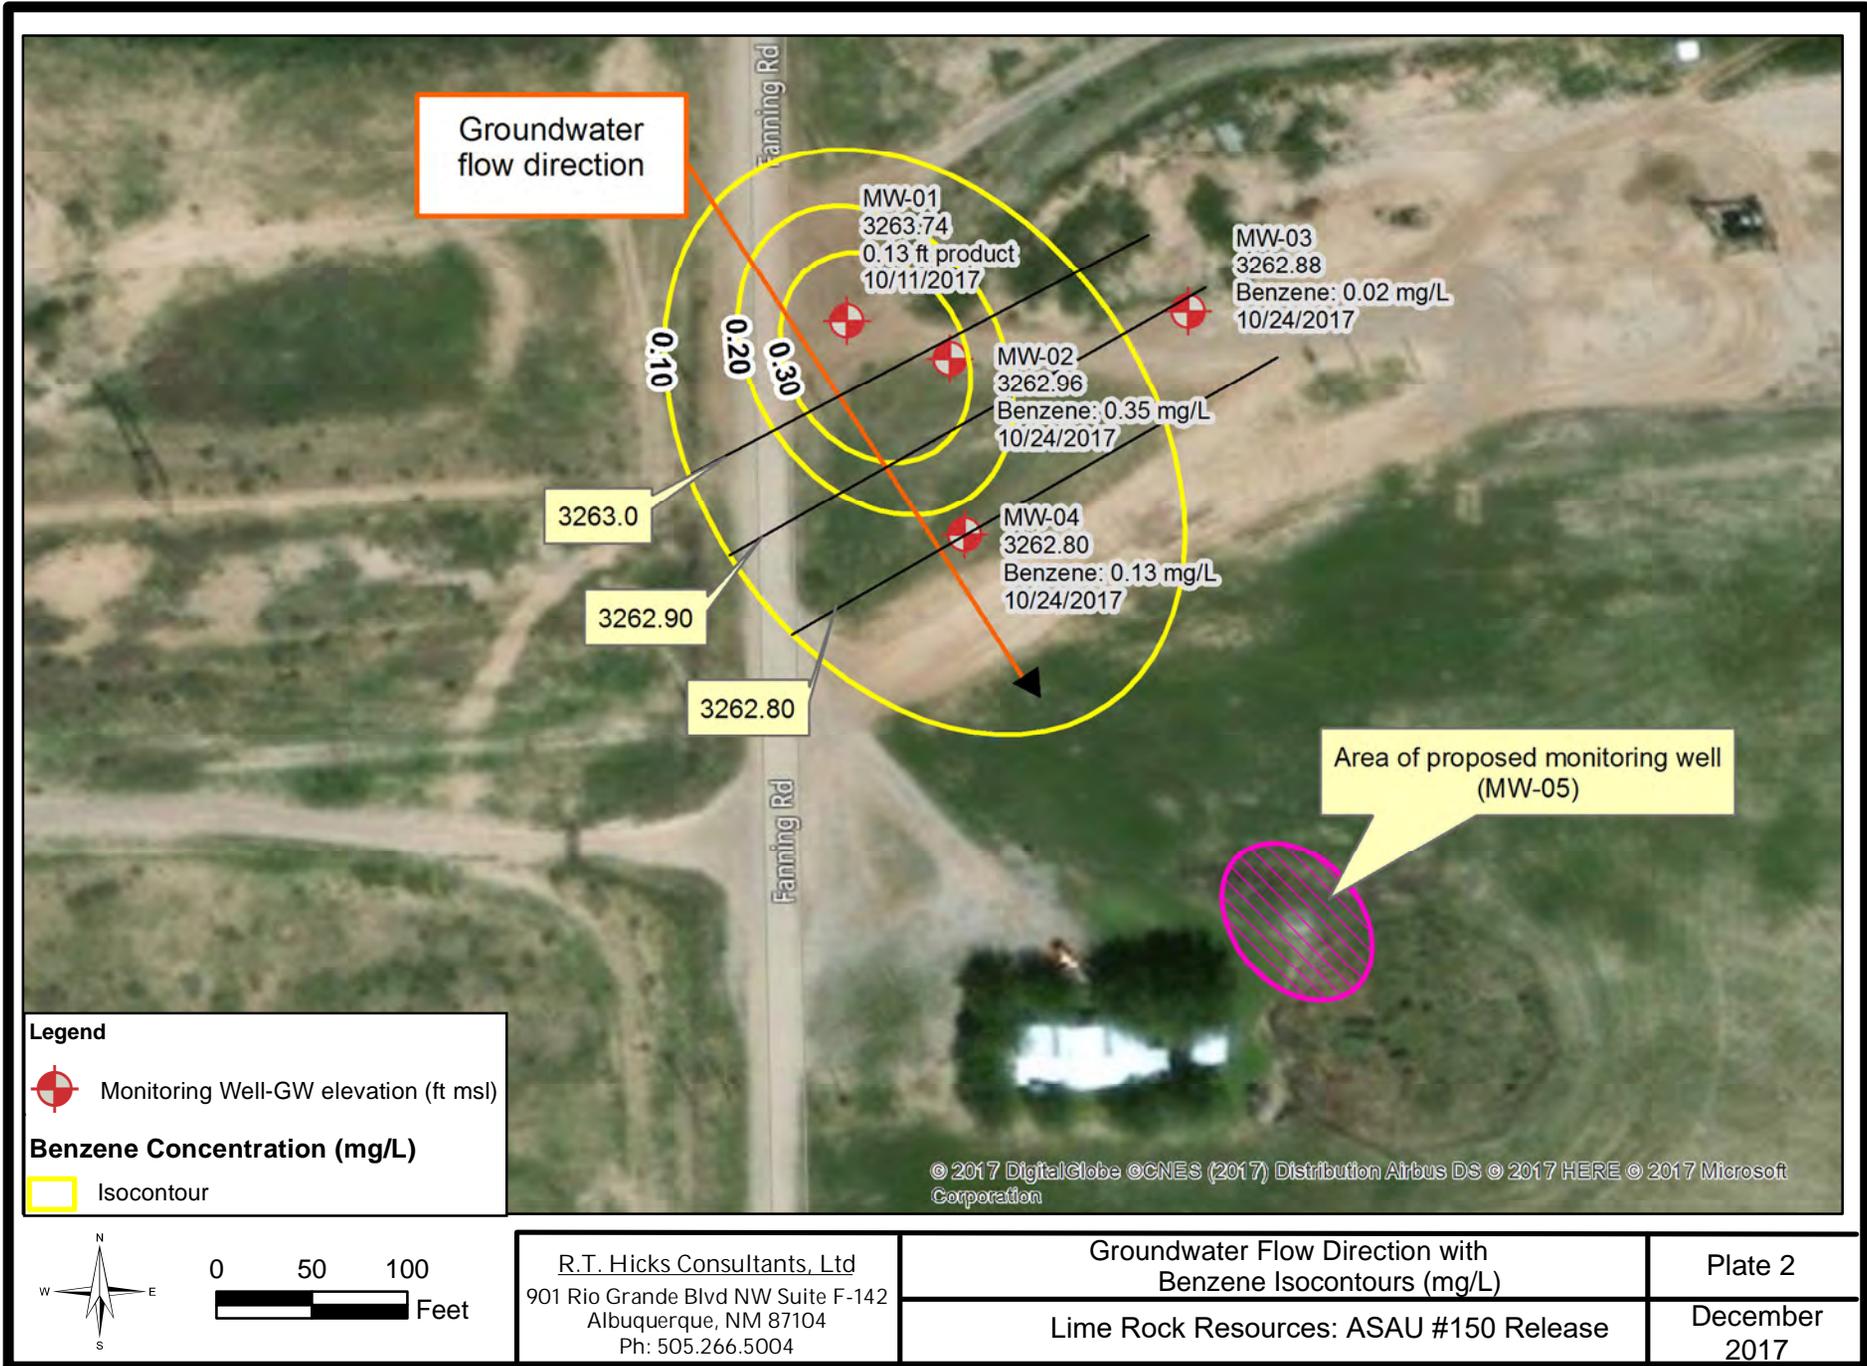
R.T. Hicks Consultants, Ltd 901 Rio Grande Blvd NW Suite F-142 Albuquerque, NM 87104 Ph: 505.266.5004	Groundwater Flow Direction with Benzene Isocontours (mg/L)	Plate 2
	Lime Rock Resources: ASAU #150 Release	December 2017

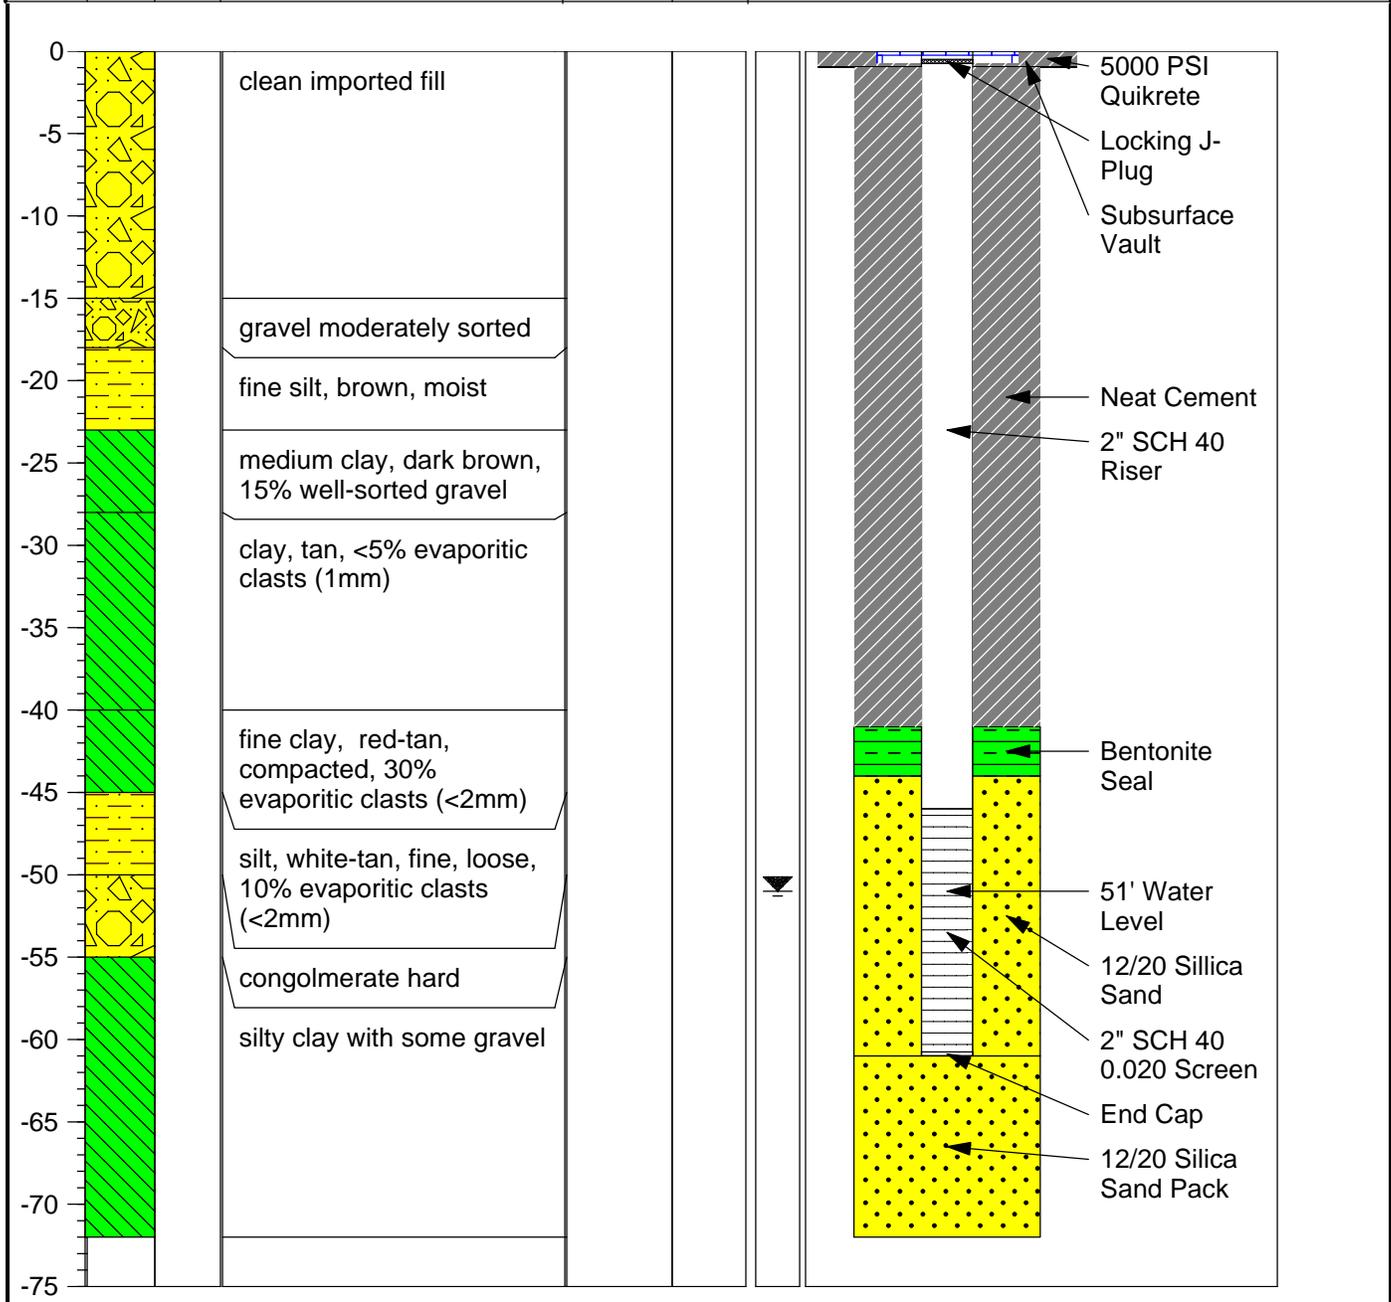
Logger:		Kristin Pope		Client:		Lime Rock Resources		Well ID:		MW-2	
Driller:		Atkins Engineering Associates, Inc.		Project Name:		ASAU #150 Trunkline Release					
Drilling Method:		Hollow-Stem Auger; 8" borehole		Location:		Sec. 14, T18S, R26E					
Start Date:		6/6/2017									
End Date:		6/6/2017									
		East side of Fanning Road, south of Artesia, NM (Atoka)				32.743127°, -104.347963°					
Depth (feet)	Description	Lithology	Comments	Well Construction		Depth (feet)

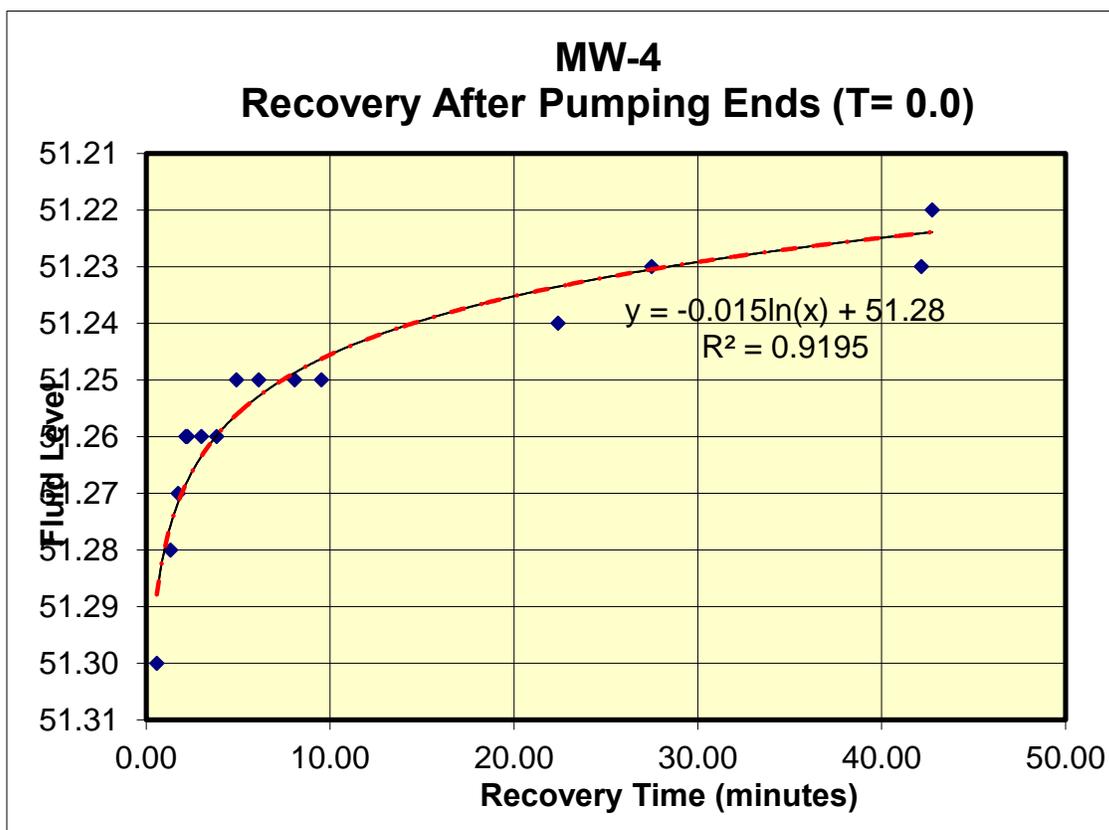
Figure 1

The dashed, red line is a logarithmic trendline fitted to the data. The R<sup>2</sup> value of 0.92 is much closer to 1.0 than to 0.0. An R<sup>2</sup> value close to 1.0 means that the trendline is a “good fit” compared to an R<sup>2</sup> value of 0.0.

A semi log method of pump-test interpretation was applied to the data. Because there was so little drawdown (and insufficient ability to measure the small changes - note the step like nature of the data points in Figure 1), the method did not yield results that we consider highly accurate. The calculated hydraulic conductivity was on the order of hundreds of feet/day. These are consistent with reported hydraulic conductivities for gravels and sands and in agreement with materials observed in the boring logs.

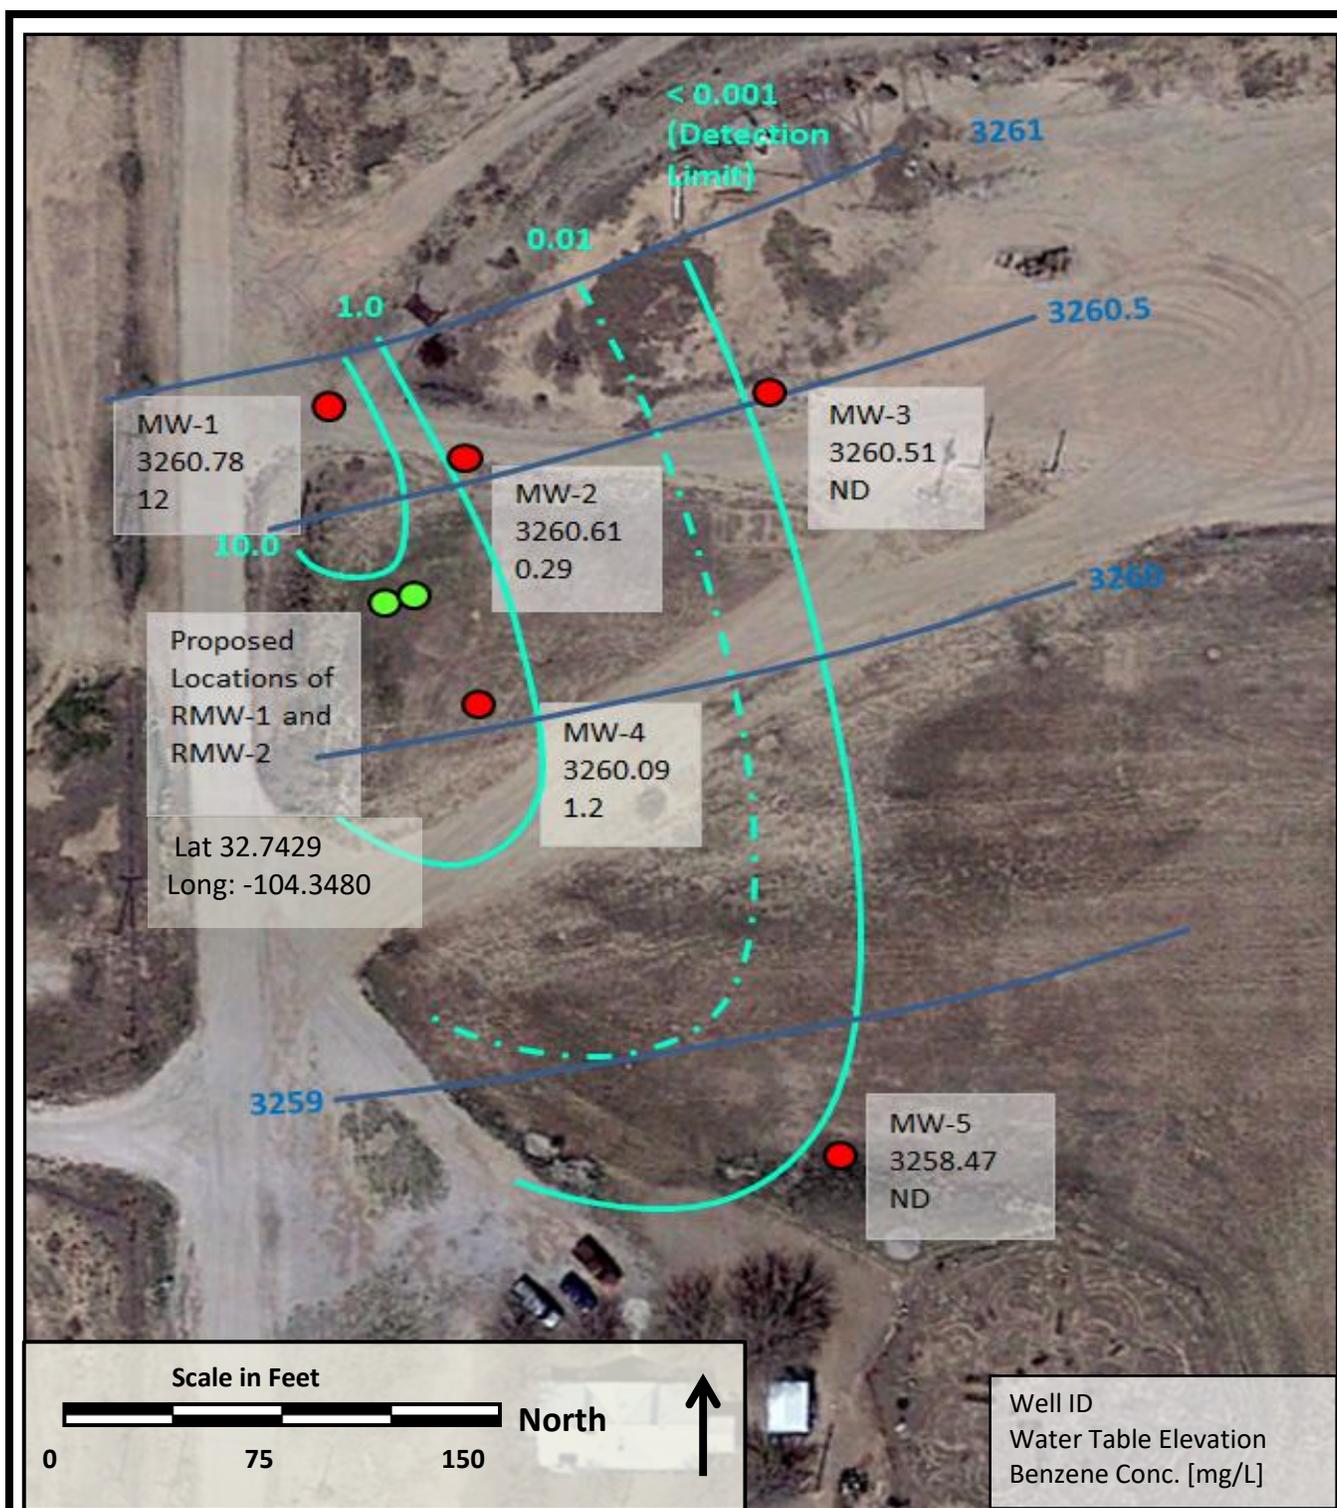
R.T. Hicks Consultants, Ltd 901 Rio Grande Blvd NW Suite F-142 Albuquerque, NM 87104 505-266-5004	<b>Benzene Concentration Contours</b> <b>August 2018 Sampling</b> <b>(Logarithmic Scale Contours)</b>	<b>Plate 8</b>
	Lime Rock Resources: ASAU Release	November, 2018
