**Re: Remediation Closure Report
ConocoPhillips
On behalf of Solaris Water Midstream, LLC
Pine Springs 2 State SWD #001 Release
Unit Letter K, Section 2, Township 26 South, Range 25 East
Eddy County, New Mexico
Incident ID NAB1817955890
2RP-4832**

Closure Report
September 27, 2024

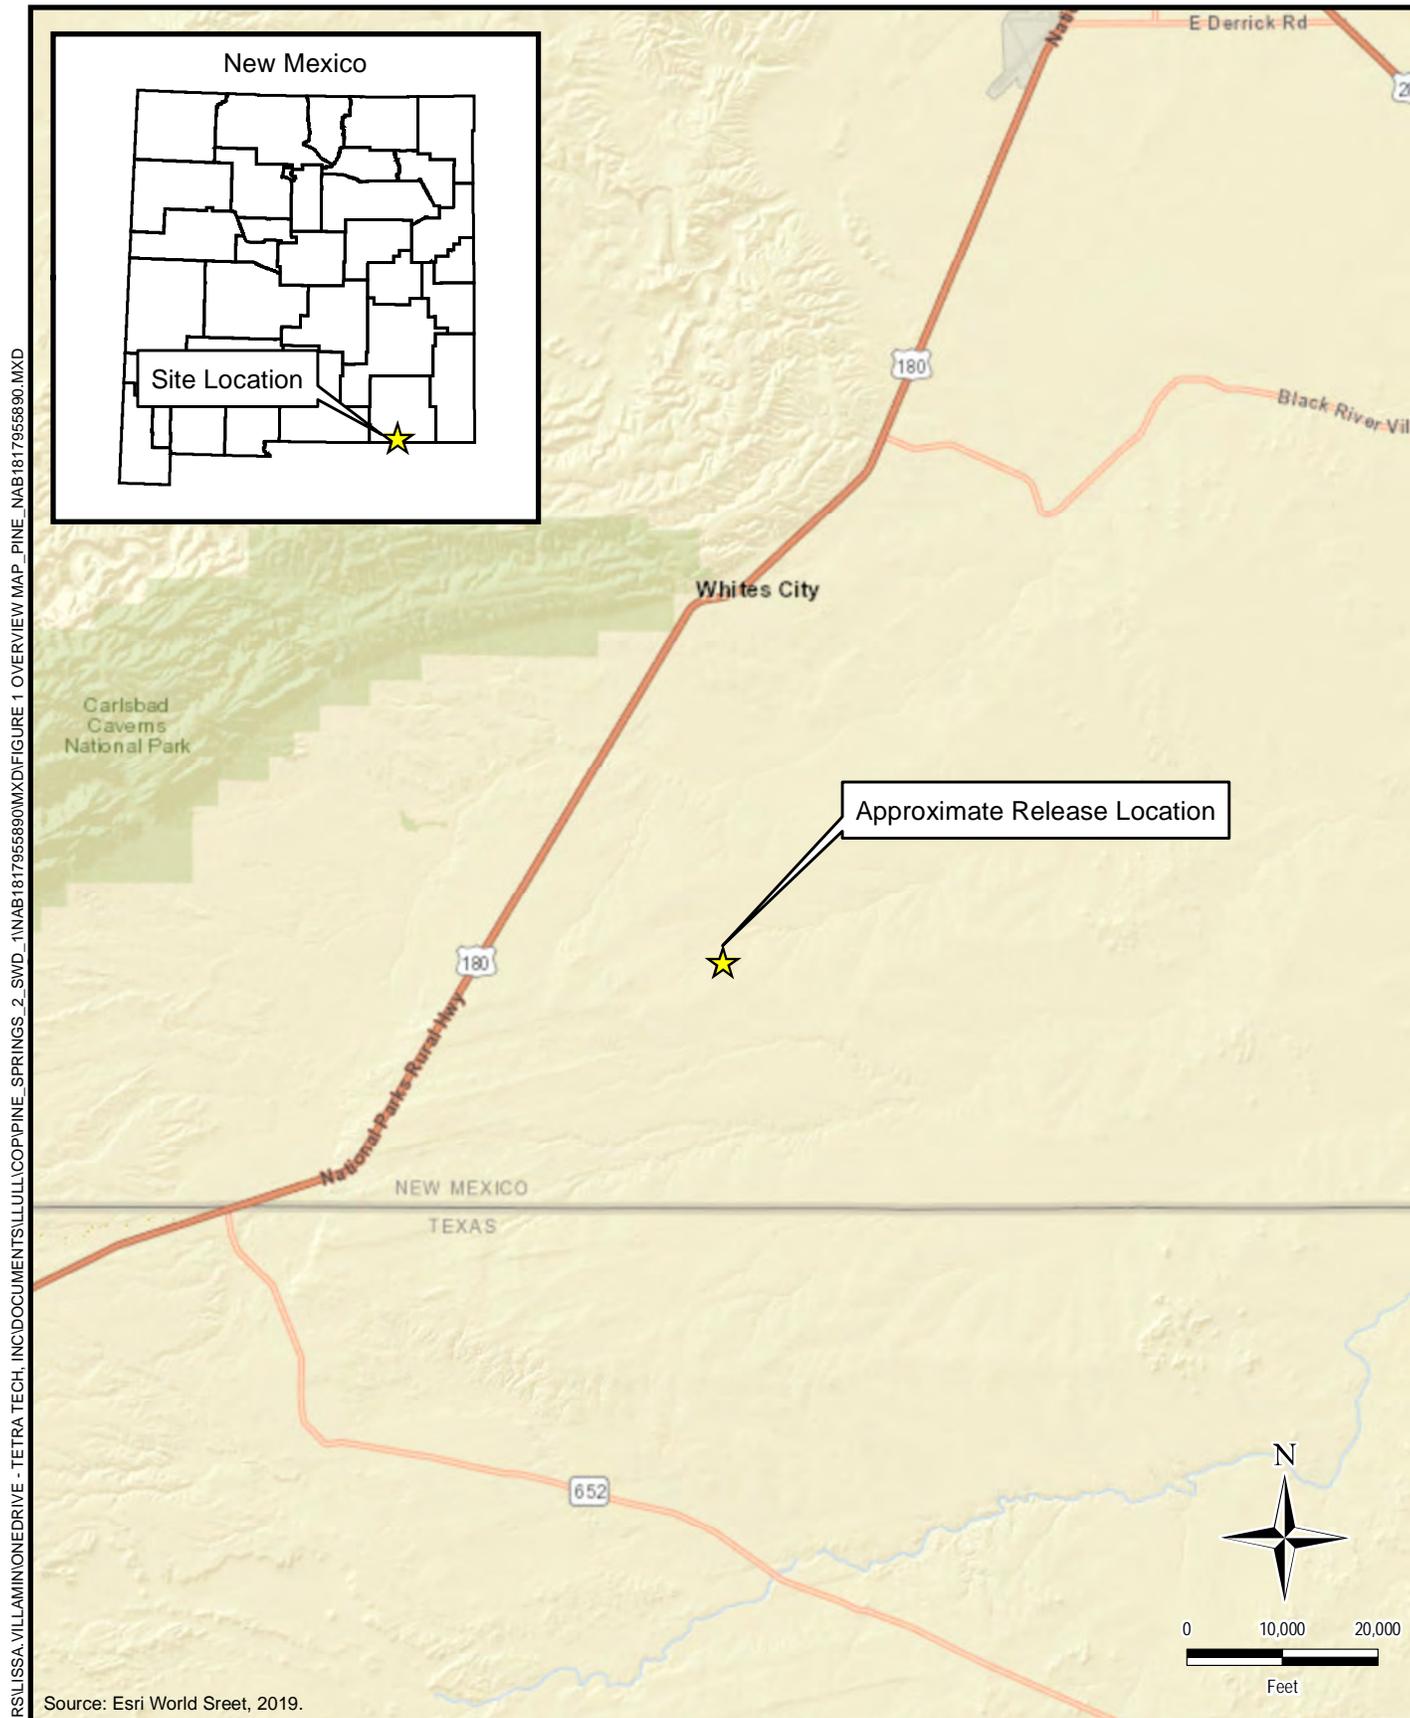
<p>TETRA TECH</p> <p>www.tetratech.com</p> <p>901 West Wall Street, Suite 100 Midland, Texas 79701 Phone: (432) 682-4559 Fax: (432) 682-3946</p>	<p>CONOCOPHILLIPS</p> <p>NAB1817955890 (32.071359°, -104.366918°) EDDY COUNTY, NEW MEXICO</p>	<p>PROJECT NO.: 212C-MD-02878</p> <p>DATE: NOVEMBER 16, 2023</p> <p>DESIGNED BY: LMV</p>
	<p>PINE SPRINGS 2 STATE SWD #001 RELEASE OVERVIEW MAP</p>	<p>Figure No. 1</p>

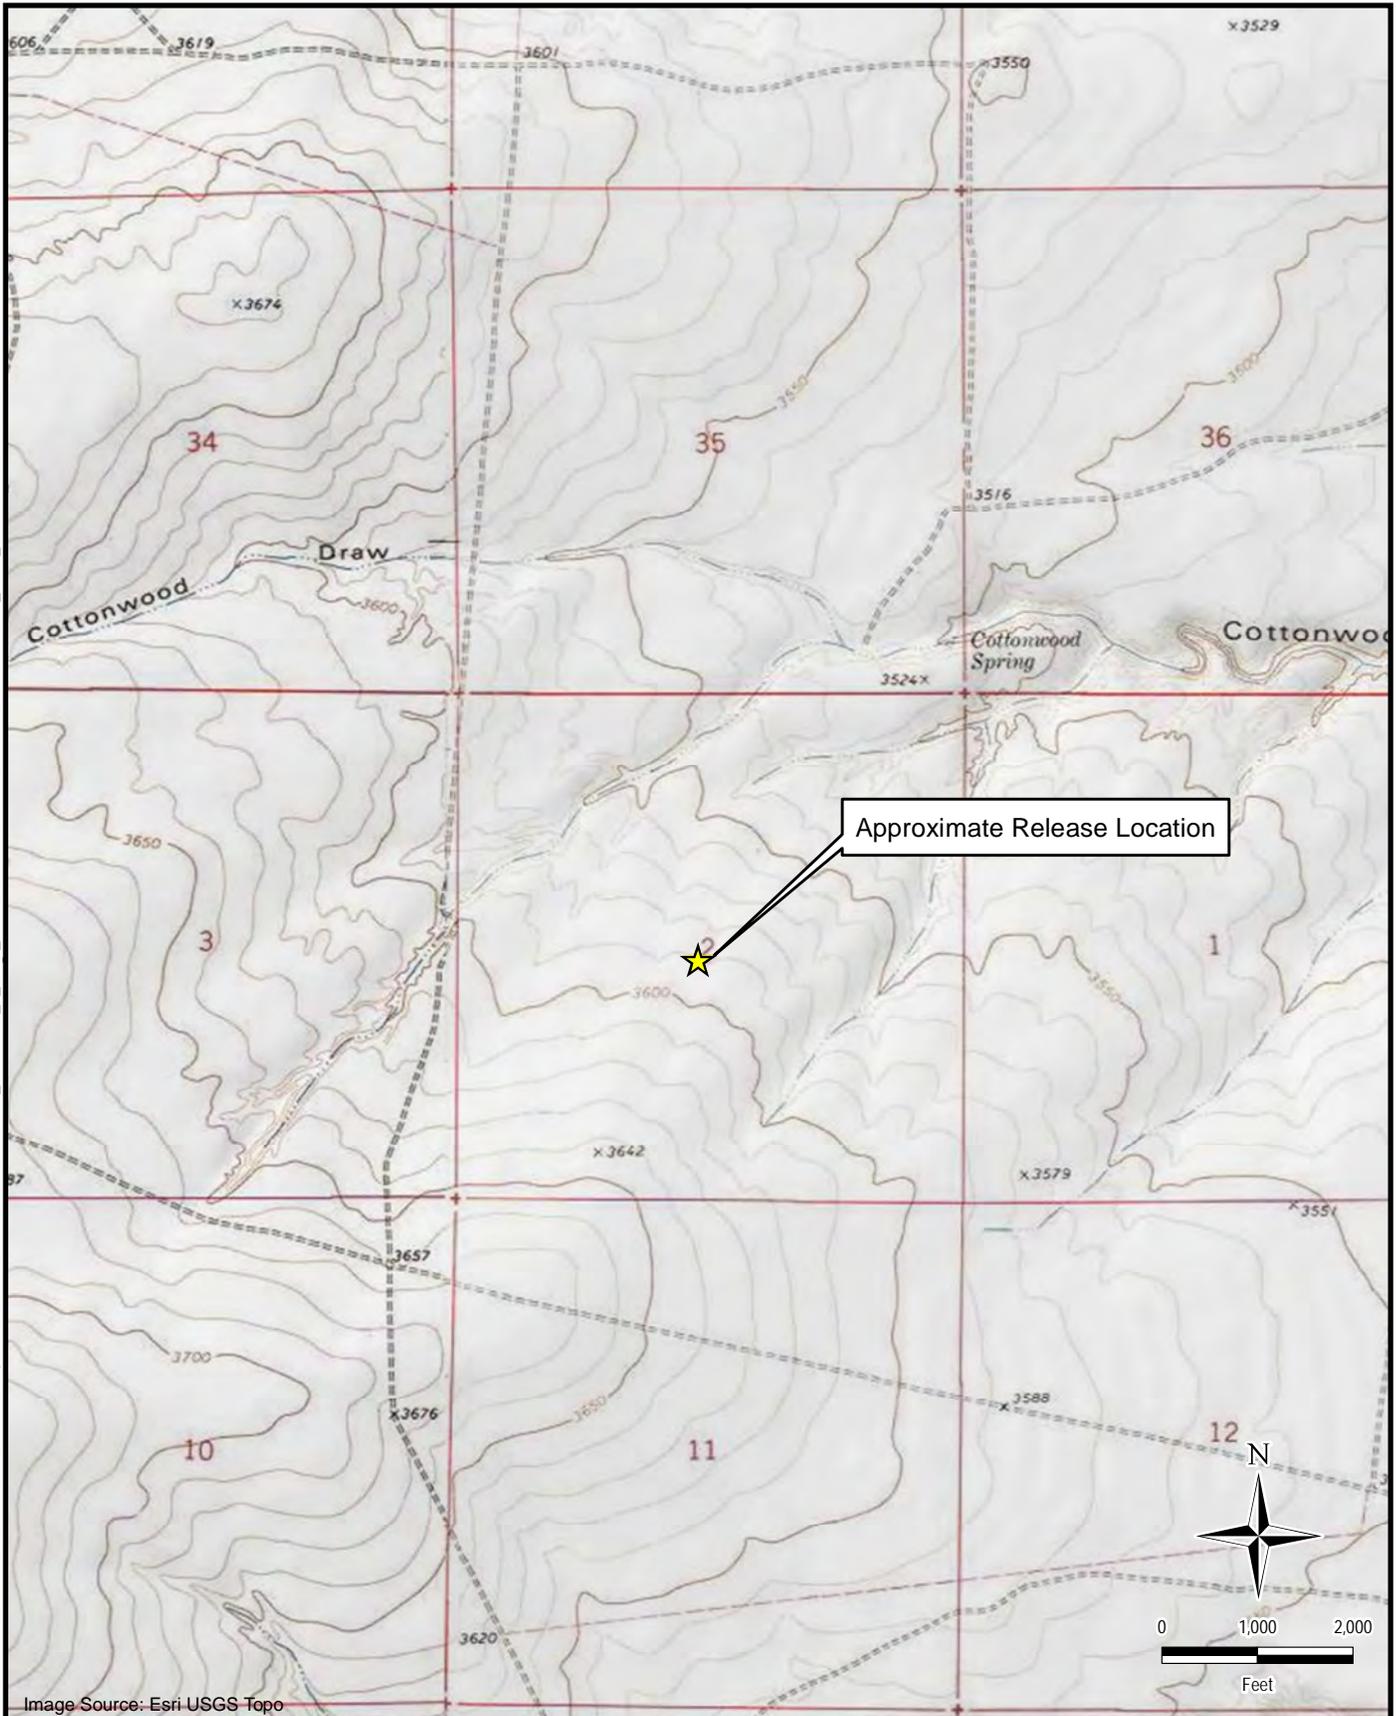
<p>TETRA TECH</p> <p>www.tetrattech.com</p> <p>901 West Wall Street, Suite 100 Midland, Texas 79701 Phone: (432) 682-4559 Fax: (432) 682-3946</p>	<p>CONOCOPHILLIPS</p> <p>NAB1817955890 (32.071359°, -104.366918°) EDDY COUNTY, NEW MEXICO</p>	<p>PROJECT NO.: 212C-MD-02878</p>
	<p>PINE SPRINGS 2 STATE SWD #001 RELEASE TOPOGRAPHIC MAP</p>	<p>DATE: NOVEMBER 16, 2023</p> <p>DESIGNED BY: LMV</p>
		<p>Figure No. 2</p>

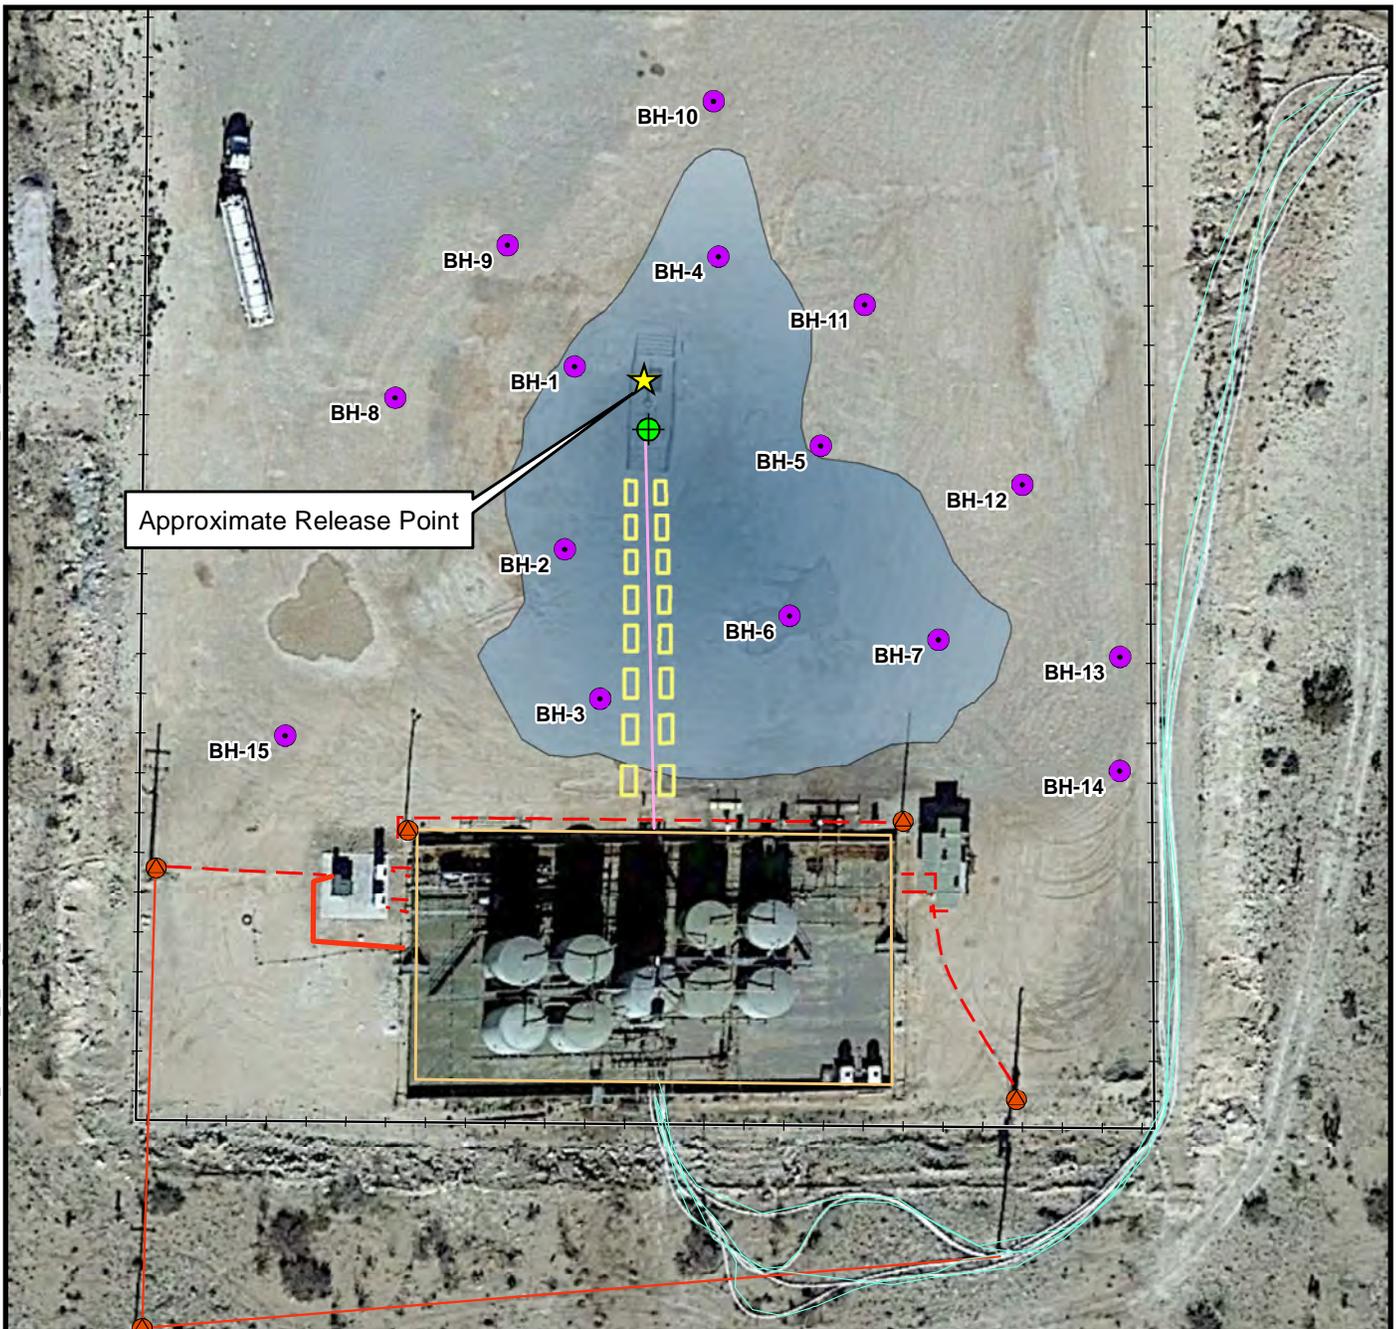
PROJECT NO.:	212C-MD-02878
DATE:	DECEMBER 08, 2023
DESIGNED BY:	LMV
Figure No.	4

PINE SPRINGS 2 STATE SWD #001 RELEASE
TETRA TECH APPROXIMATE RELEASE EXTENT AND SITE ASSESSMENT

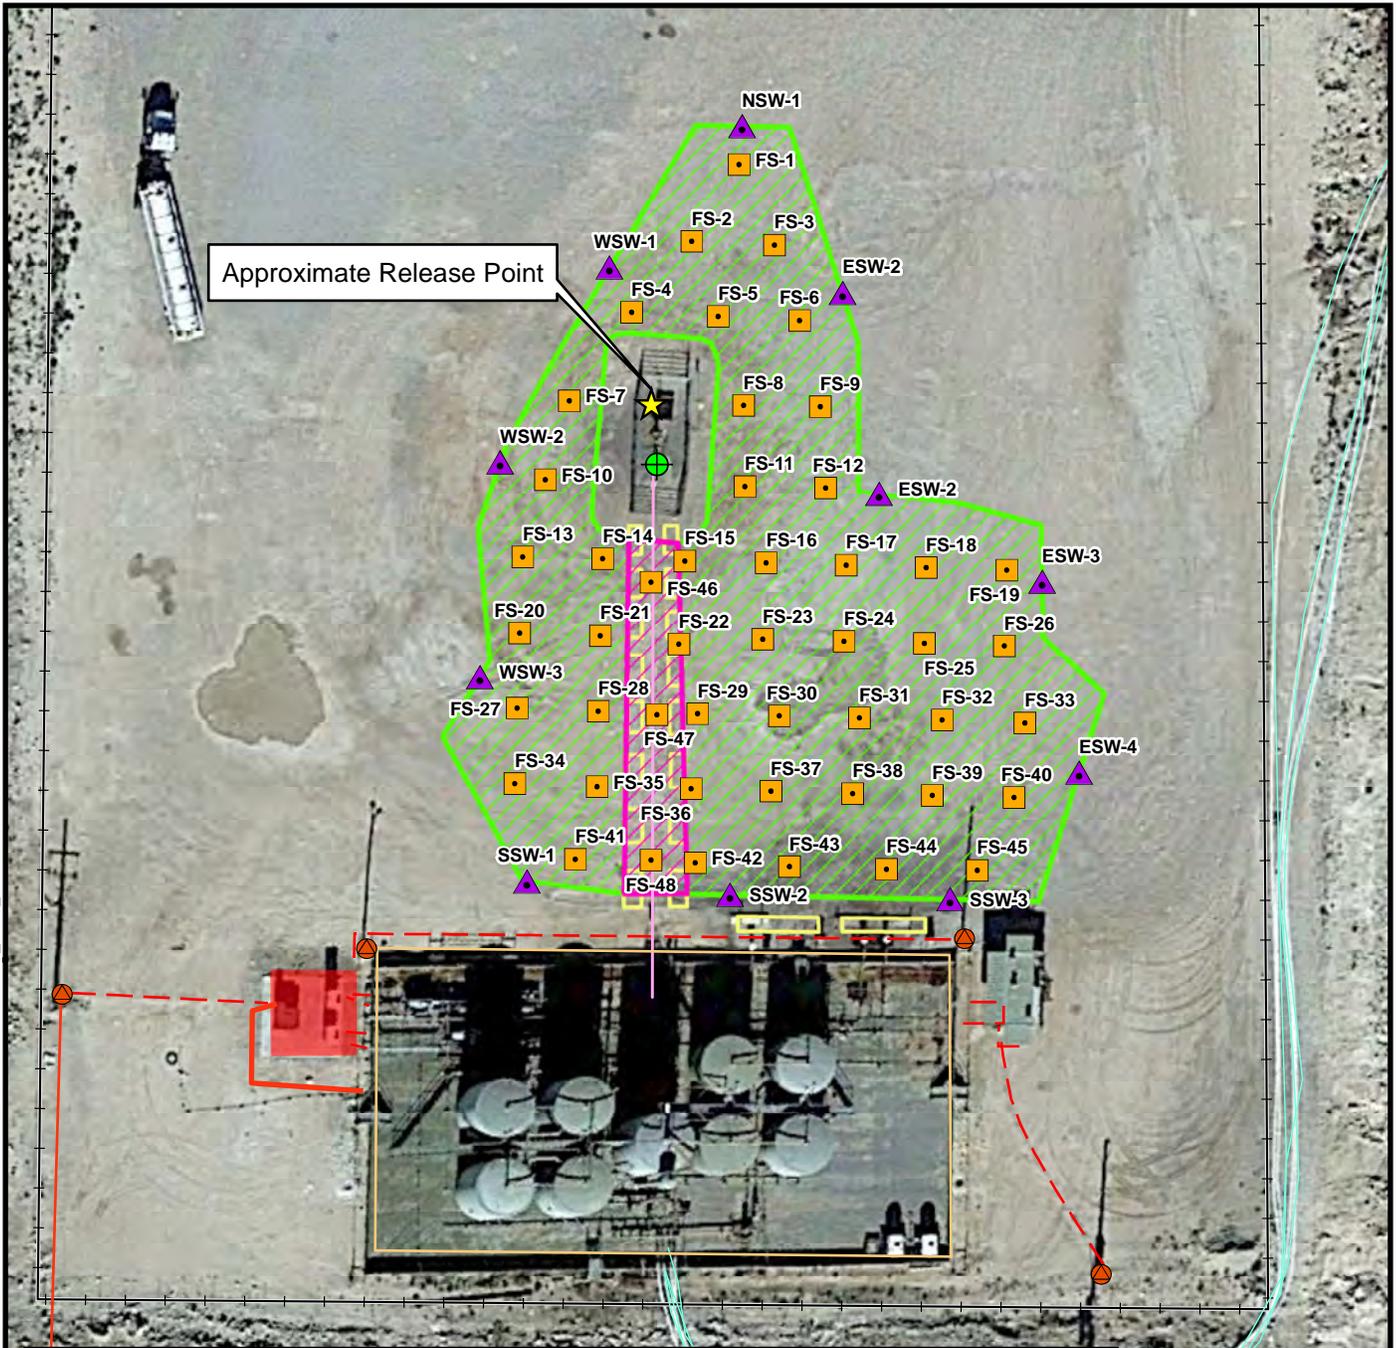
Legend					
	Floor Confirmation Sample Location		Excavated Area - 3' BGS		Subsurface Electrical Lines
	Sidewall Confirmation Sample Location		Scraped Area - 6" BGS		Overhead Power Line
	Wellhead		Cement Block		Raised Electrical Line
	Power Pole		Electrical Panel		Raised Steel Line
			Approximate Berm Location		Surface Polyline
			Fenceline

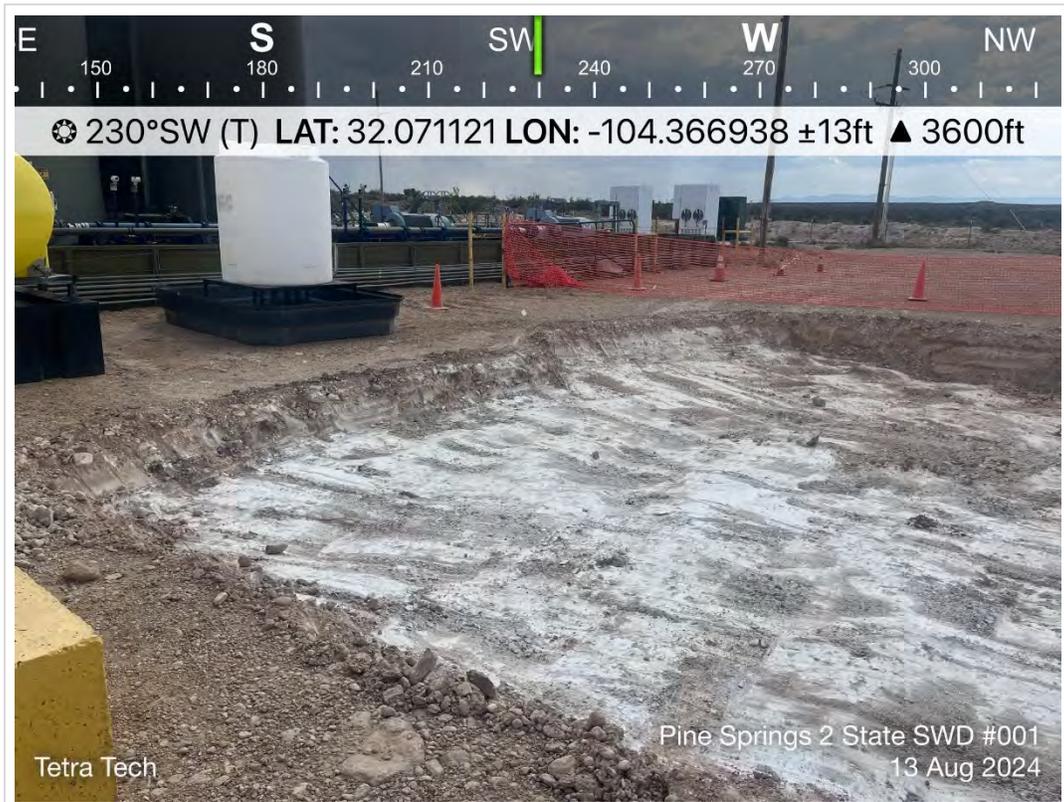
TETRA TECH, INC. PROJECT NO. 212C-MD-02878	DESCRIPTION	View southwest. Initial excavation on western section of approved work plan.	1
	SITE NAME	Pine Springs 2 State SWD #001 Release	8/13/2024

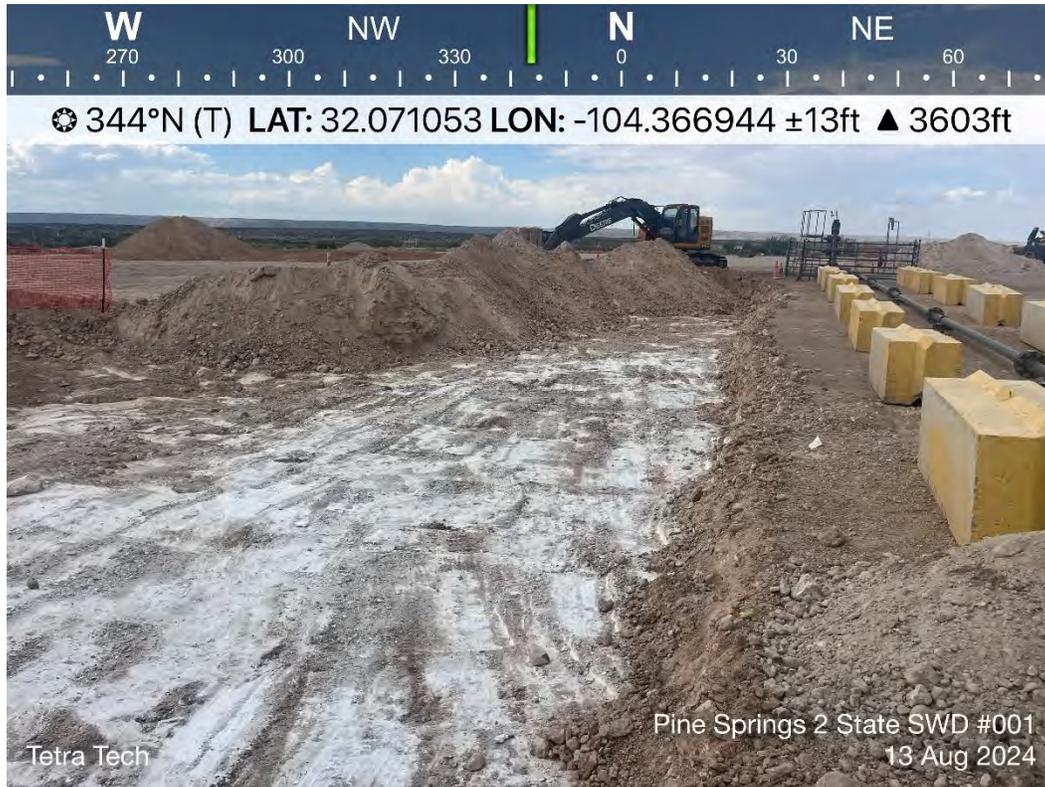
TETRA TECH, INC. PROJECT NO. 212C-MD-02878	DESCRIPTION	View north. Start of excavation at Site for approved work plan.	2
	SITE NAME	Pine Springs 2 State SWD #001 Release	8/13/2024

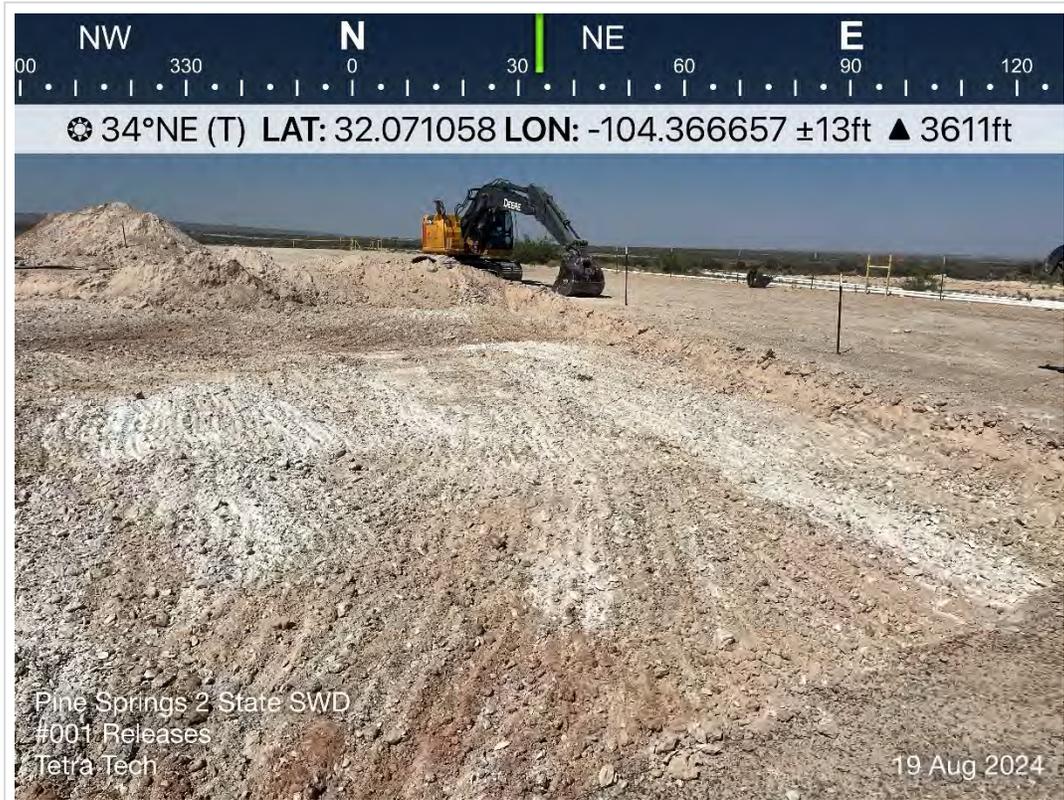
TETRA TECH, INC. PROJECT NO. 212C-MD-02878	DESCRIPTION	View northeast. Eastern section of excavation progressing from approved work plan.	3
	SITE NAME	Pine Springs 2 State SWD #001 Release	8/19/2024

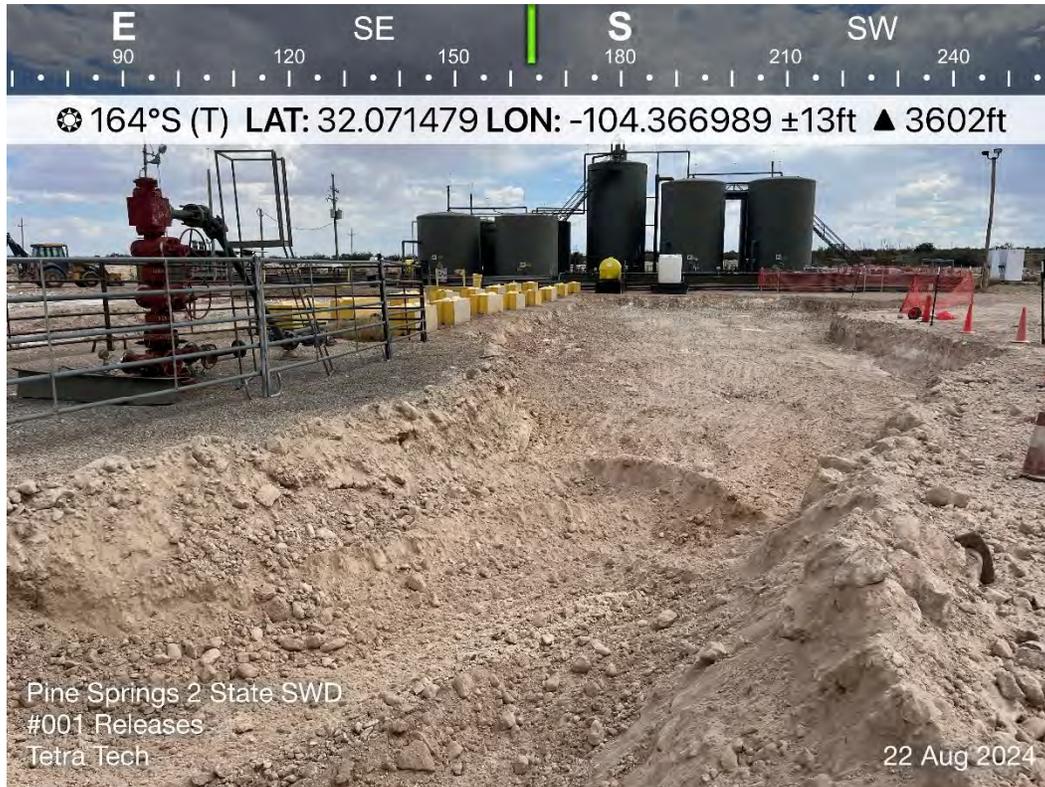
TETRA TECH, INC. PROJECT NO. 212C-MD-02878	DESCRIPTION	View south. Western section of excavation with wellhead visible on left-side of photo.	4
	SITE NAME	Pine Springs 2 State SWD #001 Release	8/22/2024

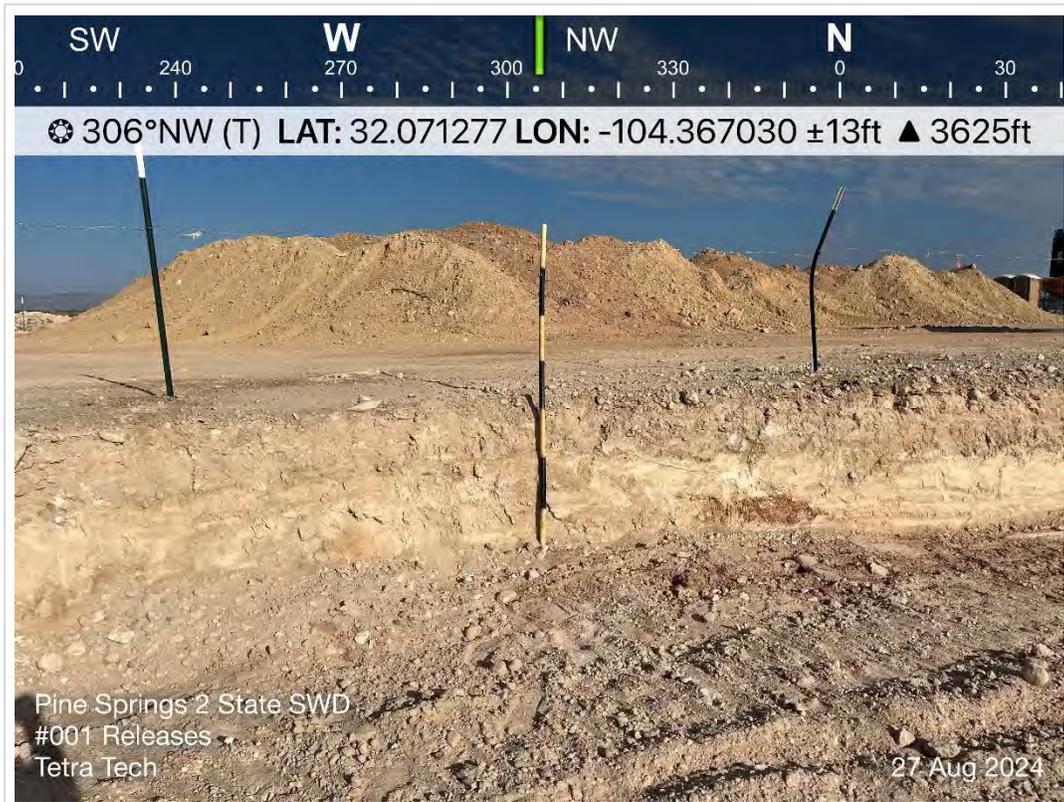
TETRA TECH, INC. PROJECT NO. 212C-MD-02878	DESCRIPTION	View northwest. Western sidewall with measuring stick indicating depth of excavation.	5
	SITE NAME	Pine Springs 2 State SWD #001 Release	8/27/2024

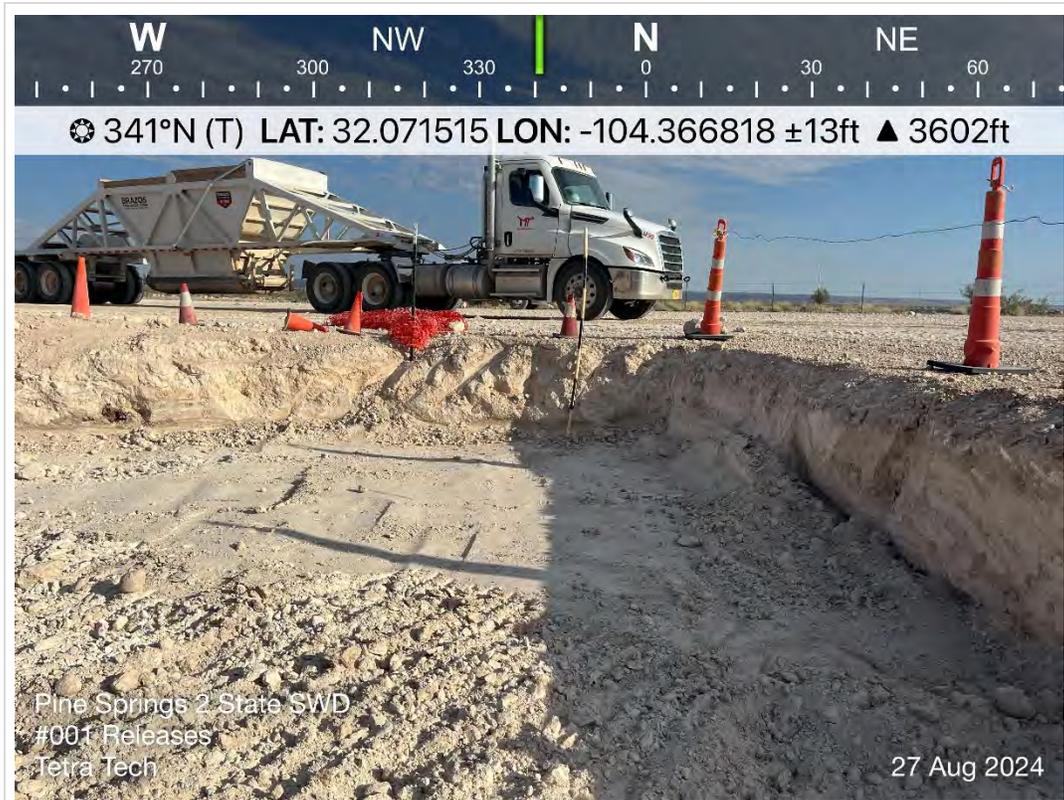
TETRA TECH, INC. PROJECT NO. 212C-MD-02878	DESCRIPTION	View north. Northern sidewall with measuring stick indicating depth of excavation.	6
	SITE NAME	Pine Springs 2 State SWD #001 Release	8/27/2024

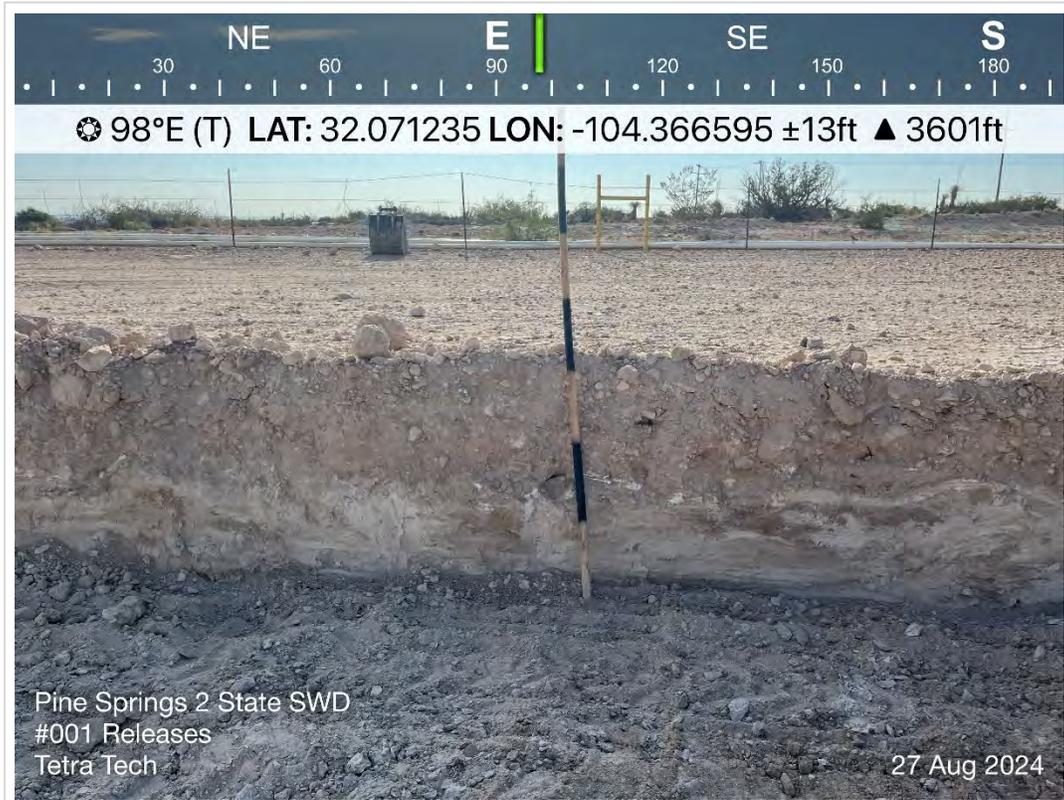
TETRA TECH, INC. PROJECT NO. 212C-MD-02878	DESCRIPTION	View east. Eastern sidewall with measuring stick indicating depth of excavation.	7
	SITE NAME	Pine Springs 2 State SWD #001 Release	8/27/2024

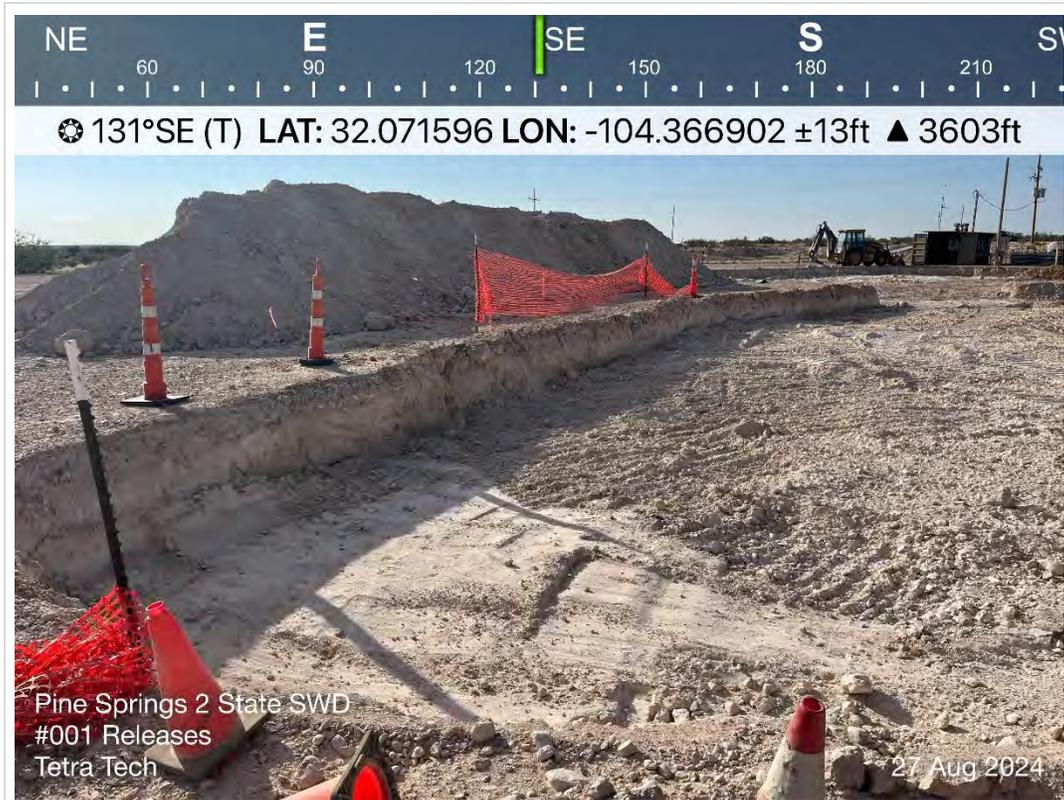
TETRA TECH, INC. PROJECT NO. 212C-MD-02878	DESCRIPTION	View southeast. Photo taken from northern extent of excavation, view of eastern sidewall.	8
	SITE NAME	Pine Springs 2 State SWD #001 Release	8/27/2024

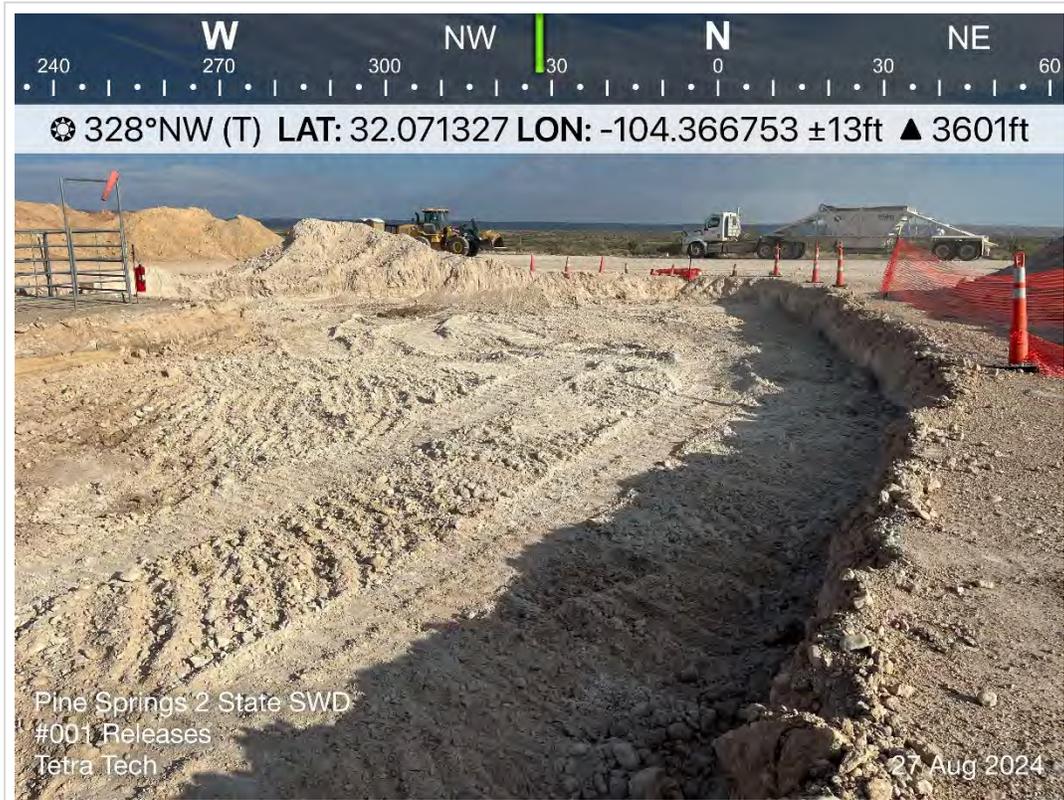
TETRA TECH, INC. PROJECT NO. 212C-MD-02878	DESCRIPTION	View northwest. Northeast section of excavation.	9
	SITE NAME	Pine Springs 2 State SWD #001 Release	8/27/2024

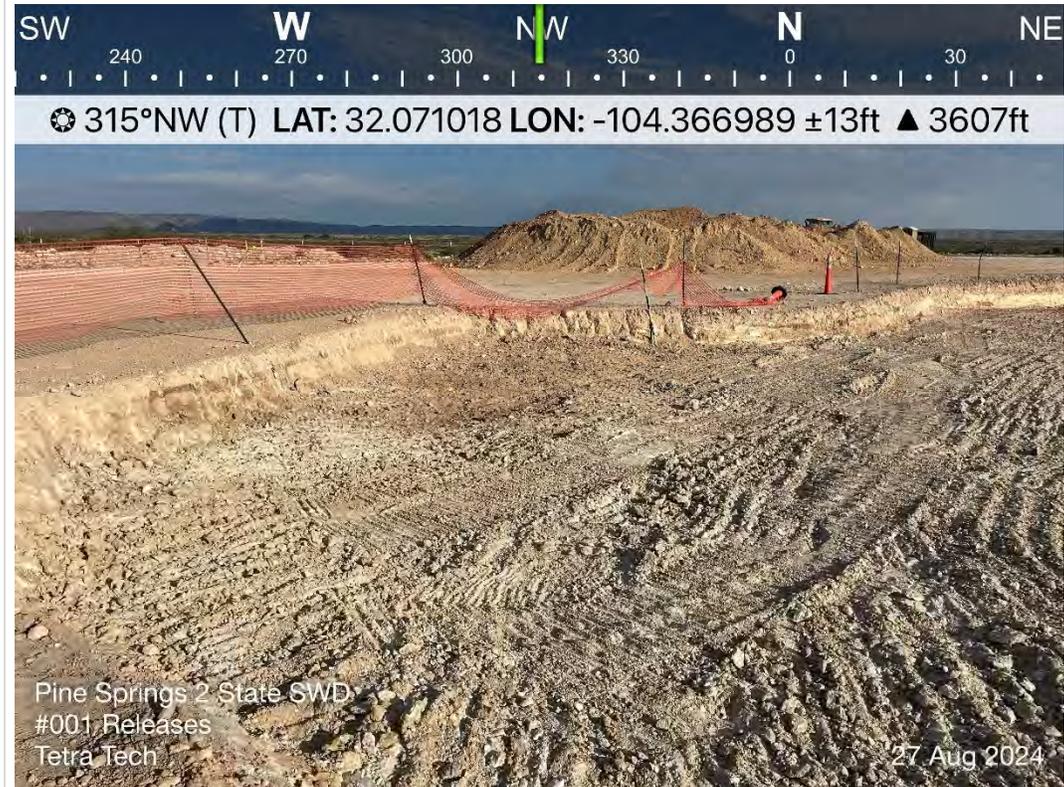
TETRA TECH, INC. PROJECT NO. 212C-MD-02878	DESCRIPTION	View northwest. Western portion of excavation and sidewall visible with measuring stick for reference.	10
	SITE NAME	Pine Springs 2 State SWD #001 Release	8/27/2024

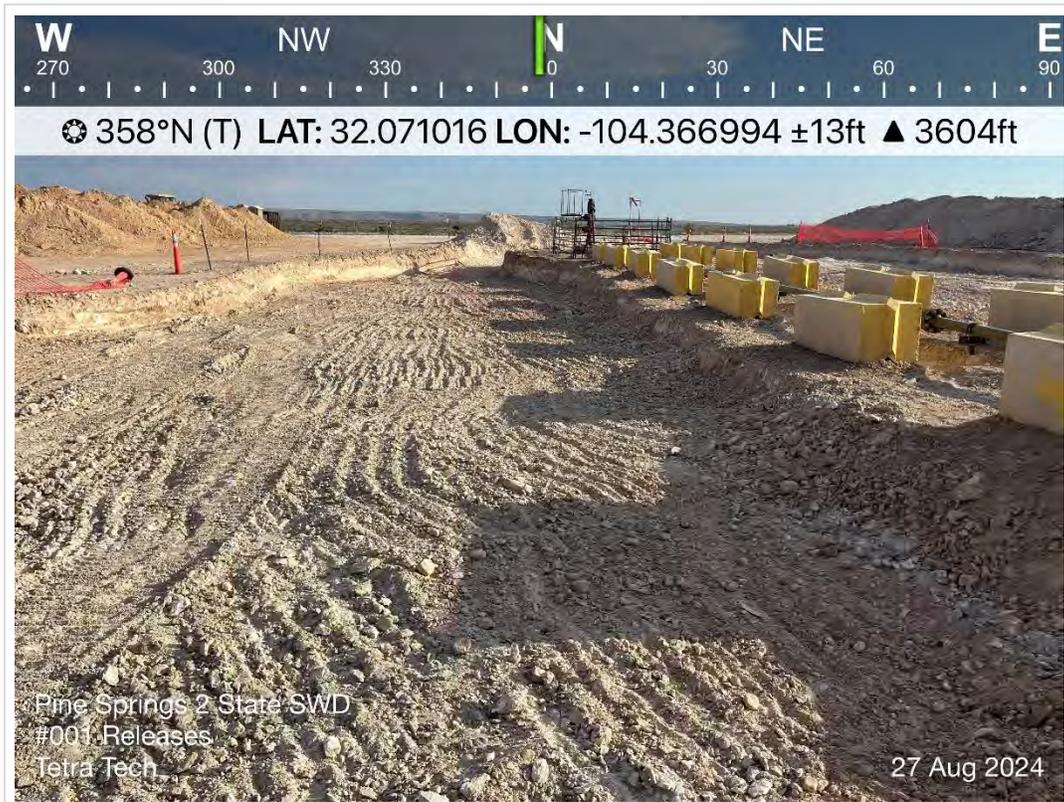
TETRA TECH, INC. PROJECT NO. 212C-MD-02878	DESCRIPTION	View north. Area of excavation west of critical facilities including well head and raised steel pipeline.	11
	SITE NAME	Pine Springs 2 State SWD #001 Release	8/27/2024

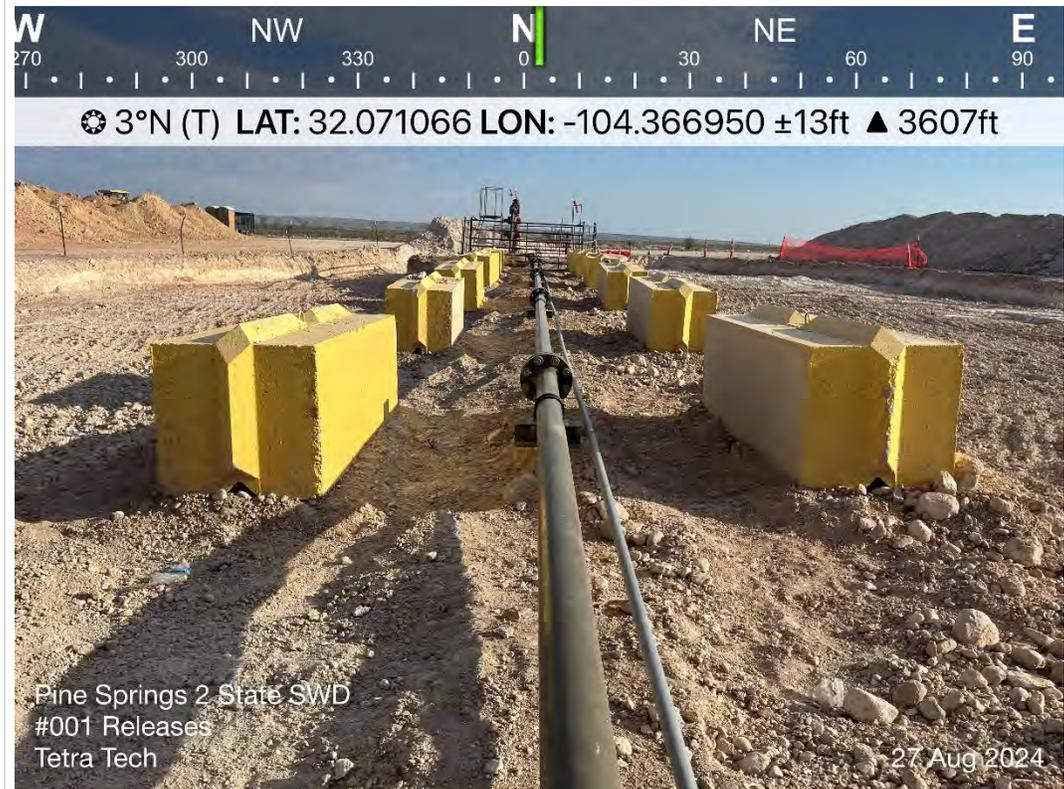
TETRA TECH, INC. PROJECT NO. 212C-MD-02878	DESCRIPTION	View north. Raised steel line surrounded by large cement blocks. Area of 6 inch scrape.	12
	SITE NAME	Pine Springs 2 State SWD #001 Release	8/27/2024

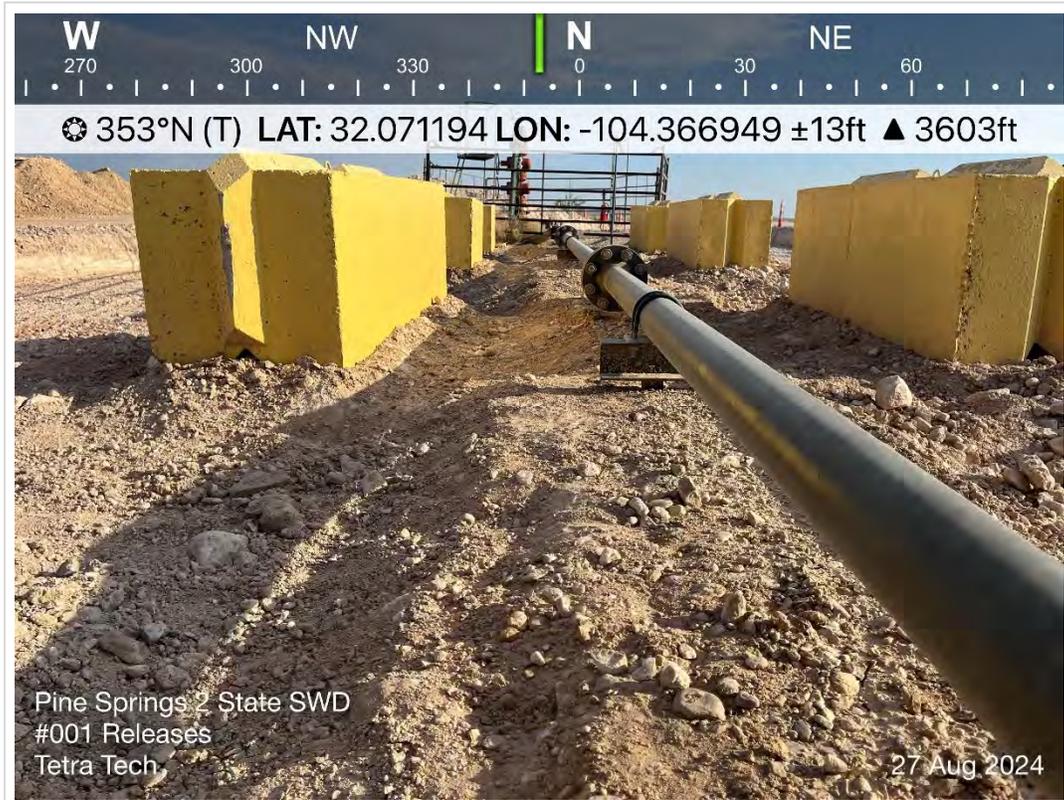
TETRA TECH, INC. PROJECT NO. 212C-MD-02878	DESCRIPTION	View south. Area of 6 inch scrape surrounding raised steel line.	13
	SITE NAME	Pine Springs 2 State SWD #001 Release	8/27/2024

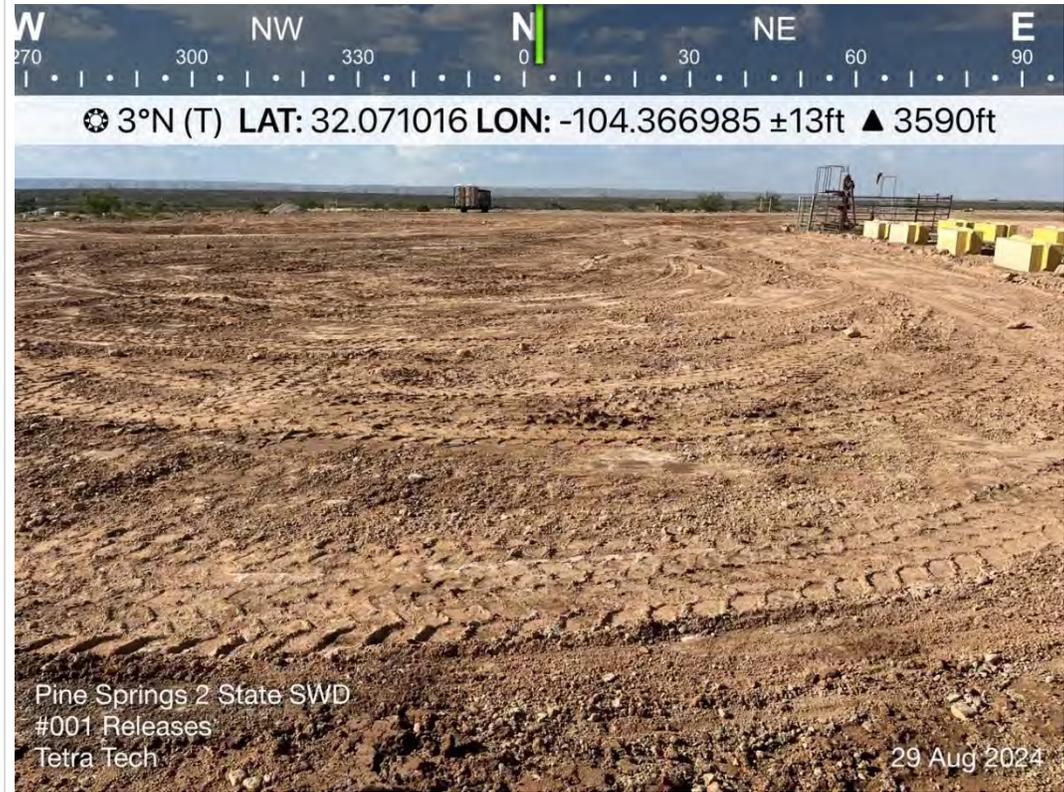
TETRA TECH, INC. PROJECT NO. 212C-MD-02878	DESCRIPTION	View north. Western section of excavation backfilled with clean materials.	14
	SITE NAME	Pine Springs 2 State SWD #001 Release	8/29/2024

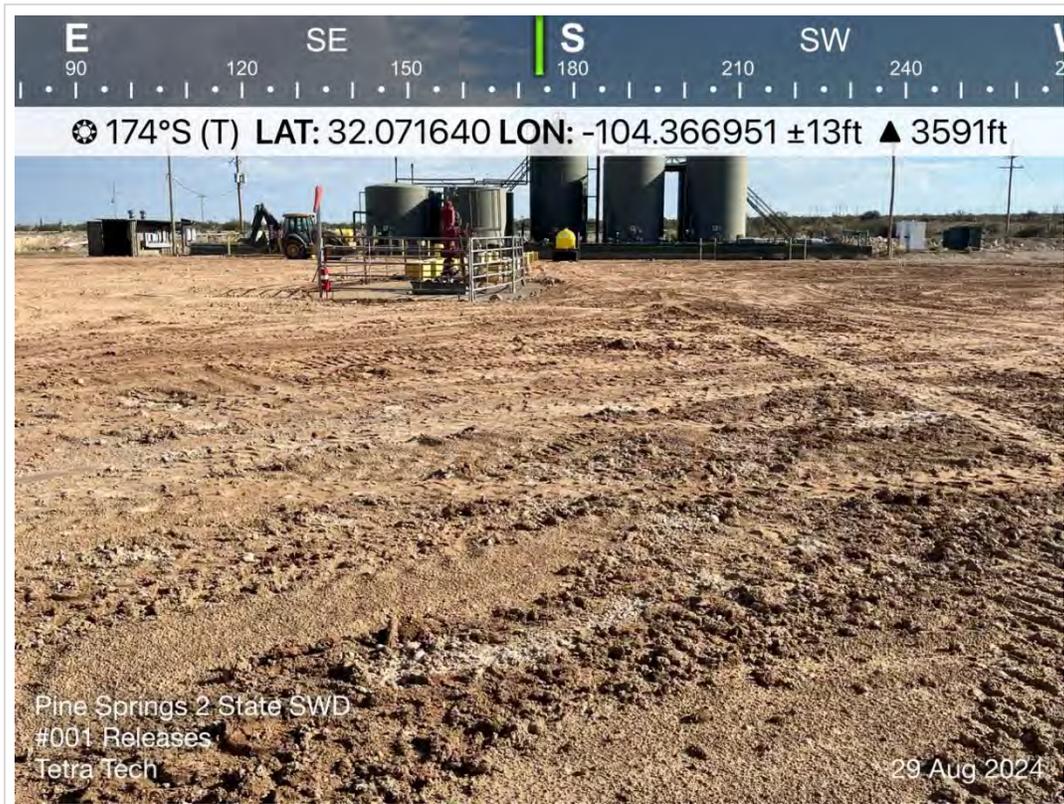
TETRA TECH, INC. PROJECT NO. 212C-MD-02878	DESCRIPTION	View south. Backfilled excavation.	15
	SITE NAME	Pine Springs 2 State SWD #001 Release	8/29/2024
