**Re: Remediation Closure Report
ConocoPhillips
On behalf of Solaris Water Midstream, LLC
Pine Springs 2 State SWD #001 Release
Unit Letter K, Section 2, Township 26 South, Range 25 East
Eddy County, New Mexico
Incident ID NAB1817955890
2RP-4832**

Closure Report
September 27, 2024

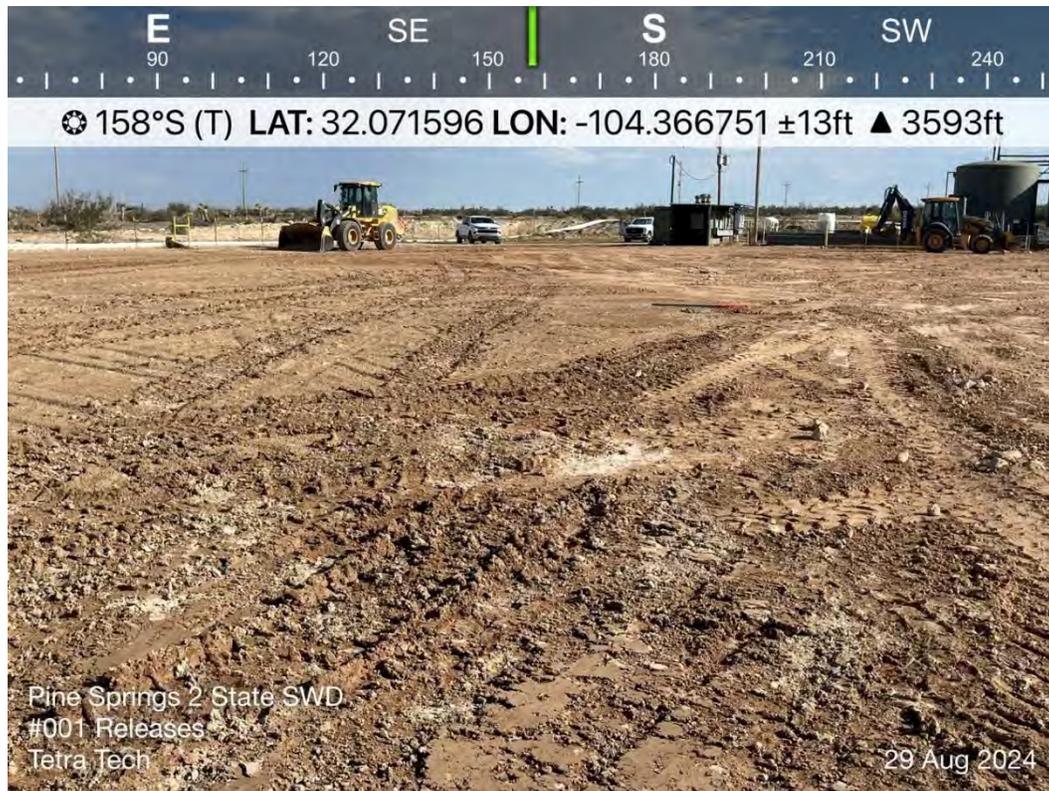
TETRA TECH, INC. PROJECT NO. 212C-MD-02878	DESCRIPTION	View south-southeast. Eastern section of excavation backfilled with clean materials.	16
	SITE NAME	Pine Springs 2 State SWD #001 Release	8/29/2024
