Re: **Closure Request** Rincon 156M

API Number 30-039-26566

**Incident Number NAPP2419441188 Rio Arriba County, New Mexico**

Enduring Resources Closure Request Rincon 156M

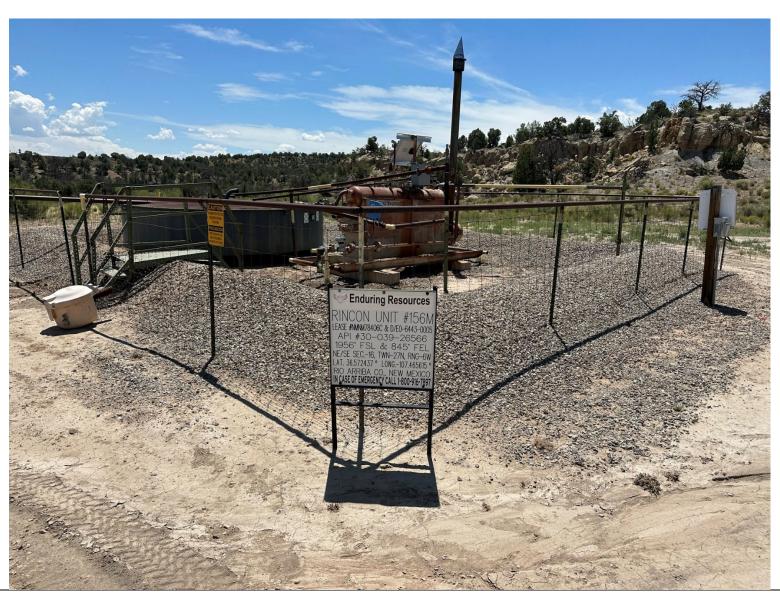
#### Photo #1

Site, showing earthen berm secondary containment around tank and separator, looking southwest.

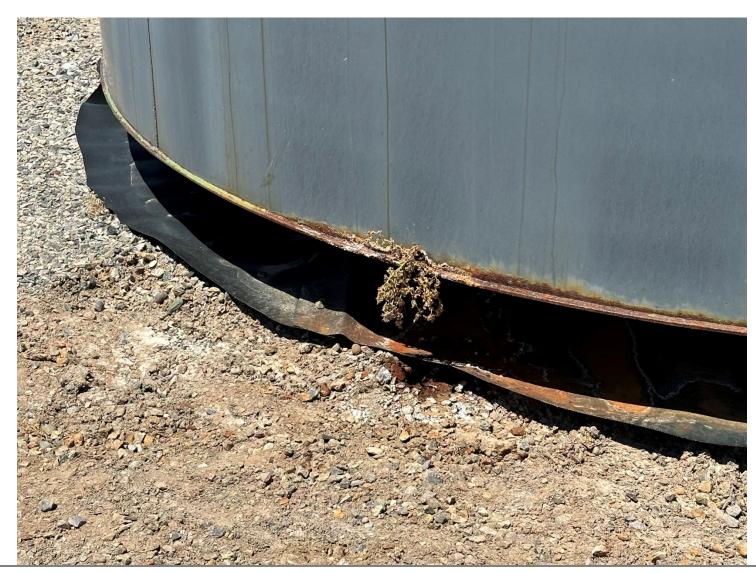
On July 11, 2024, a pinhole leak caused by corrosion was observed by a vacuum truck operator who was dispatched to remove 70 barrels (bbls) from the produced water tank. Upon noticing the leak, the vacuum truck operator proceeded to drain the tank dry, recovering approximately 62 bbls. The pinhole leak resulted in the release of approximately 8 bbls of produced water within the earthen berm secondary containment around the tank and separator. Enduring reported the release to the New Mexico Oil Conservation Division (NMOCD) and submitted a Form C-141 Application (Form C-141) on July 12, 2024. The release was assigned Incident Number NAPP2419441188.

Photo #2 Release point, pinhole corrosion.

Excavation activities were conducted at the Site to address the July 11, 2024, release of produced water from a pinhole leak caused by corrosion. Laboratory analytical results for the confirmation soil samples, collected from the final excavation extent, indicated that all COCs were compliant with the Site Closure. Based on the soil sample analytical results, no further remediation was required. Enduring has backfilled the excavation with material purchased locally and recontoured the Site to match pre-existing site conditions.

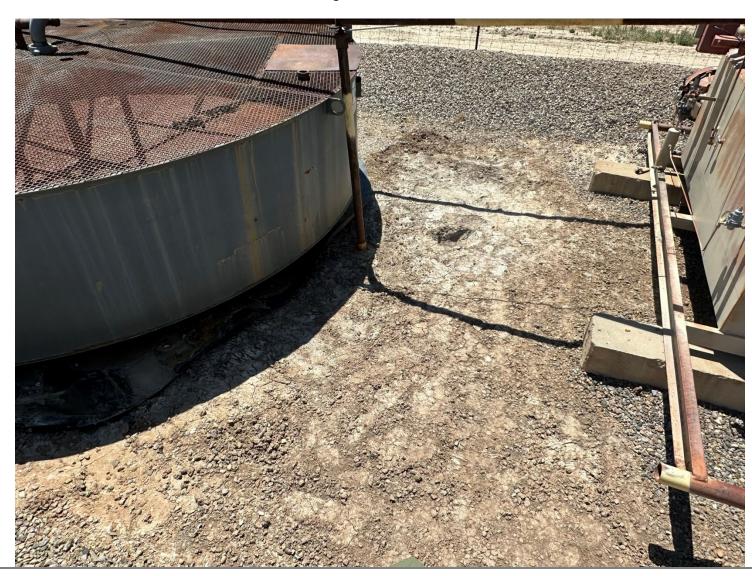
Photo #3
Initial field screening and hand shovel excavated areas.

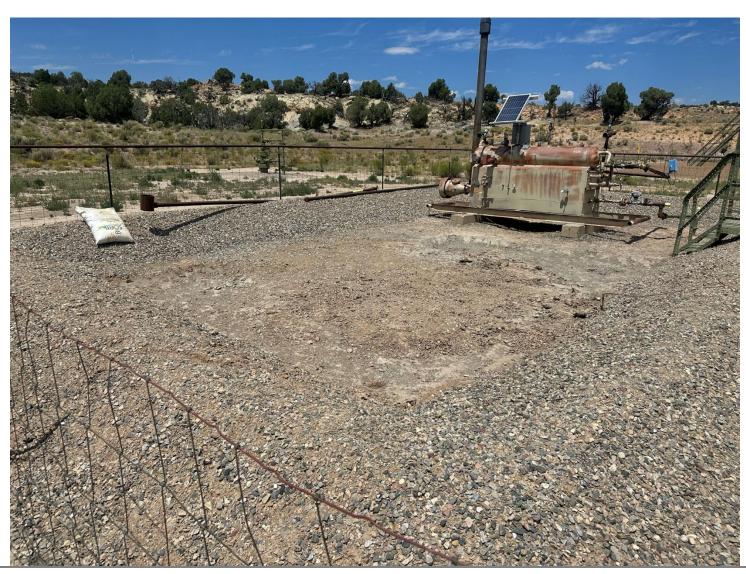
#### Photo #4

Additional excavation after tank was removed, looking northwest.

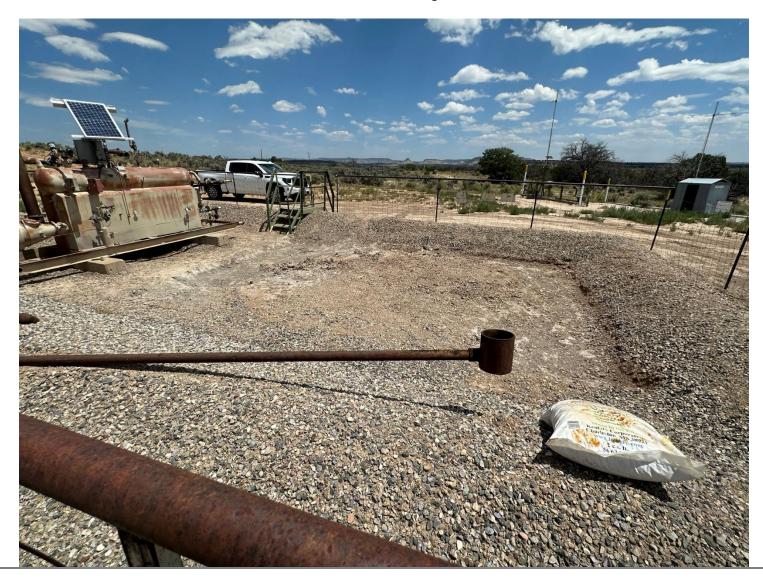
Photo #5
Excavated area, looking east.

The excavation area measured approximately 392 square feet. A total of approximately 10 cubic yards of impacted soil was removed during the excavation activities. The impacted soil was transported and properly disposed of at the Envirotech, Inc. Landfarm in Farmington, New Mexico.
