Remediation Summary & Soil Closure Request

XTO Energy, Inc.

PLU 328H

NMOCD Reference No. nAPP2409947565

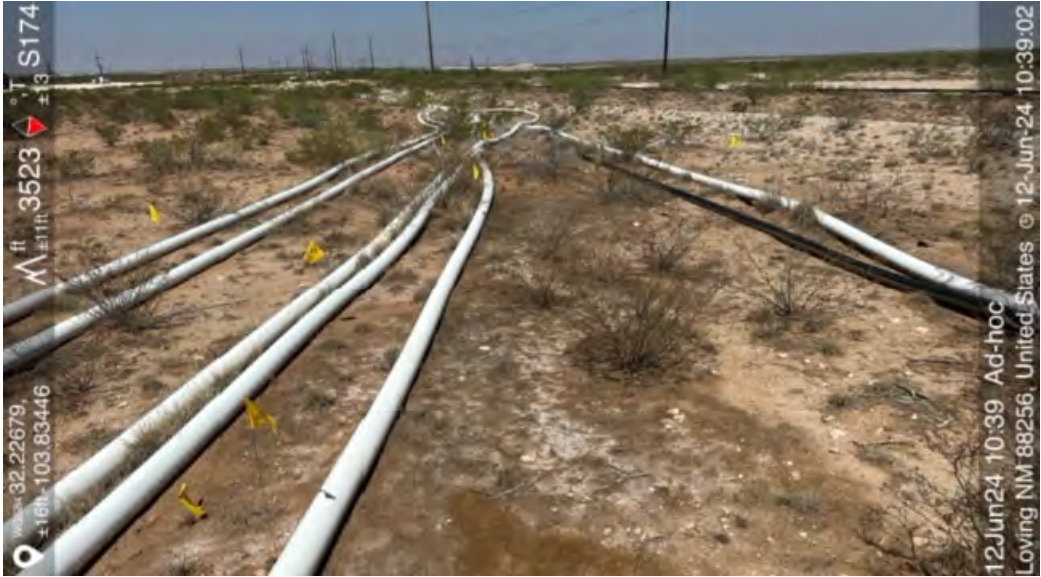
| Photo Number: 1 | |

| Photo Direction: South | |
| Photo Description: View of the affected area. | |

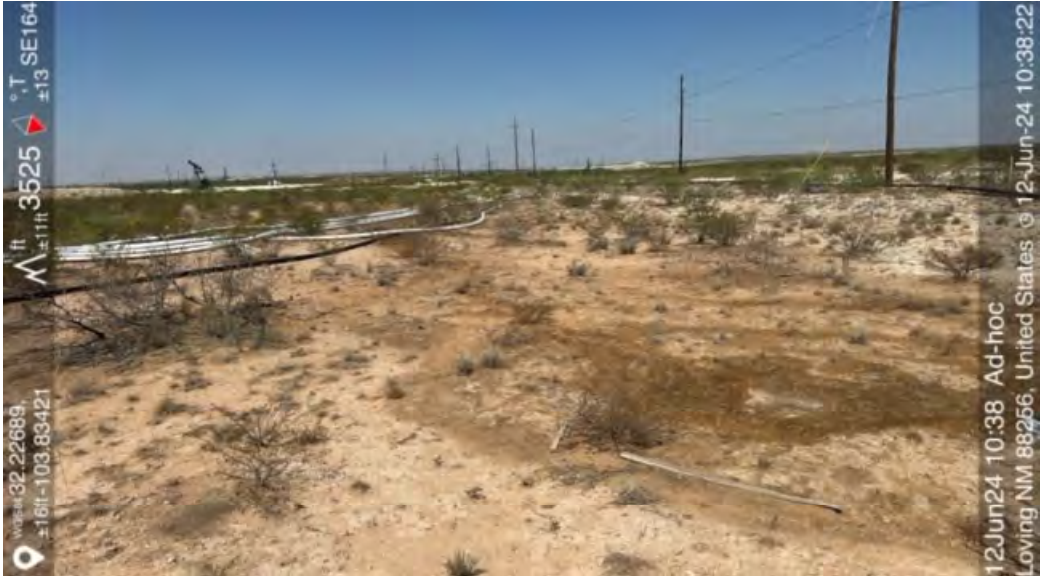
| Photo Number: 2 | |

| Photo Direction: South-Southeast | |
| Photo Description: View of the affected area. | |

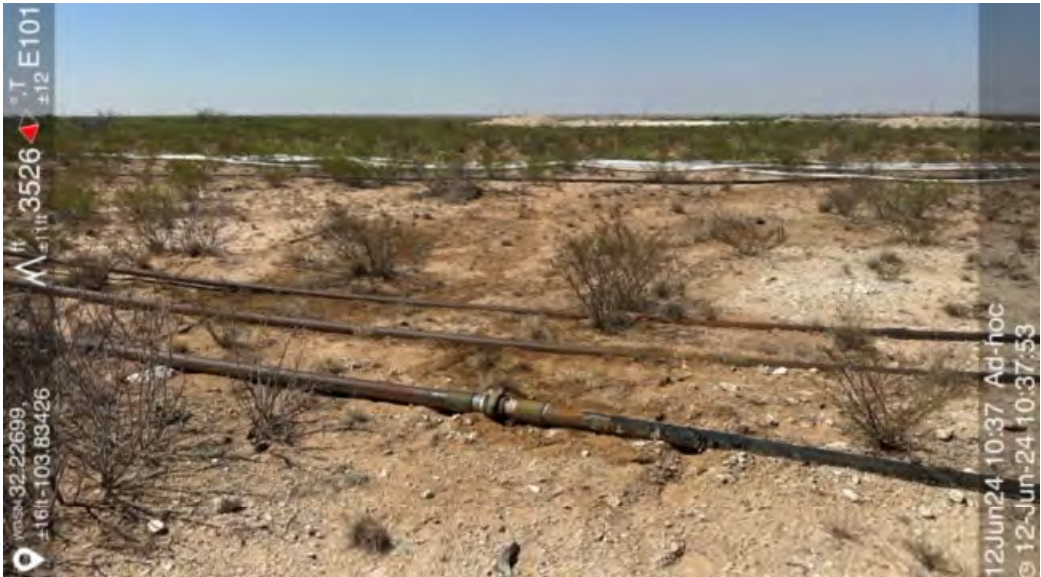
| Photo Direction: East | |
| Photo Description: View of the affected area. | |

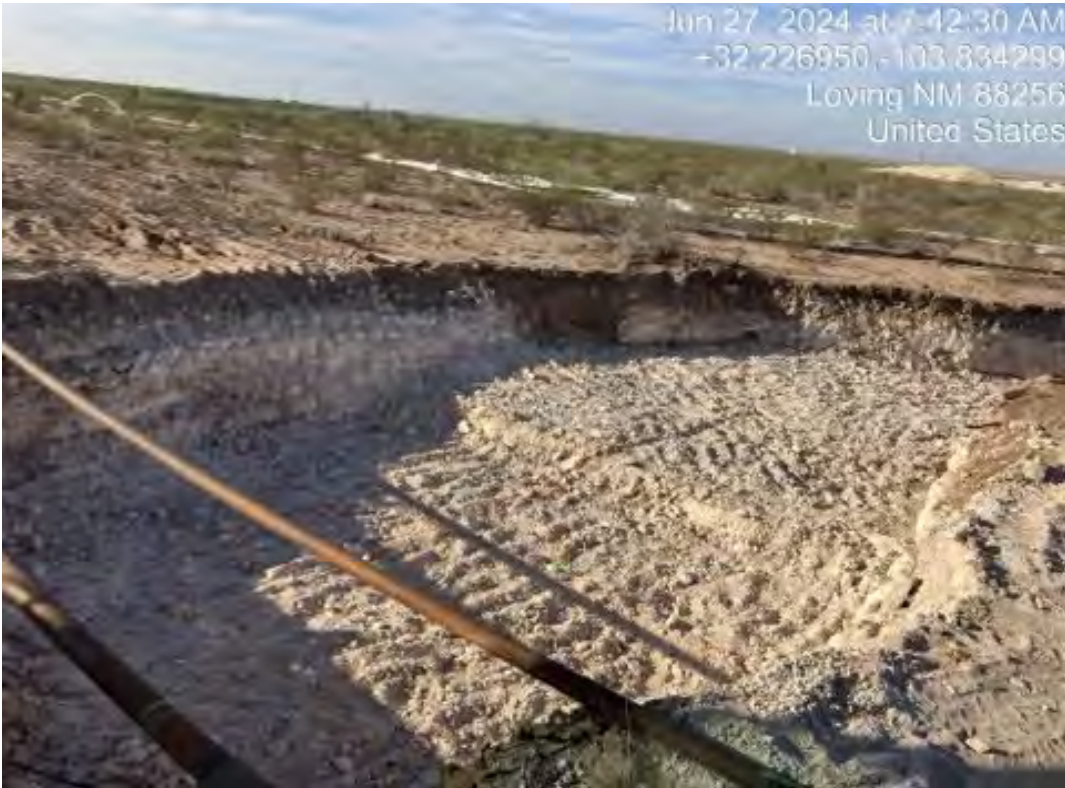
| Photo Number: 5 | <p>Jun 27, 2024 at 7:42:30 AM +32.226950, -103.834299 Loving NM 88256 United States</p> |

| Photo Direction: South | |
| Photo Description: View of the excavated area. | |

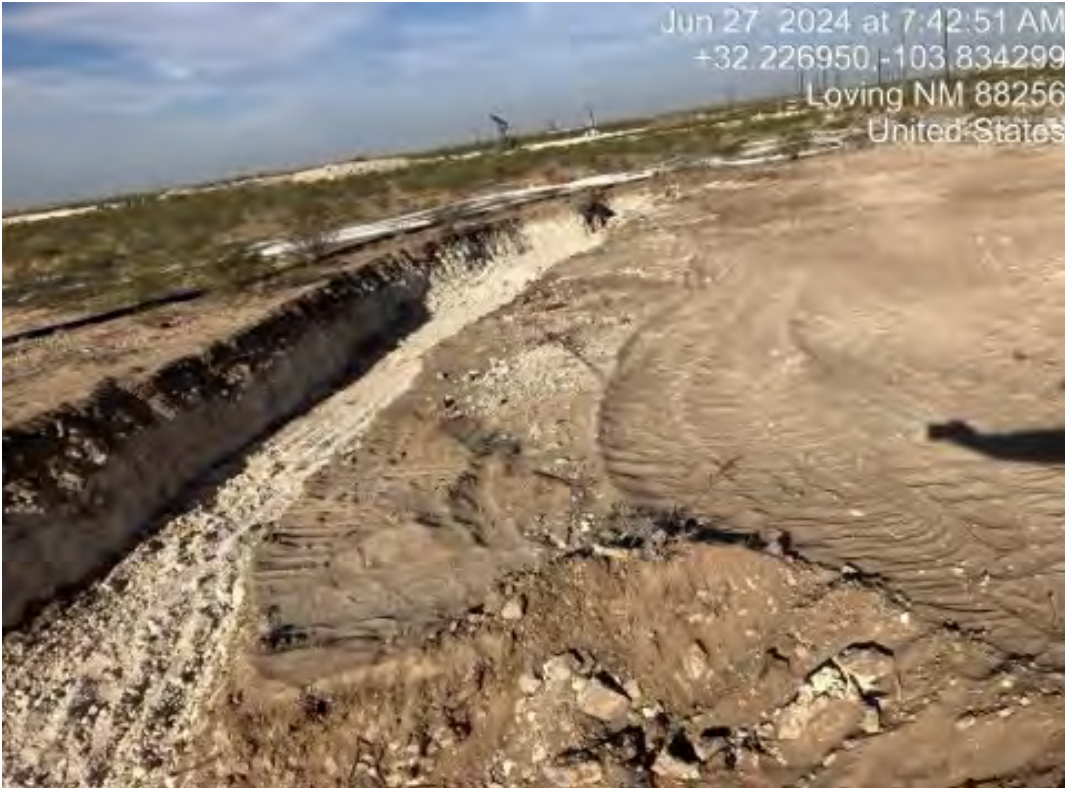
| Photo Number: 6 | <p>Jun 27, 2024 at 7:42:51 AM +32.226950, -103.834299 Loving NM 88256 United States</p> |

| Photo Direction: Southwest | |
| Photo Description: View of the excavated area. | |

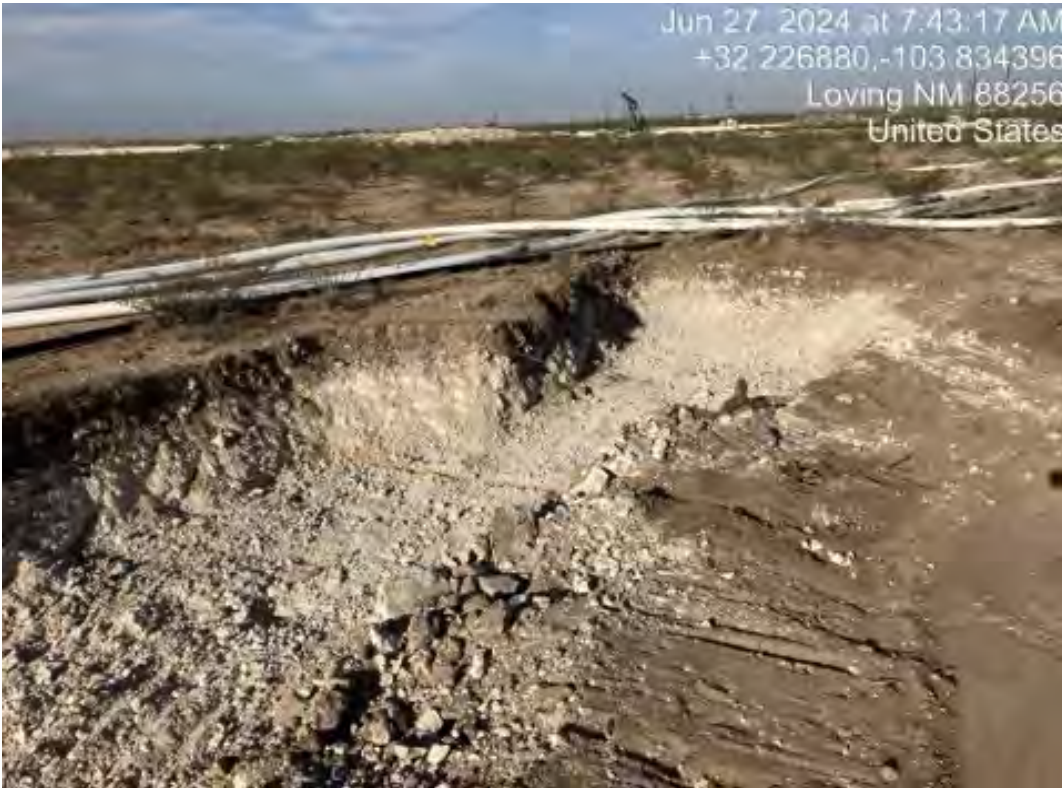
| Photo Number: 7 | <p>Jun 27 2024 at 7:43:17 AM +32 226880,-103 834396 Loving NM 88256 United States</p> |

| Photo Direction: Southwest | |
| Photo Description: View of the excavated area. | |

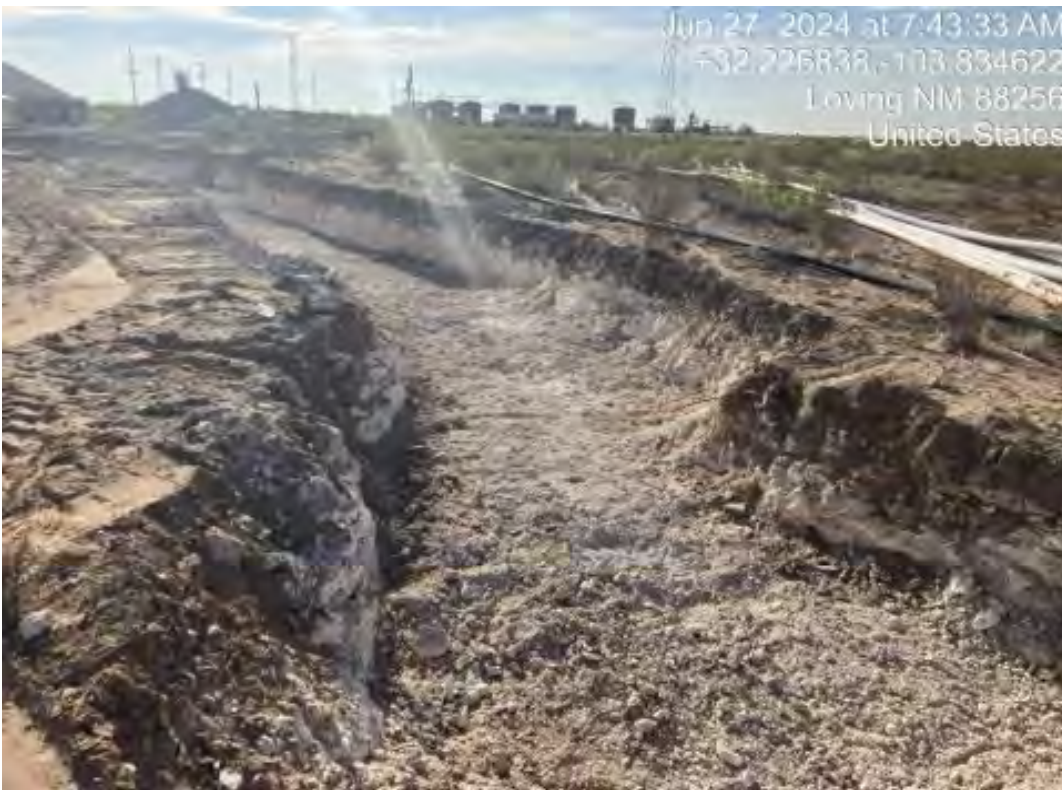
| Photo Number: 8 | <p>Jun 27 2024 at 7:43:33 AM +32 226838,-103 834622 Loving NM 88256 United States</p> |

| Photo Direction: East | |
| Photo Description: View of the excavated area. | |

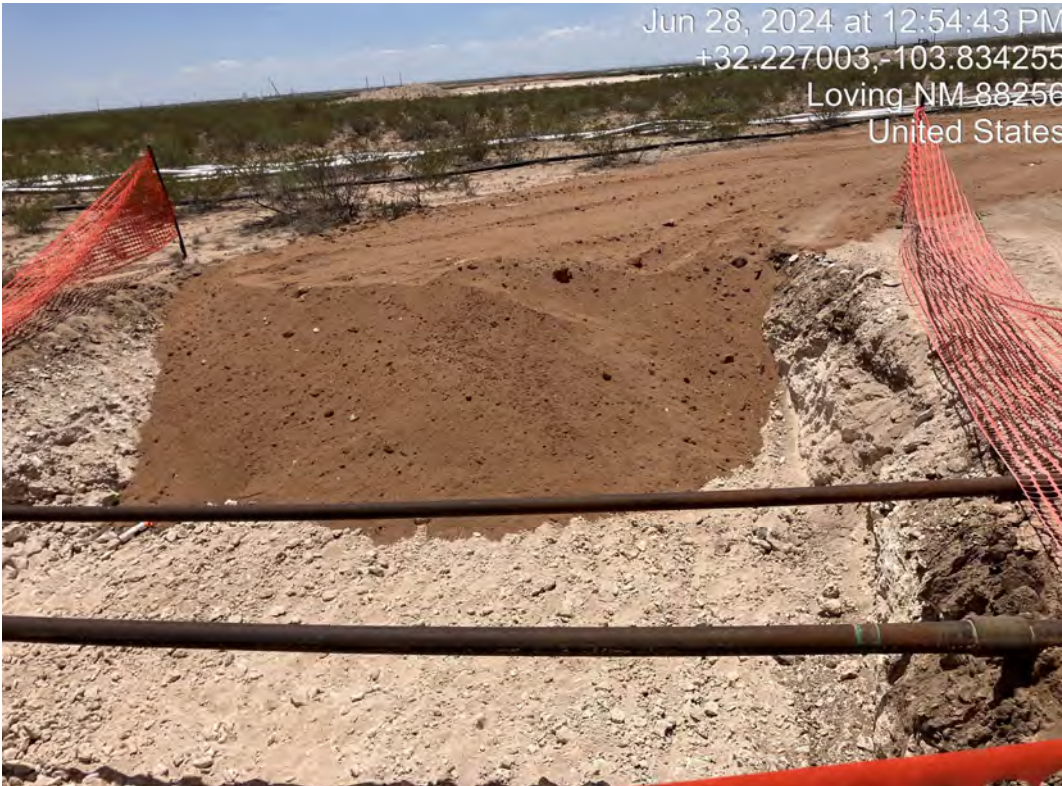
| Photo Number: 9 | <p>Jun 28, 2024 at 12:54:43 PM +32.227003, -103.834255 Loving NM 88256 United States</p> |

| Photo Direction: South | |
| Photo Description: View of the excavated area during backfilling. | |

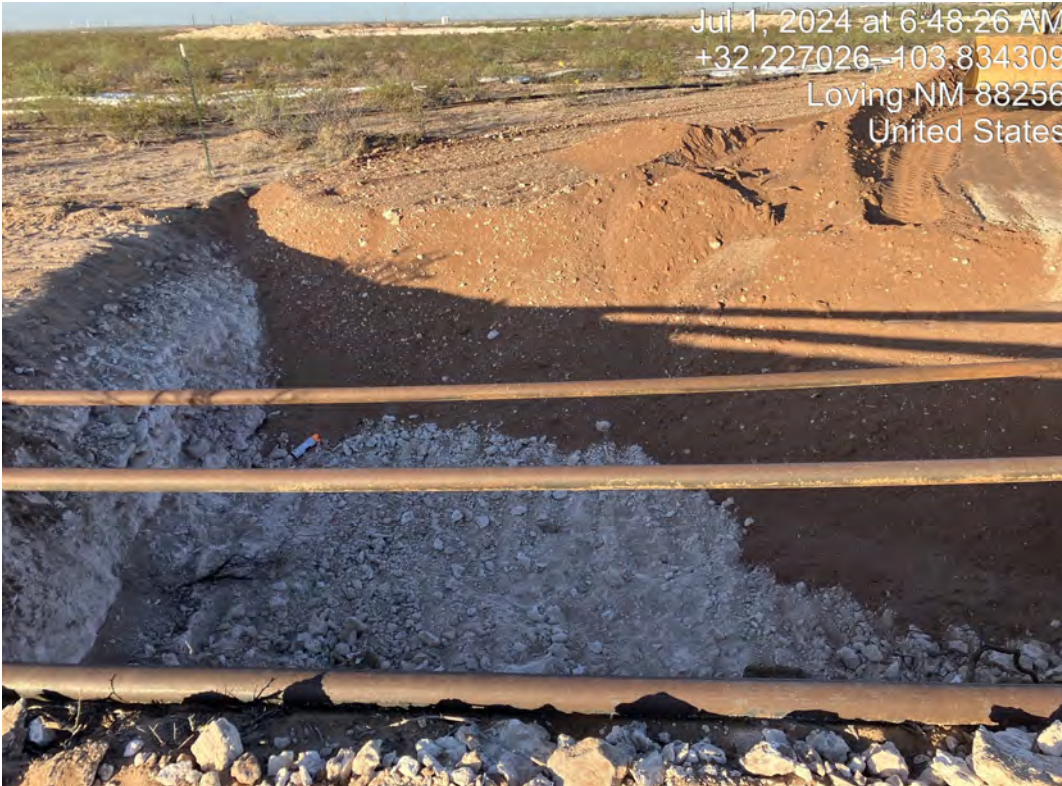
| Photo Number: 10 | <p>Jul 1, 2024 at 6:48:26 AM +32.227026, -103.834309 Loving NM 88256 United States</p> |

| Photo Direction: South-Southwest | |
| Photo Description: View of the excavated area during backfilling. | |

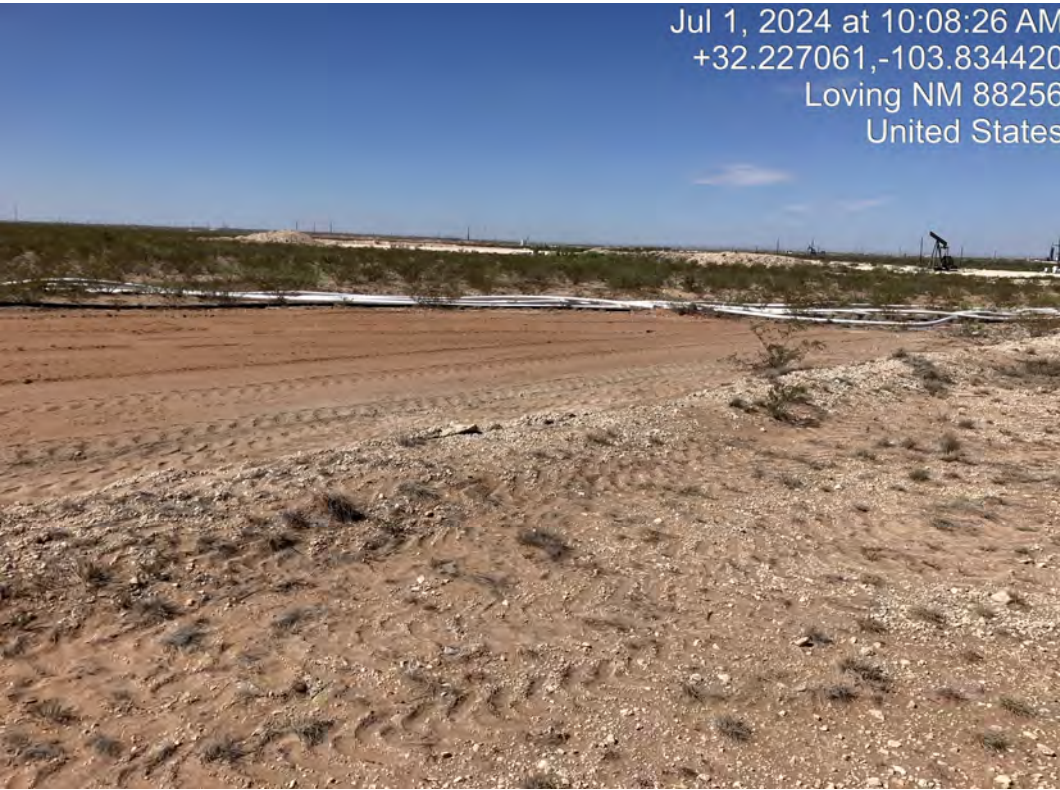
| Photo Number: 11 | <div>Jul 1, 2024 at 10:08:26 AM +32.227061,-103.834420 Loving NM 88256 United States</div> |

| Photo Direction: South-Southwest | |
| Photo Description: View of the remediated area following backfilling and regrading. | |

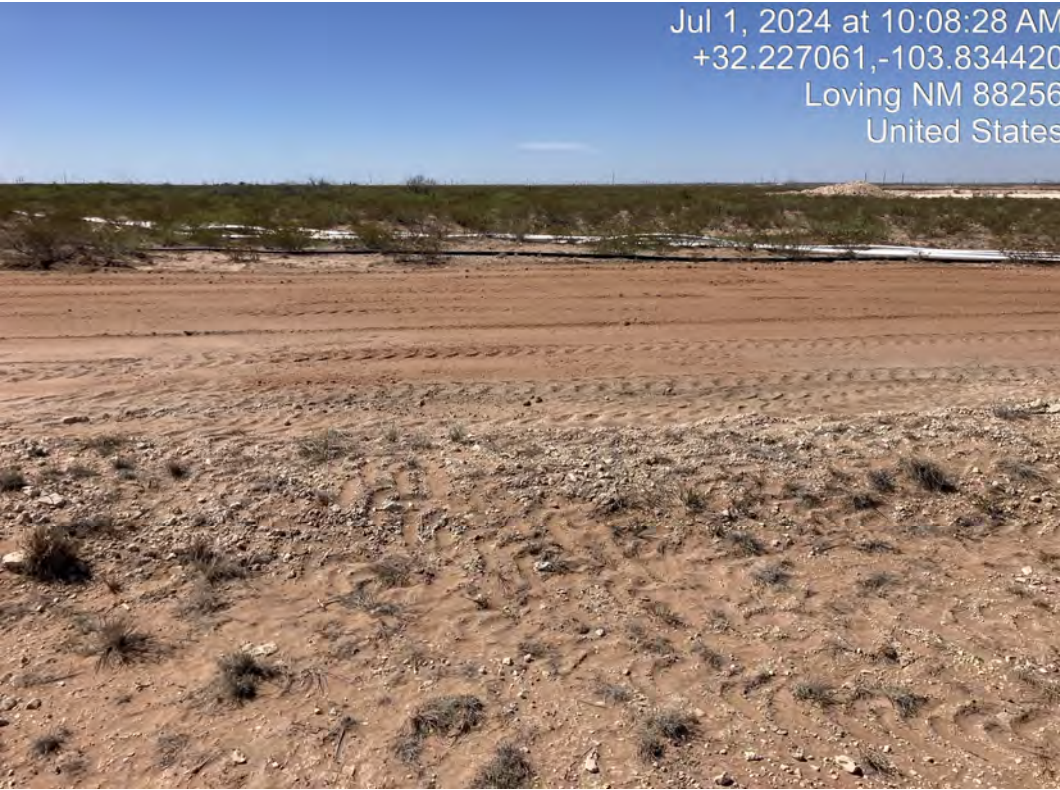
| Photo Number: 12 | <div>Jul 1, 2024 at 10:08:28 AM +32.227061,-103.834420 Loving NM 88256 United States</div> |

| Photo Direction: South-Southeast | |
| Photo Description: View of the remediated area following backfilling and regrading. | |

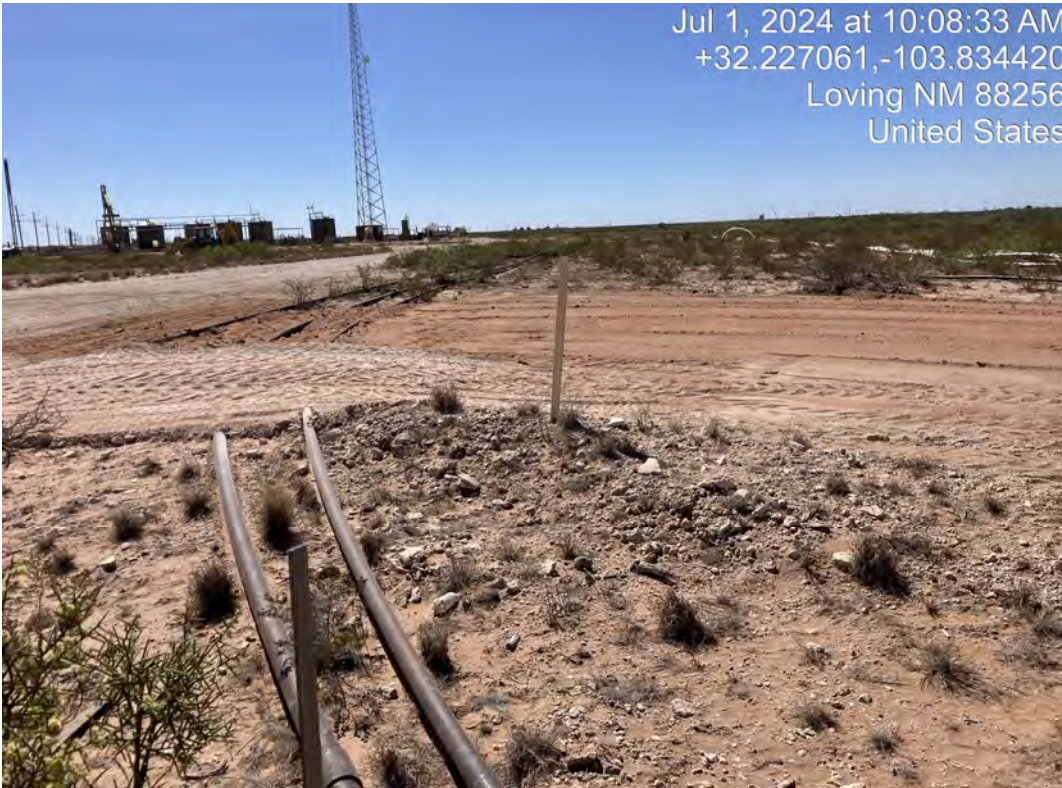
| Photo Number: 13 | <p>Jul 1, 2024 at 10:08:33 AM +32.227061,-103.834420 Loving NM 88256 United States</p> |

| Photo Direction: Southeast | |
| Photo Description: View of the remediated area following backfilling and regrading. | |

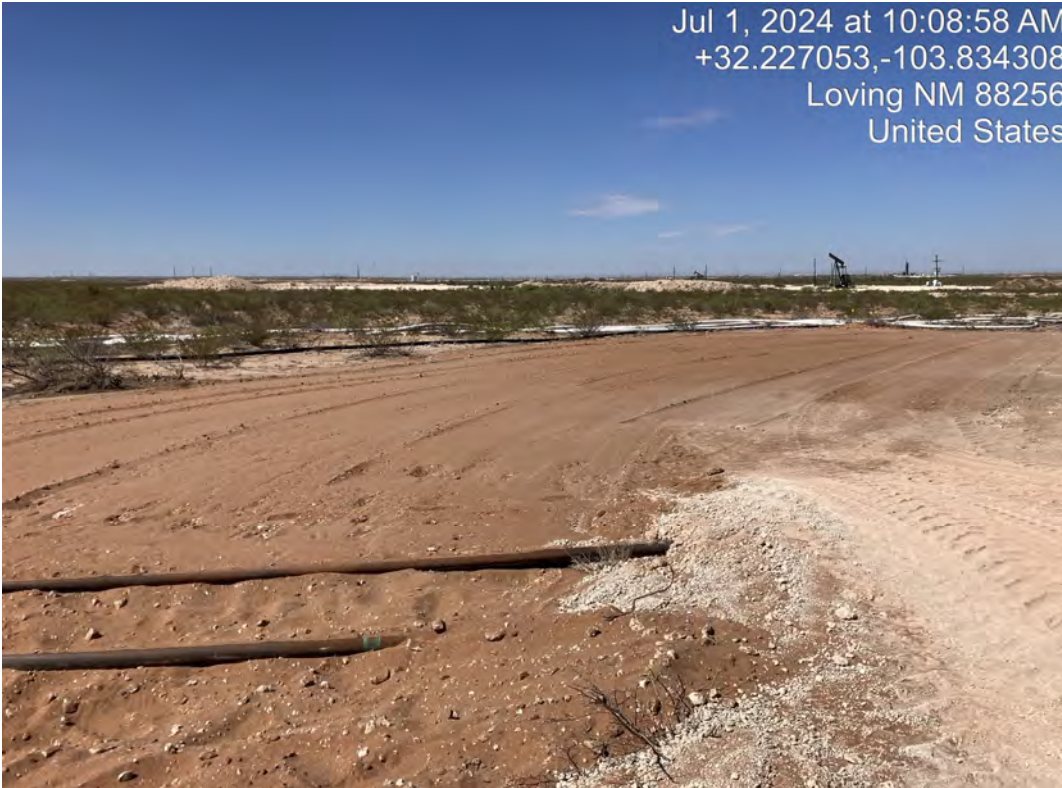
| Photo Number: 14 | <p>Jul 1, 2024 at 10:08:58 AM +32.227053,-103.834308 Loving NM 88256 United States</p> |

| Photo Direction: Southwest | |
| Photo Description: View of the remediated area following backfilling and regrading. | |

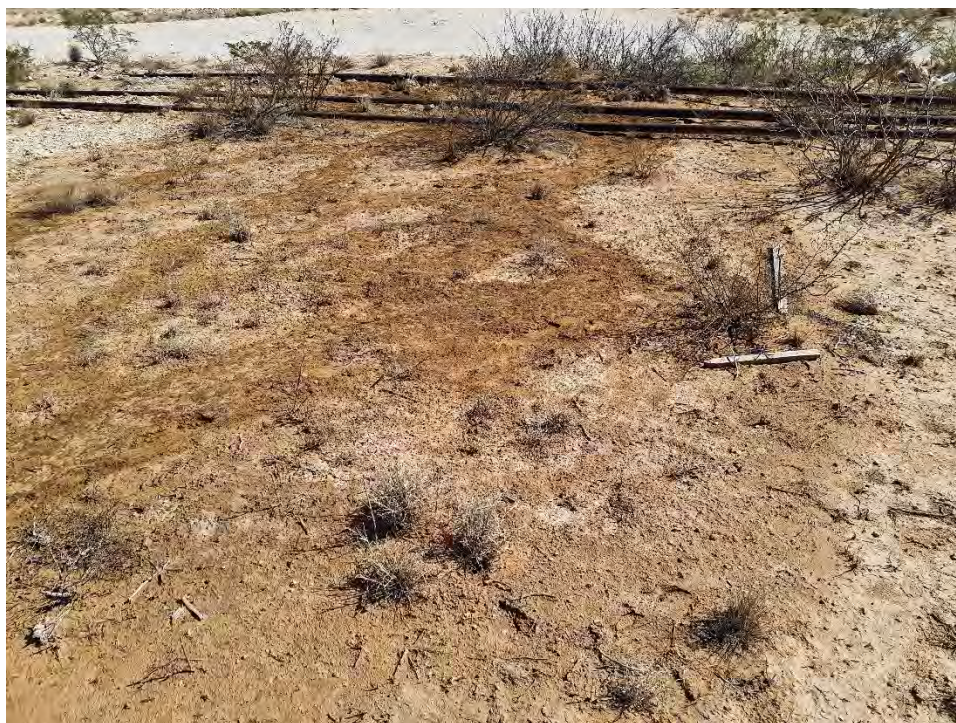
Figure 4. Overview of inadvertent release and source, facing north (Frame T13-6647).

| Photo Frame | Site No. | Caption | Photo Type | Orientation |
|---|---|---|---|---|
| T13-6647 | N/A | Overview of inadvertent release and source | Release Area | Facing North |

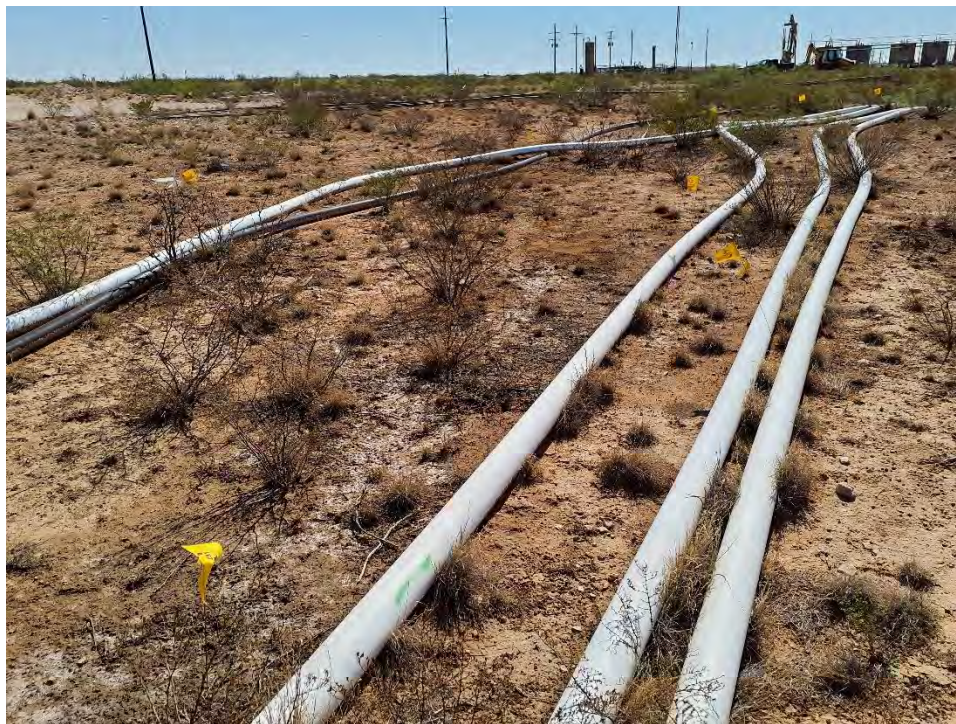
Figure 5. Overview of the release in the southwestern section, facing north (Frame T13-7846).

| Photo Frame | Site No. | Caption | Photo Type | Orientation |
|---|---|---|---|---|
| T13-7846 | N/A | Overview of the release in the southwestern section | Release Area | Facing North |
