Re: Closure Request

Bronco CS

Incident Number NAPP2409952956

Eddy County, New Mexico

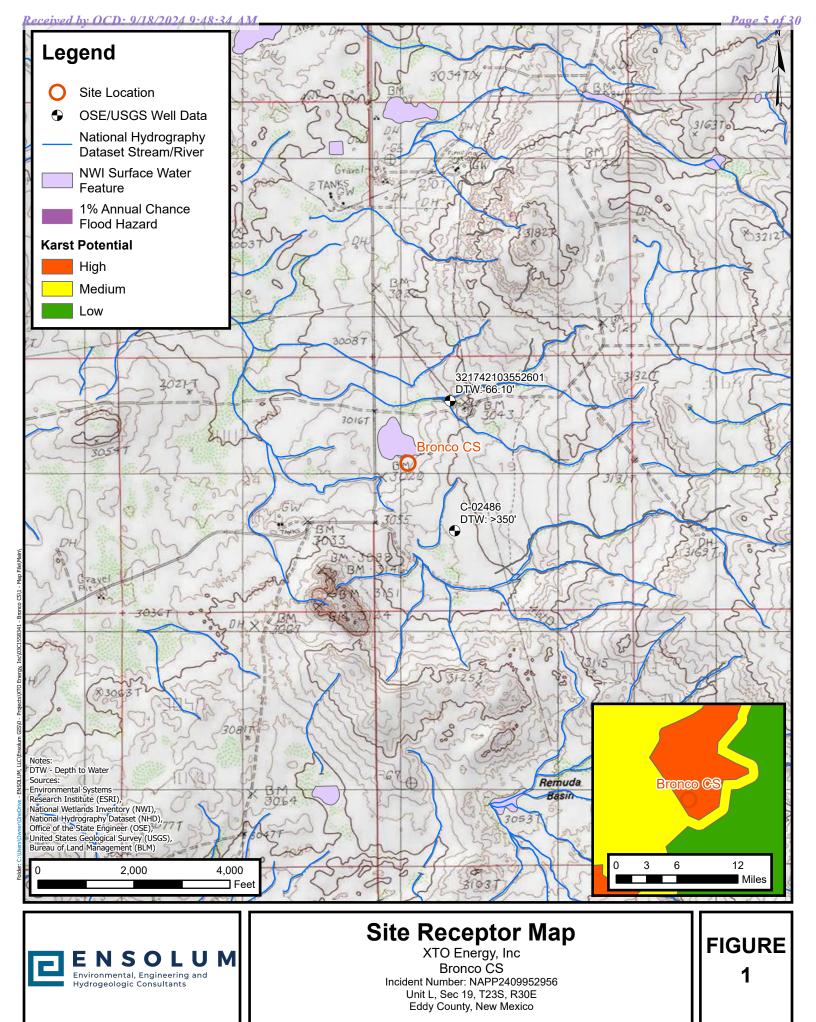
Figure 1 Site Receptor Map

The Site was characterized to determine the applicability of Table I, Closure Criteria for Soils Impacted by a Release, of Title 19, Chapter 15, Part 29 (19.15.29) of the New Mexico Administrative Code (NMAC). Results from the characterization desktop review are presented below and potential site receptors are identified on Figure 1.

Depth to groundwater at the Site is estimated to be between 50 and 100 feet below ground surface (bgs) based on the nearest groundwater well data. The closest permitted groundwater well with depth to groundwater data is United States Geological Survey (USGS) well 321742103552601, located approximately 0.29 miles northeast of the Site. The groundwater well has a reported depth to groundwater of 66.1 feet bgs and a total depth of 100 feet bgs. All wells used for depth to groundwater determination are presented on Figure 1. The referenced well records are included in Appendix A.

The closest continuously flowing or significant watercourse to the Site is a dry wash, located approximately 646 feet southwest of the Site. The Site is greater than 200 feet from a lakebed, sinkhole, or playa lake and greater than 300 feet from an occupied residence, school, hospital, institution, church, or wetland. The Site is greater than 1,000 feet to a freshwater well or spring and is not within a 100-year floodplain or overlying a subsurface mine. The Site is underlain by unstable geology (high potential karst designation area). Site receptors are identified on Figure 1.

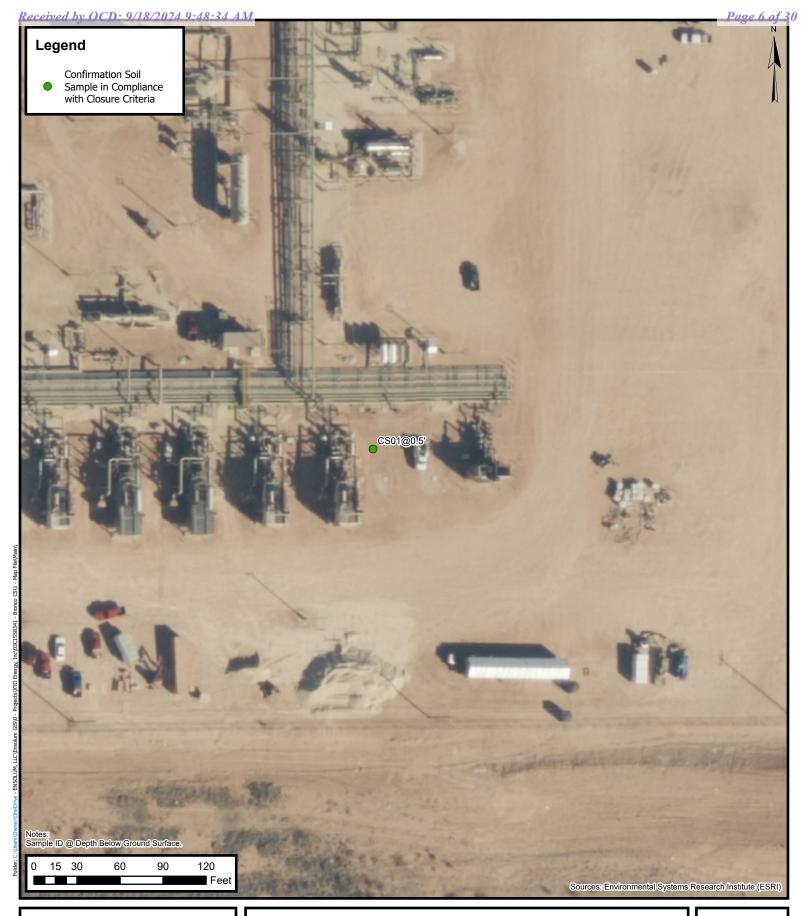
FIGURE 2

On June 24, 2024, site assessment activities were conducted to evaluate the presence or absence of impacts to soil following the incident, a small fire with no fluids released. One composite soil sample (CS01) was collected beneath the equipment where the fire occurred, at a depth of 0.5 feet bgs. The soil sample was field screened for volatile organic compounds (VOCs) utilizing a calibrated photoionization detector (PID) and chloride utilizing Hach® chloride QuanTab® test strips. The soil sample location was mapped utilizing a handheld Global Positioning System (GPS) unit and is depicted on Figure 2. Photographic documentation was completed immediately following the fire and during the site visit. A photographic log is included in Appendix B.

Laboratory analytical results for soil sample CS01 indicated that benzene, BTEX, TPH, and chloride concentrations were compliant with the Site Closure Criteria. Laboratory analytical results are summarized in Table 1 and the complete laboratory analytical reports are included as Appendix C.

Confirmation Soil Sample Locations XTO Energy, Inc Bronco CS Incident Number: NAPP2409952956

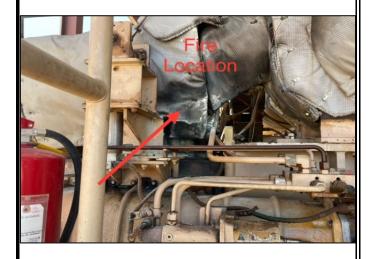
Photograph: 1 Date:03/28/2024

On March 28, 2024, a small fire occurred on a heat exhaust blanket of one of the compressors. The fire was immediately extinguished by an XTO operator with a fire extinguisher. There were no fluids released or recovered. XTO submitted an Initial C-141 Application (C-141) on April 8, 2024. The incident was assigned Incident Number NAPP2409952956.

Description: Heat exhaust blanket where fire occurred.
