OCD INCIDENT # nAPP2417439748

Incident Closure

Arena Roja Fed #6

Incident Closure
July 2024

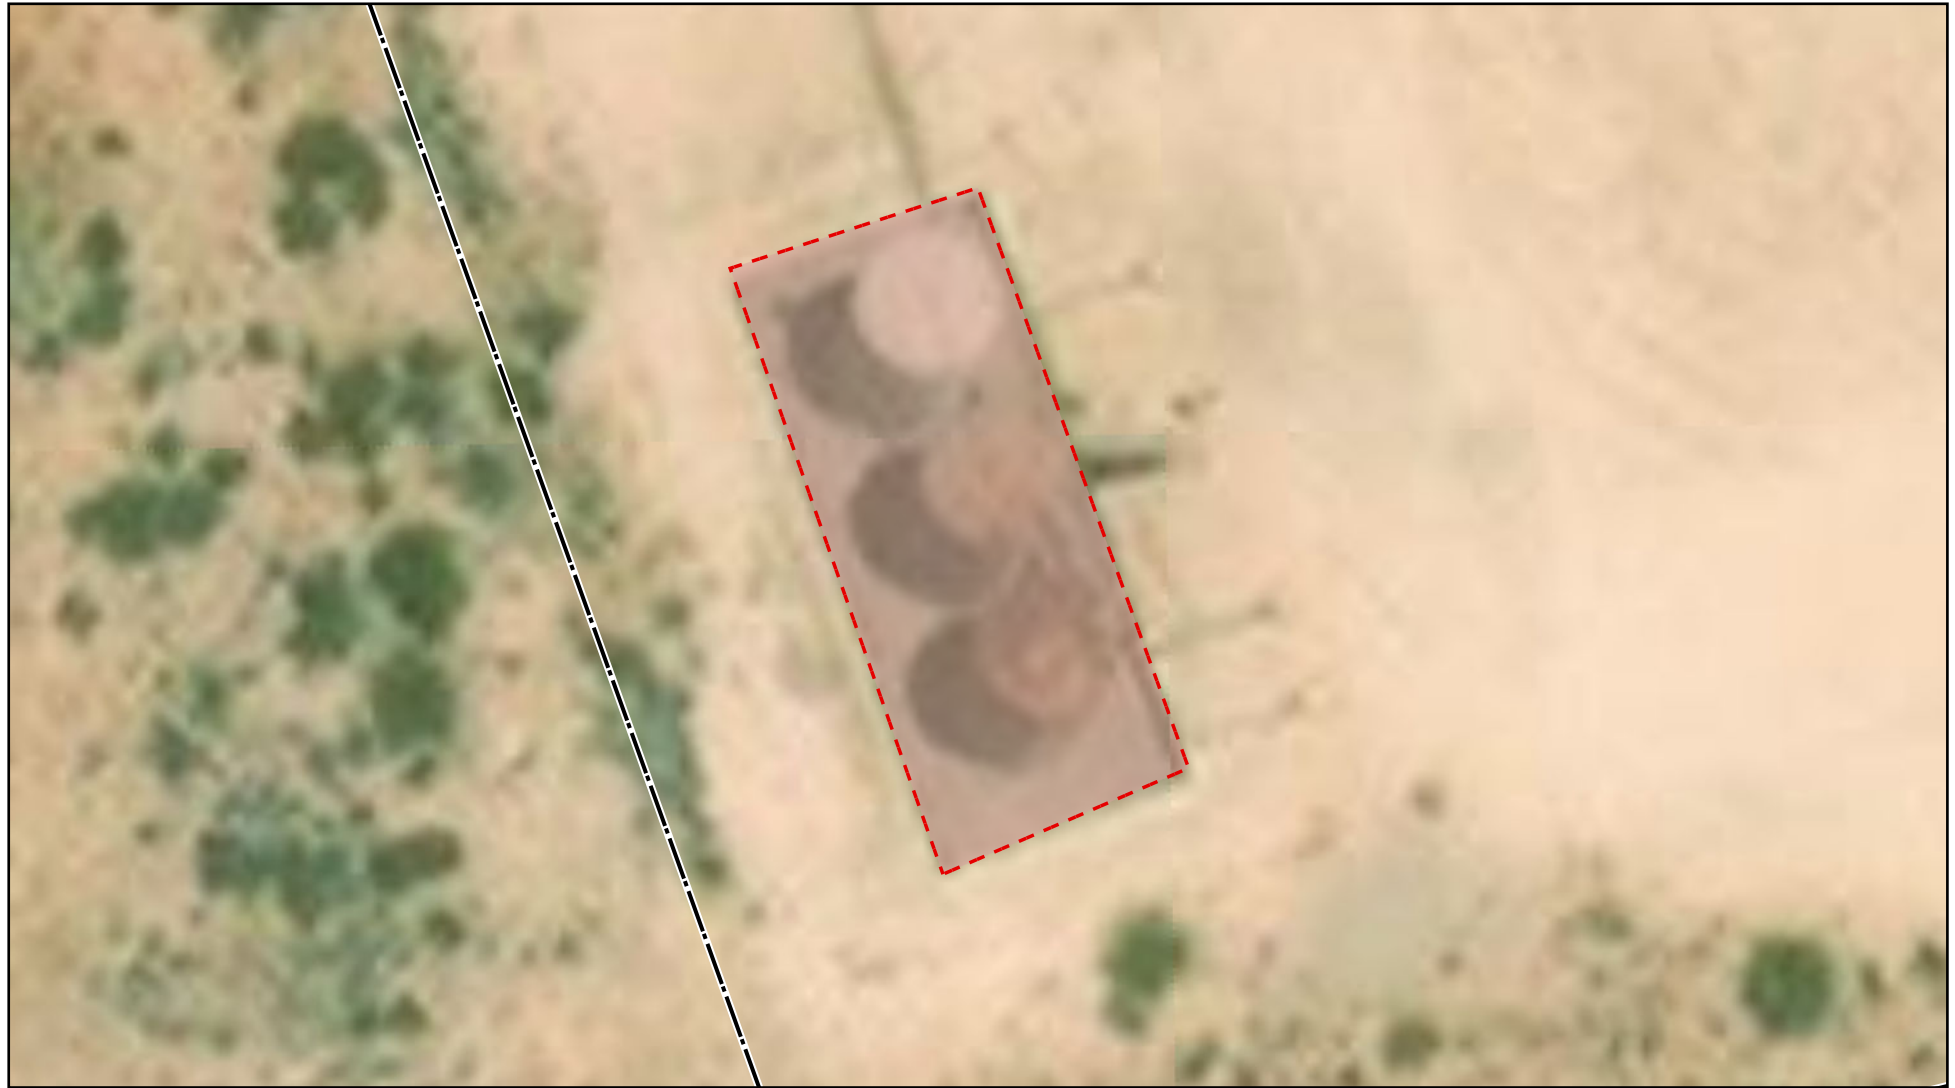
FIGURE:

Release Area (~ 1,956 sq. ft.)

**Release Area Schematic
Arena Roja Fed #6**

The site is located approximately 12.5 miles southwest of Jal, New Mexico. The legal location for the site is Unit G, Section 28, Township 26 South and Range 35 East in Lea County, New Mexico. The release area is located on federal property. An aerial photograph and site schematic are presented on Figure 1.

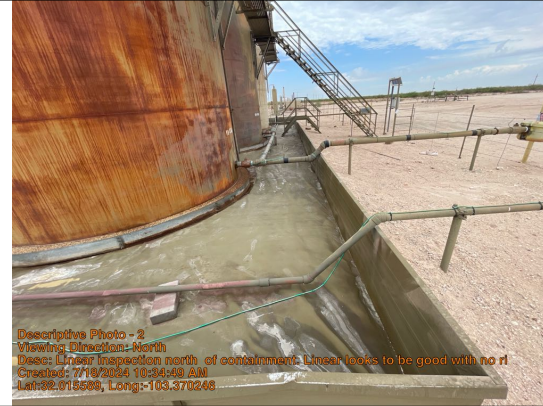
Viewing Direction: North

Linear inspection north of containment. Linear looks to be good with no rips or tears

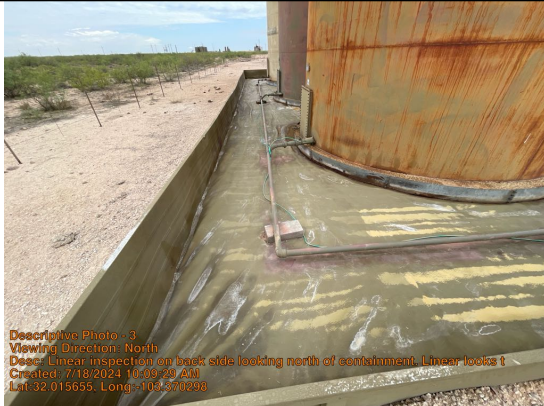
Viewing Direction: North

Linear inspection on back side looking north of containment. Linear looks to be good with no rips or tears

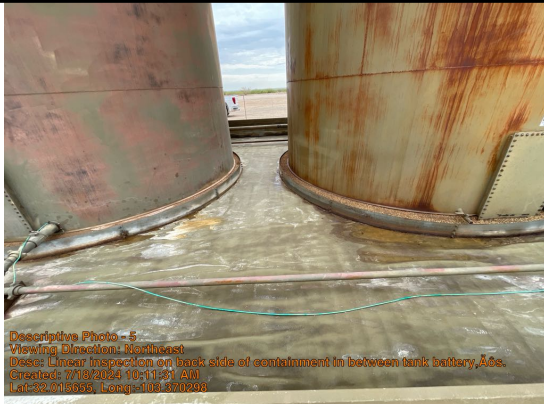
Viewing Direction: Northeast

Linear inspection on back side of containment in between tank battery's. Linear looks to be good with no rips or tears

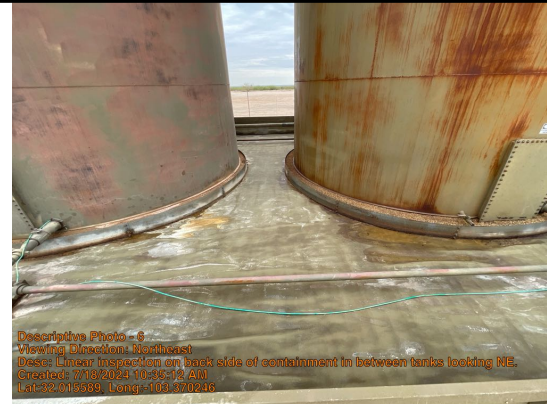
Viewing Direction: Northeast

Linear inspection on back side of containment in between tanks looking NE. Linear looks to be good with no rips or tears

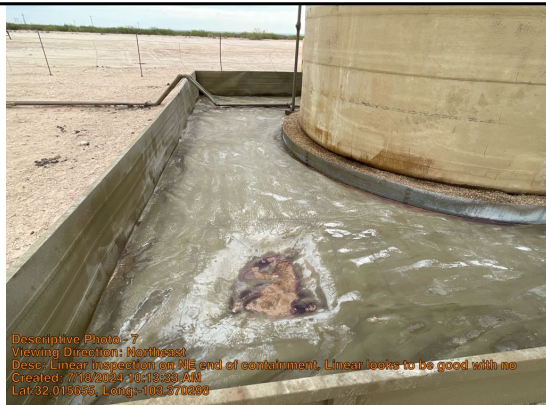
Viewing Direction: Northeast

Linear inspection on backside of containment looking NE. Linear looks to be good with no rips or tears

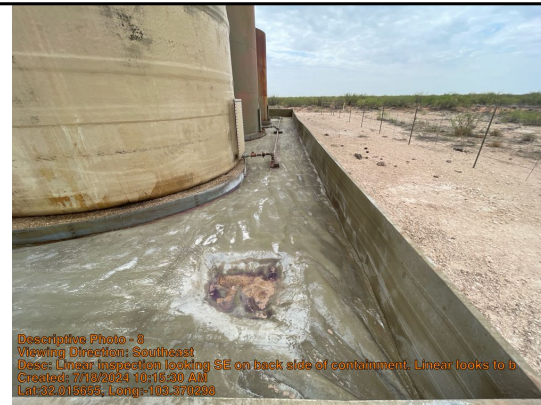
Viewing Direction: Southeast

Linear inspection looking SE on back side of containment. Linear looks to be good with no rips or tears

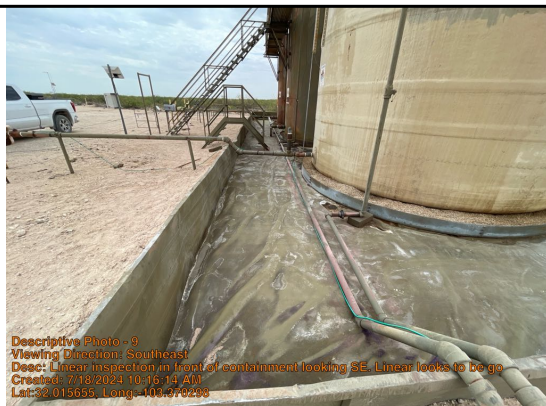
Viewing Direction: Southeast

Linear inspection in front of containment looking SE. Linear looks to be good with no rips or tears

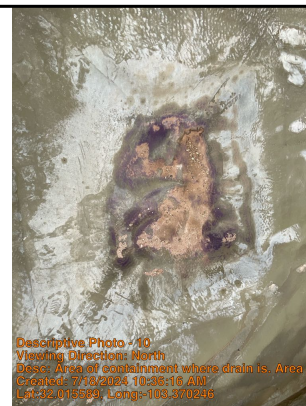
Viewing Direction: North

Area of containment where drain is. Area is covered with linear with no rips or tears
