LAGUNA SALADO SOUTH #1

Remediation Work Plan

Laguna Salado South #001

NMOCD Incident ID nAB1506157520

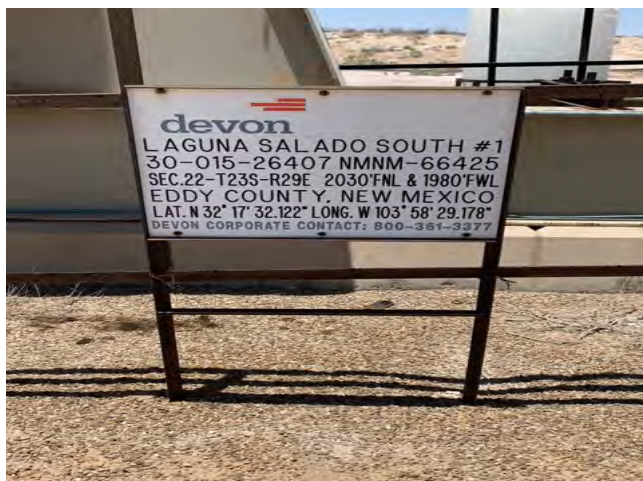
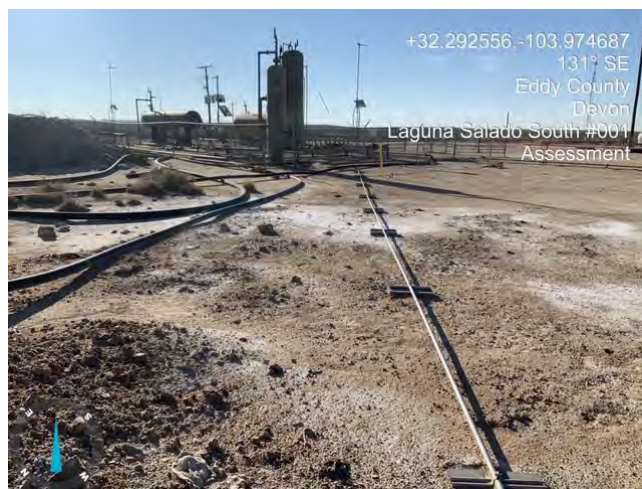
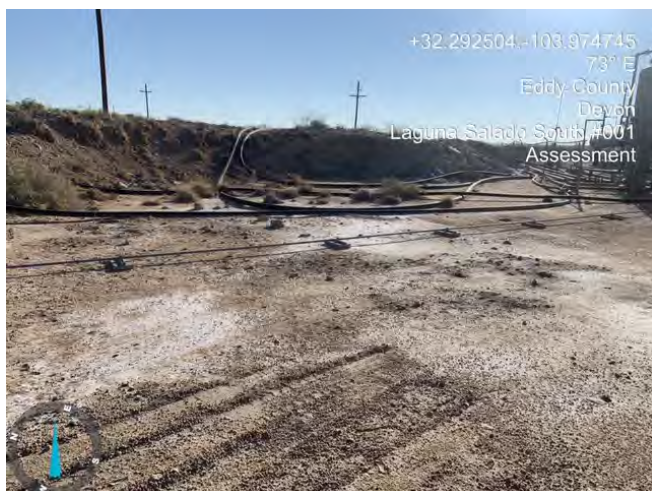
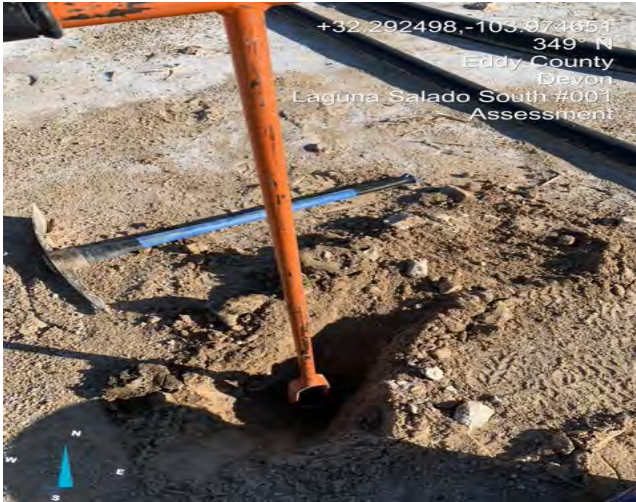
Assessment Pictures September 2024

On September 13, 2024, Pima personnel returned to the site to collect the requested additional background samples as well as delineation samples for the correct affected area. Two (2) sample points were located 60 yards north of the pad and 60 yards east of the road as directed by the NMOCD comments above. Discrete samples were collected from these 2 points from depth intervals of surface, 1', 2', 3', and 4' bgs. Six (6) sample points were located in the affected area of the nAB1506157520 release. Sample points 1 and 2 contain samples collected from depth intervals of surface, 1', 2', 3', and 4' bgs for the purpose of vertical delineation. Sample points 3 through 6 contain samples collected from depth intervals of surface, 1', 2', 3', and 4' bgs for the purpose of horizontal delineation.
