Incident Number: nAPP2307356662

Release Assessment and Remediation, and Deferral Request

Dayton Water Recycle

Silverback Exploration

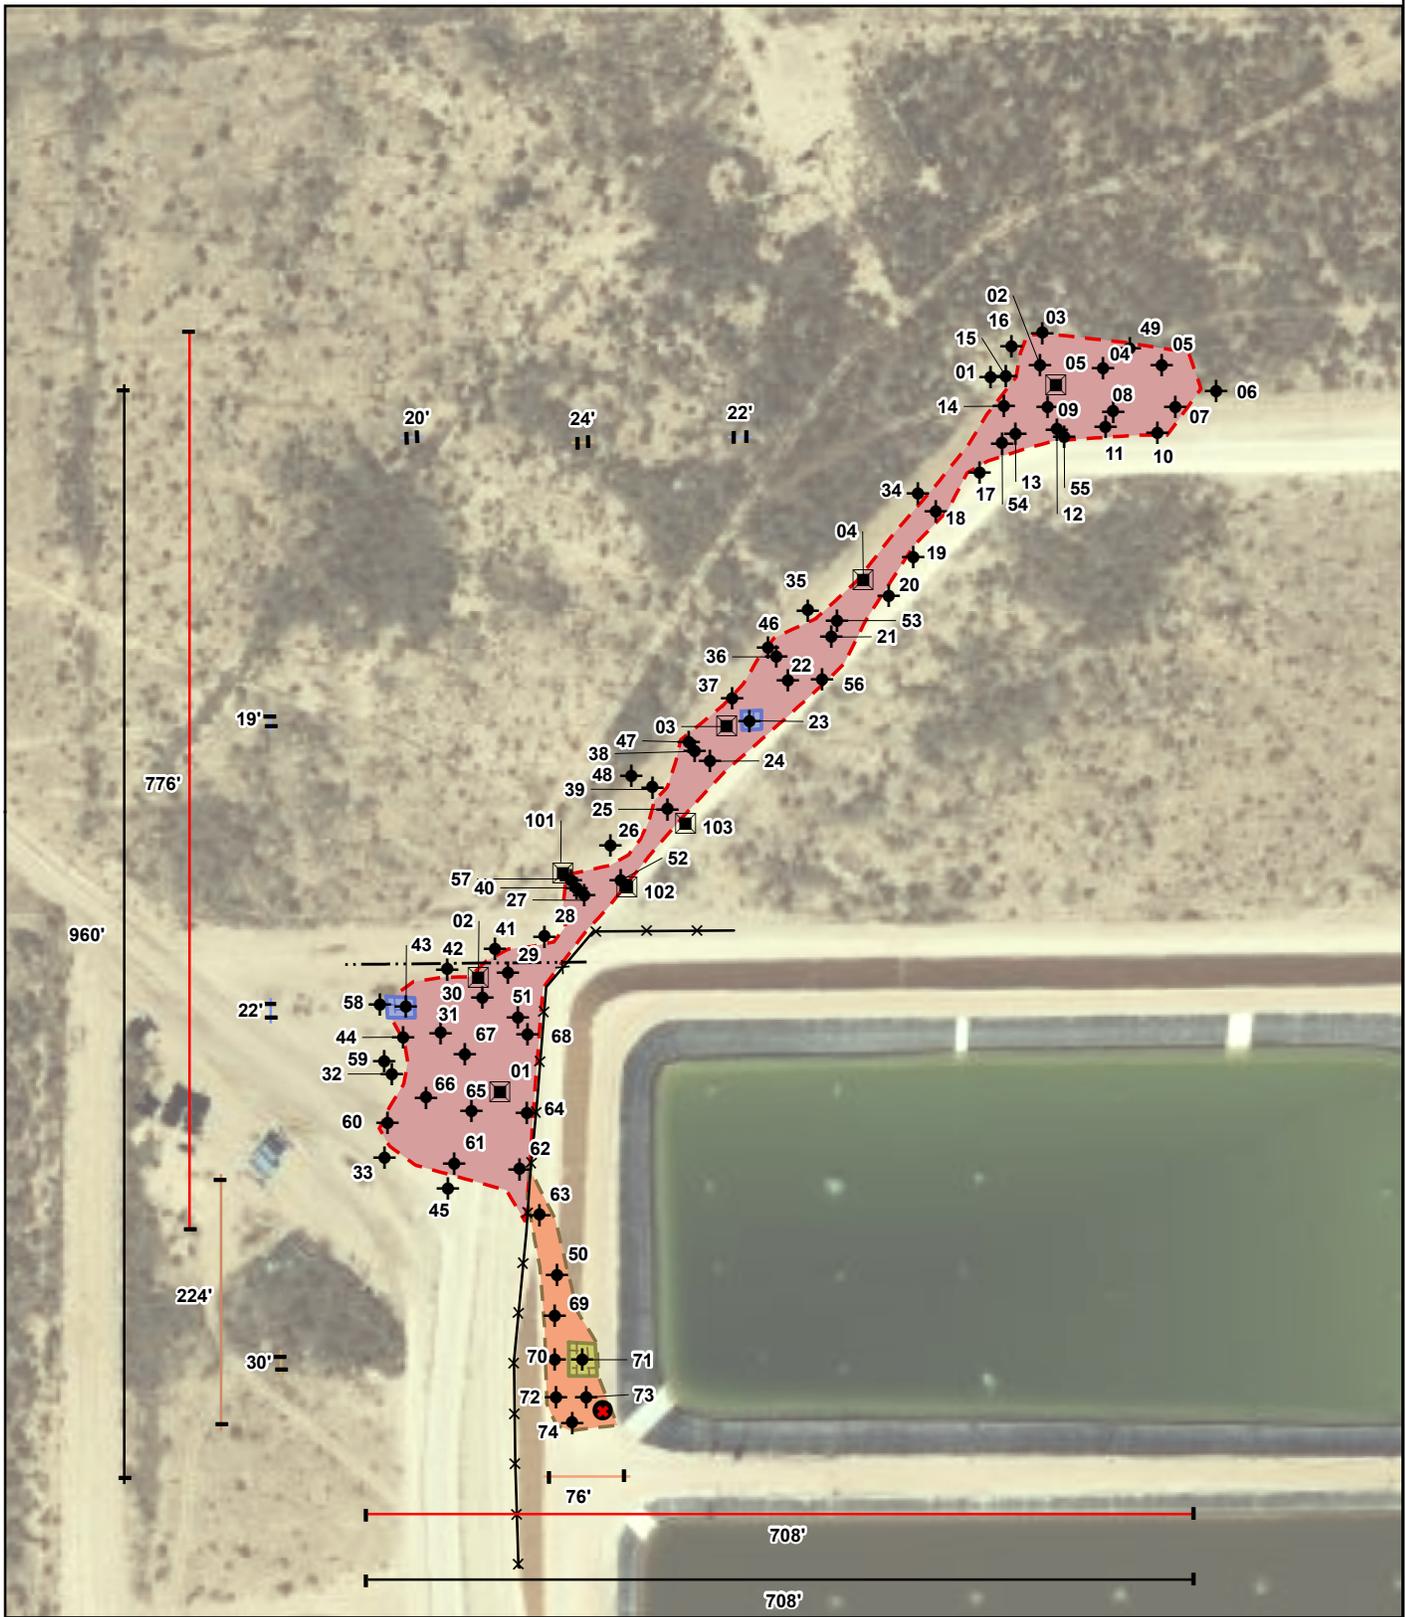
Document Path: G:\1-Projects\US PROJECTS\Silverback Exploration\23E-02248\Figure 1 Characterization Schematic Dayton Recycle (23E-02248).mxd

- ◆ Borehole (Prefixed by "BH23-")
- Point of Release
- Testpit (Prefixed by "TP23-")
- ✕ Fence
- Pipeline (Underground)
- ▭ Approximate Release Area (~55,825 sq.ft.)
- ▭ Proposed Excavation to 4' bgs (~716 sq.ft.)
- ▭ Proposed Excavation to 6" bgs (~686 sq.ft.)
- ▭ Facility Deferral Area (~7,168 sq.ft.)

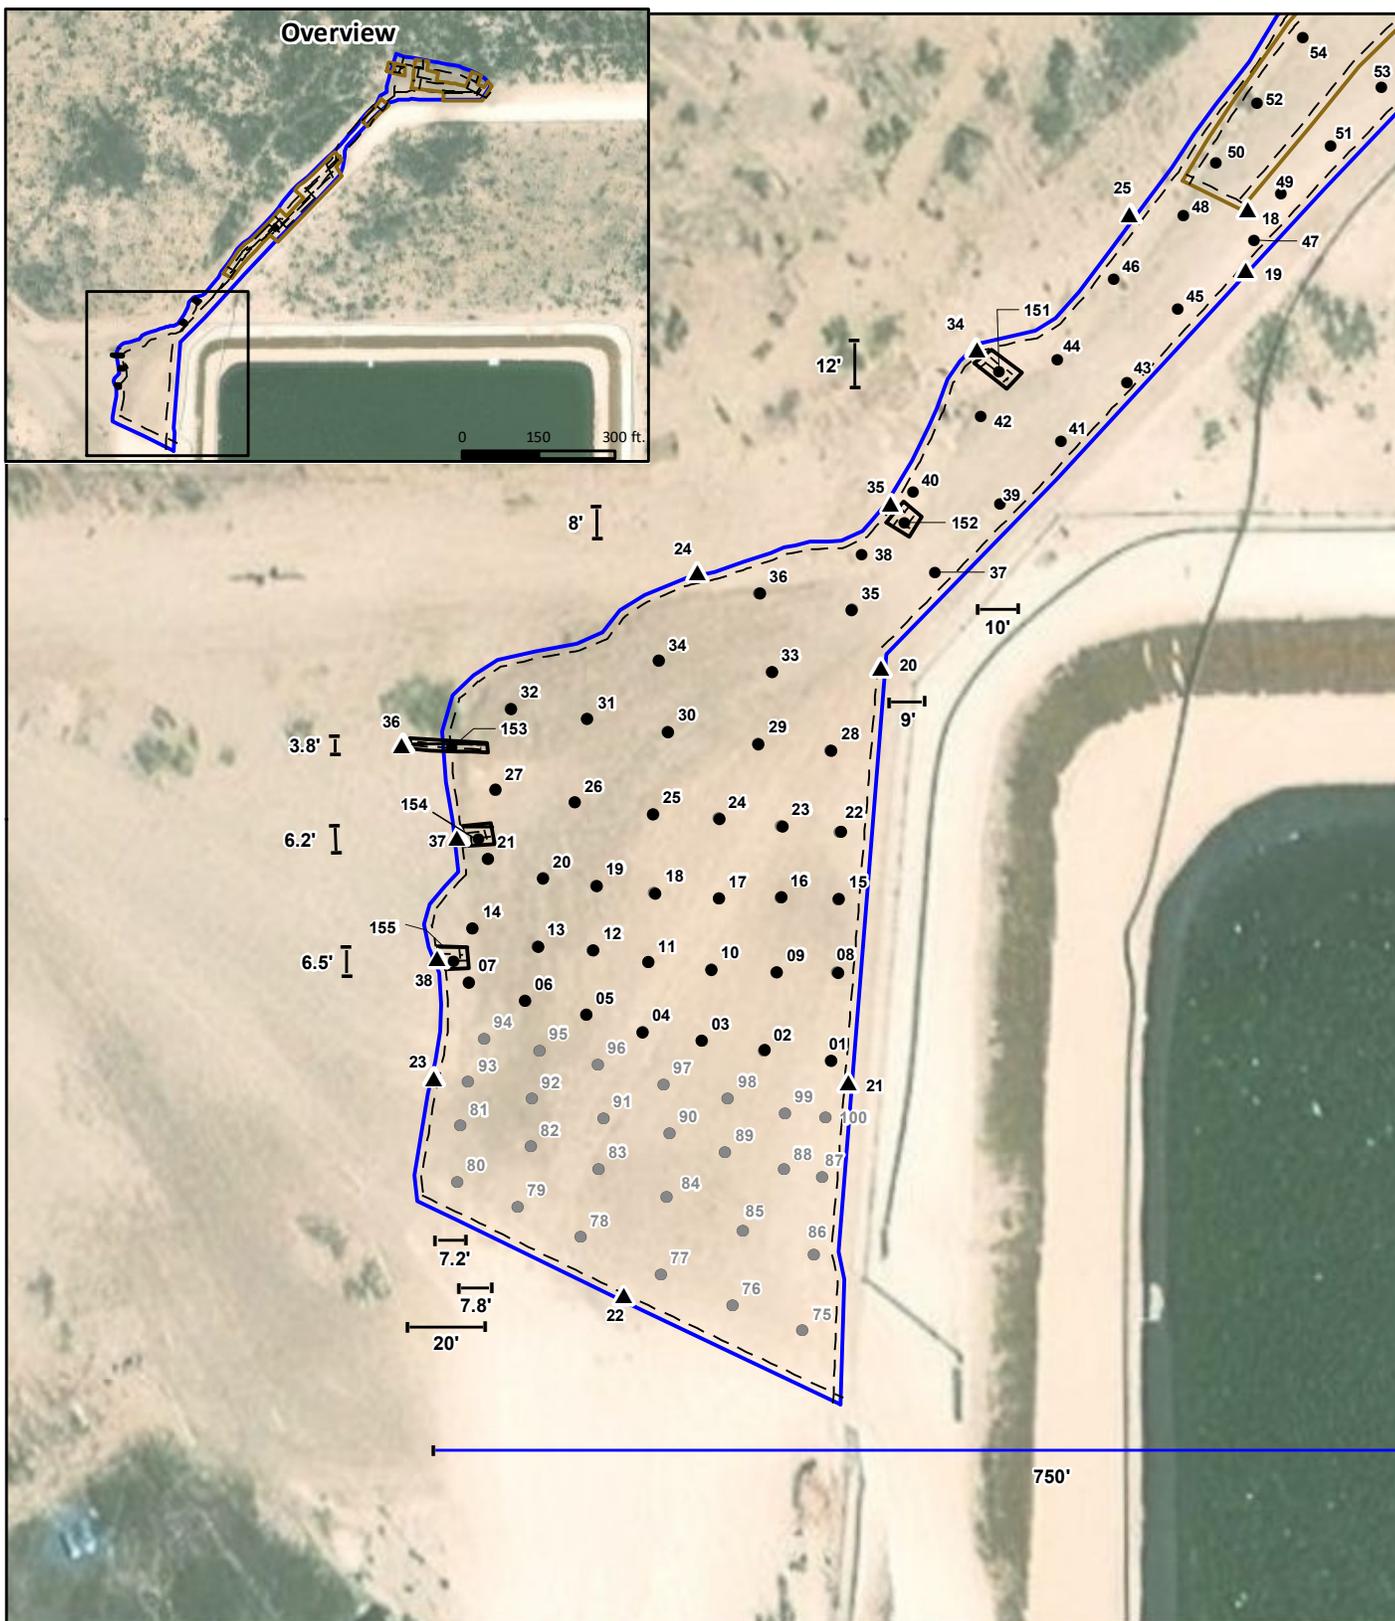
- Base Sample (Prefixed by "BS23-")
- Base Sample (Prefixed by "BS24-")
- ▲ Wall Sample (Prefixed by "WS24-")
- Excavation to 1' bgs (~58,492 sq.ft.)
- Excavation to 2' bgs (~17,184 sq.ft.)
- Trench Area to 4' bgs (~335 sq.ft.)

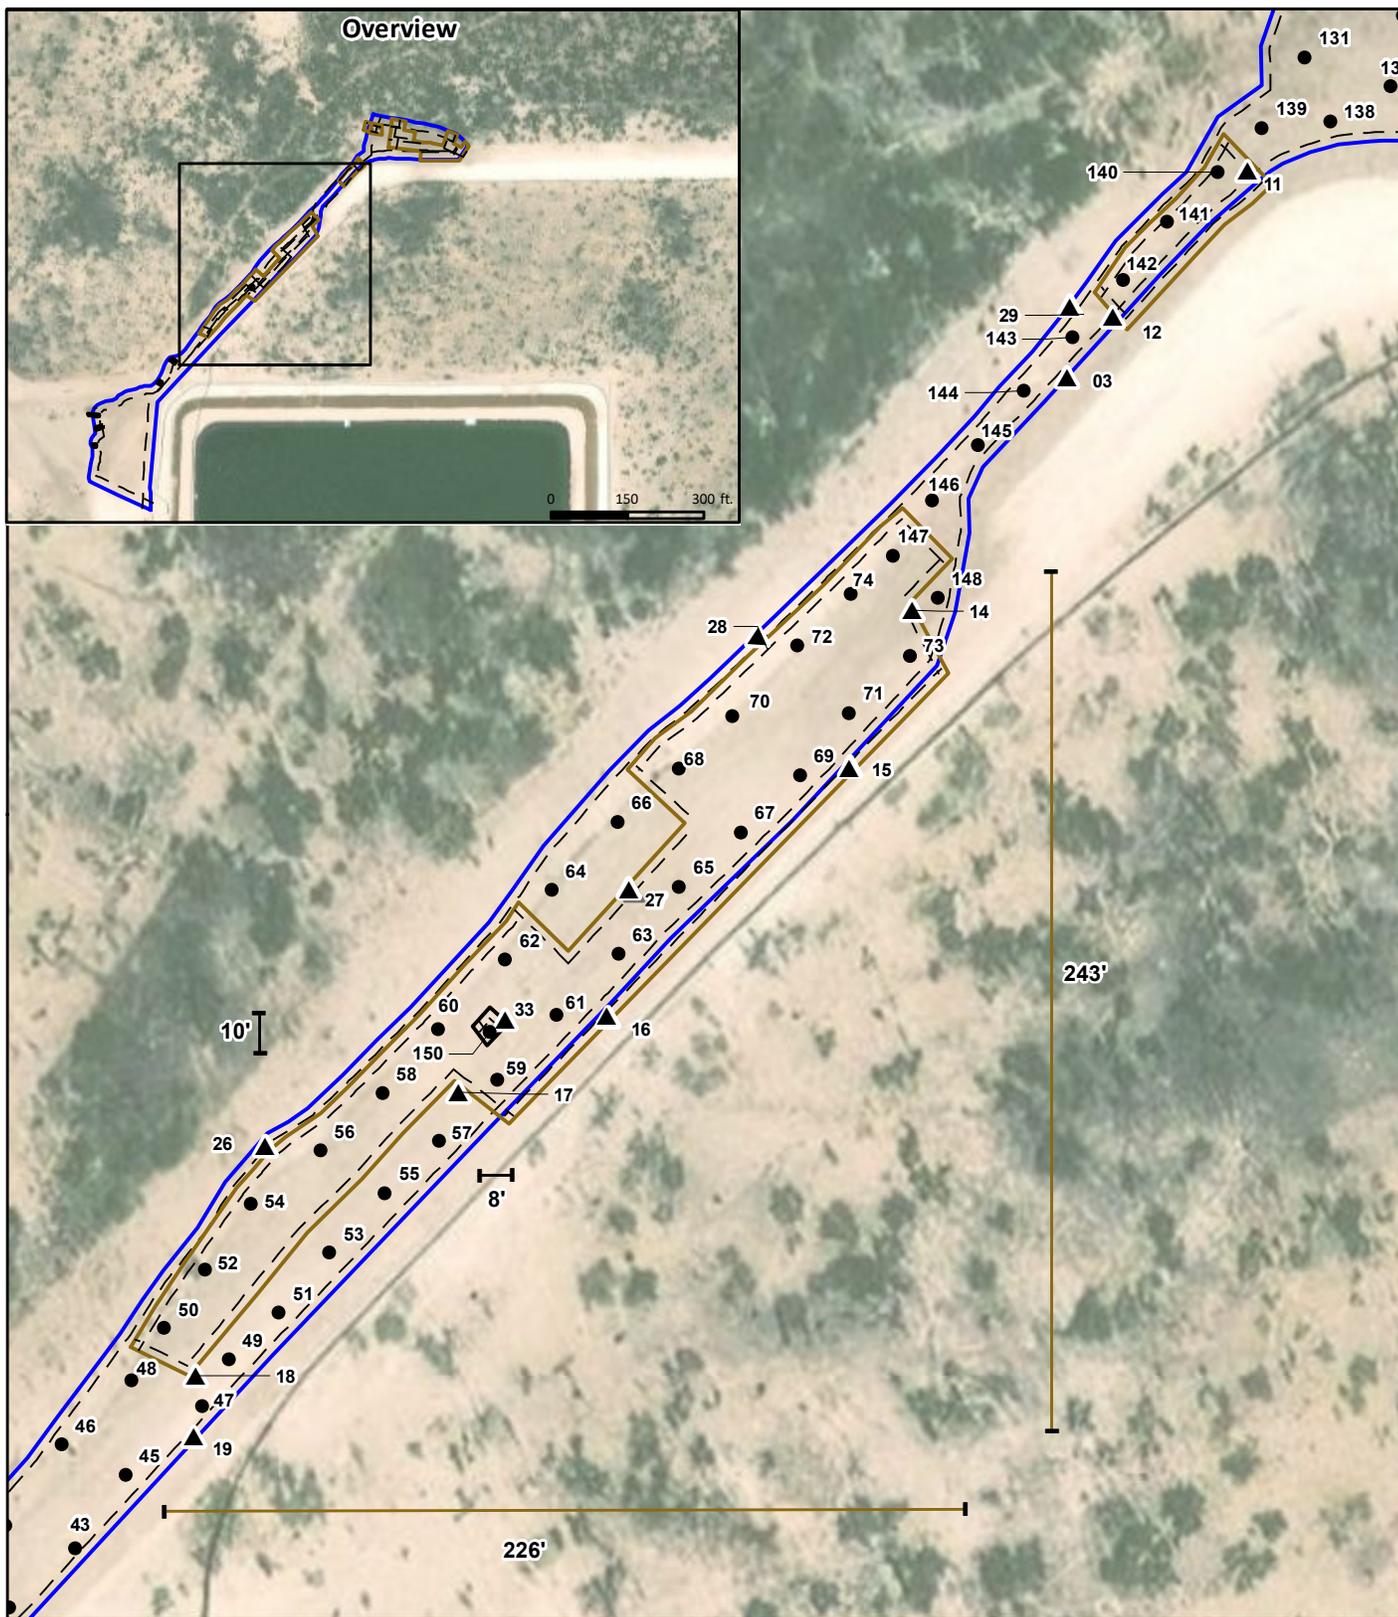
Document Path: S:\04 - Geomatics\1 - Projects\US PROJECTS\Silverback Exploration\23E-02248\Figure 2a Confirmatory Sampling Site Schematic Dayton Recycle Release Middle (23E-02248)ID:8841.mxd

- Base Sample (Prefixed by "BS24-")
- ▲ Wall Sample (Prefixed by "WS24-")
- Excavation to 1' bgs (~58,492 sq.ft.)
- Excavation to 2' bgs (~17,184 sq.ft.)
- Trench Area to 4' bgs (~335 sq.ft.)

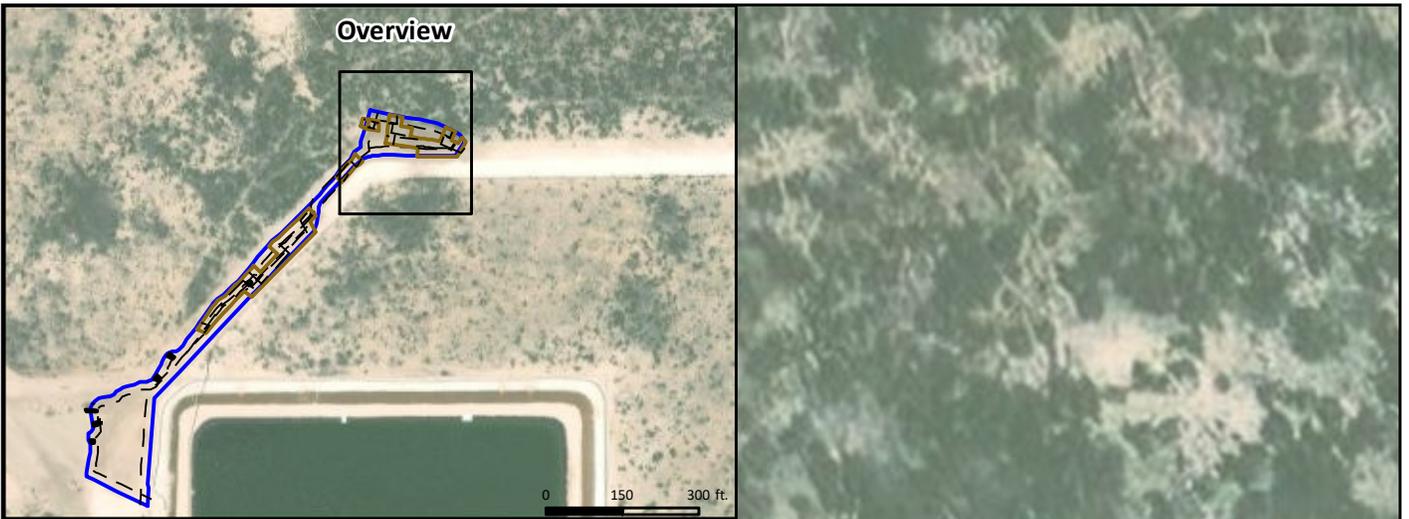
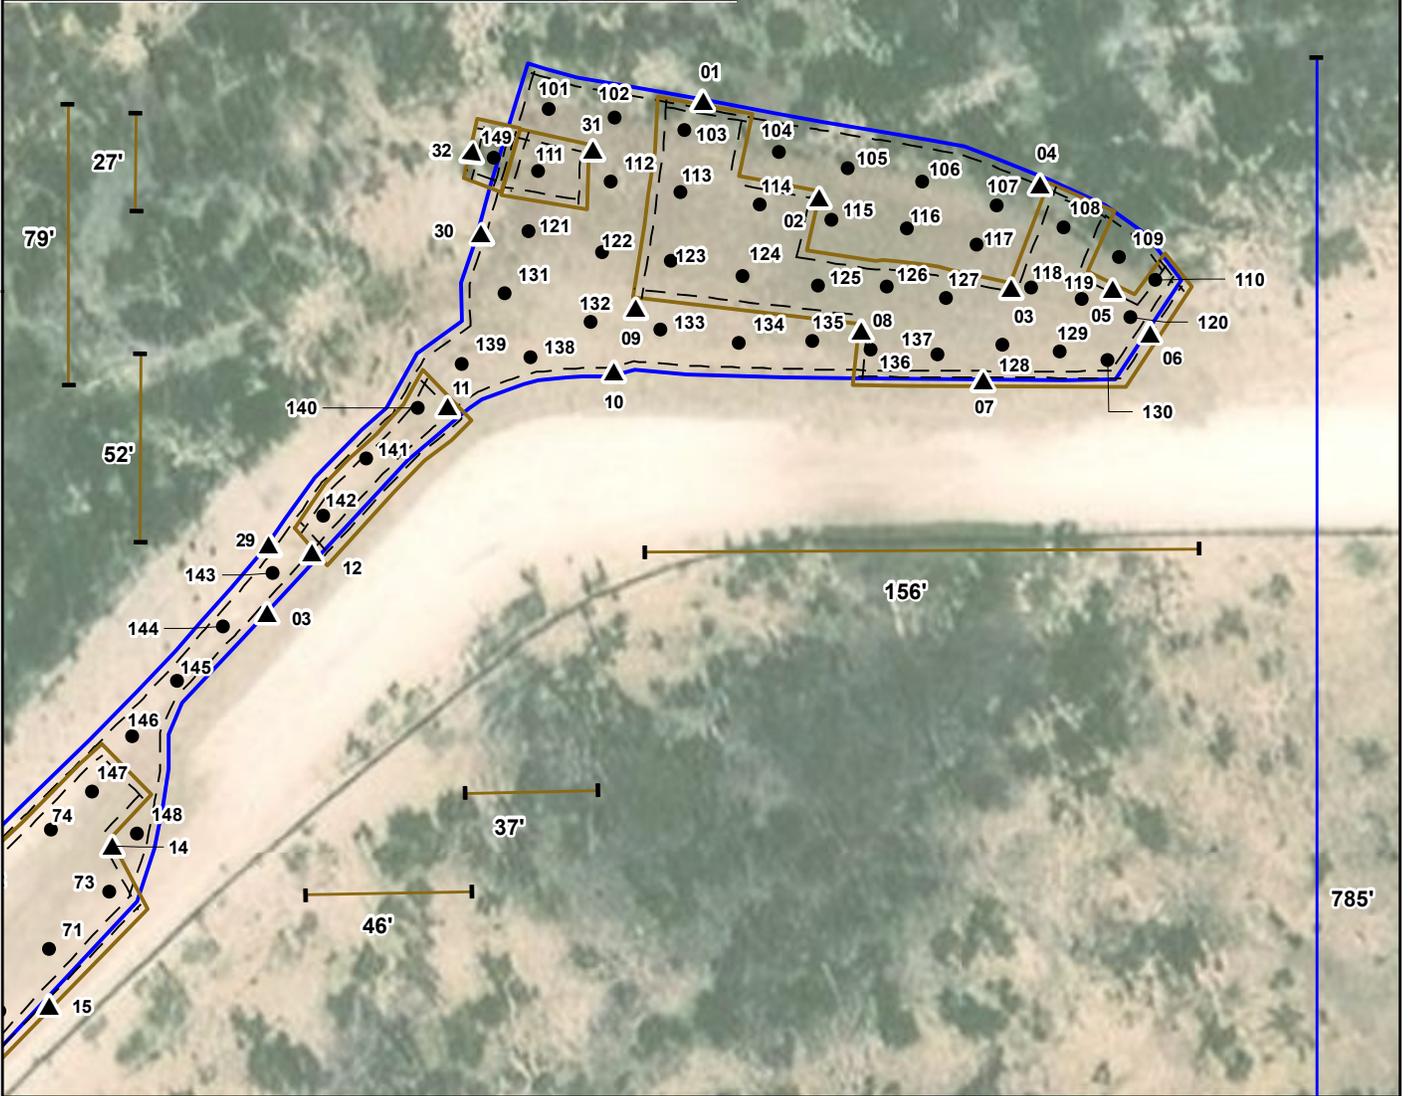
Document Path: S:\04 - Geomatics\1 - Projects\US PROJECTS\Silverback Exploration\23E-02248\Figure 2 Confirmatory Sampling Site Schematic Dayton Recycle Release North (23E-02248)ID1884_1.mxd

- Base Sample (Prefixed by "BS24-")
- ▲ Wall Sample (Prefixed by "WS24-")
- Excavation to 1' bgs (~58,492 sq.ft.)
- Excavation to 2' bgs (~17,184 sq.ft.)
- Trench Area to 4' bgs (~335 sq.ft.)

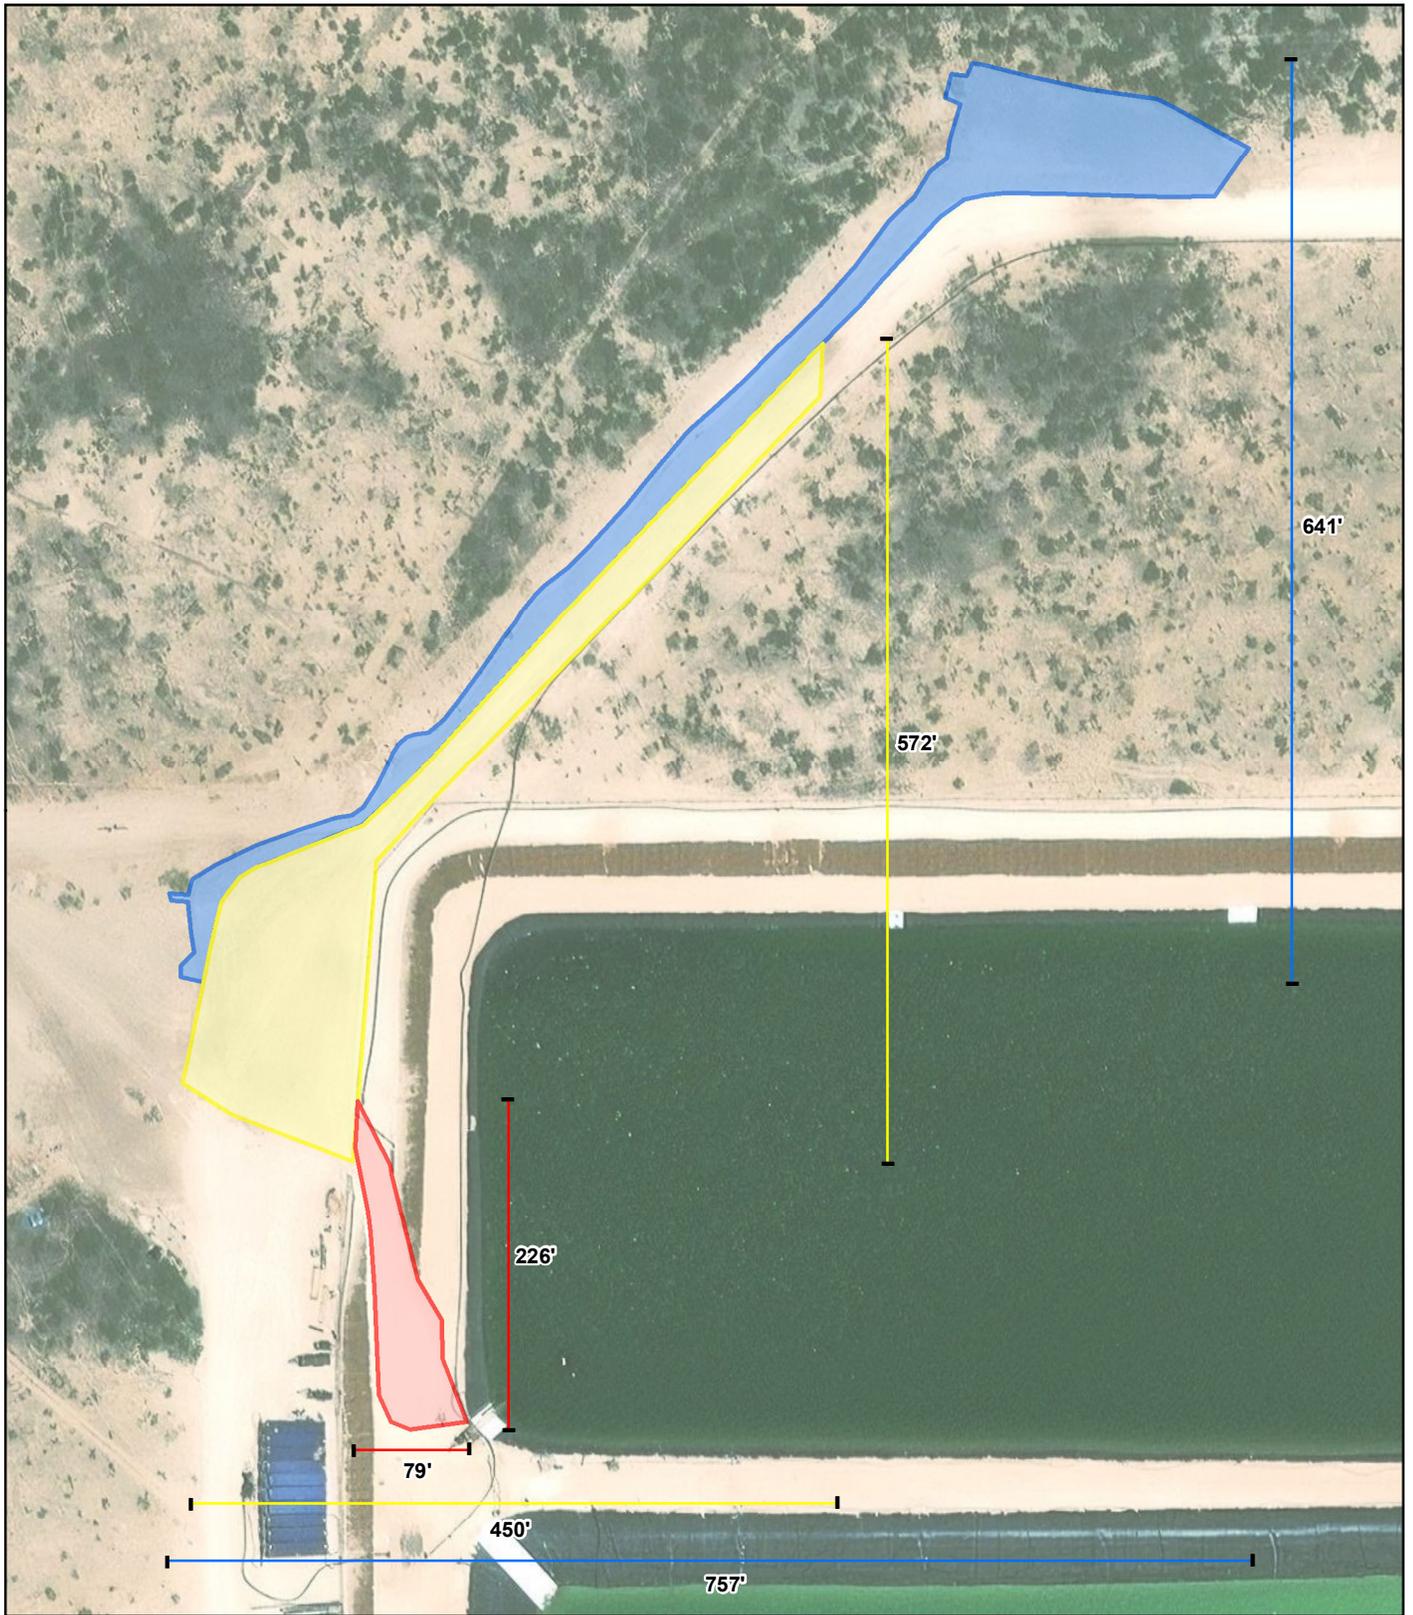
Document Path: C:\I-Projects\US PROJECTS\Silverback Exploration\23E-02248\Figure 3 Dayton Recycle Land Reclamation Schematic (23E-02248)ID18683.mxd

■ Deferral Area (~ 7,234 sq. ft.)
 ■ Land Reclamation Areas (~ 29,609 sq. ft.)
 ■ Reconstructed Pad/Lease Road (~ 32,855 sq. ft.)

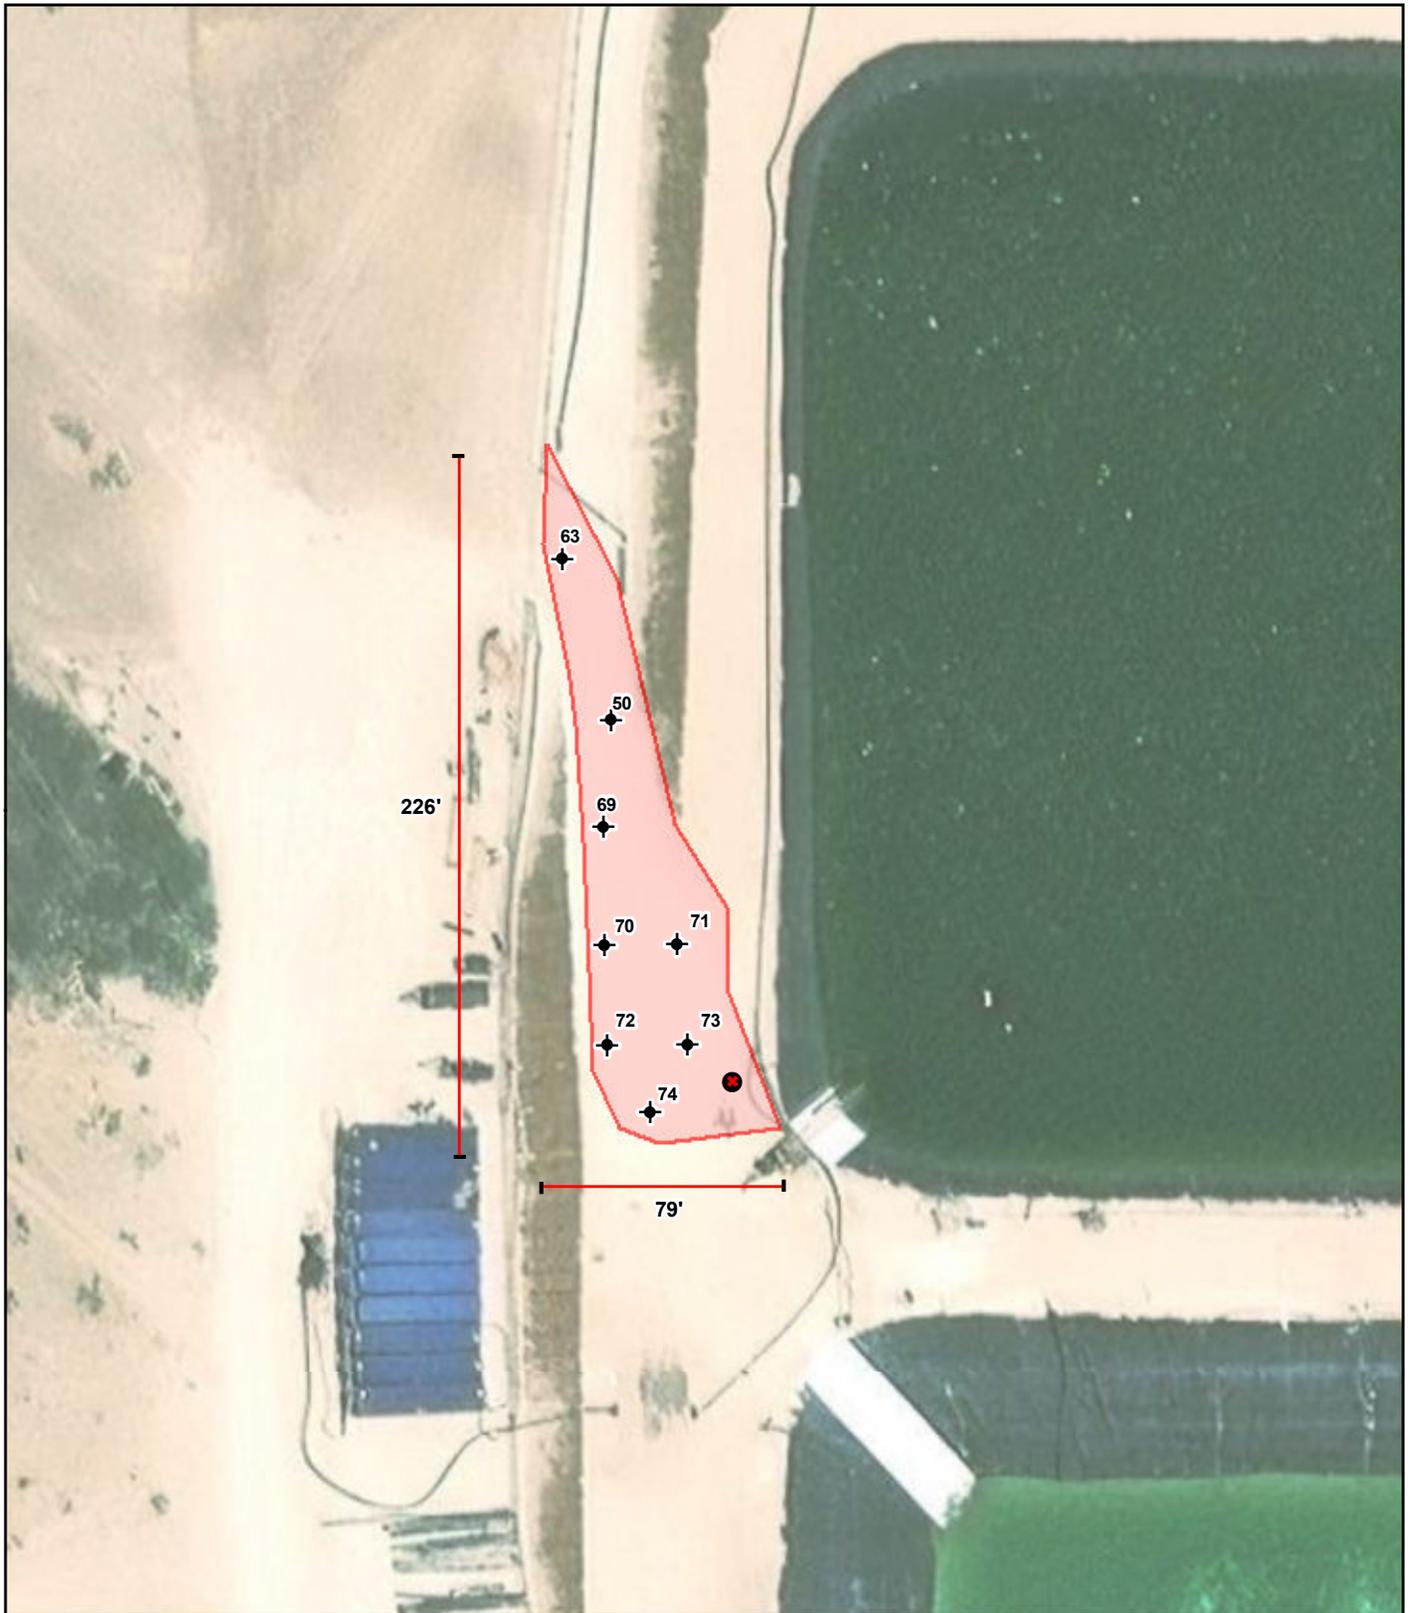
Document Path: S:\04 - Geomatics\1 - Projects\US PROJECTS\Silverback Exploration\23E-02248\Figure 4 Deferral Schematic (23E-02248)ID 18842.mxd

- ◆ Borehole (Prefixed by "BH23-")
- Point of Release
- Deferral Area (~7,234 sq.ft. | ~520 ft.)

On behalf of Silverback, Vertex requests deferral of the portions of the release that are designated in proximity to the pond and are deemed unsafe for excavation of contaminated materials. The release and deferral request areas have been delineated with the understanding that should the deferral request be accepted, restoration of this portion of the release will be deferred until such time as all oil and gas activities are terminated, and the site is reclaimed following remediation activities as per NMAC 19.15.29.13. Those areas are identified on Figure 4. Facility deconstruction will be required to complete remediation of the release, which poses a risk to the structural integrity of the pond.

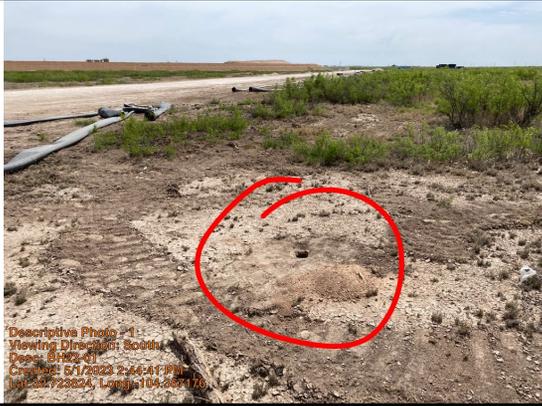
BH23-01

Descriptive Photo - 1
Viewing Direction: South
Date: 5/1/2023
Created: 5/1/2023 2:44:41 PM
Lat:32.723824, Long:-104.367176

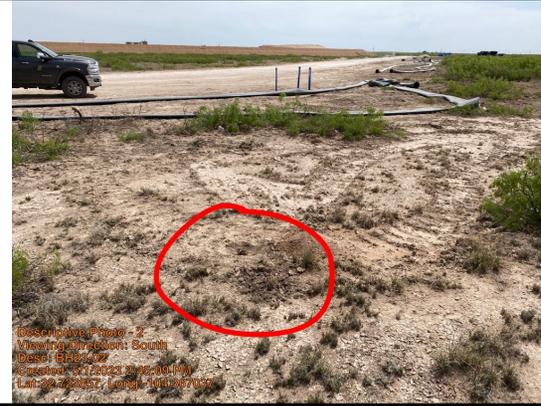
BH23-02

Descriptive Photo - 2
Viewing Direction: South
Date: 5/1/2023
Created: 5/1/2023 2:46:20 PM
Lat:32.723827, Long:-104.367037

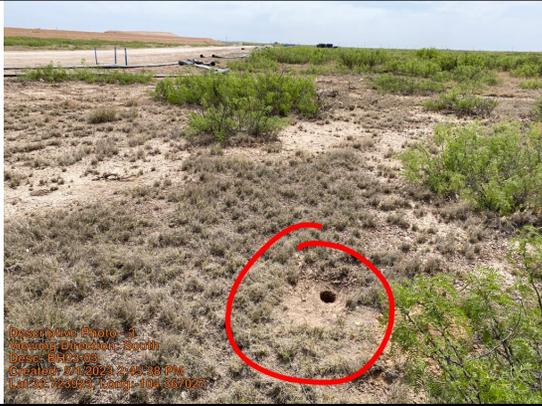
BH23-03

Descriptive Photo - 3
Viewing Direction: South
Date: 5/1/2023
Created: 5/1/2023 2:46:38 PM
Lat:32.723824, Long:-104.367027

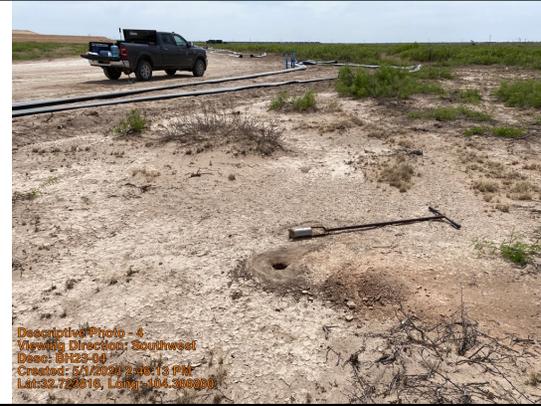
BH23-04

Descriptive Photo - 4
Viewing Direction: Southwest
Date: 5/1/2023
Created: 5/1/2023 2:46:13 PM
Lat:32.723816, Long:-104.366980

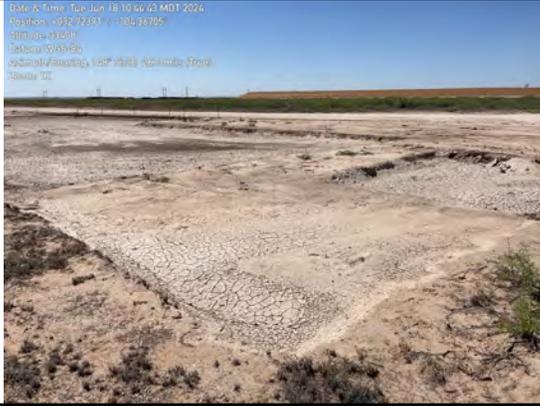
Northern portions of excavation

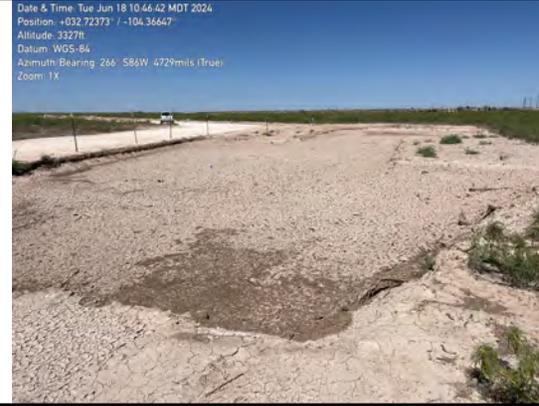
Northern portions of excavation

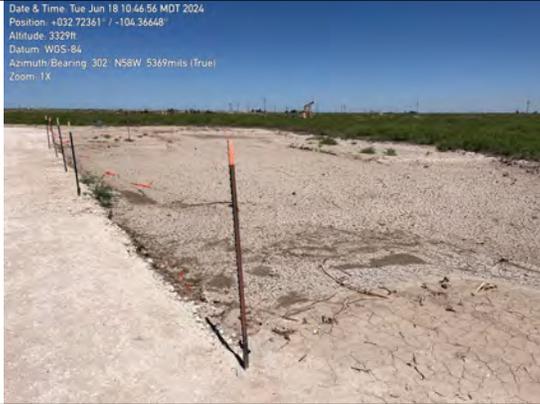
Northern portions of excavation

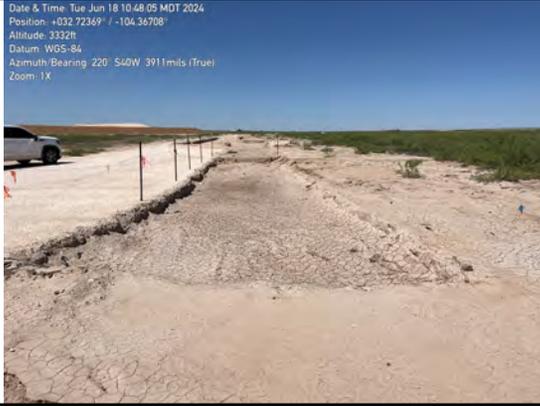
Corridor between northern and middle portions

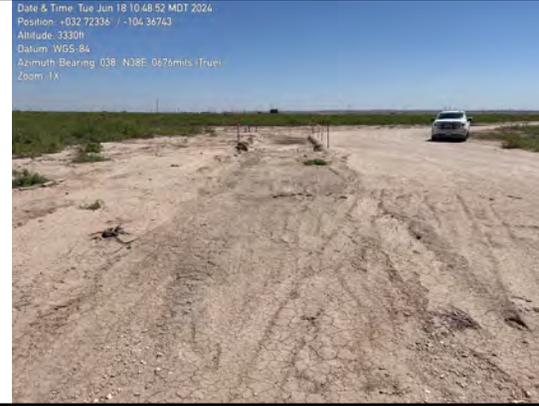
Corridor between northern and middle portions

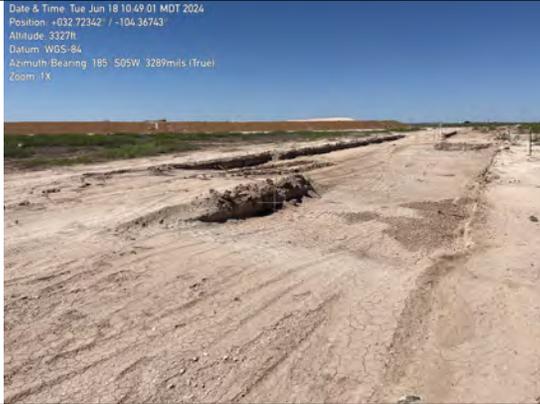
Middle portions of excavation

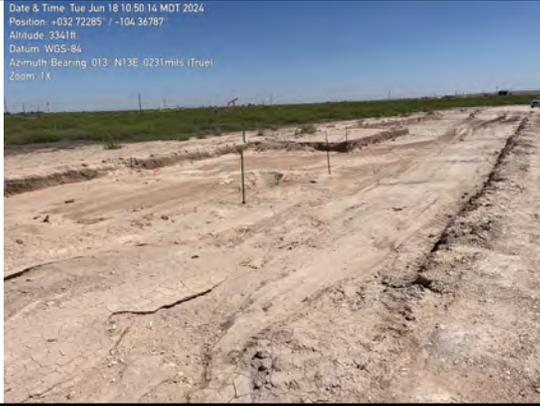
Middle portions of excavation

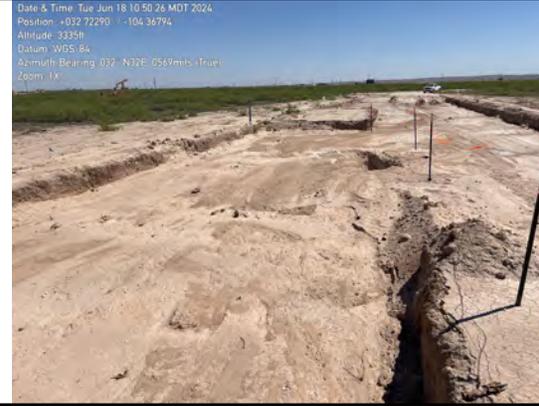
Middle portions of excavation

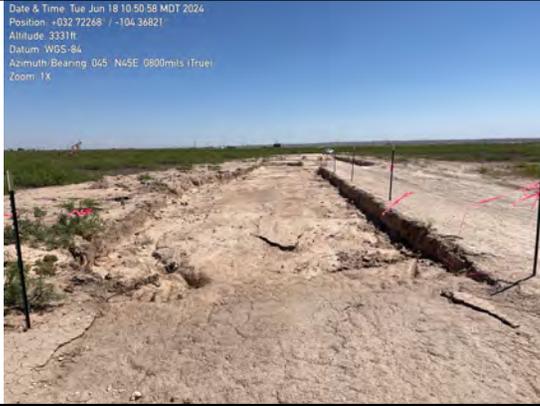
Middle portions of the excavation

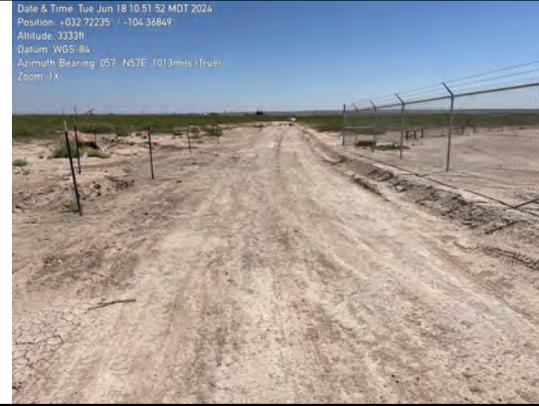
Middle portions of excavation

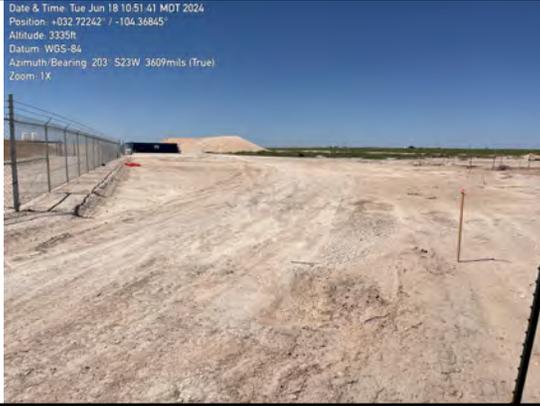
Southern portions of excavation

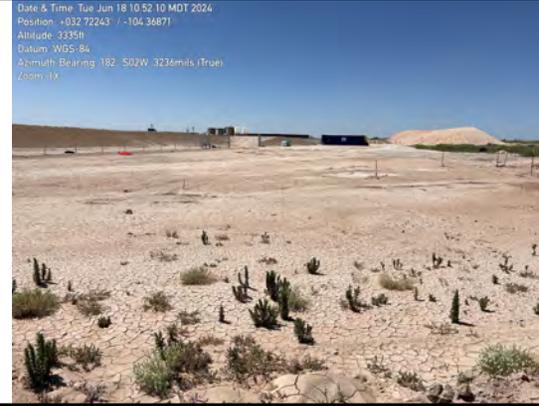
Southern portions of excavation

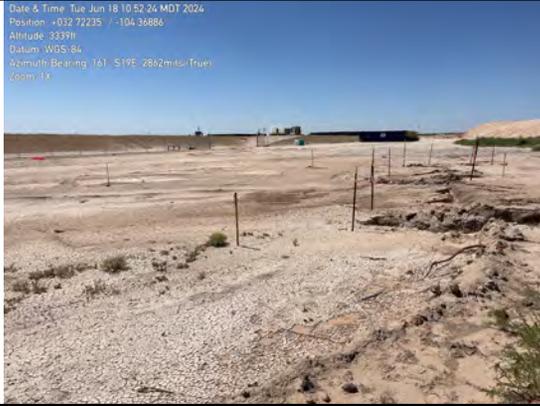
Southern portions of excavation

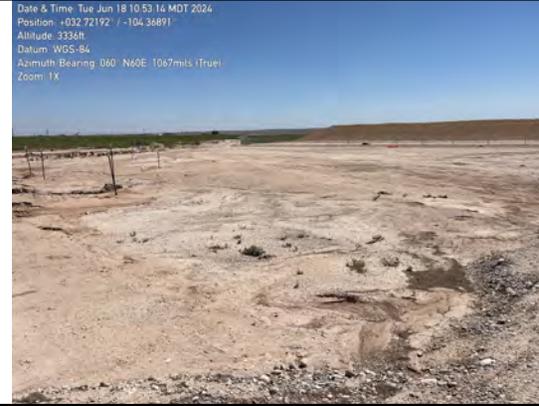
Southern portions of excavation

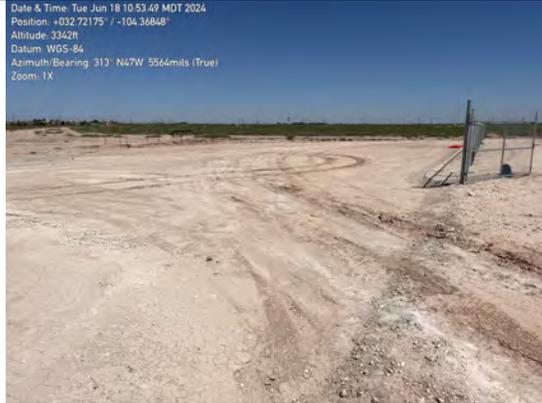
Southern portions of excavation

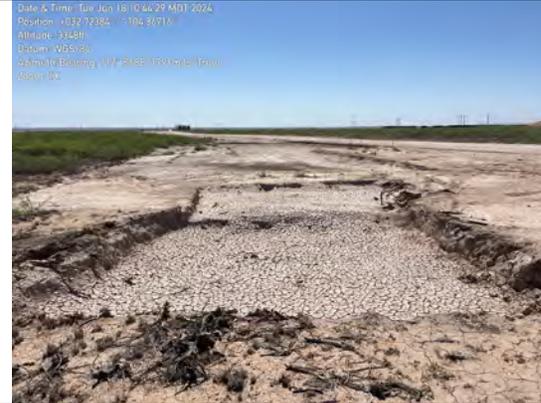
Sampling area for WS24-32/BS24-149

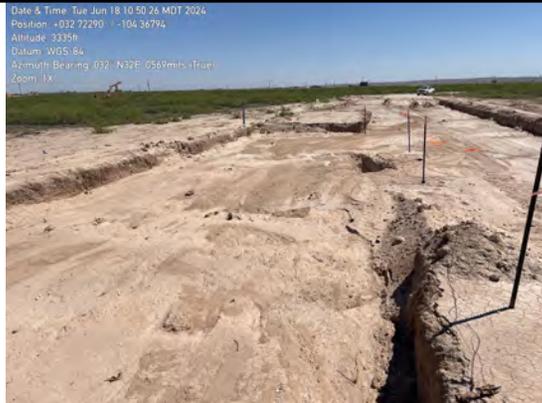
Sampling area for WS24-33/BS24-150

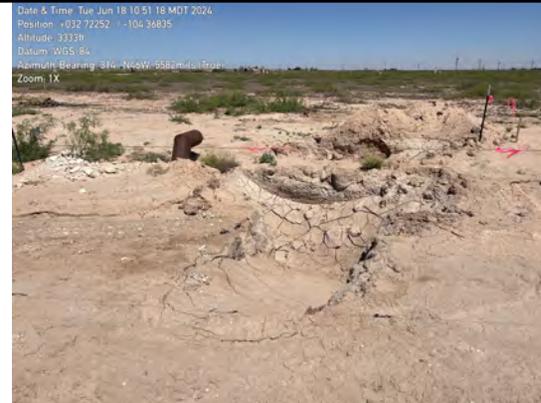
Sampling area for WS24-34/BS24-151

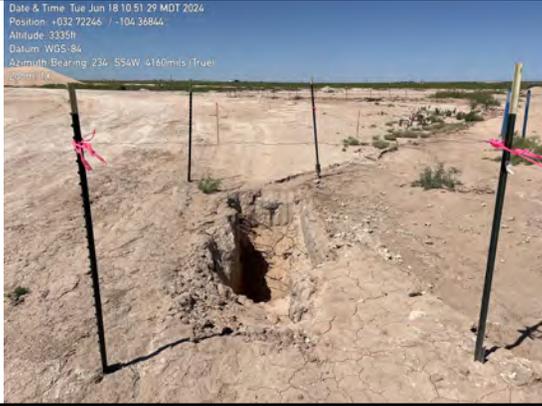
Sampling area for WS24-35/BS24-152

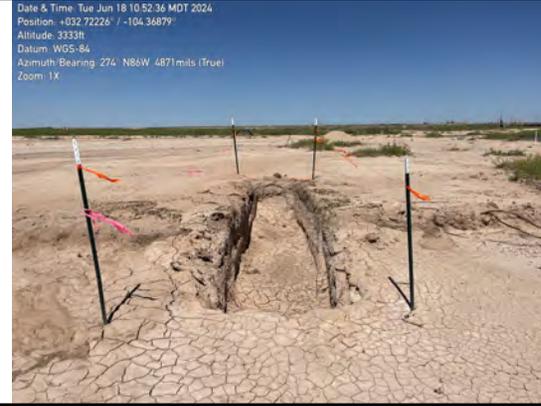
Sampling area for WS24-36/BS24-153

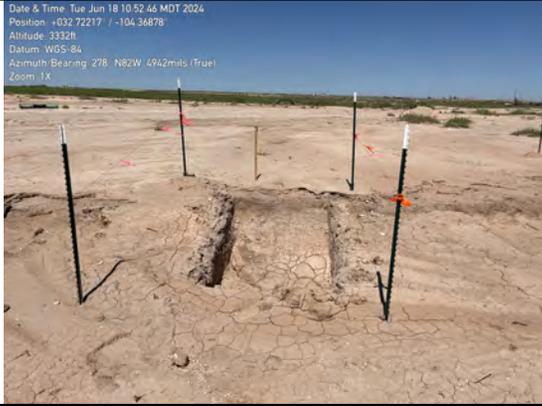
Sampling area for WS24-37/BS24-154

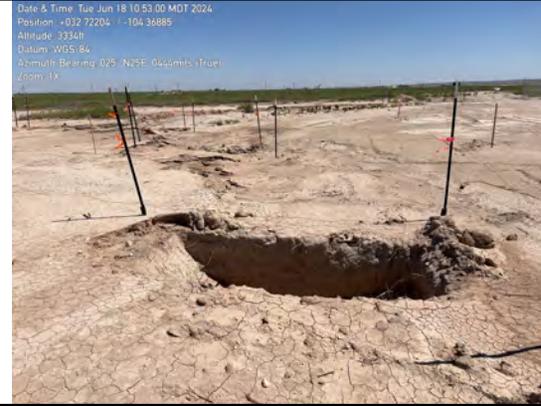
Sampling area for WS24-38/BS24-155

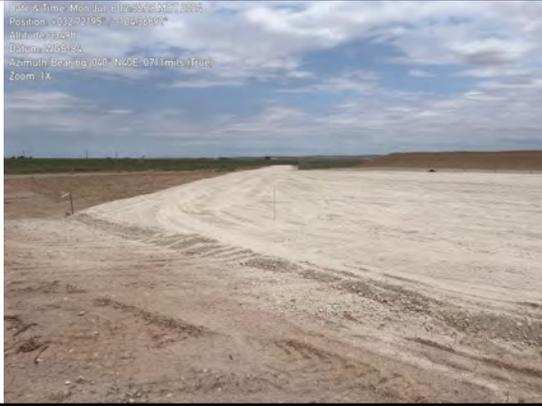
Southern portions of backfilled excavation

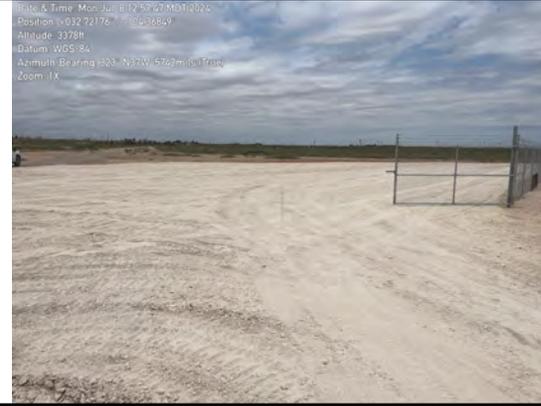
Southern portions of backfilled excavation

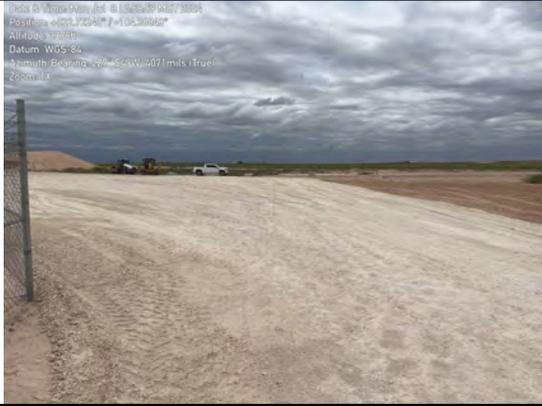
Southern portions of backfilled excavation

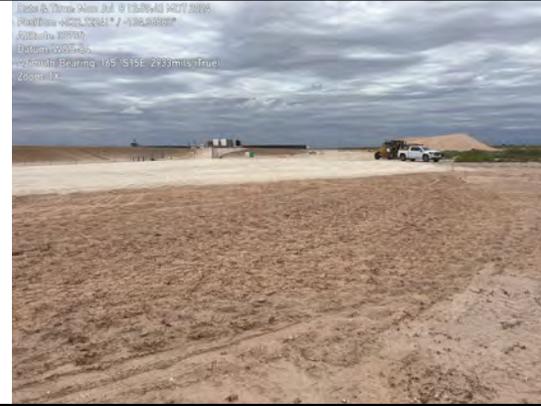
Southern portions of backfilled excavation

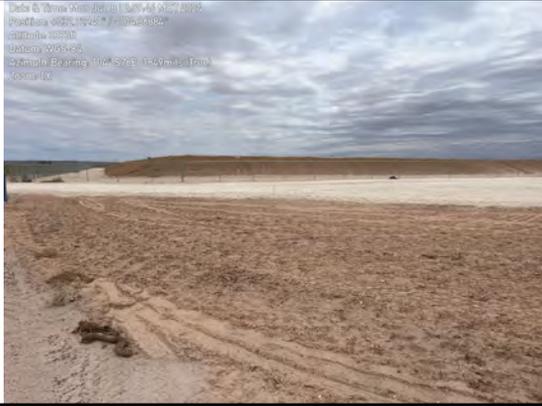
Southern portions of backfilled excavation

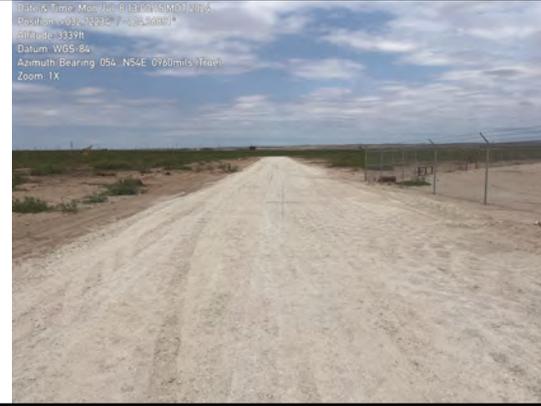
Backfilled lease road

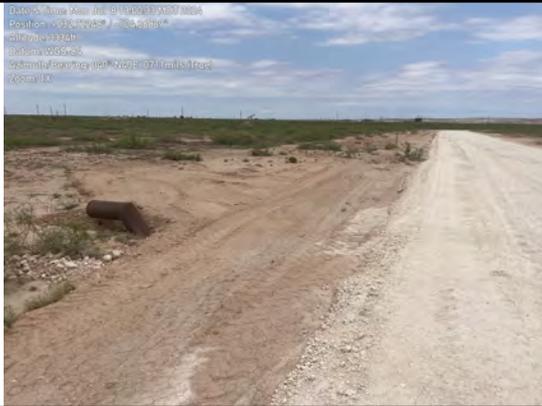
Middle portions of backfilled excavation

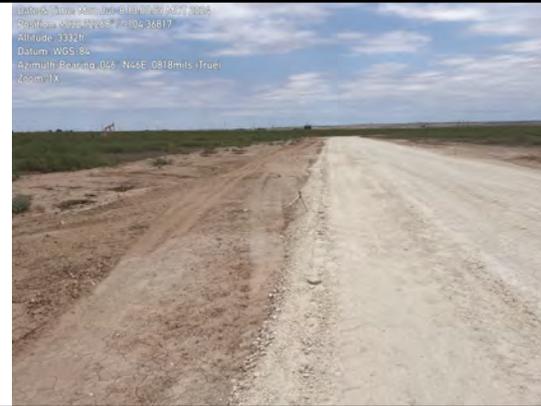
Middle portions of backfilled excavation

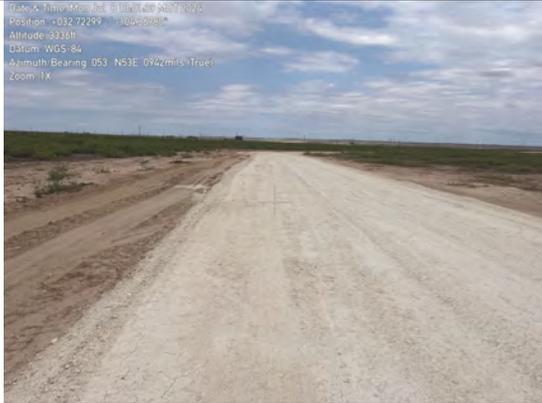
Middle portions of backfilled excavation

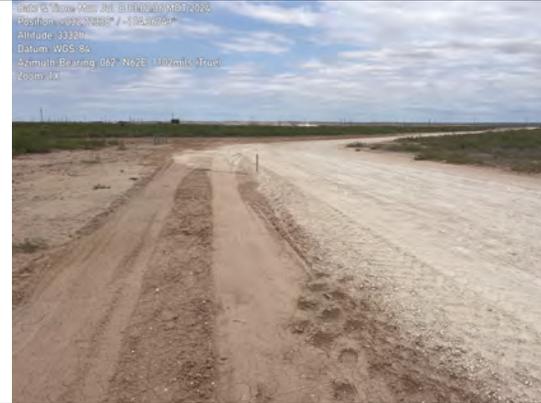
Backfilled road and pipeline ROW

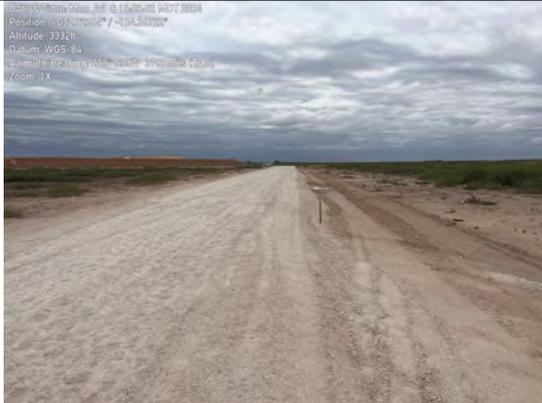
Backfilled road and pipeline ROW

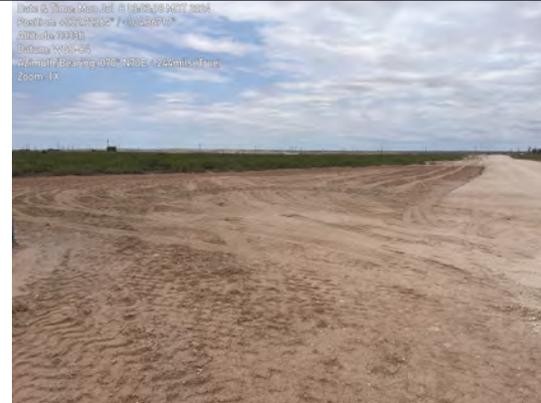
Northern portions of backfilled excavation
