Incident Number: nAPP2307356662

Release Assessment and Remediation, and Deferral Request

Dayton Water Recycle

Silverback Exploration

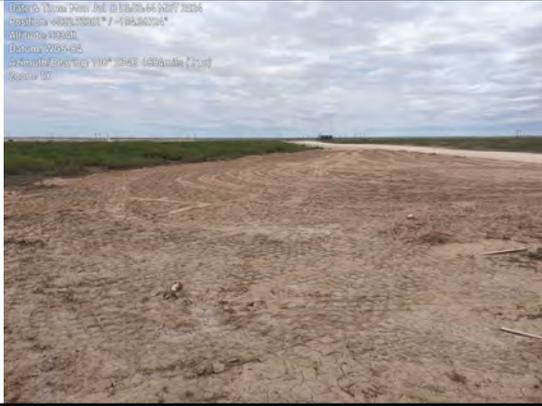
Northern portions of backfilled excavation

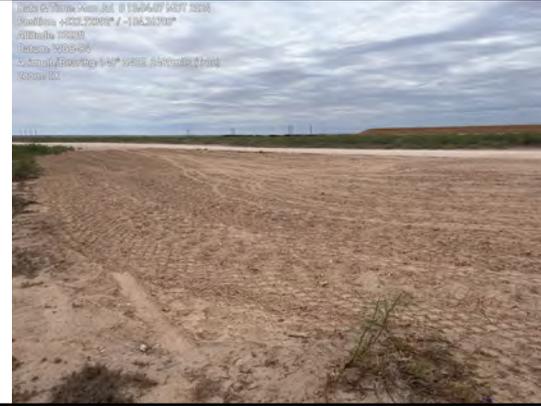
Northern portions of backfilled excavation

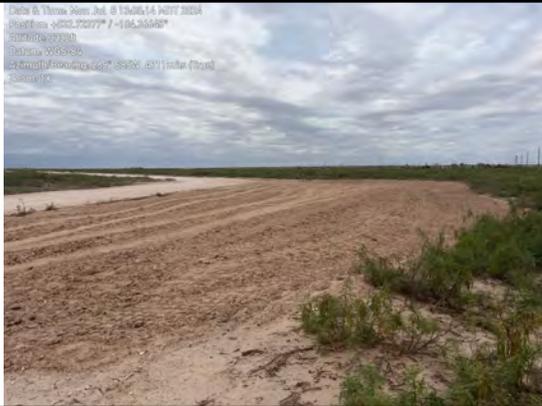
Northern portions of backfilled excavation

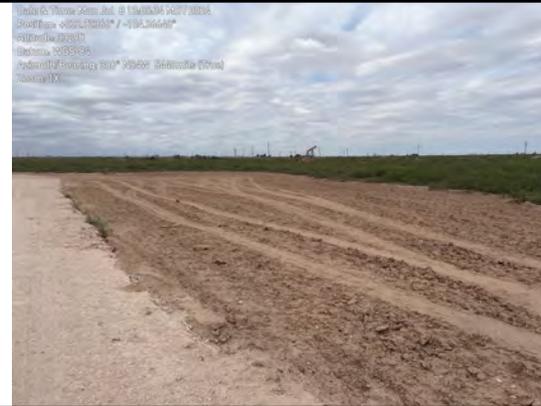
Northern portions of backfilled excavation
